September 13, 2010

RE: Preliminary Report; Art Glass Dome, Skylight & Lighting

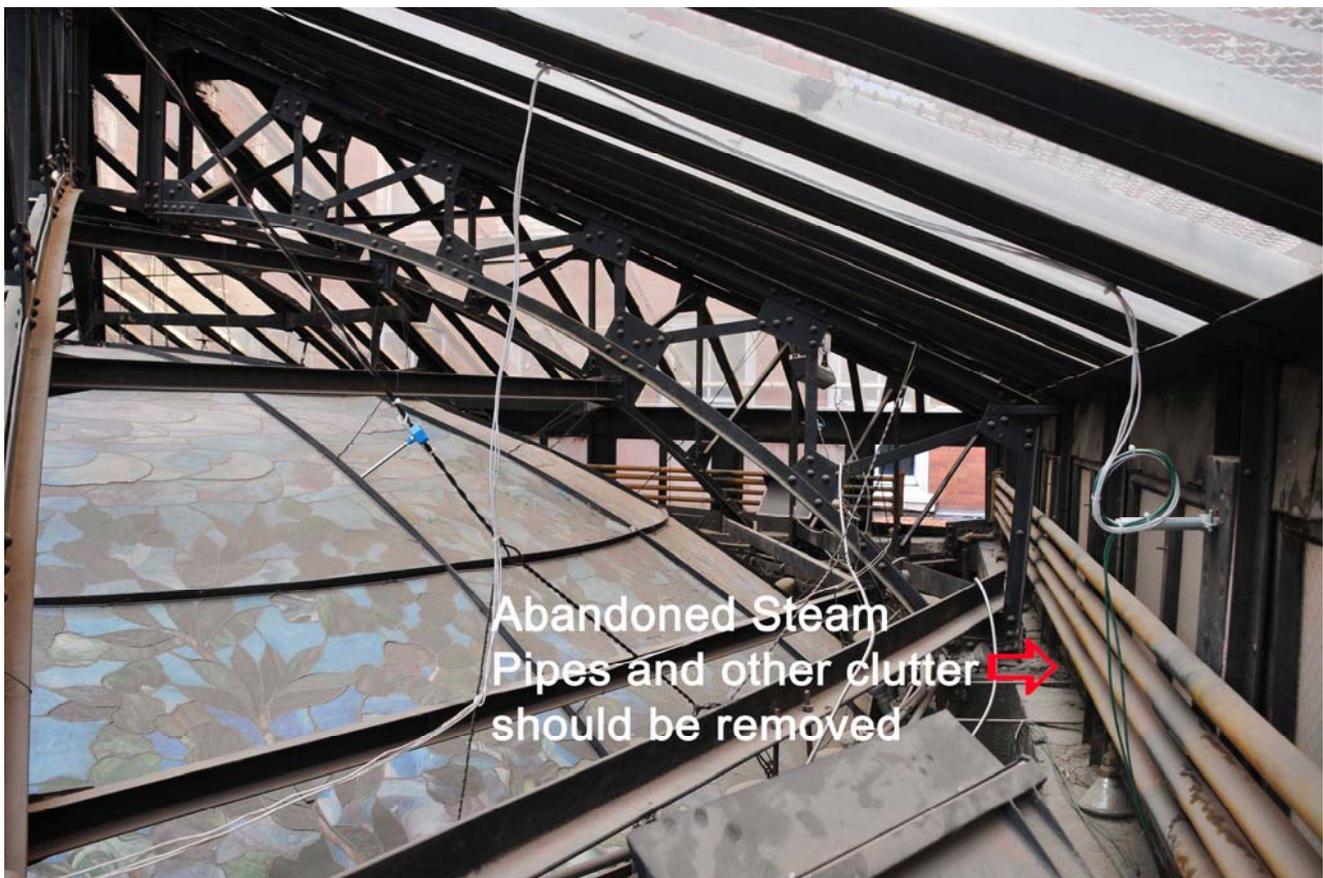
The diffusing skylight is generally in good condition for nearly a century of service. It was originally glazed with hammered wire-glass throughout but the original glass only survives on the sidewalls today. The roof diffusing glass was presumably replaced with laminated glass during the work in the 1980s. If laminated glass is verified throughout the skylight, the heavy-gauge wire screens should be removed to allow more daylight to reach the art glass and facilitate maintenance on top of the skylight and diffusing glass. The sealants on the skylight glass are presumably 25 years old and near the end of their service life. The ventilator on top of the diffusing skylight and cladding could be cleaned and painted at the same time. Any and all clutter that is not required in the interstitial space should be removed—such as the old steam pipes that were abandoned many years ago. This will allow more room to safely move around the art glass dome, reduce shadows, allow more daylight to reach the art glass, and eliminate some of the obstacles to installing better backlighting [see Fig 6.]. This is a low priority but should be considered when scheduling future building maintenance.

FIG 6. Interstitial space between the domes; abandoned steam radiation pipes on the right.

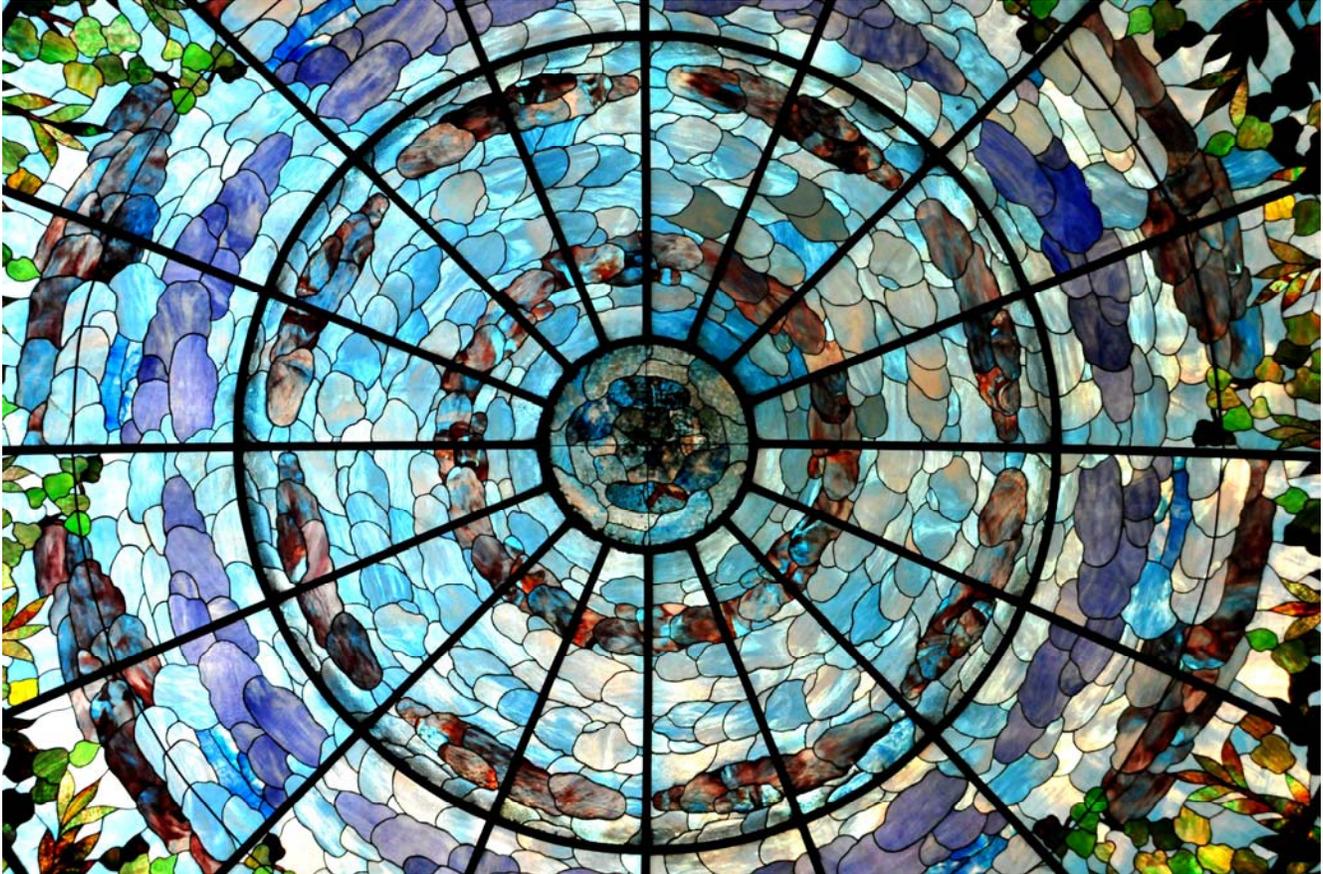
The art glass dome was made with opalescent glass first developed by Tiffany, but I did not see any “favriile” glass from Tiffany’s famed “Corona Furnaces.” Moreover, while art glass landscapes were popularized by Tiffany, this one is comparatively rudimentary in design [see Fig 7.].

Fig 7. Though beautiful in its own right, the rudimentary art glass design does not appear to be Tiffany.
