SITE VISIT - MEMORANDUM

SUBJECT: Ameren Labadie Site Visit, 9/20/11

The purpose of the visit was to assess the seeps in the berm at the Labadie Power plant ash drying ponds. Included with this memo is a satellite photo which shows the plant, coal pile, bottom ash pond, fly ash pond and the Missouri River (Attached).

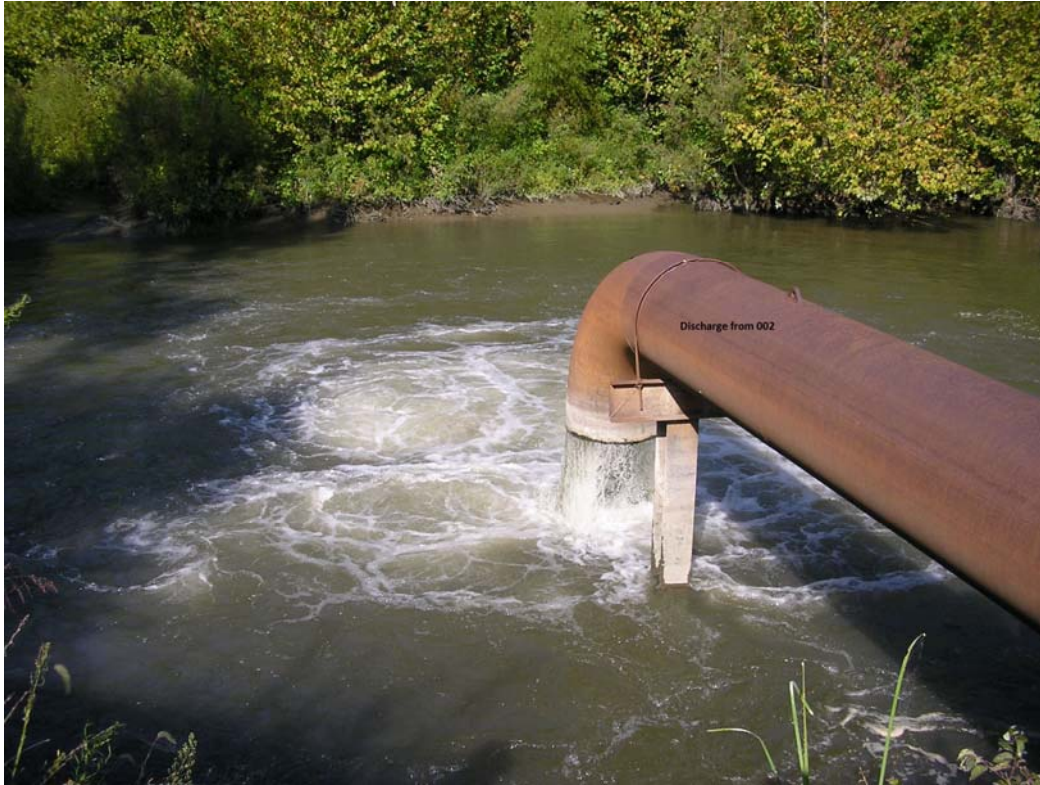
Picture #1

We found a small seep in the vicinity of the 24-inch discharge pipe that travels through the berm wall of the bottom ash pond. This discharge pipe is the permitted outfall (002) for the ash pond. The discharge from this outfall is about 25 million gallons per day (**Picture 1**). There is a low lying area below the discharge pipe where the pipe rests on a rock and soil support at the top of the bank of the unnamed tributary to the Missouri River.

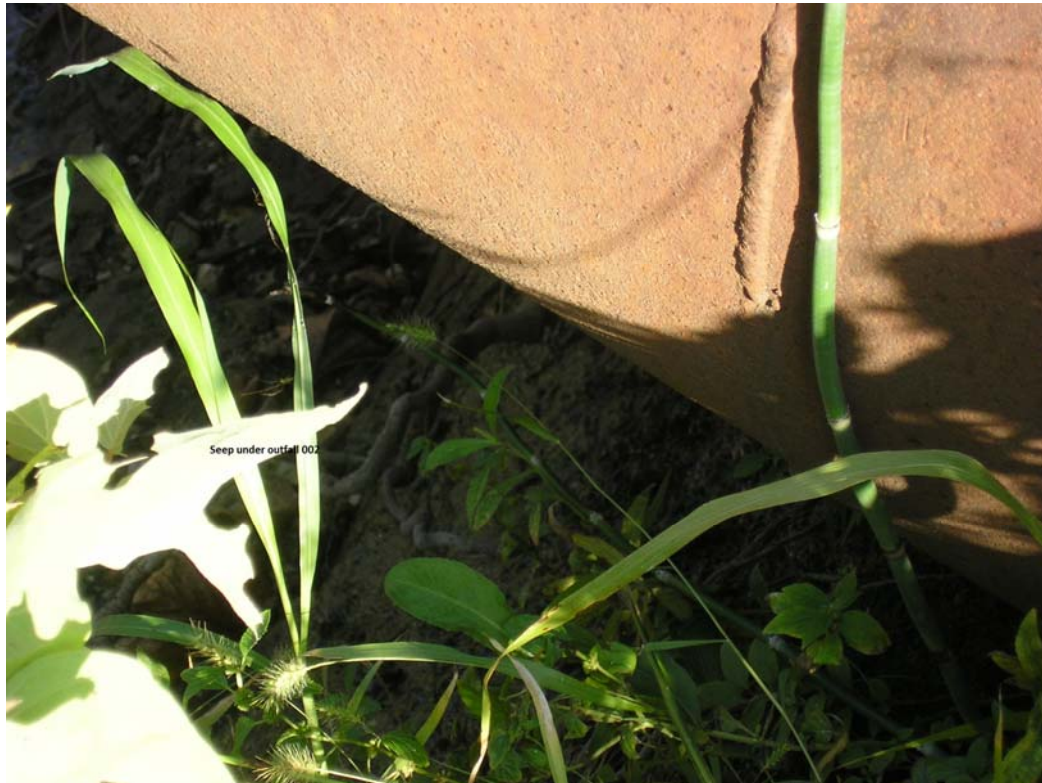
Picture #2

This low lying area collects water from precipitation, flush water from the sample tap and a small amount of water from a leaking riser pipe whose source of water is the discharge pipe. This water seeps through the pipe support and dampens the stream bank under the discharge pipe. **(Picture 2)**

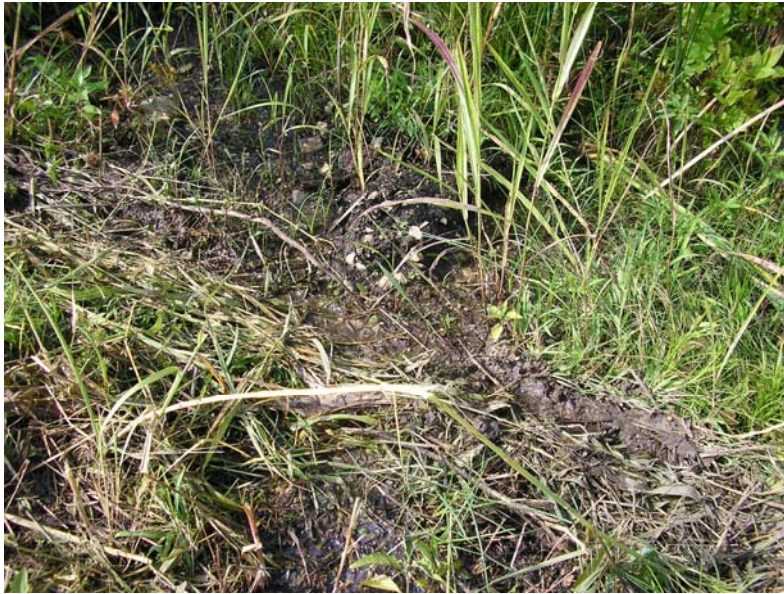
Picture #3

Two visible seeps were located along the southwest toe of the bottom ash pond berm (see attached satellite photo). One seep was very small with the discharge rate unknown and the other seep was discharging about 30 gallons per minute, according to Ameren (**Picture 3, 4**). The effluent from both seeps was running clear and discharging to a wetlands area on Ameren property and isolated from the Missouri River except during flood conditions. According to Ameren the river flood level would have to be approximately 479 – 480 feet before river water would back up into the wetland.

According to Ameren, it has begun design on a 500 foot long, 30 foot deep “cut off wall” to stop the water seeping from the along the southwest side of the bottom ash pond.

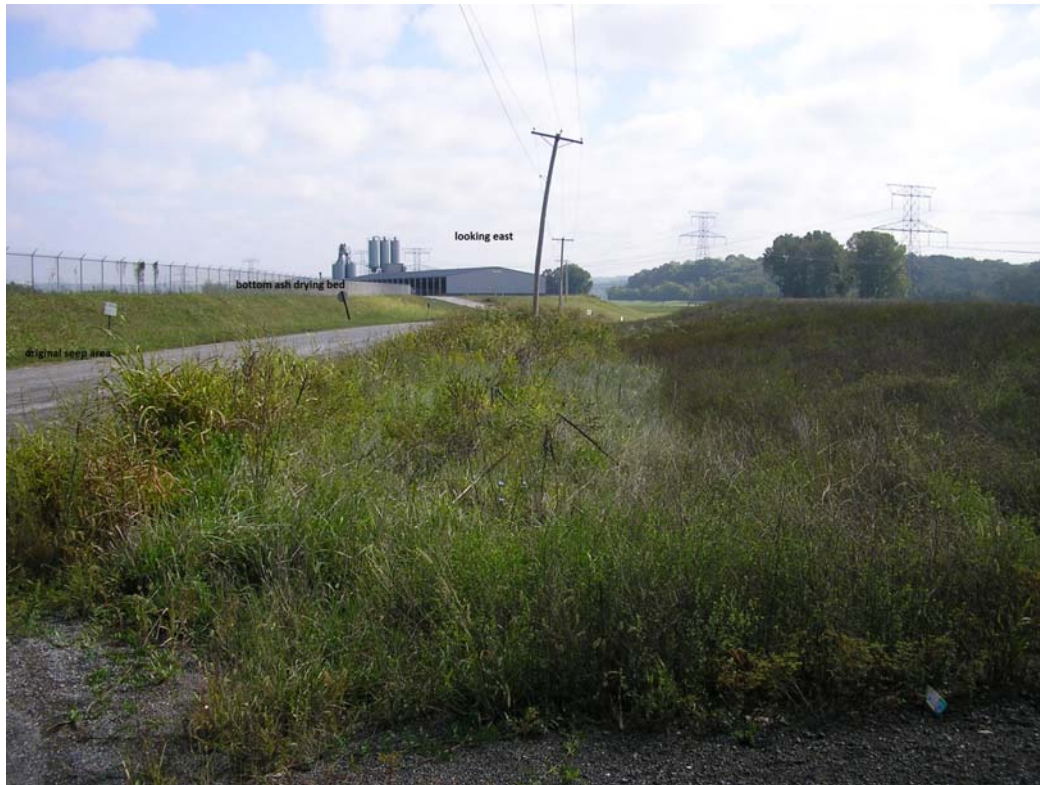
Picture #5

According to Ameren, the original 30 gallon per minute seep reported in 1992 at the south corner of the bottom ash pond (see attached satellite photo) had ceased in 2008 when Ameren filled the area in anticipation of an ash reuse project. The project lost funding **(Picture 5)**.
