# Aviation Investigation Preliminary Report

<b>Location:</b>	Minden, NV	<b>Accident Number:</b>	WPR24FA304
<b>Date &amp; Time:</b>	September 16, 2024, 09:46 Local	<b>Registration:</b>	N78074 (A1); N844CP (A2)
<b>Aircraft:</b>	Globe Swift GC-1B (A1); TEXTRON AVIATION Cessna T206H (A2)	<b>Injuries:</b>	1 Fatal (A1); 2 None (A2)
<b>Flight Conducted Under:</b>	Part 91: General aviation - Personal (A1); Part 91: General aviation - Instructional (A2)

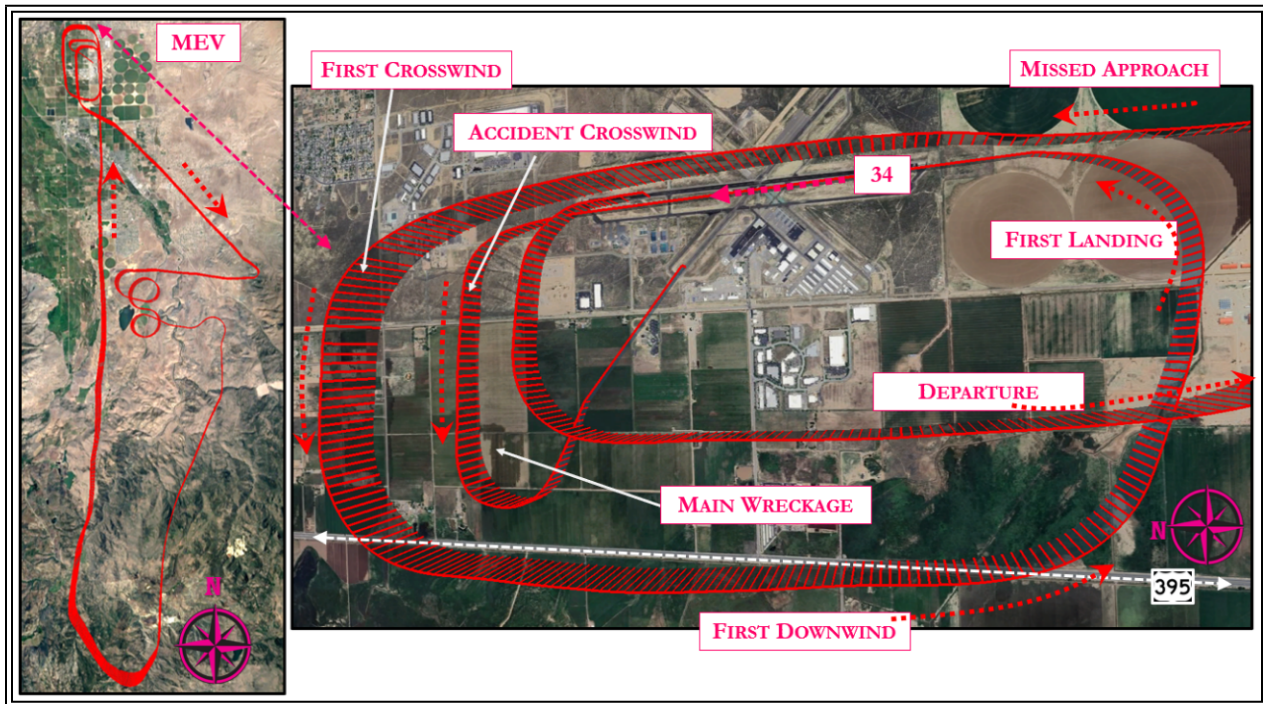
The Cessna was equipped with a Garmin G1000 that recorded trip parameters on an SD card. The recorded data disclosed that the Cessna departed Minden at 0908. After takeoff, the airplane executed several maneuvers south of the airport before returning and overflying runway 34 at 0941 (while at an altitude of 5,700 feet msl). The airplane entered the crosswind leg of the traffic pattern about 1 nm north of the approach end of runway 16 and turned left onto the downwind leg at 5,825 feet msl, flying directly above US-395. After touching down on the runway, the airplane took off again at 0945:20. The airplane turned crosswind about 0.4 nm of the approach end of runway 16 at 0946:25 at an altitude of 5,225 feet msl. The ADS-B data shows the airplane then making a left turn and descending to runway 12 (see Figure 01 below).

Figure 01: Cessna ADS-B and G1000 tracks.

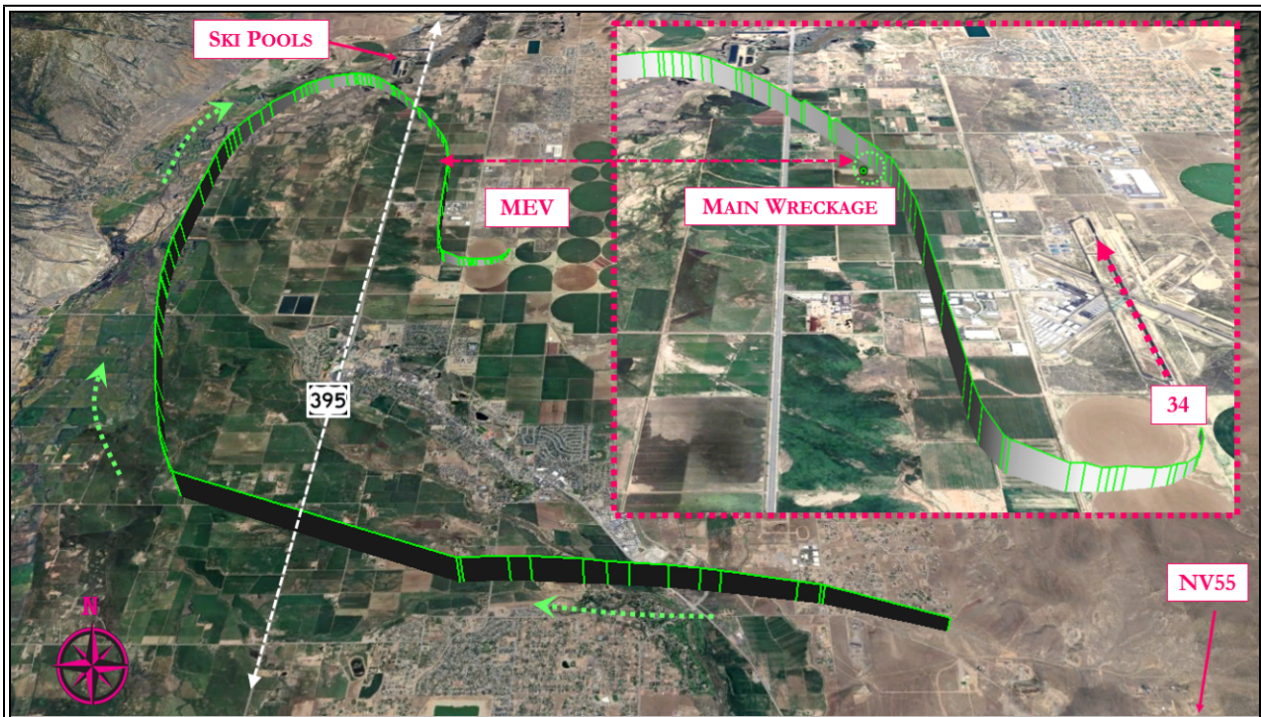
The Swift was not equipped with ADS-B and no radar data was available at the time of this writing. The pilot often flew the friend's GC-1B Swift airplane that was equipped with ADS-B (wired to the navigation lights) and a higher-horsepower engine than the accident Swift. Investigators located several flight tracks that were attributed to when the pilot was flying, one of which occurred on July 20, 2024 and originated from NV55 and terminated at KMEV (see Figure 02 below). The friend confirmed that this was the pilot's exact normal pattern and that he was flying the airplane at that time. It is presumed that the prior approximate 15-minute flight was similar to the accident flight path.

Figure 02: Swift pilot's prior traffic pattern to runway 34

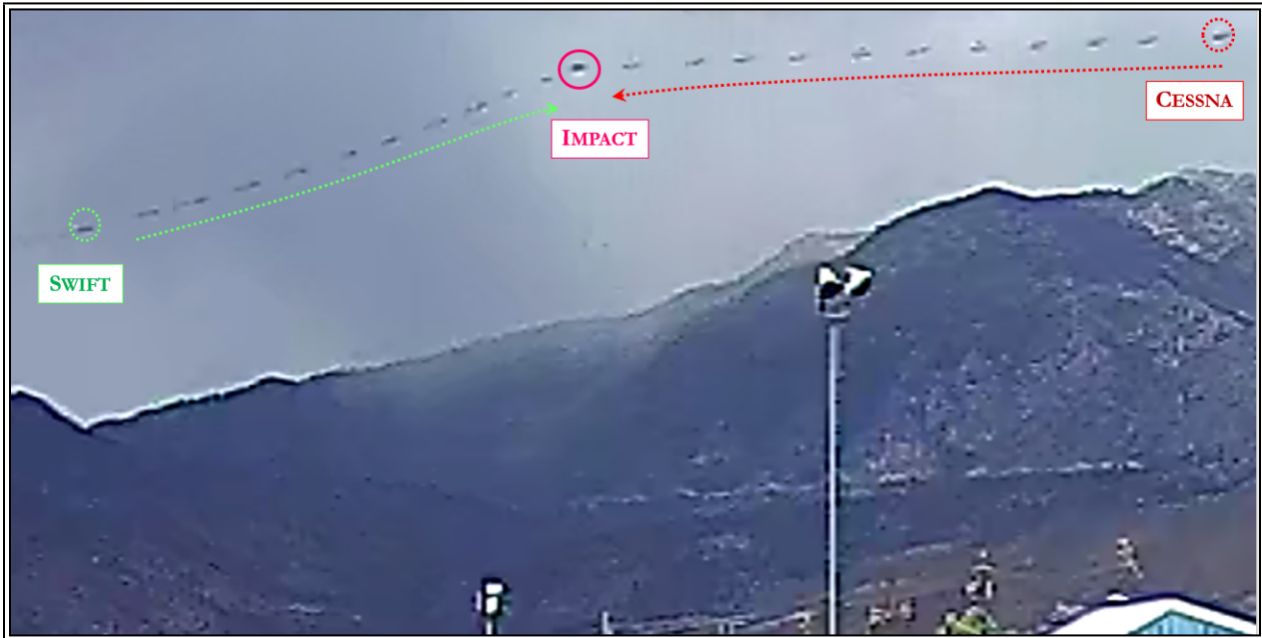
Numerous cameras captured low-quality footage of the airplanes' movements leading up to the impact. An airport security camera showed the Cessna on crosswind in a gradual ascent and the Swift arriving from Jack's Valley, northwest of KMEV (see Figure 03 below). A dashcam video from a driver heading north on the US-394 showed the Swift crossing west over the freeway and at a slightly higher altitude of

Figure 03: Composite footage of a northwest-facing airport security camera showing the impact.

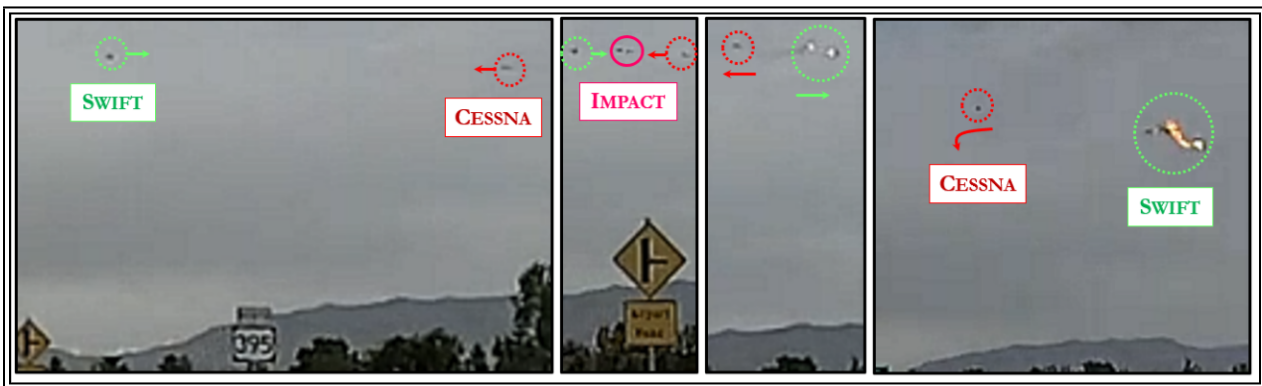
the Cessna just prior to impact (see Figure 04 below). After impact, the Swift can be seen erupting in flames and falling near vertical to the fields below. It could not be definitively determined if the Swift made an evasive maneuver before the impact or if either airplane had the navigation and strobe lights operating.

Figure 04: Clips of dashcam footage showing the seconds before and after the impact.

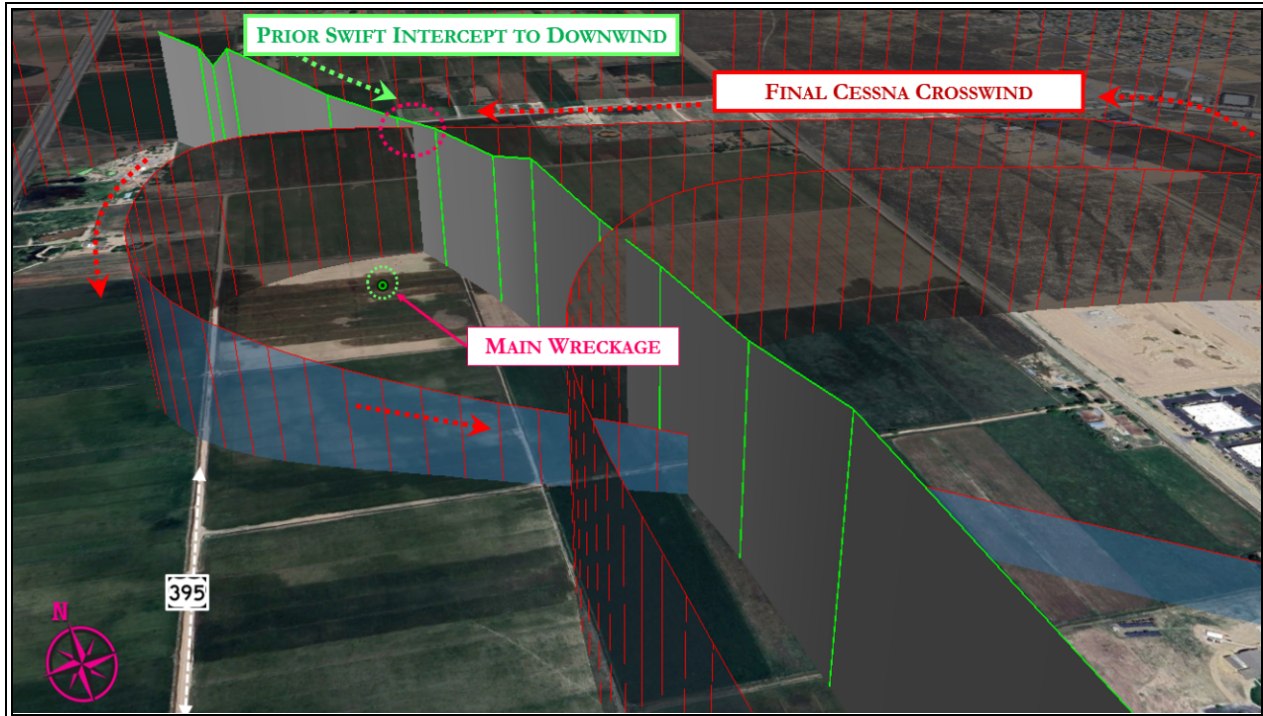
Comparing the Cessna flight track and the prior Swift flight track showed that the paths intersected near the location where the videos appeared both of them collided (see Figure 05 below).

Figure 05: Comparison of the Cessna's accident flight track and the Swift pilot's prior flight.

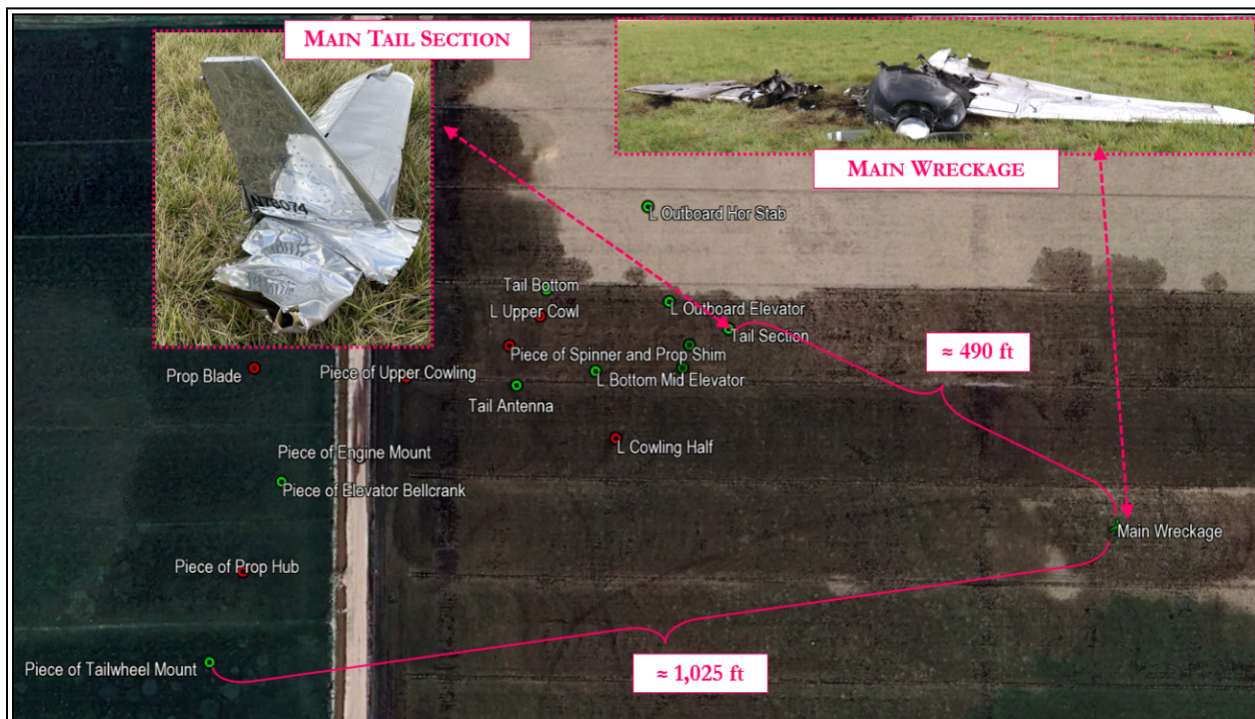
located 450 feet from the main wreckage, was missing the bottom tail cone, the outboard right elevator, horizontal stabilizer, and the rudder, all of which were found nearby in the debris field. The debris field stretched over 1,025 feet and contained intermingled pieces from both the Cessna and Swift (see Figure 06 below). Numerous fragments of the Swift's skin were scattered throughout the debris field, with the majority coming from the lower tail section. Numerous pieces of debris were coated with red hydraulic oil from the Cessna's propeller hub.

Figure 06: Main debris field (green dots from the Swift and red dots from the Cessna).

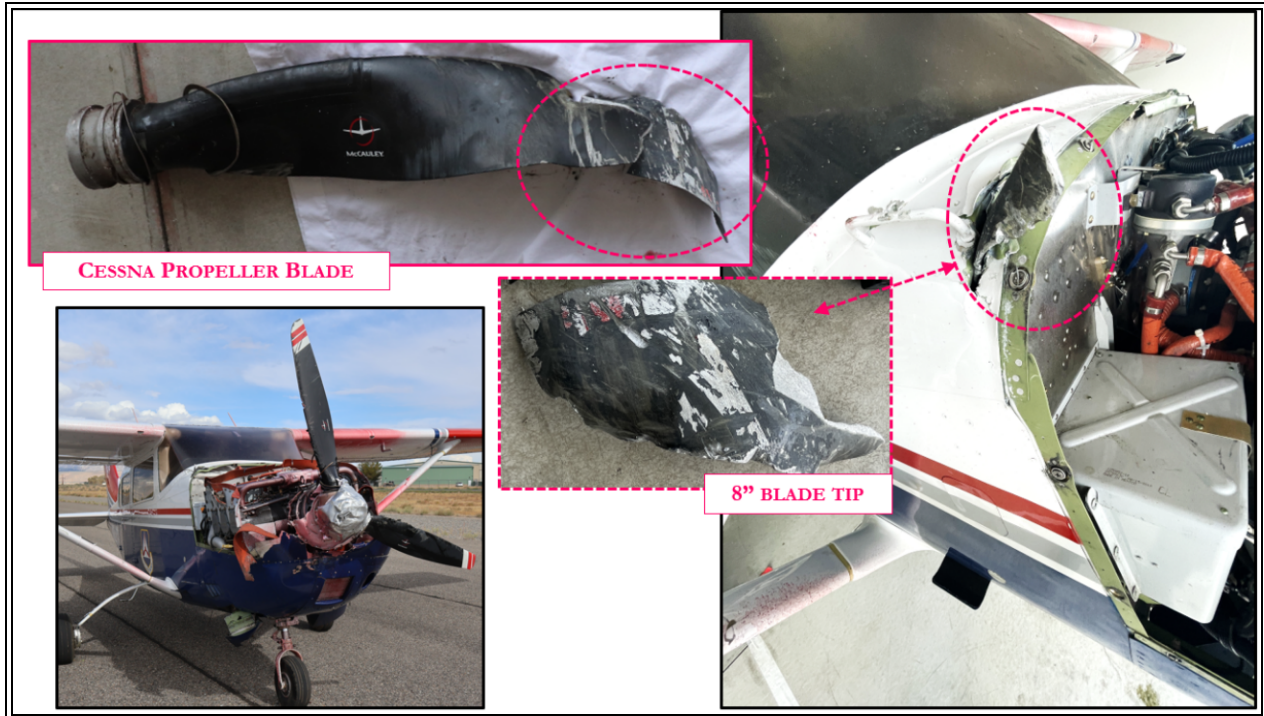
An examination of the Cessna revealed that one propeller blade had separated from the hub, with the main portion found in the debris field and the tip lodged in the firewall area (see Figure 07 below). The engine had canted to the right from the mounts breaking. Postaccident investigation also revealed that the Swift's tailwheel, along with portions of its mounting, was lodged entirely underneath the Cessna's engine, obscured from view without moving the engine (see Figure 08 below). Additionally, the Cessna's front-right engine mount had completely broken away from the airframe and was found near the tailwheel, having punctured the tunnel.

Figure 07: Cessna propeller (missing blade).

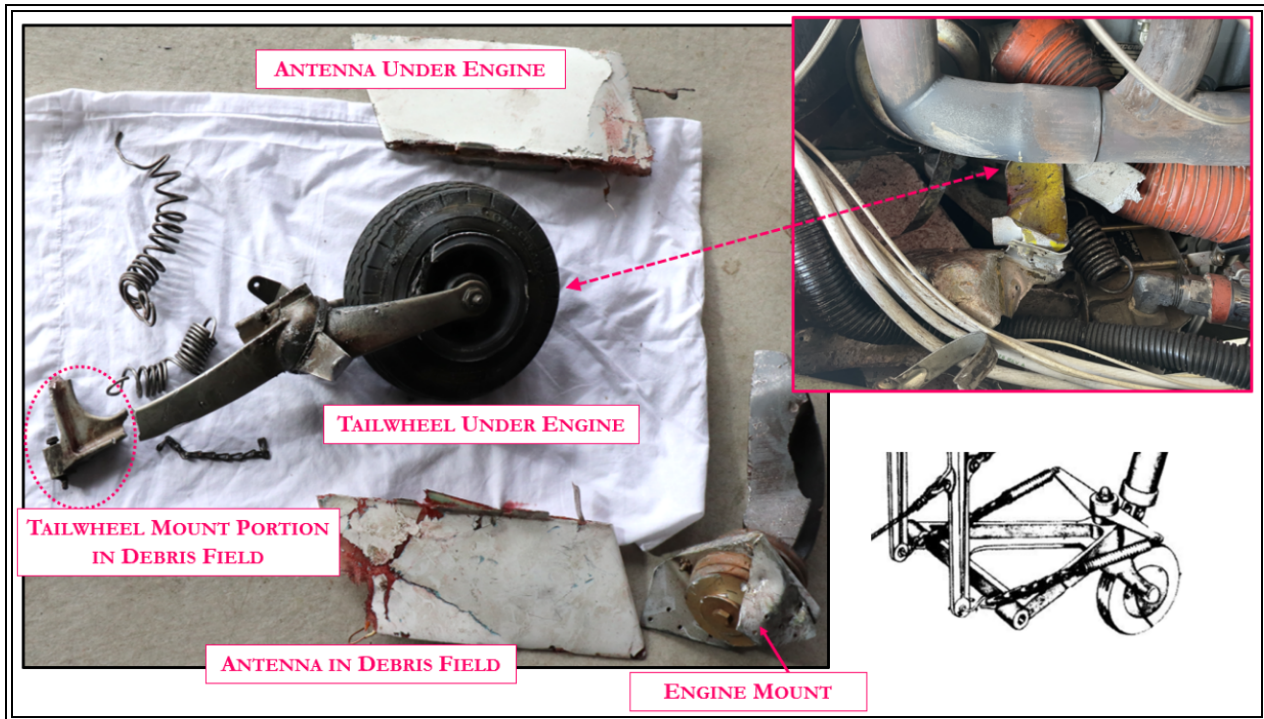
Figure 08: Swift tailwheel and antennas.
