# Aviation Investigation Final Report

<b>Location:</b>	Stagecoach, Nevada	<b>Accident Number:</b>	WPR23MA113
<b>Date &amp; Time:</b>	February 24, 2023, 21:14 Local	<b>Registration:</b>	N273SM
<b>Aircraft:</b>	Pilatus PC-12/45	<b>Aircraft Damage:</b>	Substantial
<b>Defining Event:</b>	Loss of control in flight	<b>Injuries:</b>	5 Fatal
<b>Flight Conducted Under:</b>	Part 135: Air taxi & commuter - Non-scheduled - Air Medical (Discretionary)

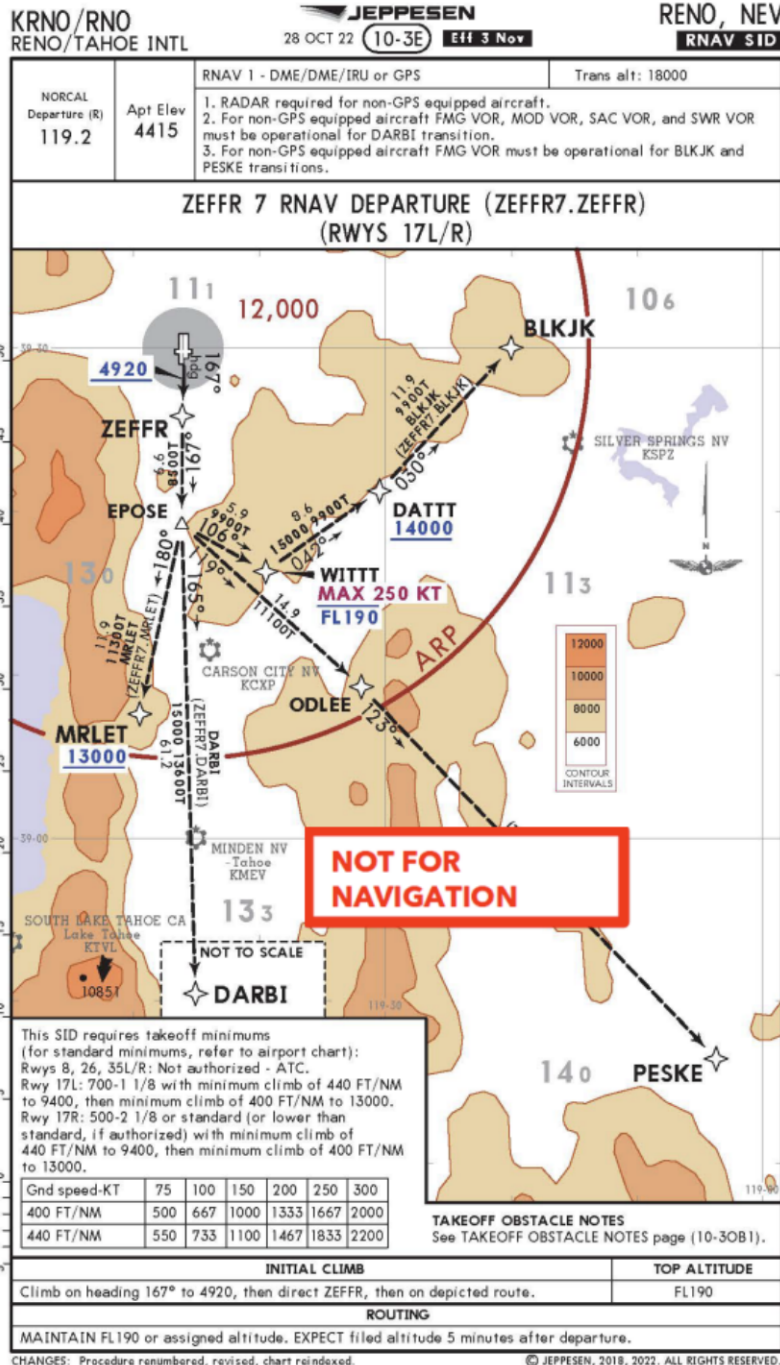
Figure 1. ZEFFR7 Standard Instrument Departure Procedure (Source: Jeppesen)

The flight was issued an instrument flight rules clearance to SLC that included the ZEFFR7 standard instrument departure procedure from RNO via the BLKJK transition (see figure 1). BLKJK was a GPS waypoint located about 20 nautical miles (nm) east of RNO. The pilot was cleared for takeoff from runway 17L about 2059, and ADS-B data showed the airplane was airborne about 45 seconds later. About 1 minute later, the pilot was given a frequency change and instructed to contact departure control, which the pilot acknowledged.

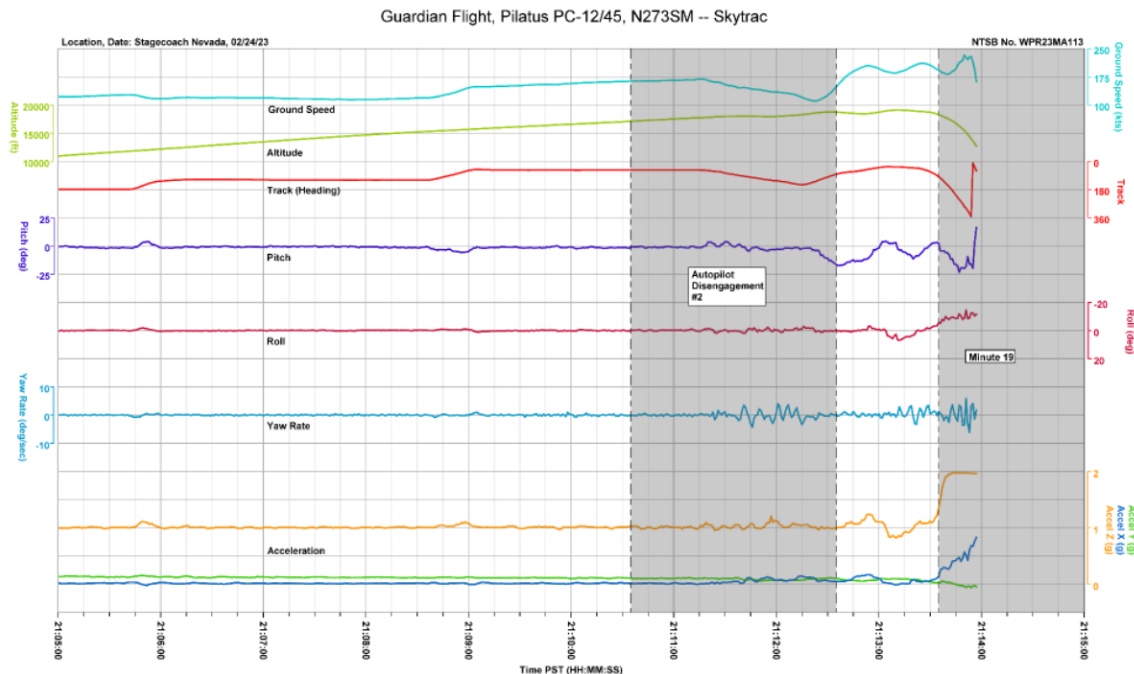
Data from the Skytrac transmitter (as shown below in figure 5), showed that recorded acceleration values asymptotically approached 2g, but never exceeded that value. Skytrac was asked if this was unusual and responded that "The maximum value it will display is the 2G." Pitch, roll, yaw rate, and acceleration data from the Skytrac transmitter was considered as trend data.

Figure 5: Plot of the accident sequence recorded by the Skytrac ISAT-200A. The estimated time frame of the second autopilot disengagement and minute 19 are shown in gray.
