## National Transportation Safety Board Aviation Accident Preliminary Report

| <b>Location:</b> | Panama City, FL | <b>Accident Number:</b> | ERA22FA149 |
| <b>Date &amp; Time:</b> | March 8, 2022, 18:46 Local | <b>Registration:</b> | N182XT |
| <b>Aircraft:</b> | Cessna 182Q | <b>Injuries:</b> | 2 Fatal |

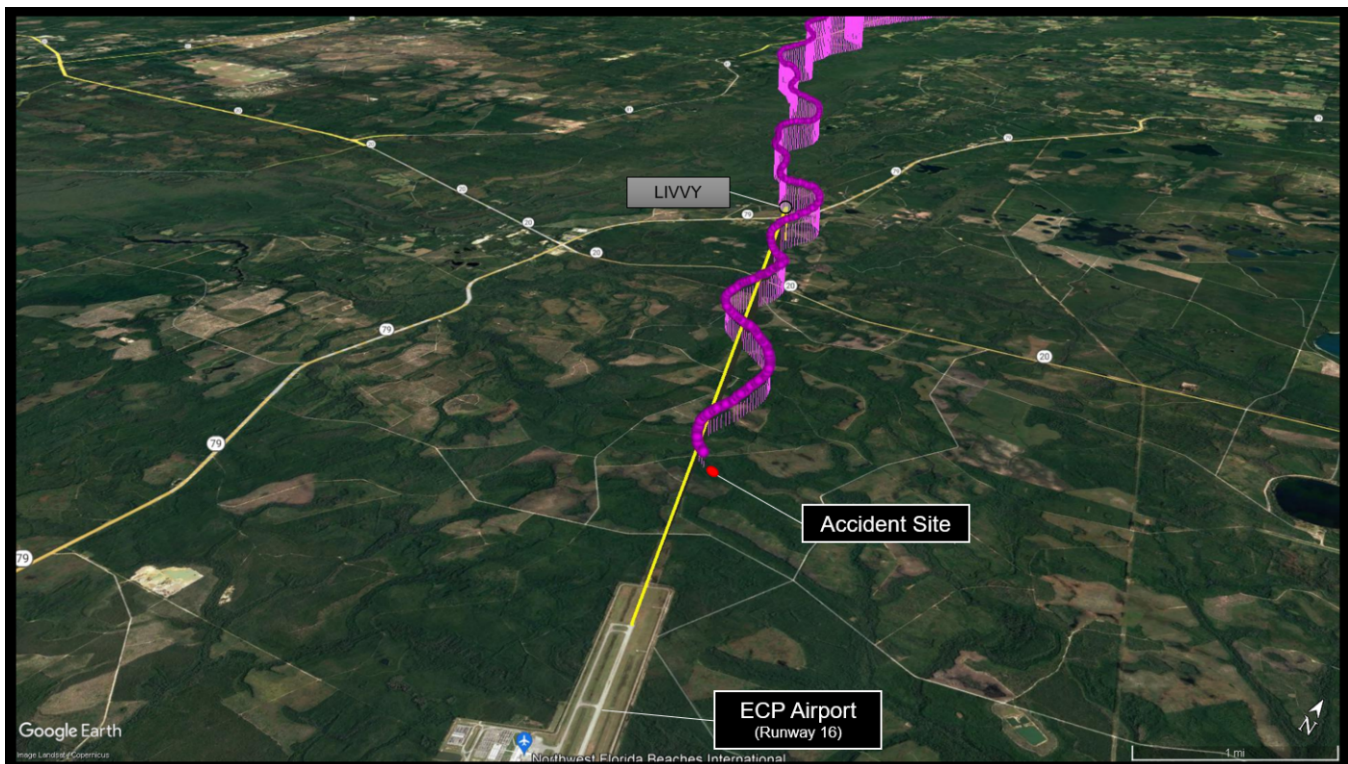
Review of the ADS-B flight track in the final approach phase found that the airplane's course deviated left and right from the initial approach fix to the accident site, which was 1.55 nautical miles from the runway threshold. The airplane's altitude showed momentary descents and climbs while on final approach. The final ADS-B data point recorded the airplane at 75 ft mean seal level, 144 knots groundspeed, with a ground track heading of 130°. Figure 1 shows the accident site, the final approach course represented as the yellow line, and the airplane's flight track represented in the magenta line.

Figure 1: Overview of the flight track, final approach course, and accident site.
