**Incident Type:** 111-Building fire

# Preliminary Fire Investigation Report Narrative

**Incident No:** 250005003

**Address:** 1475 East Avenue, Chico, CA

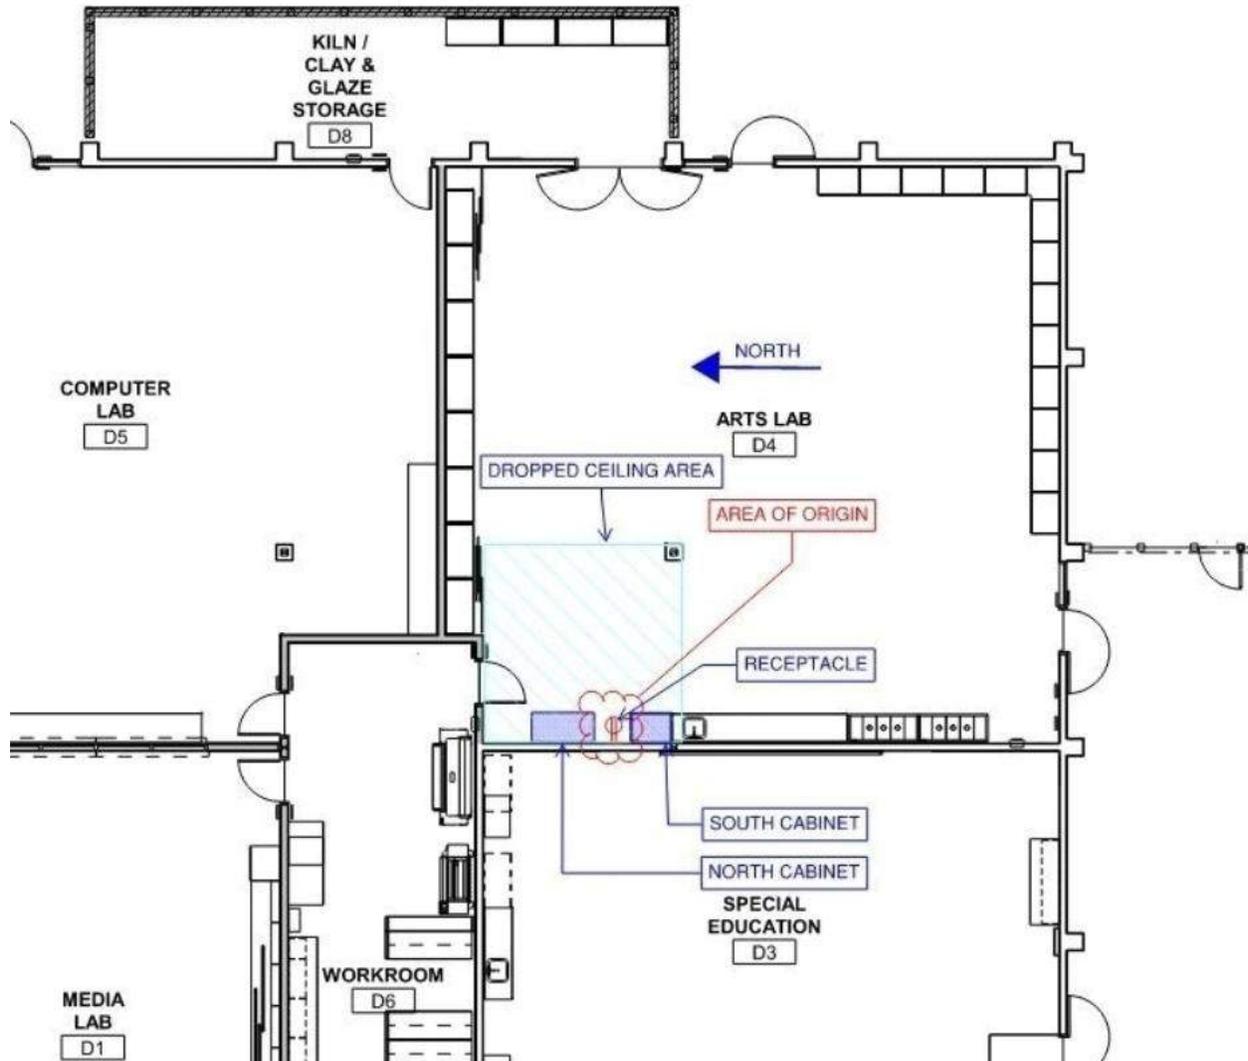
FIGURE 2 - BUILDING PLAN

Upon investigation, I found fire damage to the northwest corner of classroom D4. The fire appeared to be contained to the interior area of the classroom only.

The west wall had the most severe fire damage. The fire damage on the west wall began in the northwest corner of the room and extended south along the wall for approximately fourteen feet, until the lower ceiling transitioned to the higher ceiling. The fire effects on the west wall originated approximately eight feet from the northwest corner and started approximately one foot off the floor level near an electrical receptacle. This was ultimately determined to be the area of origin.

The cause of the fire remains undetermined, as multiple ignition sources were present in the area of origin, including the electrical receptacle and the heat gun. In my opinion, it is probable that the fire's cause was electrical in nature. Based on the information obtained during my investigation, the fire cause classification is accidental.
