# River Corridor Plan for the East Branch of the North River in Halifax and Whitingham, Vermont

December 21, 2017

Reach M02, Halifax

**Fitzgerald Environmental Associates, LLC.**  
18 Severance Green, Suite 203  
Colchester, VT 05446

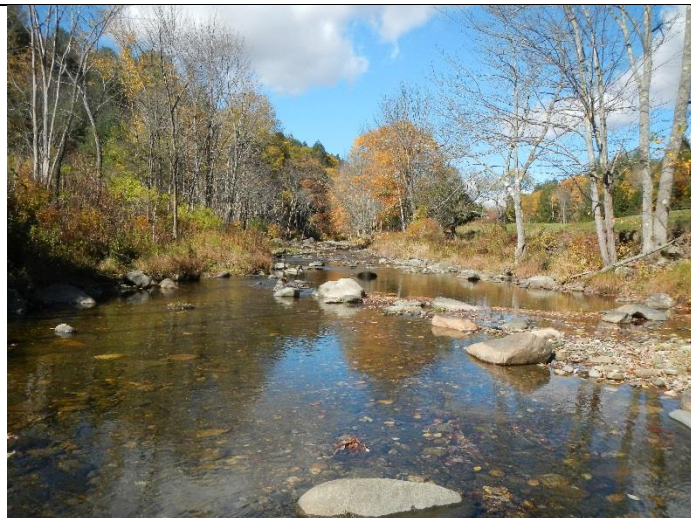
Historically incised and straightened F-type channel.

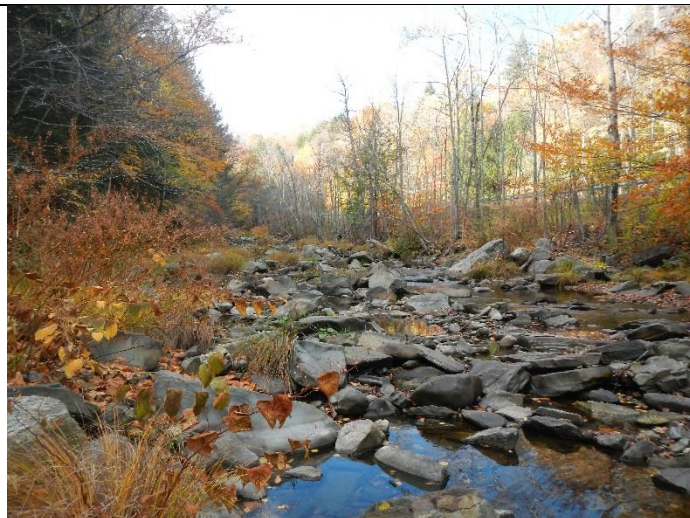
Historically straightened and incised F-type channel.

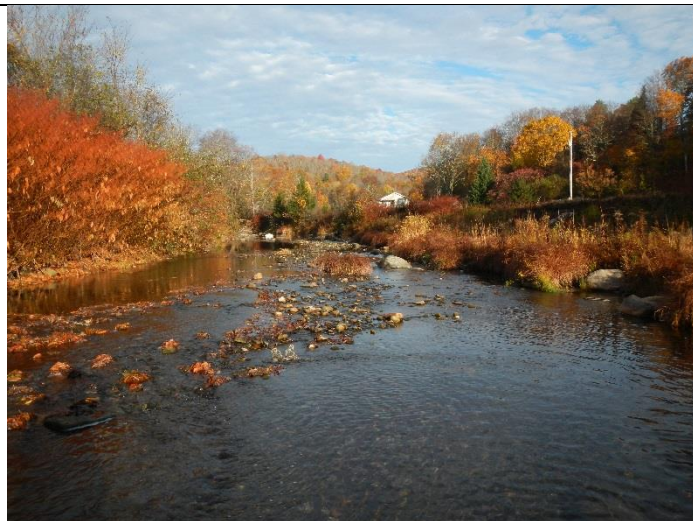
Segment upstream of beaver activity, with evidence of historic incision.

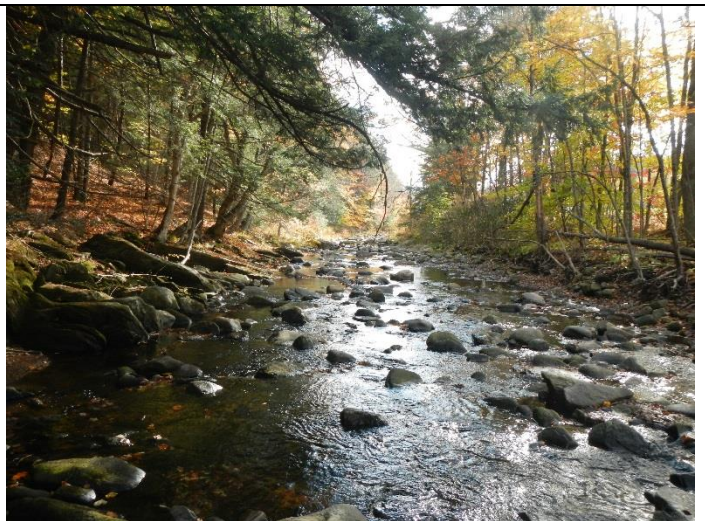
F-type channel near the top of the segment, historically incised due to straightening and encroachment.

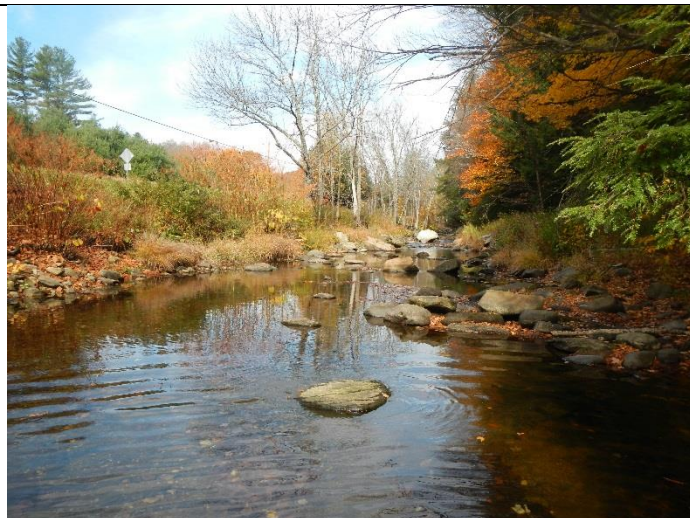
F-type channel due to historic straightening and armoring.

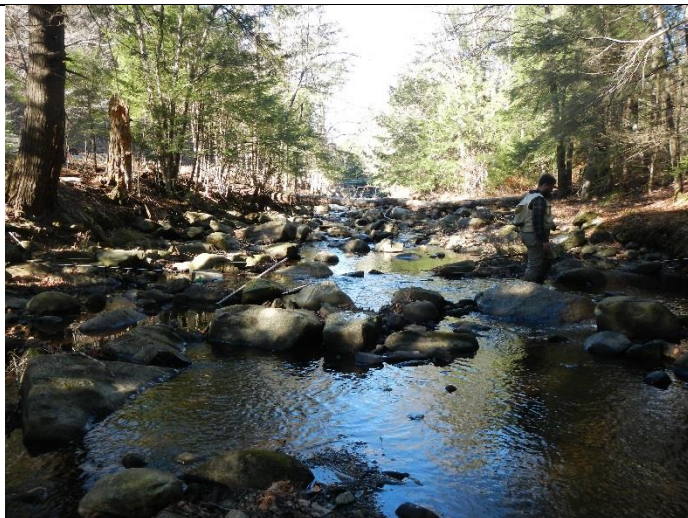
F-type channel due to straightening and encroachment

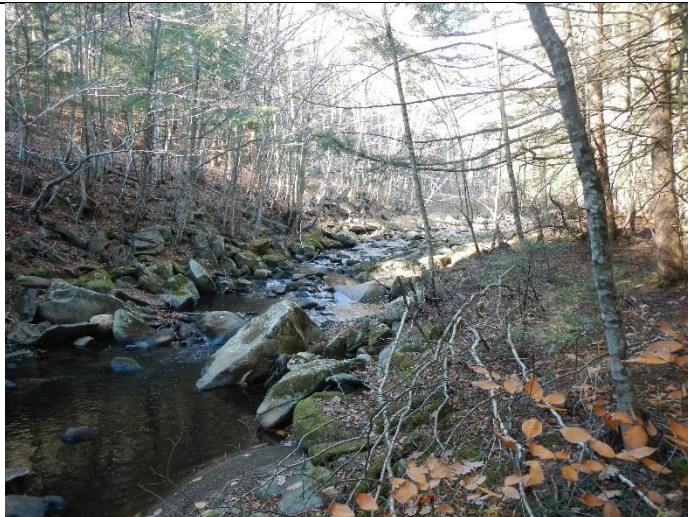
F-type channel due to straightening and encroachment.

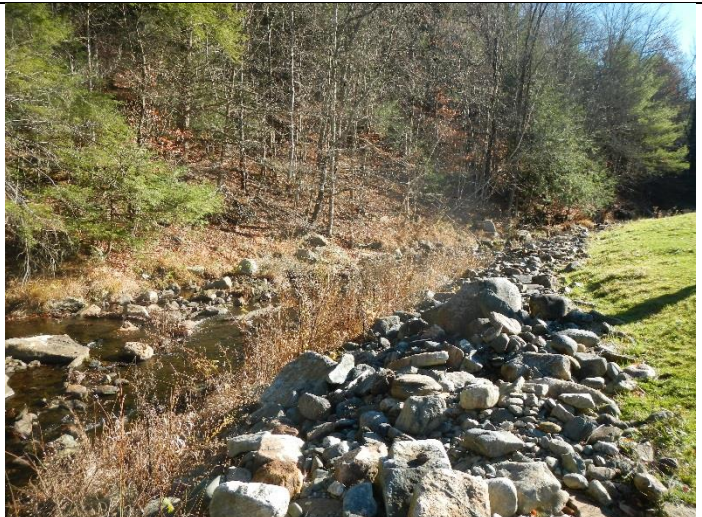
Bank straightening and armoring along cow pasture.

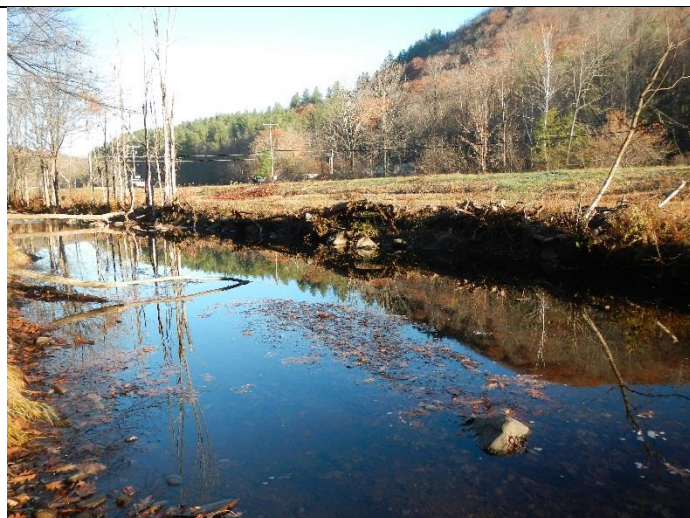
F-type channel due to historic straightening and encroachment.

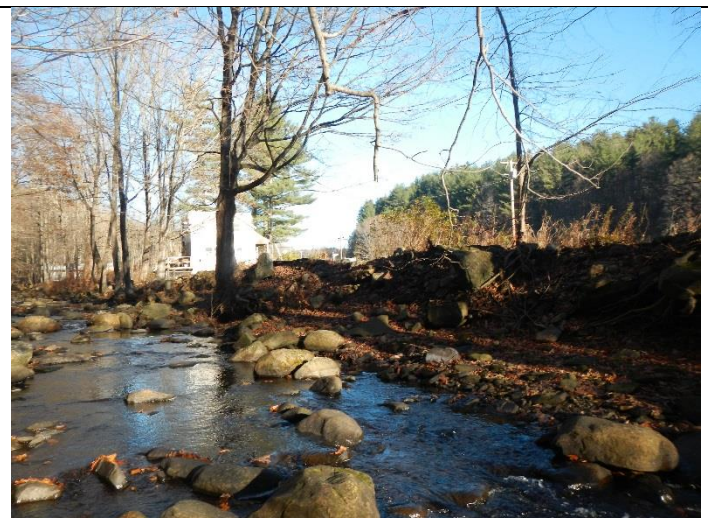
Historically straightened channel with an old berm on the left bank.

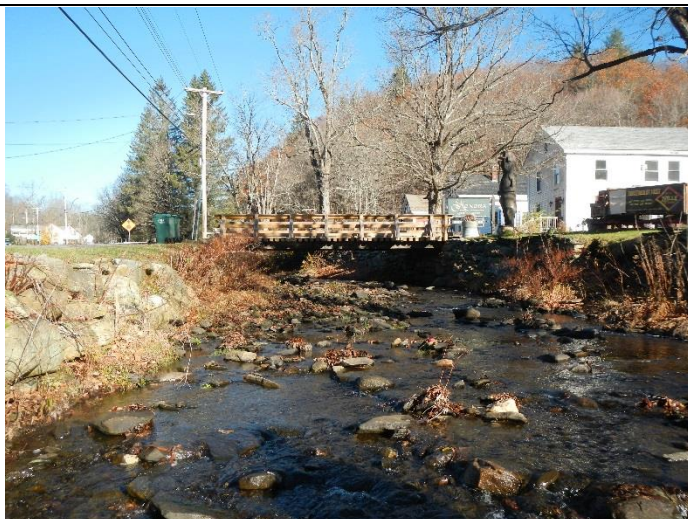
F-type channel due to straightening and armoring.

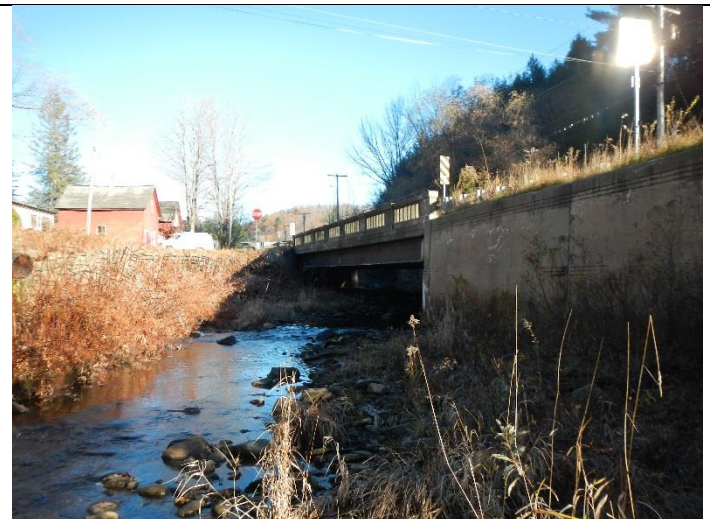
Incised channel at the intersection of Route 112 and Holbrook Road.

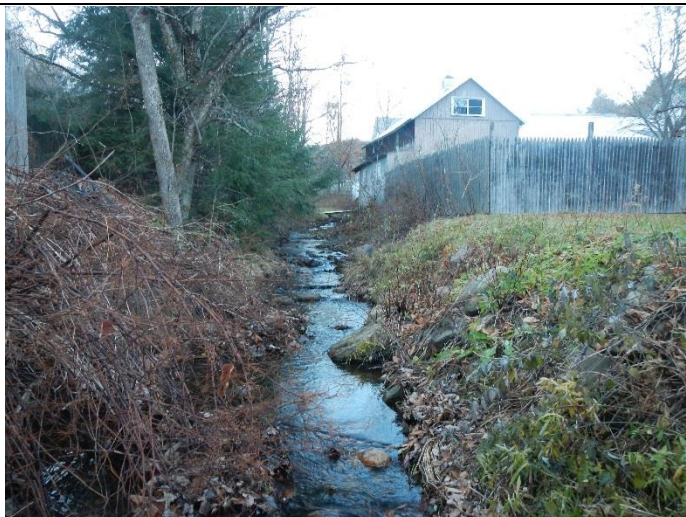
F-type channel due to historic straightening, encroachment, and armoring.

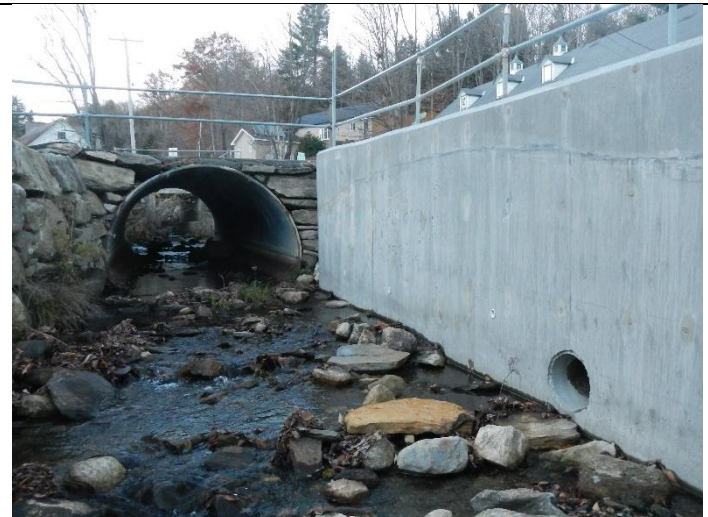
Bank armoring and constrictions at the Whitingham Municipal Complex.

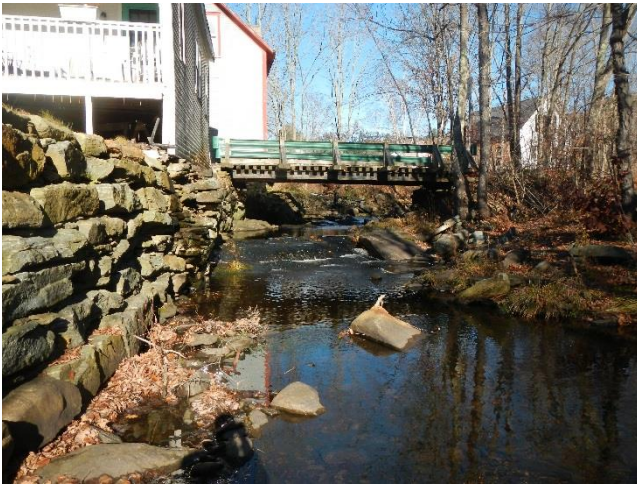
**Figure 4.10:** Extreme bank armoring on reach M06.B.

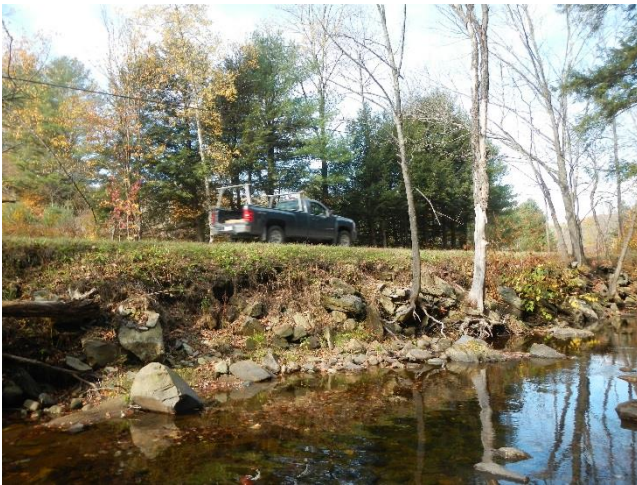
**Figure 4.12:** Bank erosion and failing armoring along Route 112 on reach M05.

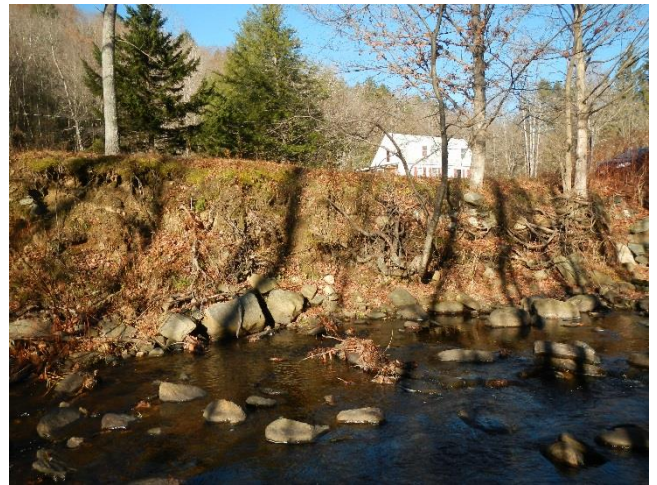
**Figure 4.13:** Bank erosion near Holbrook Road on segment M06.A.

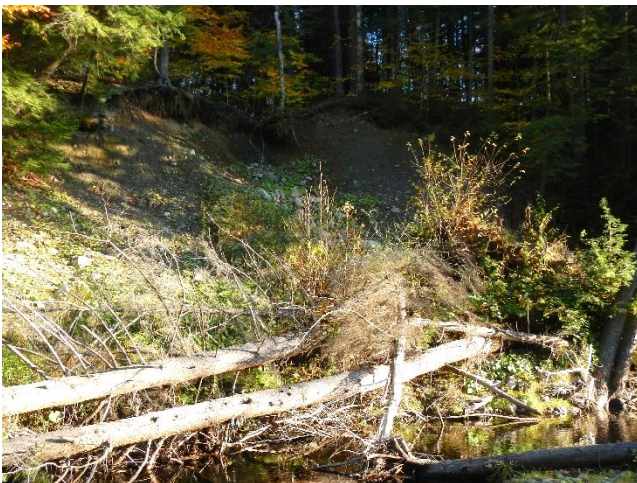
**Figure 4.14:** Mass failure on segment M03.C.

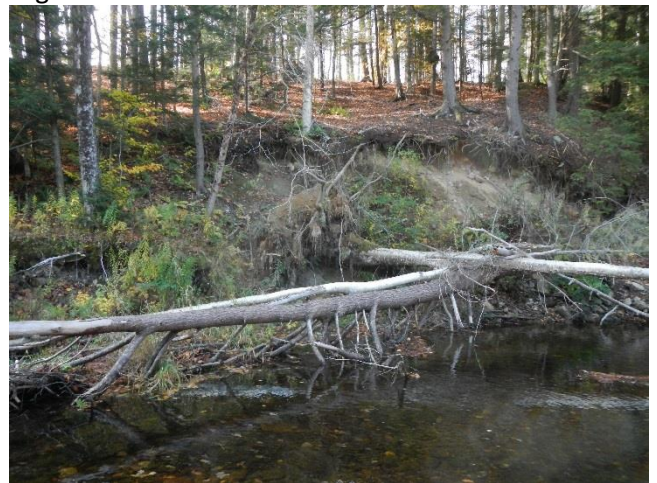
**Figure 4.15:** Mass failure on reach M05.

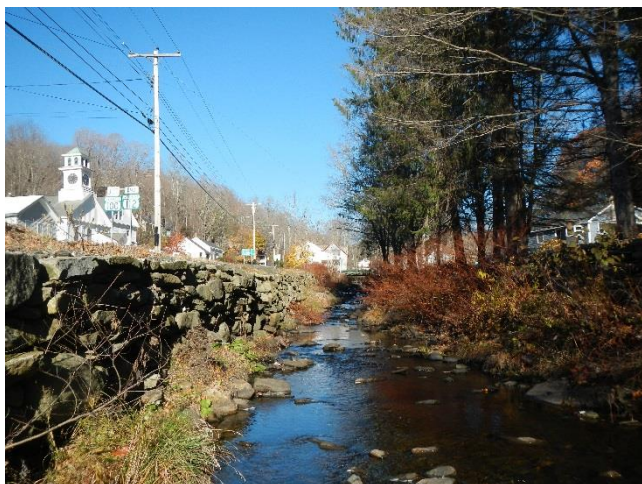
**Figure 4.17:** Extreme straightening along segment M06.B.

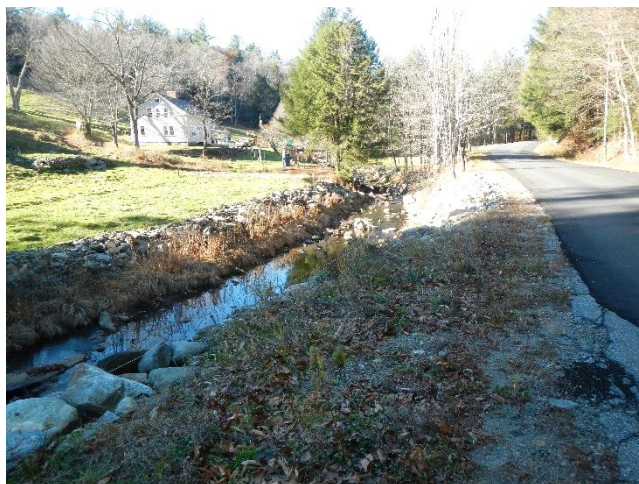
**Figure 4.18:** Bank armoring, encroachment, and straightening on reach T1.02.

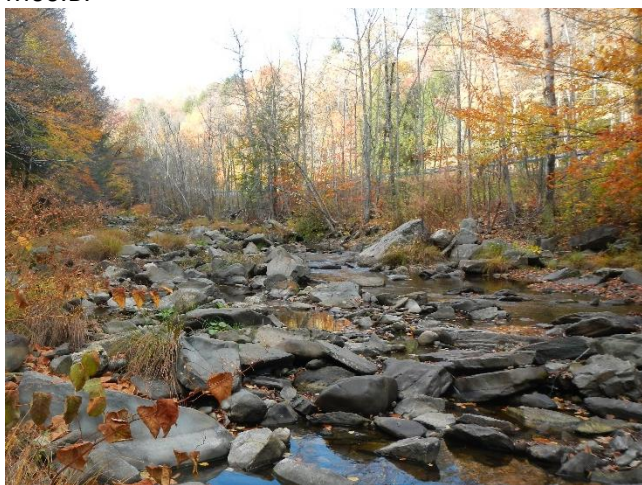
**Figure 4.19:** Extreme encroachment along Route 112 on segment M03.A.

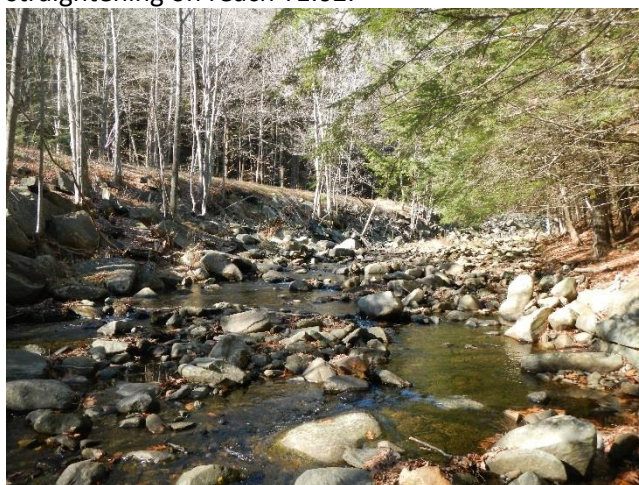
**Figure 4.20:** Extreme encroachment along Branch Road on reach T1.01.

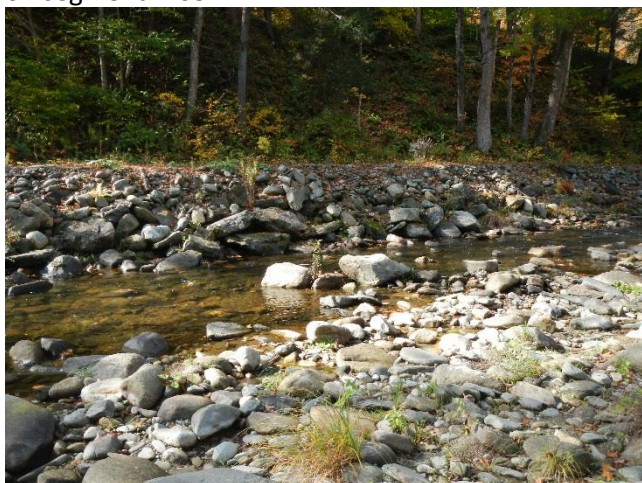
- Dredging in segments: M02, M04.A, M04.B (Figures 4.21 and 4.22).
- High density of riparian buffer width impacts in segments: M02, M03.A, M05, M06.A, M06.B, M07.A, T1.01, T1.02.

**Figure 4.21:** Dredging and windrowing on reach M02.

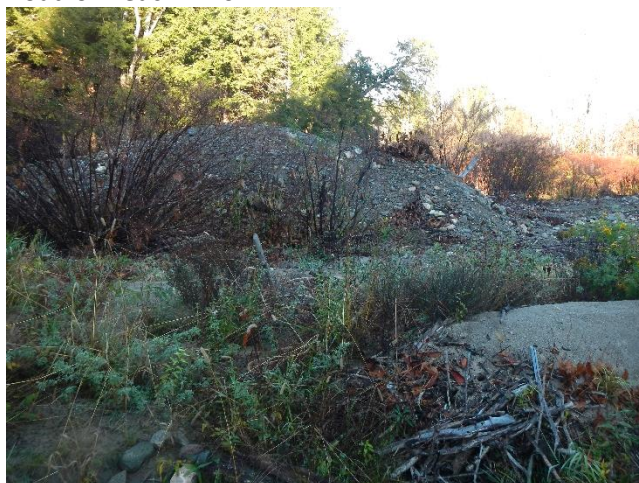
**Figure 4.22:** Dredging spoils on segment M04.A.

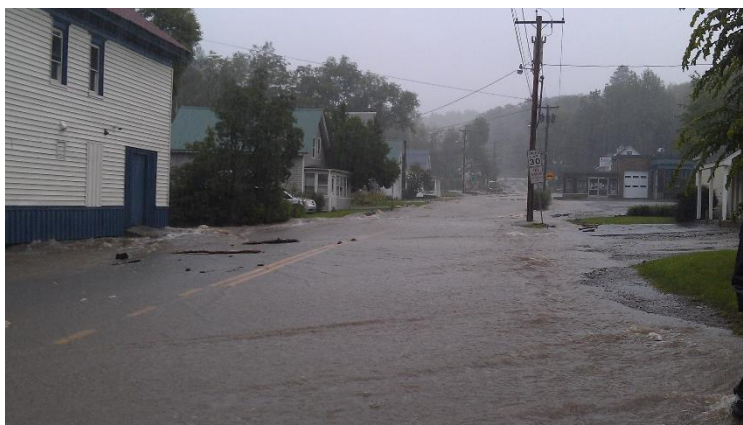
**Figure 5.1:** Tropical Storm Irene floodwaters overtopping the culvert and bridge at the Whitingham Municipal Offices and flowing south down Route 100 (photo courtesy of G. Havreluk).
