## STRUCTURES INSPECTION FIELD REPORT

P-10-002

## ROUTINE INSPECTION

| CITY/TOWN<br><b>PITTSFIELD</b> | 8-STRUCTURE NO.<br><b>P10002-0DY-DOT-634</b> | 11-Kilo. POINT<br><b>000.000</b> | 41-STATUS<br><b>A:OPEN</b> | 90-ROUTINE INSP. DATE<br><b>MAY 22, 2018</b> |

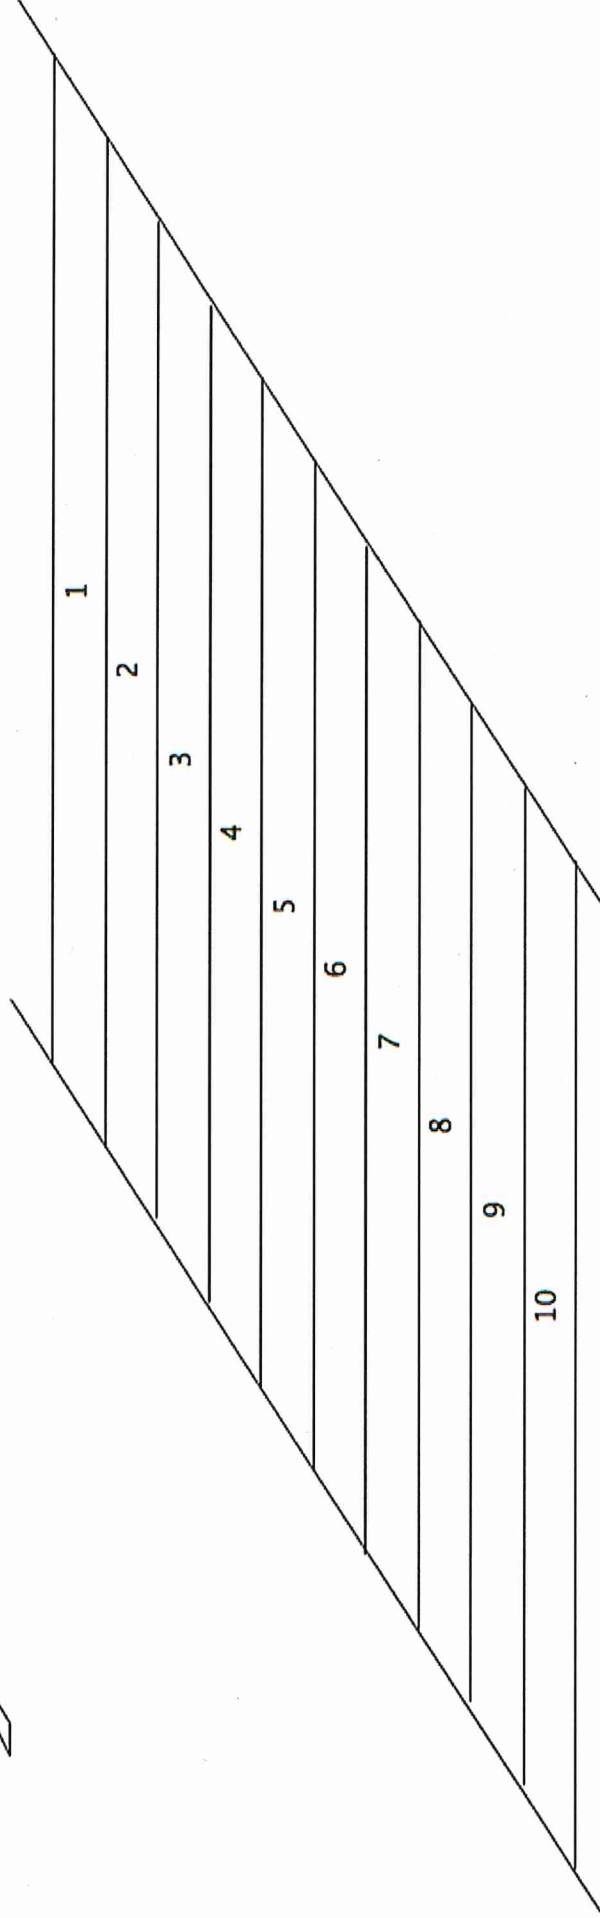
Sketch 1: Framing plan.

Holmes Road travels east and west at this location. The Housatonic Railroad travels north and south. This single span structure consists of ten prestressed butted concrete box beams, which also act as the deck, supporting an asphalt wearing surface. The beams are numbered from north to south, in accordance with the plans. See sketch 1 and photos 1 & 2.

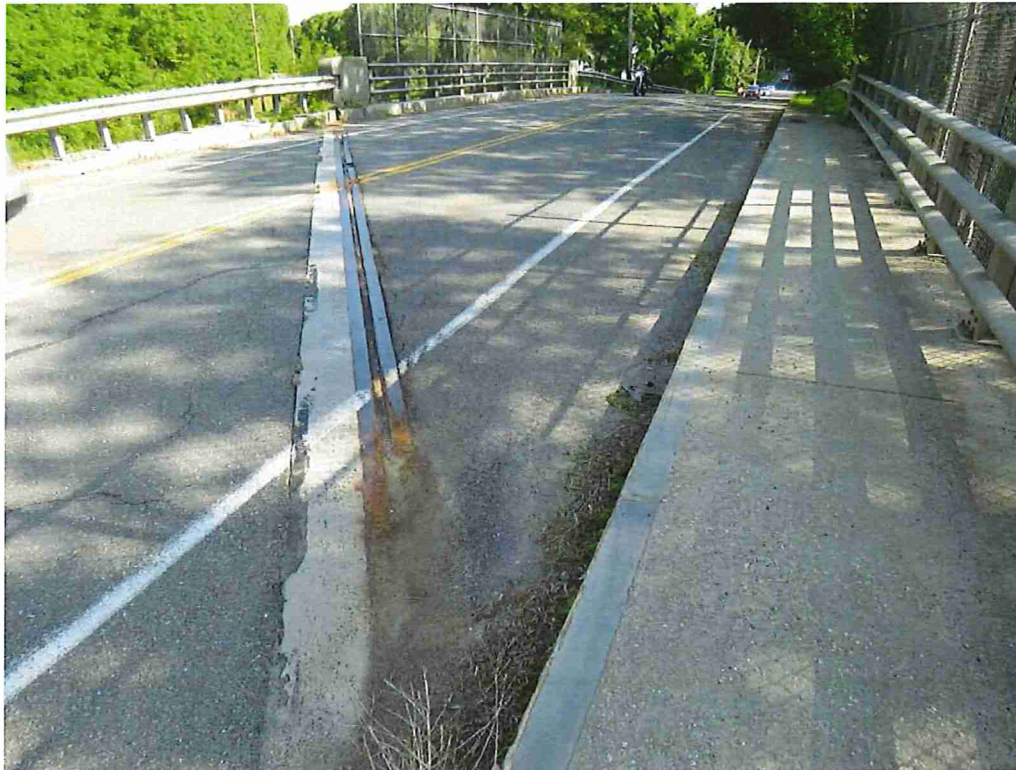
Photo 1: General topside, looking east.

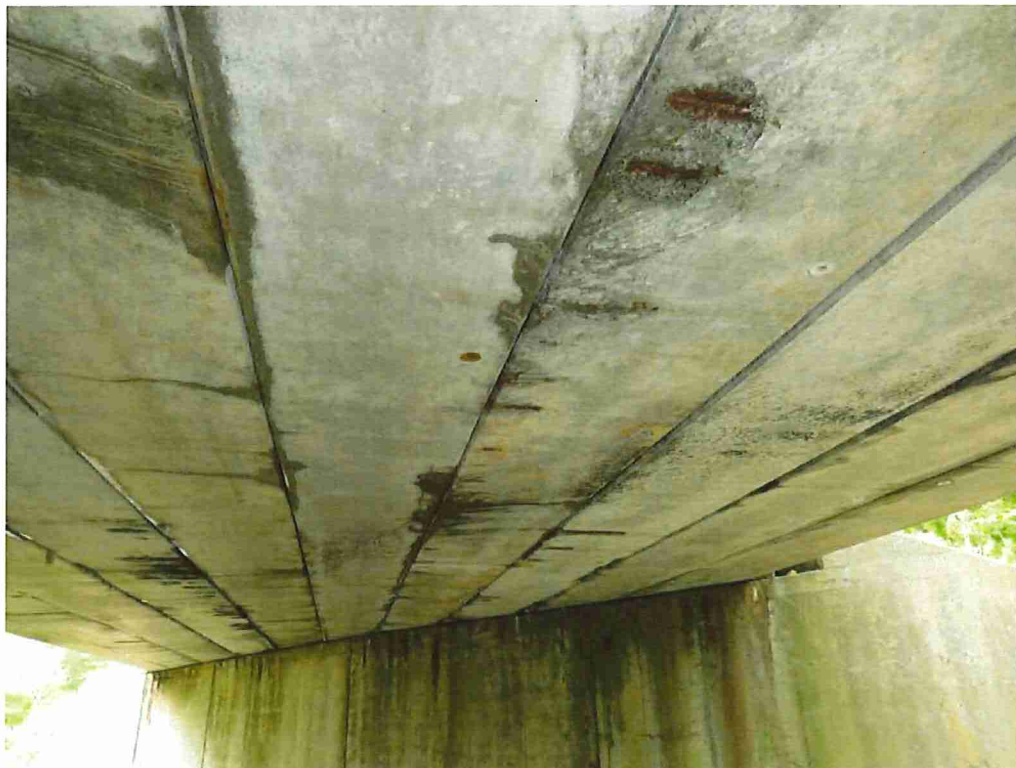
The joints between all beams have evidence of leakage. See photo 2.

Photo 2: Typical underside.

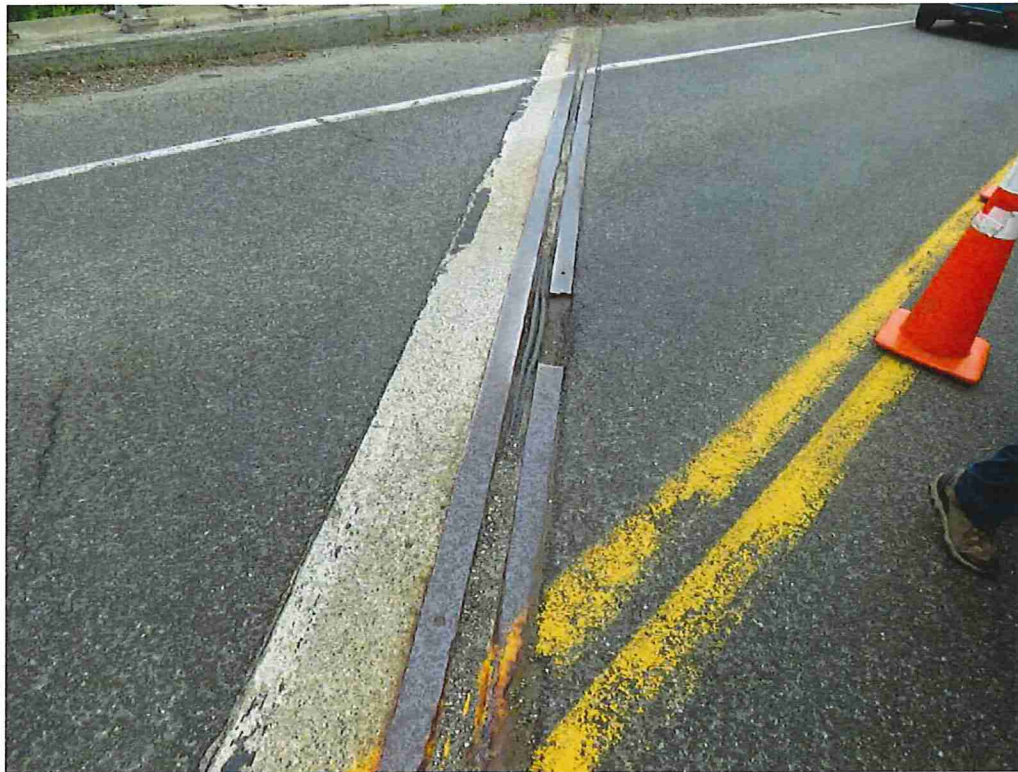
Both deck joints have laminated rusting of the steel headers near the seals and isolated tears / separations in the seals, allowing leakage to below. See photo 3.

Both deck joints have areas with accumulations of sand and debris. See photo 3.

At the west joint, in the westbound wheel path near the center, the span side steel header is broken, approximately 18" long. See photo 3.

Photo 3: Broken section of the west joint header. Also, note the debris lodged in the joint.

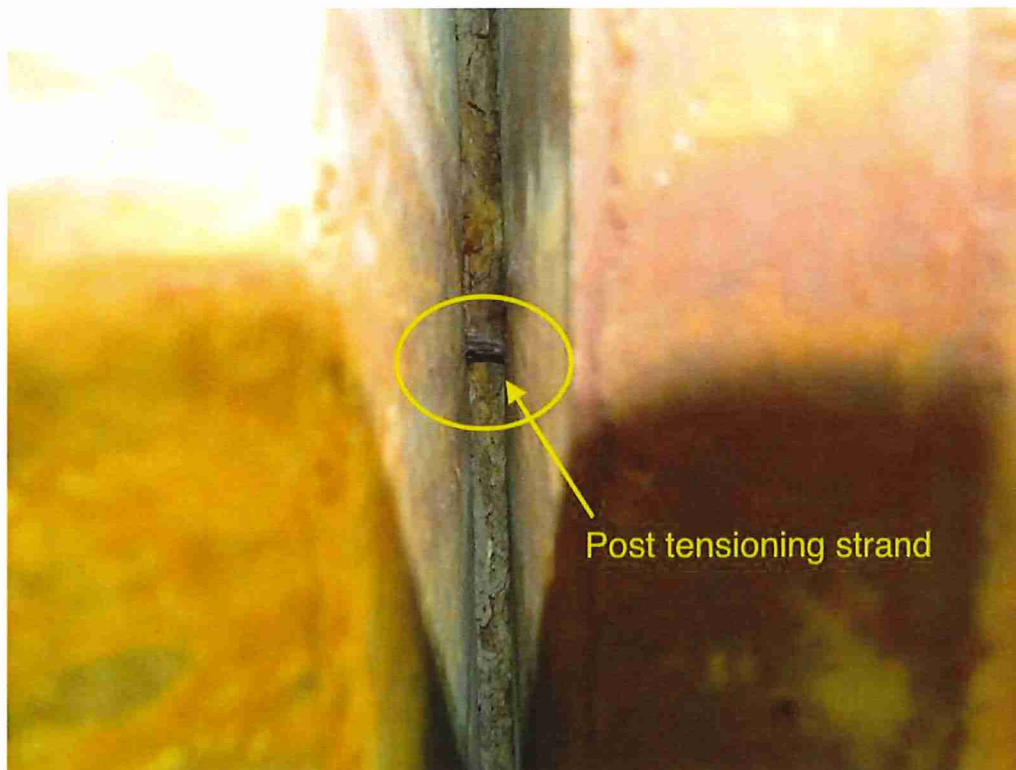
Between beams 1 - 4 and 8 - 10, the post tensioning strands have moderate corrosion with delamination. See photo 4.

Photo 4: Typical rusted post tensioning strand.

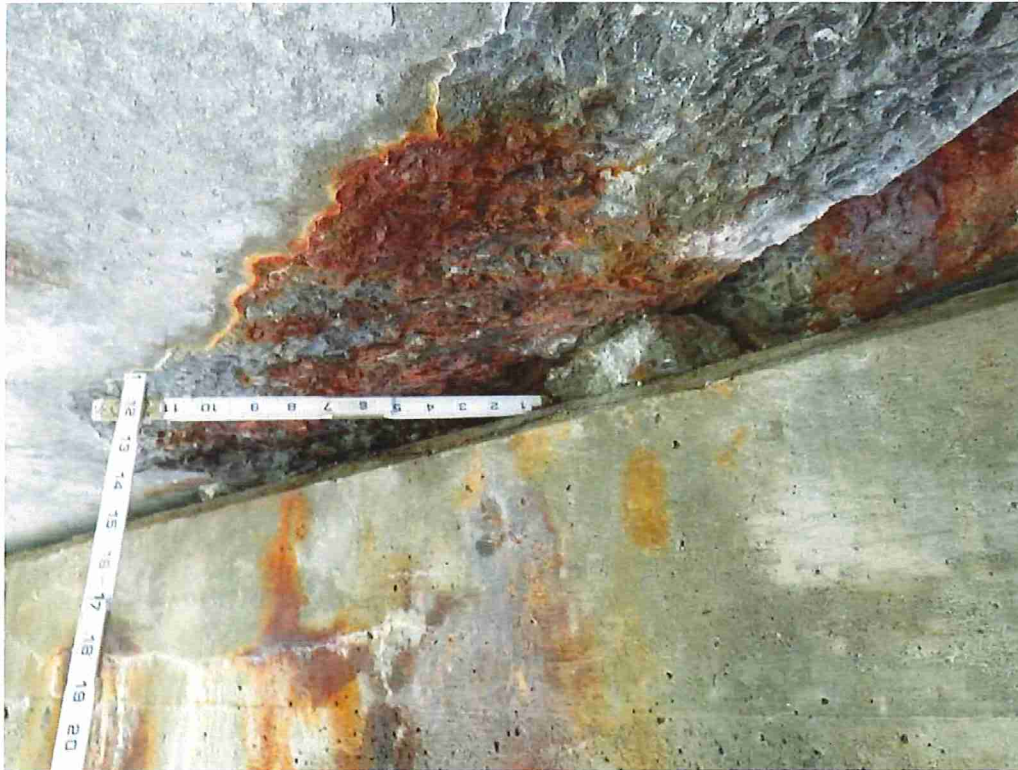
At the west abutment, the north edge is spalled, 12" wide x 24" long x 1-1/2" deep, with one exposed and corroded tendon. See photo 5.

**Photo 5:** Spall at the west end of beam 7 with one exposed tendon.

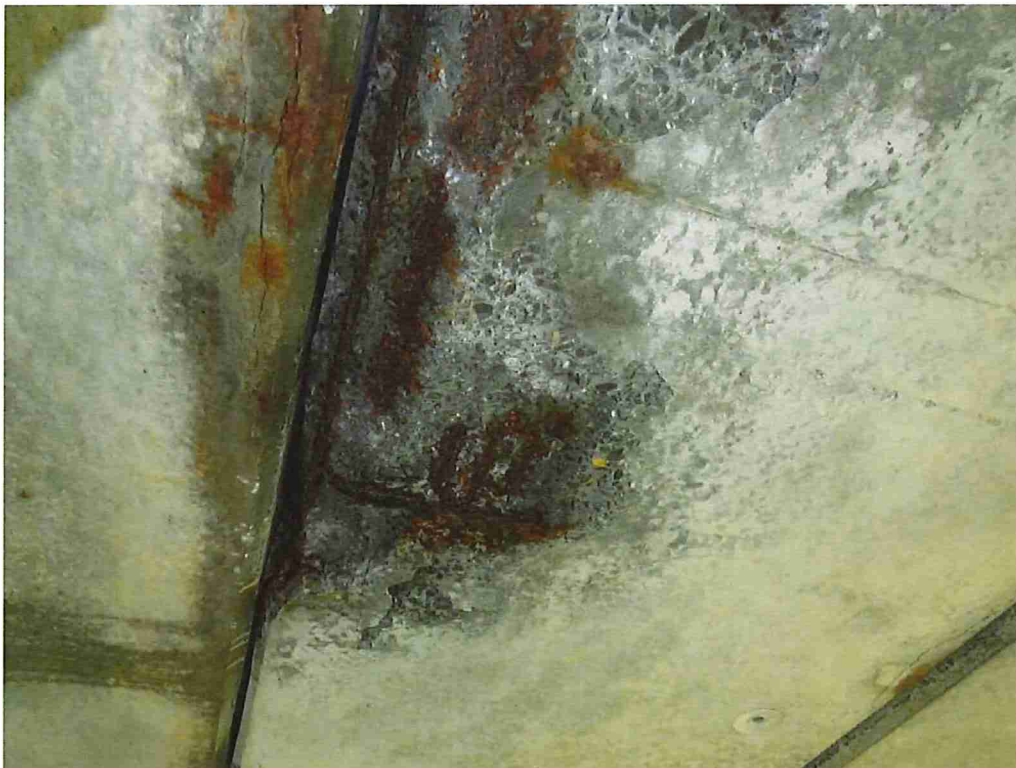
At 24' from the west abutment, there is a spall starting at the north edge, 3' long x 2' wide x 8" high x 2" deep, with five tendons exposed and corroded. See photo 6.

**Photo 6:** Exposed tendons in beam 7 at 24' from the west abutment.

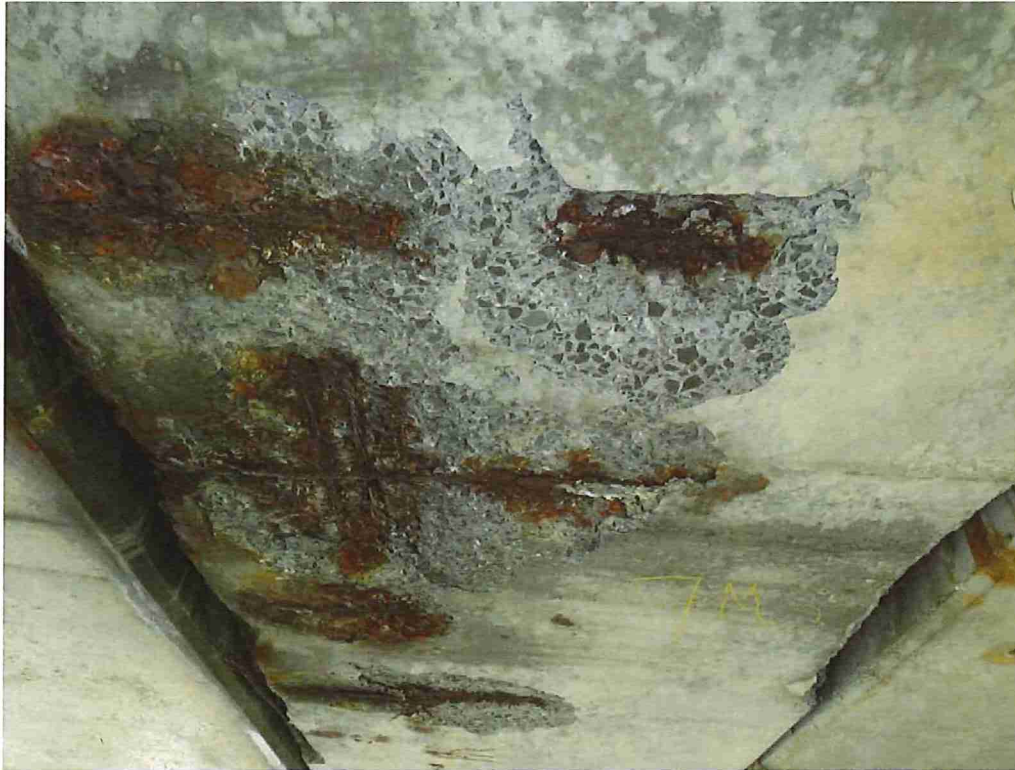
At 40' from the west abutment, the north edge has a spall, 6' long x 20" wide x 8" high, with six tendons exposed and corroded or broken. See photo 7.

**Photo 7:** Beam 7 at 40' from the west abutment. Note all of the exposed tendons.

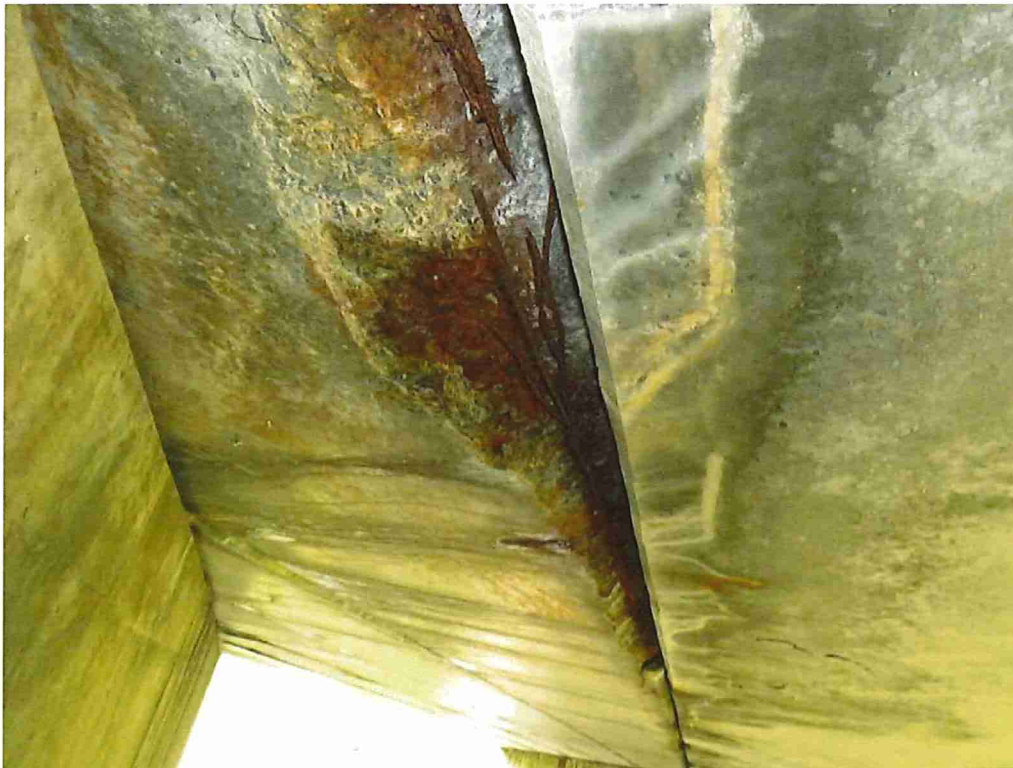
At the west abutment, the south edge has a corner spall, 12' long x 6" wide x 4" high, with two tendons exposed and corroded or broken. Extending from this spall, the corner is hollow and has longitudinal cracks, 5' long x up to 1/8" wide. See photo 8.

**Photo 8:** Spall and severed tendon at the west end of beam 6.

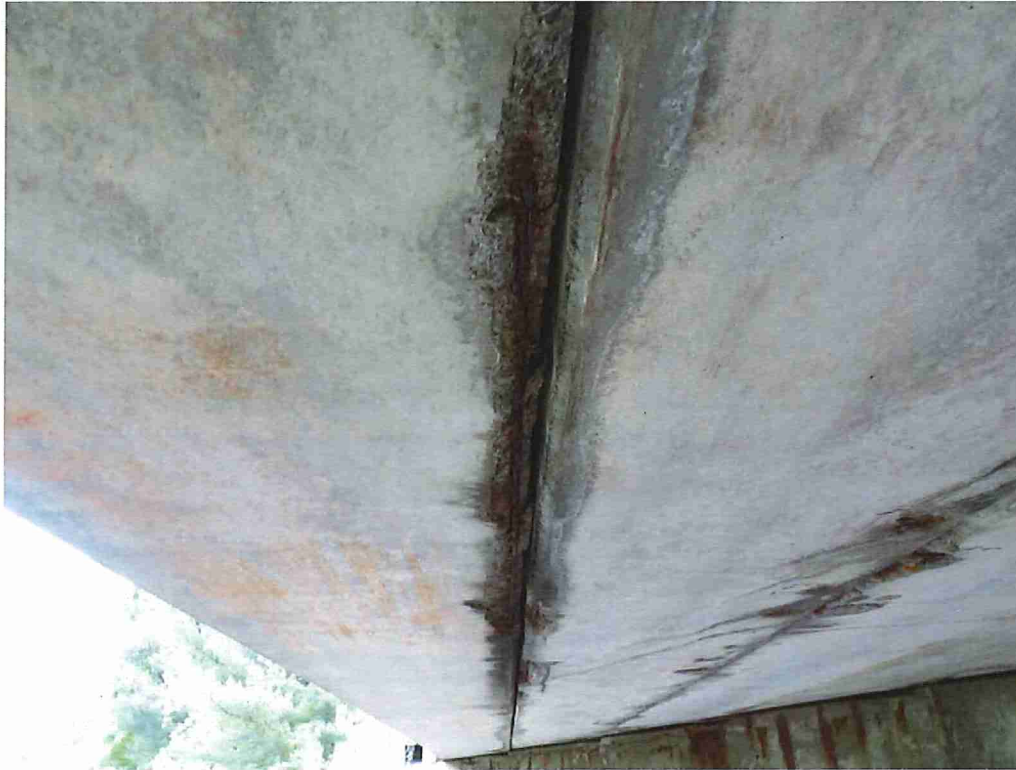
At 35' to 46' from the west abutment, the north edge has several spalls, up to 3' long x 4" wide x 4" high, with one tendon exposed and corroded. There are hollow areas between these spalls. See photo 9.

At 25' from the west abutment, the south edge has a spall, 10' long x 4" wide x 4" high, with one tendon exposed and broken. See photo 9.

Photo 9: Spalling near mid-span of beams 1 & 2.

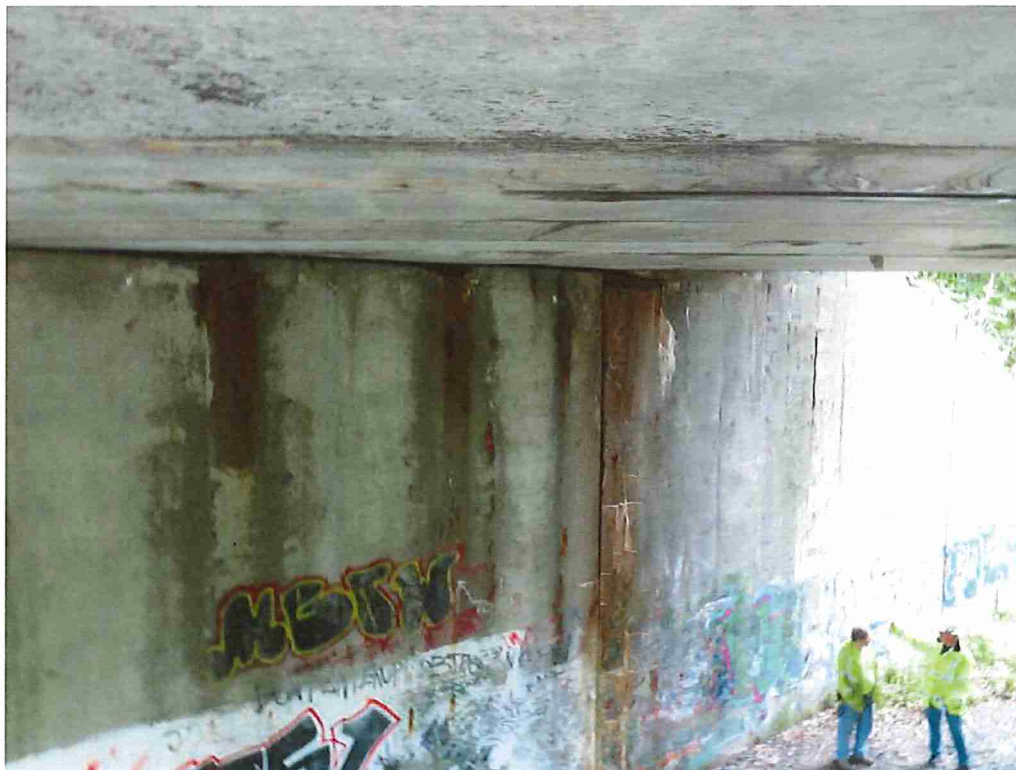
Both breastwalls, the top 2' +/- near the seat, have evidence of or active leakage, moderate to heavy horizontal or mapcracking, up to 1/4" wide, with rust staining, and random spalls. See photo 10.

Below beam 9, there is a 1' long x 8" high x 2" deep spall, near the top. See photo 10.

Below beam 10, there is a spall, 3' wide x 8" high x 3" deep, with rust stains and leakage. The concrete surrounding this spall is hollow. See photo 10.

Photo 10: Rust staining and minor spalls in the east breastwall.

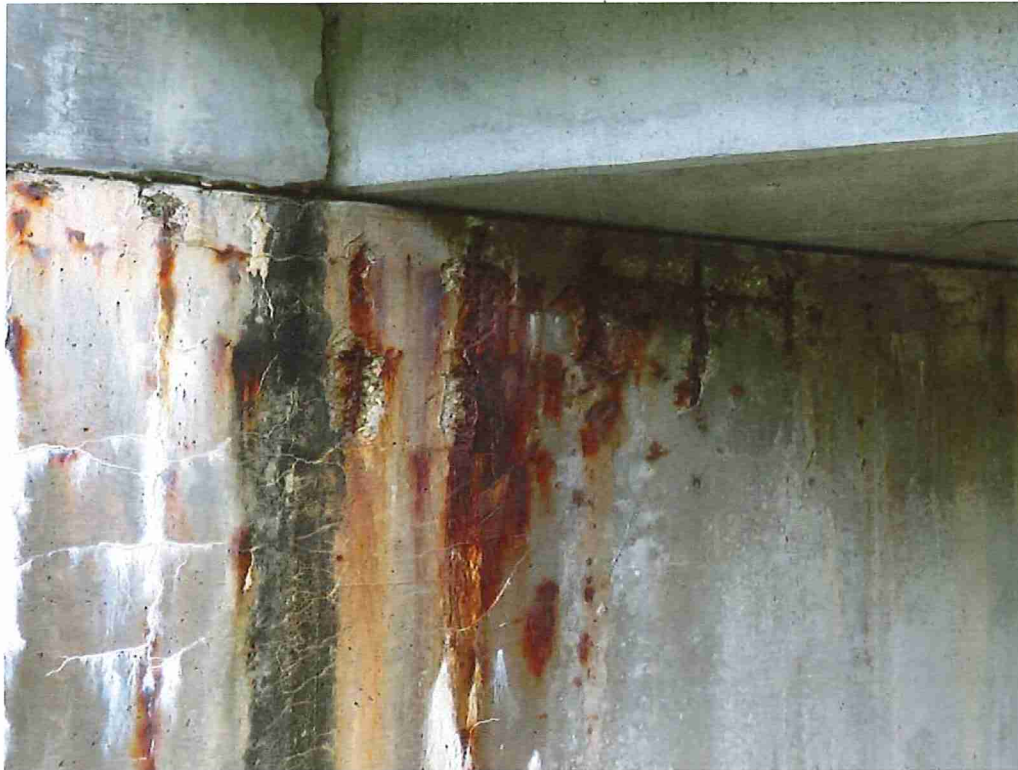
Below beam 10, the top has an area of shallow rebar, 6' wide x 4' high, causing cover spalls and heavy mapcracking with efflorescence and rust staining. See photo 11.

**Photo 11: Spalls, cracking and rust staining at the south end of the west breastwall.**
