STRUCTURES INSPECTION FIELD REPORT ROUTINE & SPECIAL MEMBER INSPECTION

BR. DEPT. NO. **P-10-048**

CITY/TOWN PITTSFIELD			8ST						lo. POINT	41-STATUS P:POSTED				SP. DATE
				I				 						2024
07-FACILITY CARRIED HWY PECKS RD				MEMORIAL NAME/LOCAL NAME 27-				YR BUILT 1915	106-YR REBUILT 0000	YR F		3'D (NO	ON 106)	
06-FEATURES INTERSECTED				26-FUNCTIONAL CLASS DIST. BRIDG				E INSPECTI	ON ENGINEER	L.A.	Briggs			
WATER ONOTA BR	ROOK			Urban Collector										
43-STRUCTURE TYPE				22-OWNER	21-MAI	NTAINER	TEAM	I LEAD	DER R. Manc	ari				
302 : Steel Stringer/Girder				City/ Municipal Highway A	City/ M Highw		I							
107-DECK TYPE 1 : Concrete Cast-i	n-Pla	ıce		WEATHER Sunny TEMP. (air) TEAM MEME M. RANZ

CITY/TOWN	B.I.N.	BR. DEPT. NO.	8STRUCTURE NO.	INSPECTION DATE
PITTSFIELD	51P	P-10-048	P10048-51P-MUN-BRI	JAN 22, 2024

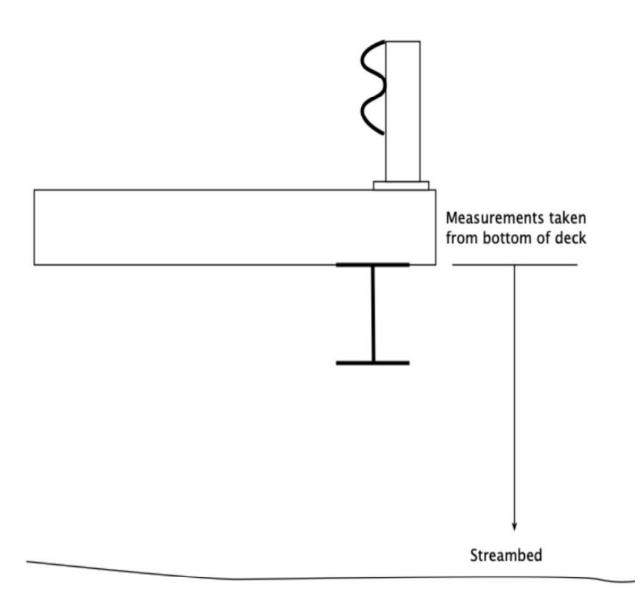
Chart 1: Channel profile readings.

Refer to chart 1 for channel profile readings.

P10048 Channel Profile Readings										
East Fascia West Fascia										
DATE	South Abutment 1/2 span North Abutment South Abutment 1/2 span North Abutment									
1/22/24	6.8 7.1 7.0 8.1 7.8					6.0

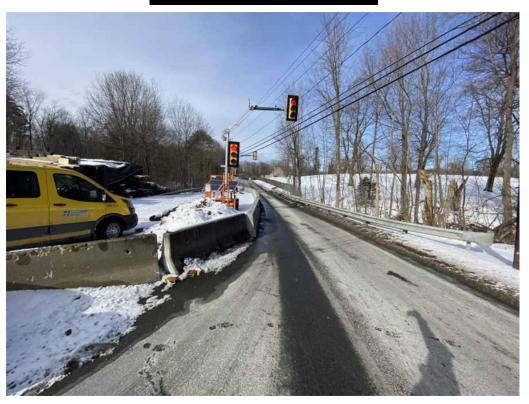
Beams 4 - 12 have been taken out of service by the placement steel barriers approximately 11'-4" away from the east interior guardrail. Refer to sketches 1 & 2 and see photo 1.

Beam 19 has been taken out of service with the placement of an interior guardrail along the east shoulder. See photo 1.

The current horizontal clearance is 10'-4". See sketches 2 & 3 and photo 1.

Photo 1: General topside, looking north.

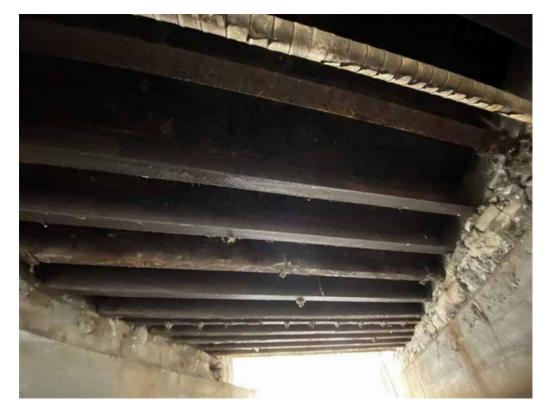
Beams 1 - 16 & 19, have no paint remaining. See photo 2, 4, 6 - 9, & 11.

Photo 2: General underside, looking west.

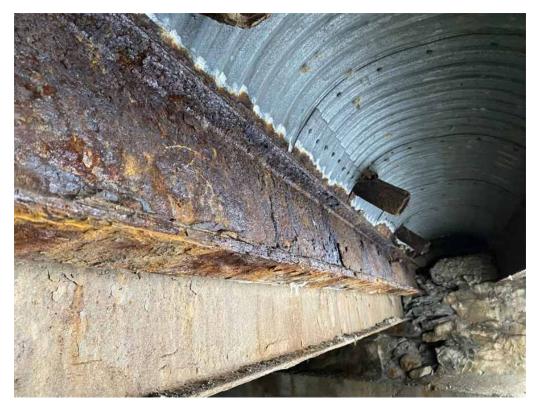
Bays 1 & 2 have corrugated steel forms in place (Jack-arch deck forms). The bottom 3" of the forms have moderate rusting with delamination, full length. See photo 4.

In bay 2, the drain pipes have moderate rusting and delamination. See photo 4.

Beams 1 - 16 have areas of moderate to severe rusting, delamination, and section loss. The worst conditions are found in areas exposed to active leakage; namely, at the ends of beams 11 & 14 and at mid-span of beams 4 - 8 & 16. There are holes in these areas. See sketches 4 - 18 and photos 4 & 6 - 9.

Photo 4: Bay 2, looking south, jack arch and drain pipe condition. Also, note the beam 3 rusting and section loss.

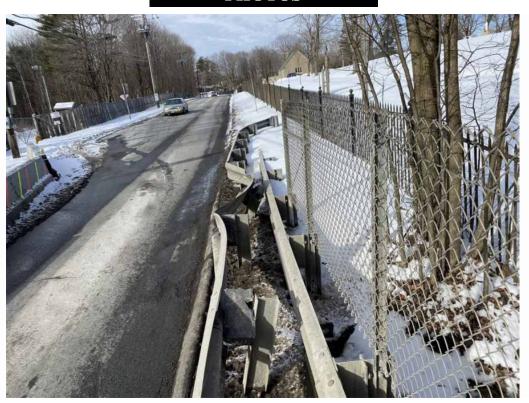
The interior east guardrail has a tear, approximately 35' long. All of the posts adjacent to the tear are bent. At the north end of the tear, two posts have detached anchor bolts. At the north end there is impact damage, 12' long x 2' bent out of plane. See photo 5.

The southeast transition panels have a tear down the center, approximately 20' long, and impact damage extending from the bridge railing. See photo 5.

Photo 5: East bridge guardrail with tear and impact damage.

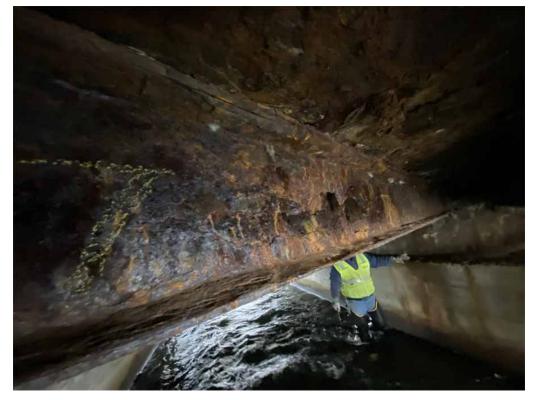
Photo 6: Holes near mid-span, in the web of beam 7.

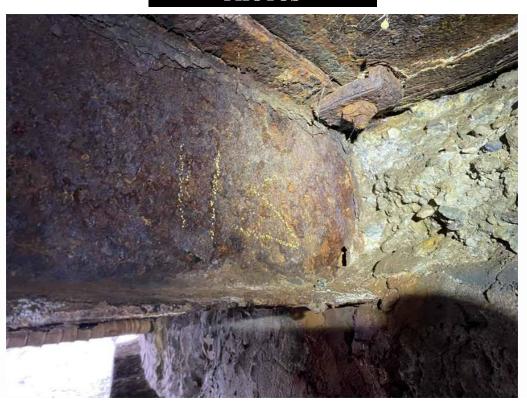
Beams 1 - 16 rest on the stone masonry abutments and are encased in concrete. See photos 7, 8, & 12.

Beams 1 -16 have single plate bearings resting directly on the stone masonry abutment. See photos 7, 8, & 12. The uneven bearing areas are causing random rotations in the beams.

Photo 7: Beam 11, south end, with section loss and holes. Note, out of service.

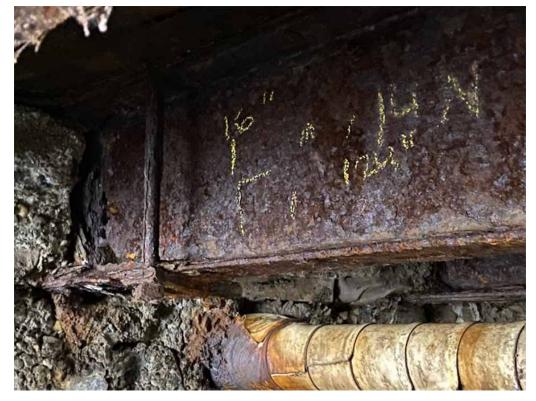
Photo 8: Beam 14, north end, with section loss and holes.

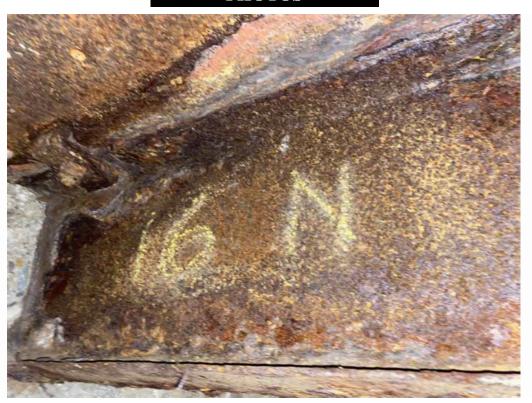
Photo 9: Beam 16, noth end, with section loss.

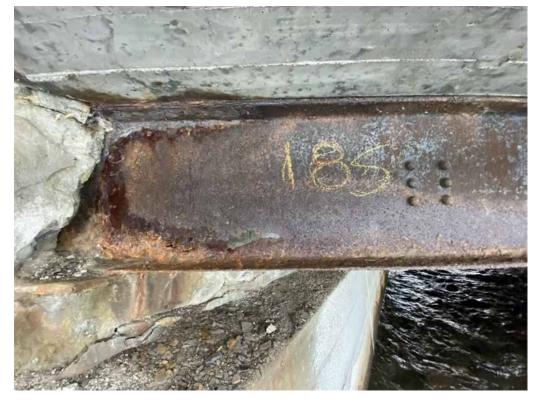
Beam 18, at the south ends, has an area of severe section loss and holes. Refer to sketch 18 and photo 10.

Bearings 17 - 19, the exposed portions of the plates have surface rusting. See photo 10.

Beams 17 & 18 have large areas of missing paint. See photo 10.

Photo 10: Beam 18, south end, with section loss and holes.

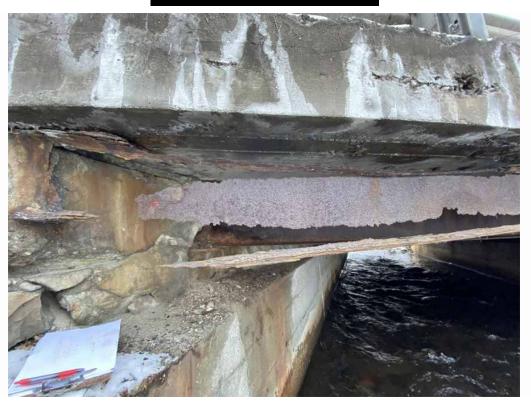
Beam 19 has failed. See photo 11.

Photo 11: East elevation, beam 19 failed. Note, out of service.

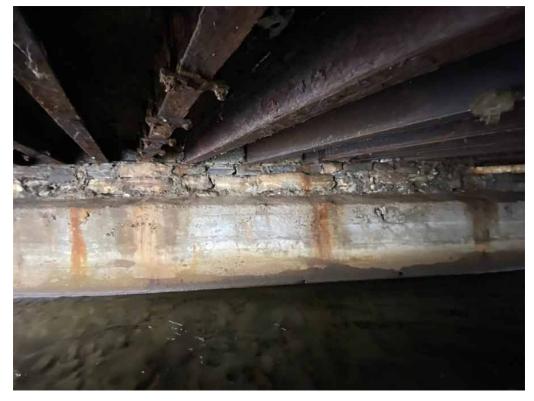
The stone masonry seats are uneven with areas of broken stones throughout. The worst conditions are found below both ends of beam 3. See photos 12 & 13.

Both breastwalls have areas of cracked and missing mortar. See photos 12 & 13.

In the stone masonry portions of the abutments, there are random areas of missing mortar throughout. See photos 12 & 13.

Photo 12: North breastwall condition.

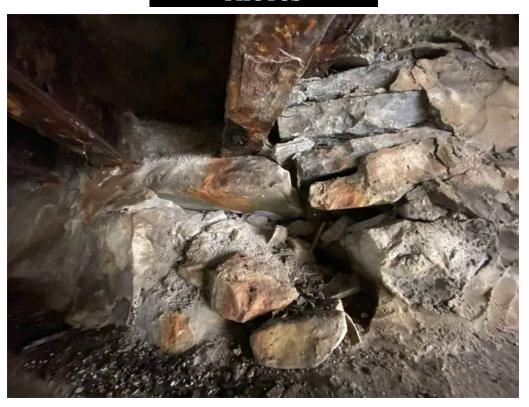
The south breastwall, under beam 4, has an area of missing and loose stones with fill spilling through, approximately 12" diameter. See photo 13.

Photo 13: Area of missing and loose stones in the south breastwall under beams 3 & 4.

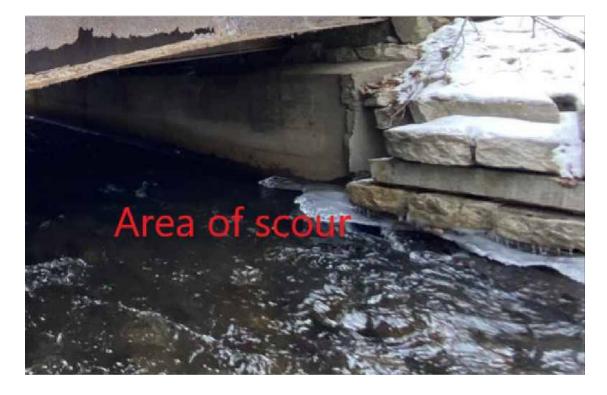
The north curtain wall is undermined starting at the downstream (east) end, 31' long x up to 33" of penetration (to the original stone masonry abutment).

The south curtain wall is scoured and undermined at the upstream (west) end, approximately 4' long x 12" of penetration. See photo 14.

Photo 14: North curtain wall scour.
