## STRUCTURES INSPECTION FIELD REPORT

## CULVERT &amp; SPECIAL MEMBER INSPECTION

BR. DEPT. NO.  
P-10-080

| CITY/TOWN<br><b>PITTSFIELD</b> | 8-STRUCTURE NO.<br><b>P10080-C12-MUN-BRI</b> | 11-Kilo. POINT<br><b>000.000</b> | 41-STATUS<br><b>D:OPEN</b> | 90-ROUTINE INSP. DATE<br><b>JAN 22, 2024</b> |

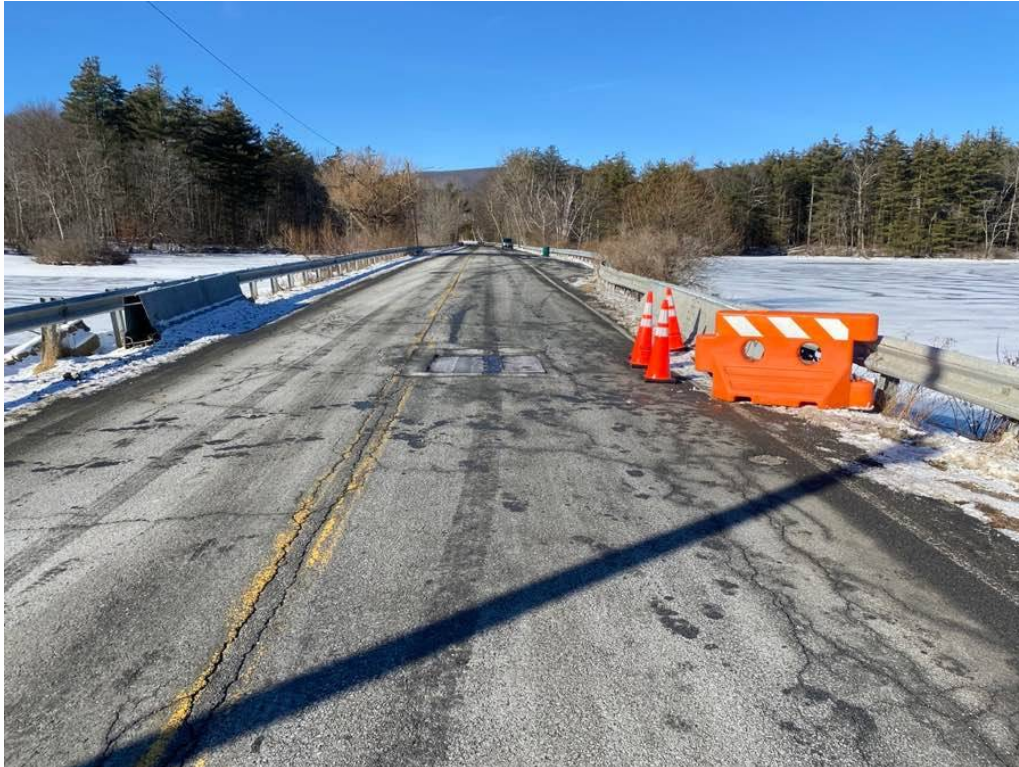
Dan Casey Memorial Drive travels east and west. Onota Lake flows from north to south. This culvert consists of one boiler iron plate pipe, 84" diameter, and two corrugated steel pipes, 36" diameter, that support gravel fill with an asphalt wearing surface. Report notes are taken from south to north, downstream to upstream, in accordance with the 2015 Bridge Inspection Handbook. See photo 1.

Temporary barriers have been installed. The barriers are not tied down and the north barrier is undermined, 10' long x up to 10" deep. The horizontal roadway clearance is to 27.8' (8.47 meters). See photo 1.

**Photo 1:** General topside, looking west.

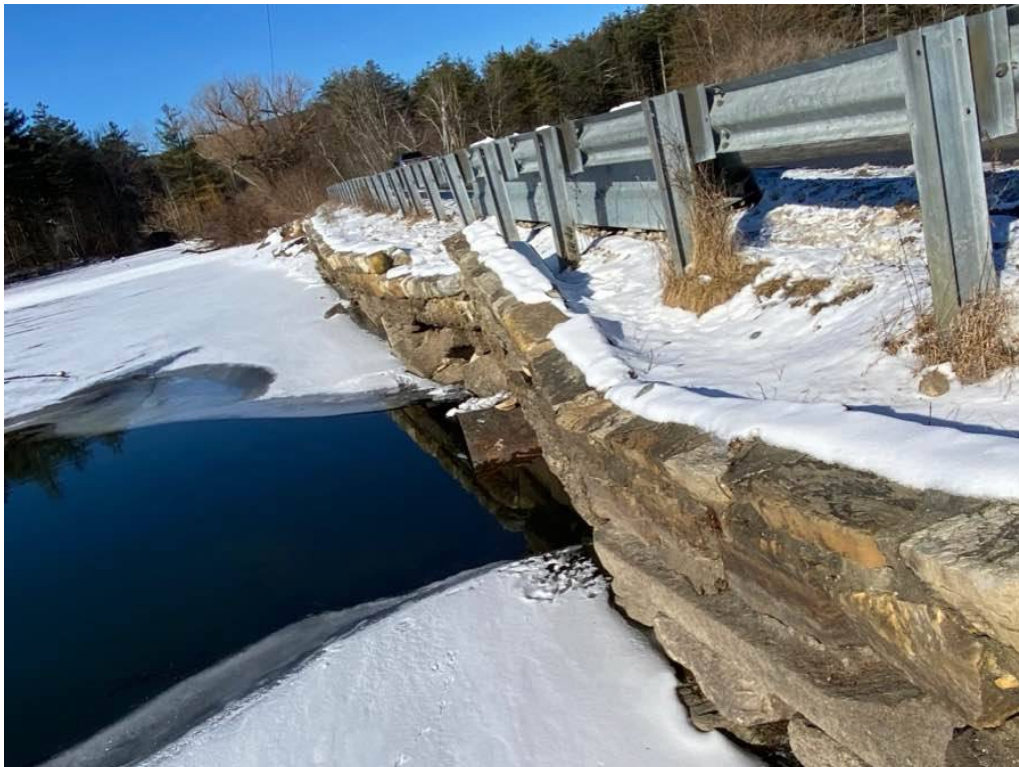
The south stone masonry headwall has areas of severe settlement and loose stones throughout. Several stones have fallen out of the wall allowing fill to spill through. This has left a settled area and holes in the embankment adjacent to the south edge of the roadway, which previously has been partially filled in with small stones. See photo 2.

The embankments between the headwalls and the traveled way have sinkholes due to the failure of the pipes and headwalls, 8' diameter x 36" deep. These sinkholes have reached the fog line and are partially filled with stone. See photos 2 - 4.

Both stone masonry retaining walls have areas of severe settlement, loose stones, and failure. See photo 2 - 4.

**Photo 2:** South end of the pipe.

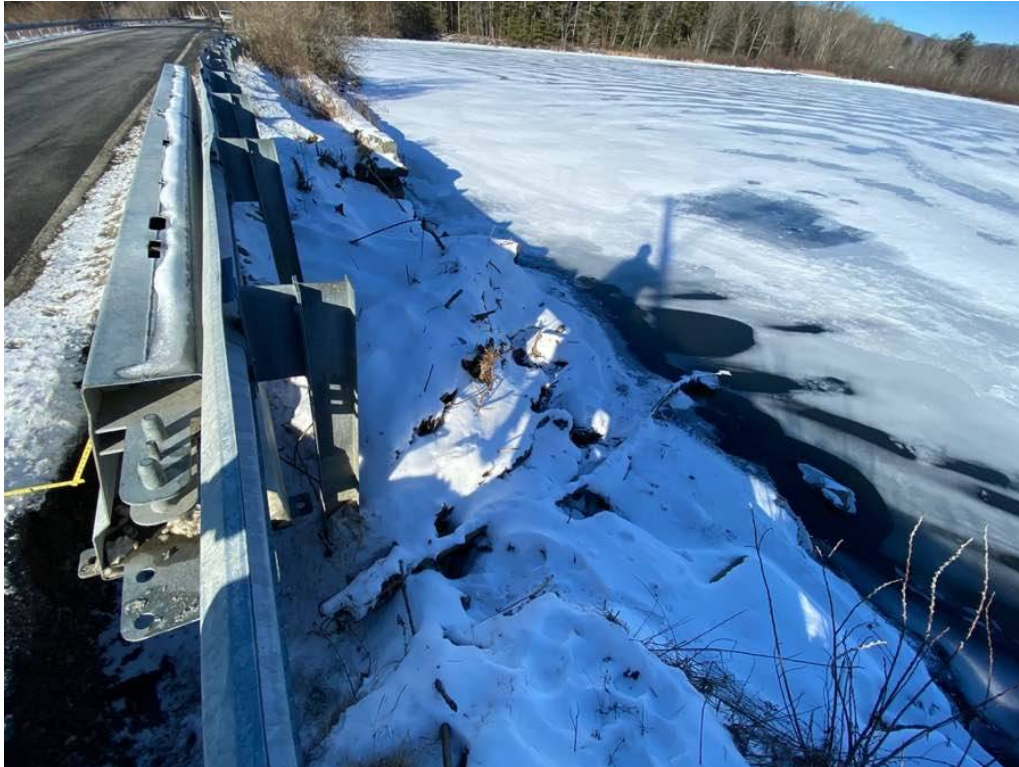
The north stone masonry headwall has collapsed in front of the culvert inlets. See photo 3.

The embankments between the headwalls and the traveled way have sinkholes due to the failure of the pipes and headwalls, up to 8' diameter x 36" deep. These sinkholes have reached the fog line, and are partially filled with stones. See photo 3 & 4.

At the northeast corner, a sinkhole is undermining the roadway, 6' long x 6' wide x 26" of unsupported asphalt. See photos 3 - 5.

At the north (upstream) end of the pipes, there is severe scour and erosion of the surrounding embankments and fill. See photo 3.

All pipe inlets are blocked and hidden by the failed headwalls as well as driftwood and other debris. This debris is restricting the flow through the structure. See photo 3.

In the gravel shoulders, there are areas of severe settlement related to the failure of the adjacent retaining walls. See photos 3 & 4.

In the gravel shoulders, there are areas of settlement related to the failure of the adjacent retaining walls. See photos 3 & 4.

**Photo 3:** Debris blocking the north end of the pipe and the collapsed north headwall.

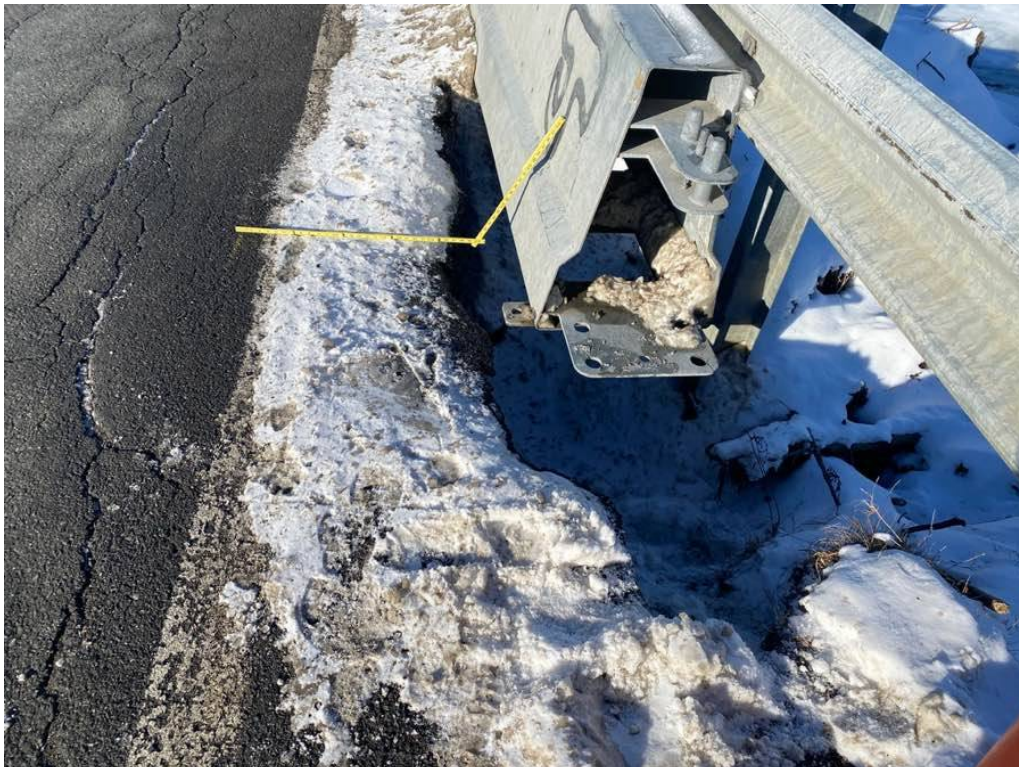
The northeast embankment is quickly eroding. See photos 4 & 5.

Along the north railing posts have been exposed by the settlement / sinkhole. barriers are in front of these areas. See photo 4.

**Photo 4:** Northeast embankment.

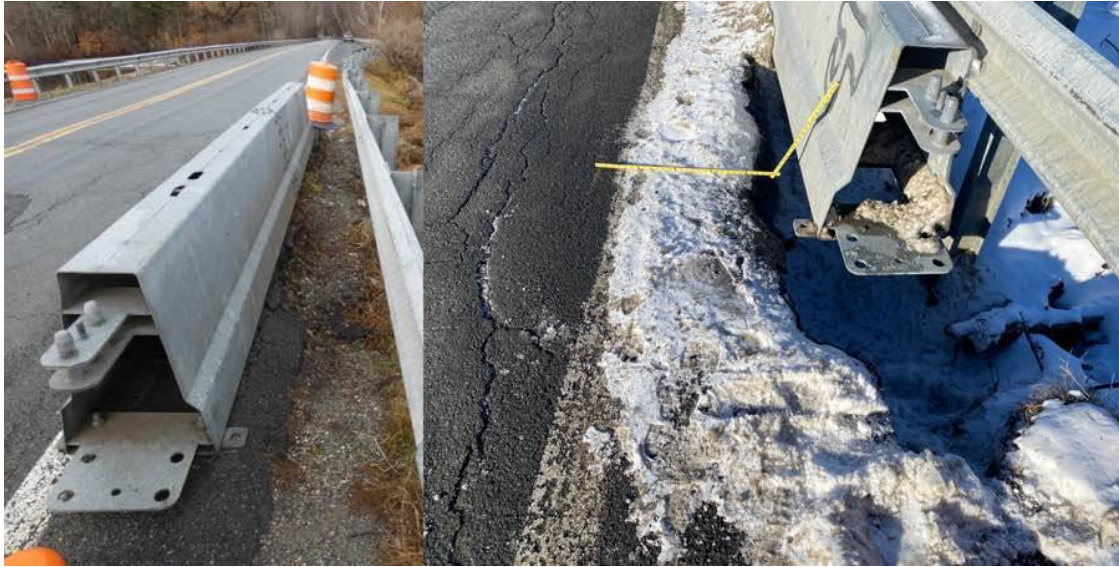
**Photo 5:** January 2023 vs January 2024.

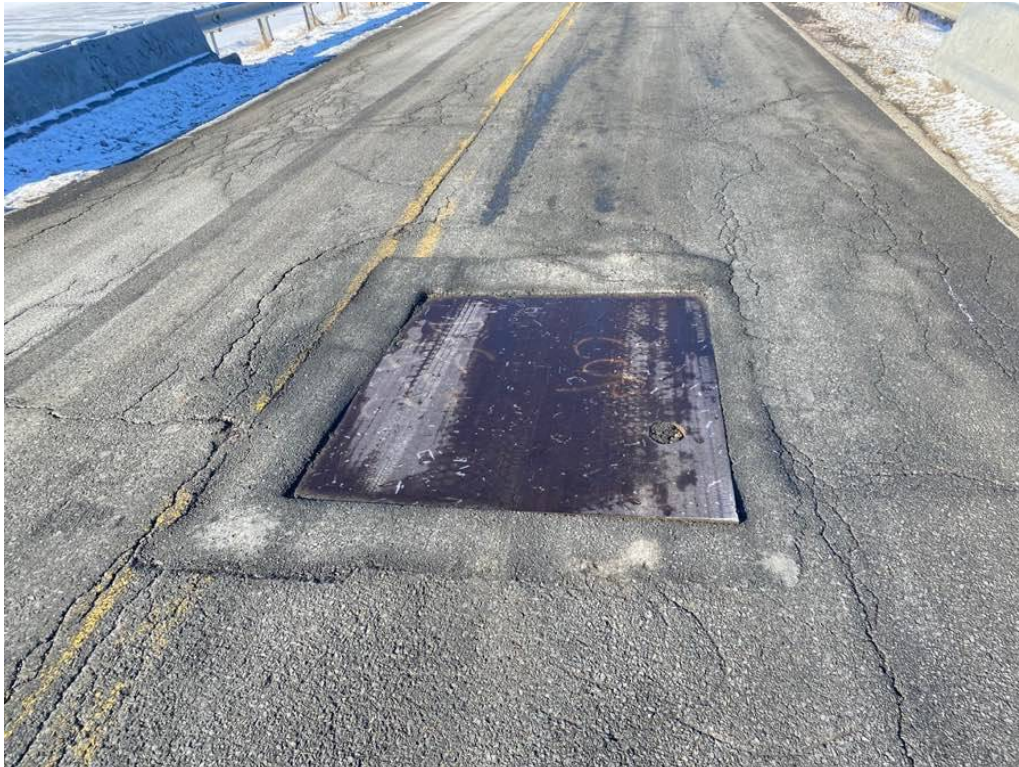
There are areas of cracking and minor settlement, with transverse cracks. See photo 6.

The center has an area of moderate to severe settlement, 6' diameter x up to 2" deep. See photo 6. This area has several patches.

At the east end of the wearing surface extending into the approach a steel plate has been paved into the roadway. The plate appears to be settled and heaved. See photo 6.

**Photo 6:** Cracking and plate in the wearing surface.
