Walk Audit Report

Dalton Avenue, Pittsfield, MA

November 2025

Pittsfield Community Design Center

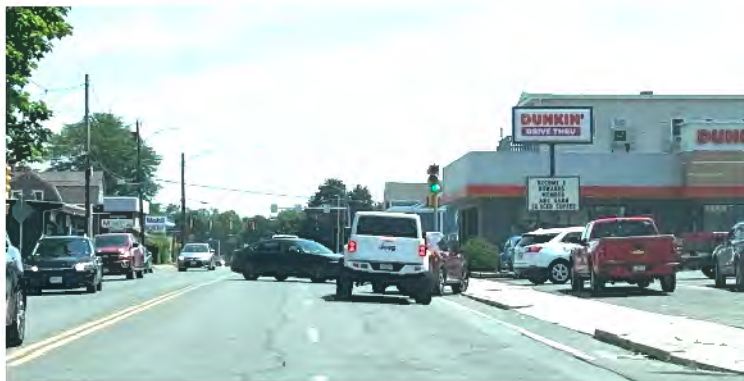
ABOVE: TRAFFIC SPILLED BACK FROM THE DUNKIN' DONUTS DRIVE-THRU.

Drive-thru traffic: The Dunkin' Donuts franchise at 84 Dalton Ave is a major traffic generator along the corridor. Drive-thru traffic frequently spills back from the parking lot onto the sidewalk and traveled way. Indeed, at the start of the audit, traffic was backed up beyond the property; blocking the sidewalk and spilling into the rightmost travel lane. This situation interferes with pedestrian travel along the sidewalk, and causes vehicles to change lanes suddenly in the area of the driveway.

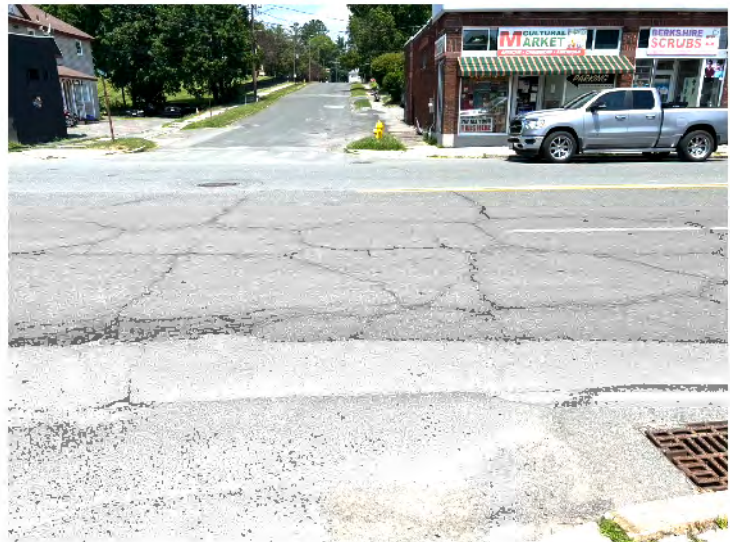
During walk audit observations, it was noted that vehicles are parked along the northerly curb of Dalton Ave immediately east of Dartmouth Street (see right). This created an obscured "sight triangle" where someone walking would need to traverse about twelve feet into the roadway to see around the parked vehicle in order to check for oncoming traffic.

ABOVE: THE TRUCK PARKED ALONG THE OPPOSITE CURB CREATED AN OBSCURED SIGHT LINE FOR PEOPLE CROSSING FROM THAT CORNER.

3. Establish “daylighting” at corners with on-street parking regulations. As noted in the walk audit observations, vehicles parked close to a street corner obscure the view of people trying to cross the street and turn out of the side street while driving, as well. **One car-length of clear space (also known as “daylighting”)** should be established at the corners of each intersection, where parking is prohibited. A parking regulation that establishes “No Parking Here to Corner” controls can be approved through the Traffic Commission put to the City Council through petition.

While signage would be the first step to restricting parking nearby the street corners, a long-term solution would be to install curb extensions or other barriers to prevent parking too close to the street corner. These should be considered at the next opportunity for street maintenance or reconstruction along this corridor. In the interim, epoxy gravel paint can be applied to the affected areas to create a contrasting surface that communicates that parking is not permitted within 20 feet of the street corner. Planters or flex posts could also be used as a light, quick, cheap solution in the interim.

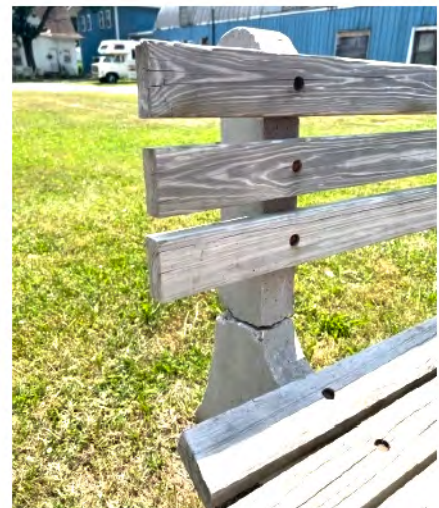
BELOW: THE BUS STOP BENCH ENCOUNTERED DURING THE WALK AUDIT IN POOR STRUCTURAL CONDITION.

Bus stop: Community members noted that there is a bench installed at the corner of Harvard Street in the outbound direction for BRTA bus routes along Dalton Ave. The bench is cracking and is at risk of breaking or causing injury if someone were to sit on it. There is no shade from trees, buildings, or otherwise in the vicinity, and likewise no cover from rain or snow. There was no evidence of a bus stop on the other side of the street, but it is presumed that passengers could flag a bus for pick up or drop off.

5. Improve the bus stop for transit riders. It is recommended that BRTA pursue installation of a new bus shelter and signage at this stop to encourage more transit use and to protect passengers from the elements while waiting for a bus.

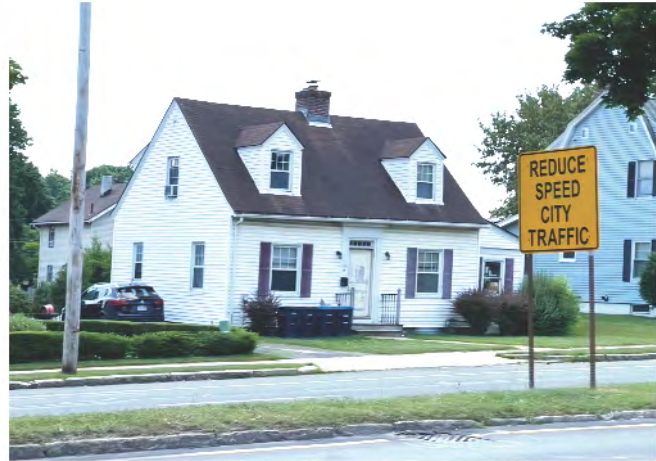
Speed limits: The corridor of Dalton Ave from Benedict Road to Woodlawn Ave does not have a posted speed limit. While this indicates that the citywide statutory speed limit applies, in practice this provides no clear guidance to motorists for consistent or predictable travel, especially on a gateway where travelers from outside the city are likely passing through. The nearest speed guidance is on the divided highway to the east, where posted speeds reduce to 35 mph, and a warning sign indicates that motorists should reduce speeds. It is presumed that the 35 mph limit carries through the "lower" Dalton Ave corridor until reaching the roundabout with Woodlawn Ave.

ABOVE: SPEED REDUCTION WARNING SIGN APPROACHING BENEDICT ROAD ON THE OUTER DALTON AVE CORRIDOR.

1. **Formalize and enforce speed limits.**
The city can formalize the speed limits on this corridor in one of two ways:

- Establish a special speed regulation to allow for regulatory speed limit signs to be posted along the corridor. This special speed regulation would need to be drafted and approved by the Pittsfield City Council.
- Post 25 mph statutory speed limits pursuant to M.G.L. Chapter 90 §17C. According to MassDOT records, the city of Pittsfield adopted this section of Chapter 90 that allows for reduction of the citywide statutory speed limit to 25 mph in 2017. The city has not installed any signage to indicate that this statutory speed limit is in place. **It is recommended that the city Highway department work to install the standard signage (see below) at conspicuous locations around gateway areas** into the city, as well as periodically in strategic locations in neighborhoods as reminders.

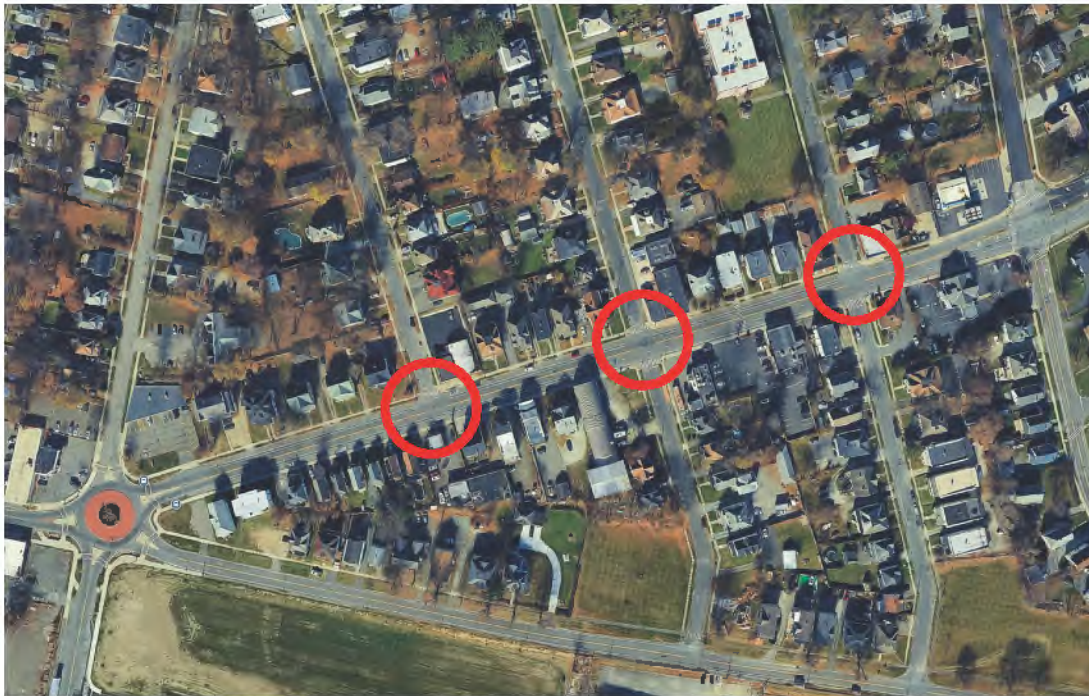
It is unknown for certain whether Luis Chin was crossing Dalton Ave directly within an unmarked crosswalk or crossing "midblock", without further details from the crash investigation. What is known is that there are only three marked crossings on Dalton Ave, two of which are on either end of the corridor: at the roundabout with Woodlawn Ave, and the

signalized intersection with Dalton Ave. The only other marked crossing is a signalized midblock crossing near the Dunkin' Donuts property. All other crossings at the intersections along Dalton Ave are unmarked.

ABOVE: LOCATIONS WHERE MARKED CROSSWALKS ARE RECOMMENDED.

2. Convert all crosswalks to marked crossings along the corridor. Given the denser, urbanized land use context along lower Dalton Ave, and given the implied 25 mph speed limit due to the city’s adoption of M.G.L. Chapter 90 §17C, all **crosswalks at intersections along the corridor should be marked to allow for more conspicuity** and for more predictable behavior from pedestrians and motorists alike. The figure below shows the intersections along Dalton Ave circled in red that would benefit from full marked crosswalks. “Yield to pedestrians in crosswalk” stanchion signs are also recommended to be used to help with traffic calming.

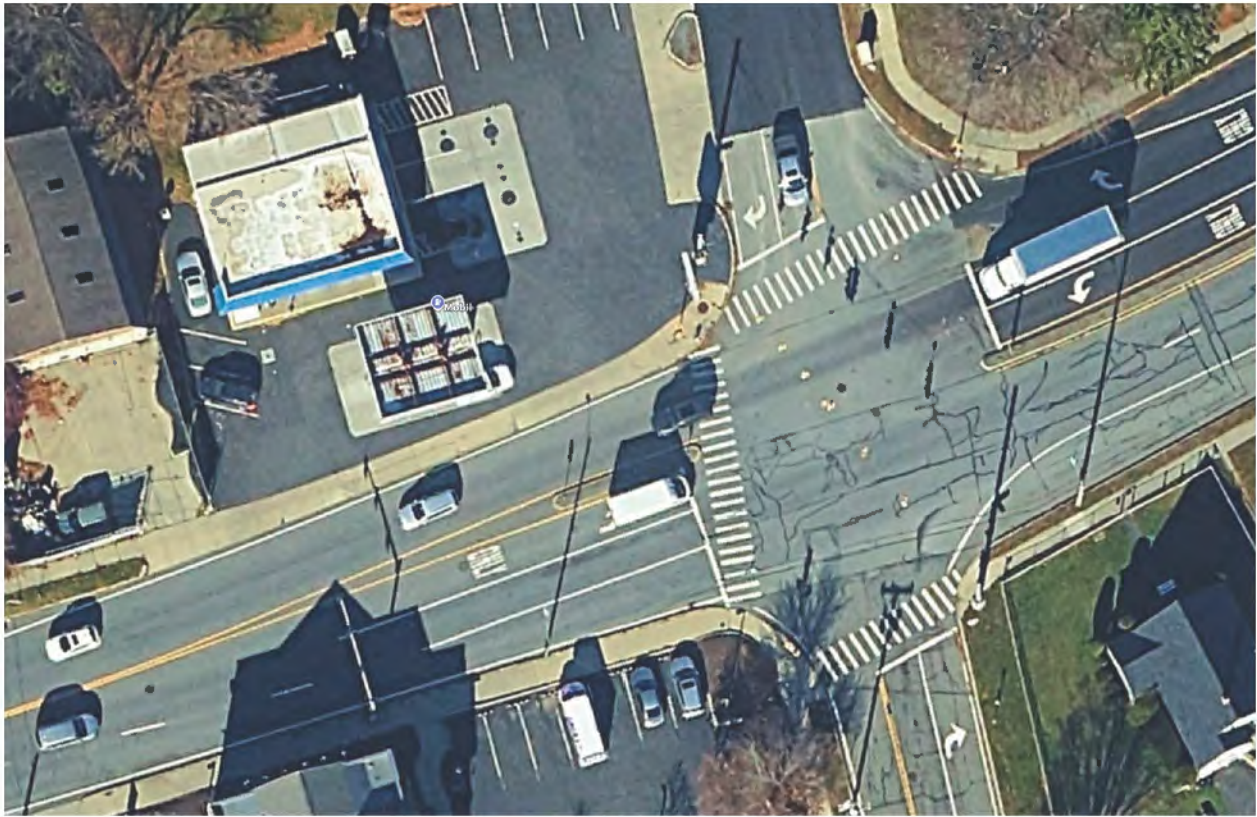
While these lane measurements are not unusual for an arterial road, the westbound travel lane on the block just prior to this (where the fatal collision occurred) is anywhere from 15 to 18 feet wide, which is prone to inviting excessive speeds.

ABOVE: THE MEDIAN ISLAND SHOWN ON THE WESTERLY LEG OF THE INTERSECTION COULD BE WIDENED TO NARROW THE “RECEIVING” LANE OF TRAFFIC PASSING THROUGH THE INTERSECTION. THE WHITE SHOULDER STRIPE CAN ALSO BE MOVED FURTHER AWAY FROM THE NORTHERLY CURB. “NO PARKING” SIGNS WOULD NEED TO BE INSTALLED.

4. Right-size travel lanes. The wide “transitional” nature of the westbound travel lane beyond Benedict Road invites speeding through this corridor, especially if the traffic light is green for

through traffic. Painting a white shoulder stripe and widening the median island on the western leg of the Dalton Ave/Benedict Road intersection would signal that reducing speed to the citywide 25 mph statutory limit is imperative. Making a pinch point creates “edge friction” for drivers that cues them to slow down naturally, beyond the need for signs.
