Saint Stanislaus Kostka Mission

CONDITION ASSESSMENT STUDY FINAL REPORT - DECEMBER 12, 2020

Executive Summary - December 12, 2020

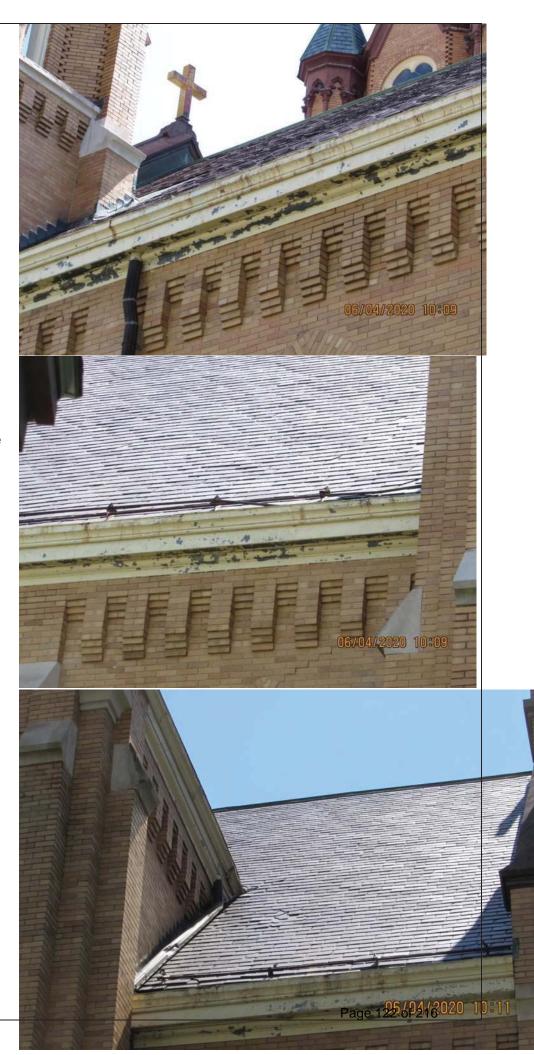
View of the west main steep sloped slate roof at the south end. Note many slate were cracked and damaged. Also note, the entire pipe snow guard fence was damaged. This location was below the roof of the west dormer.

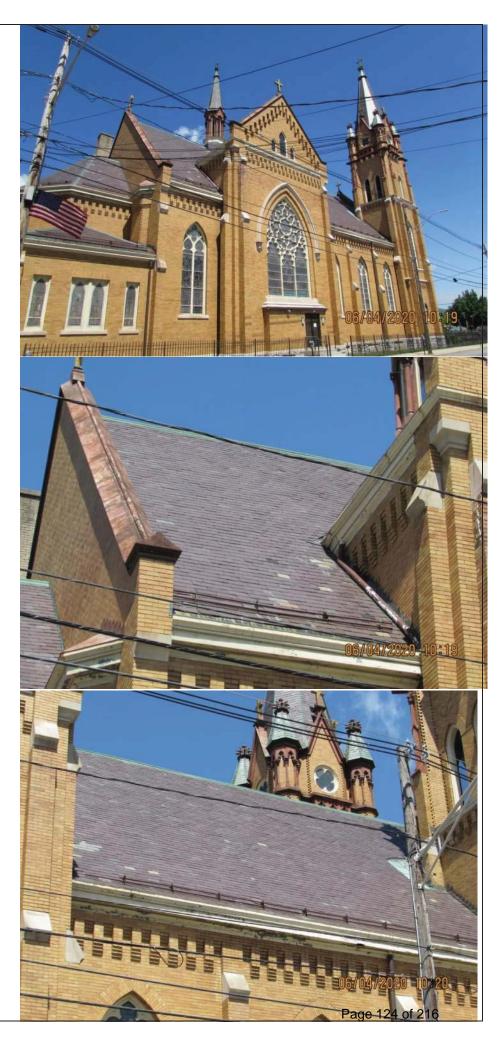
View of the east main slate roof at the north end.
Localized slate in the roof field had been repaired.

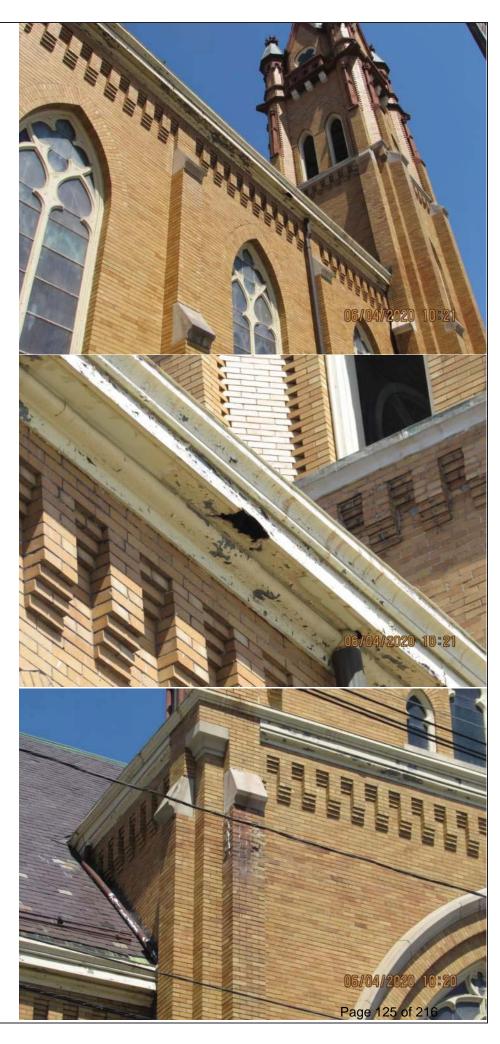
View of severe spalling of the southeast brick turret. Previous repairs made to the brick with sealant.

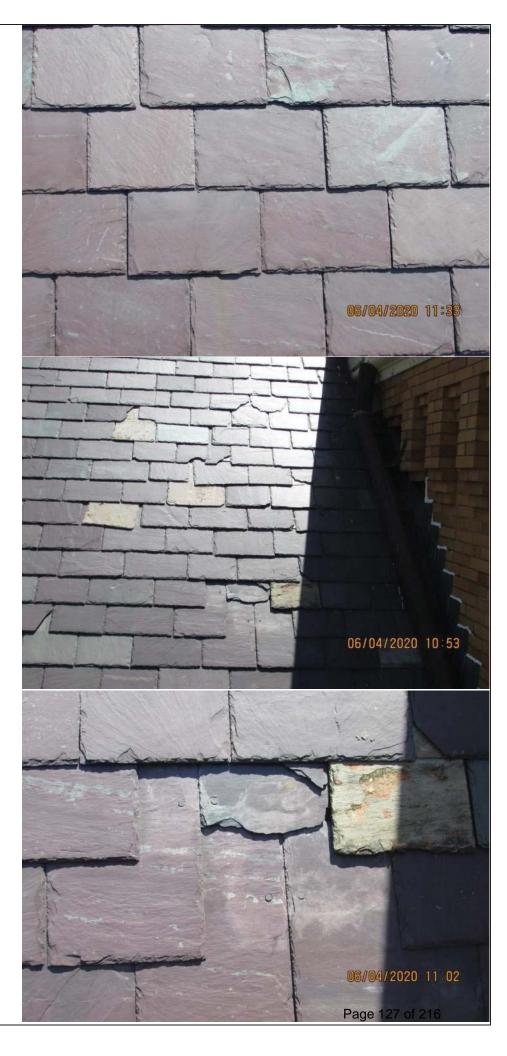
View of exposed nail fasteners where the slate were damaged. The slate fasteners were copper. Water can enter.

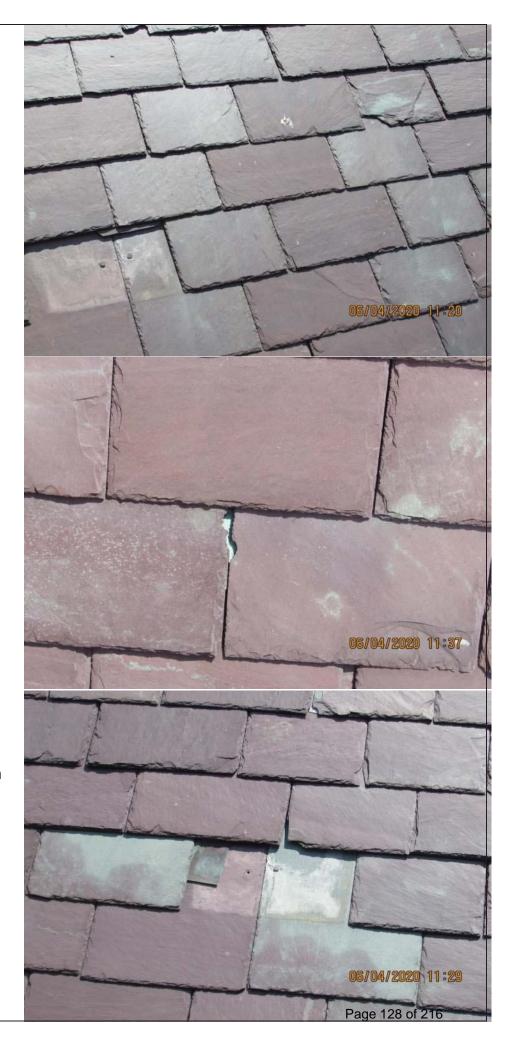
View of another failed slate bib repair. Hole in slate can allow water to enter.

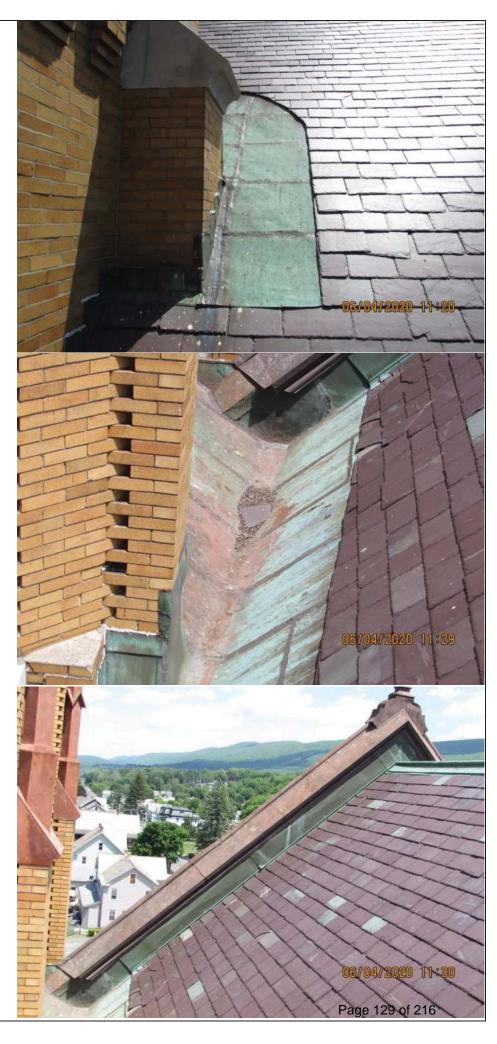
View of the north rake parapet wall on the West Main steep sloped roof. The top of the parapet was covered with terne metal coping. Copper base flashings were incorporated with the slate roof and the metal covered parapet. The copper was in fair condition. The terne metal coping condition was less than fair.

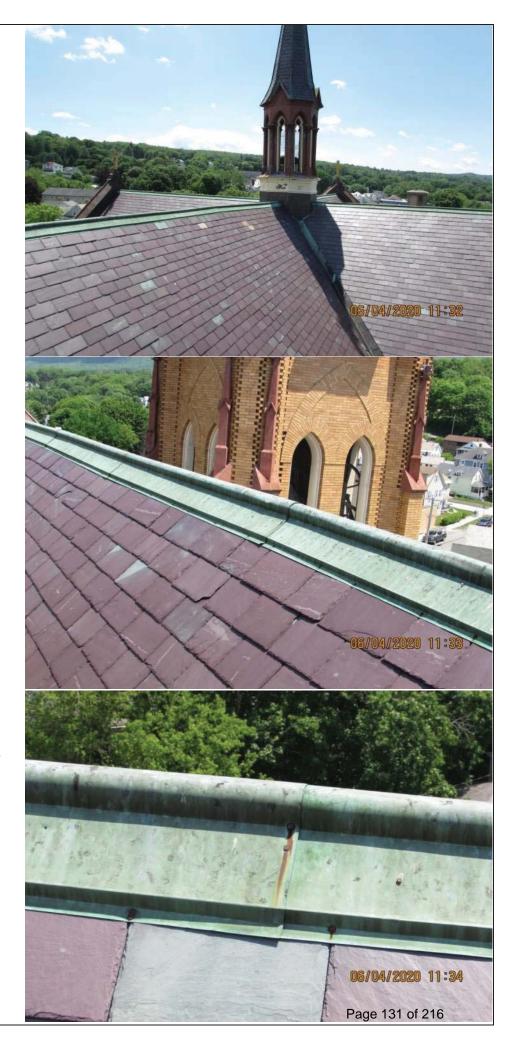
View of overlap joint of one (1) of the copper ridge roll sections. Rusted nails also secure the ridge roll sections in place.

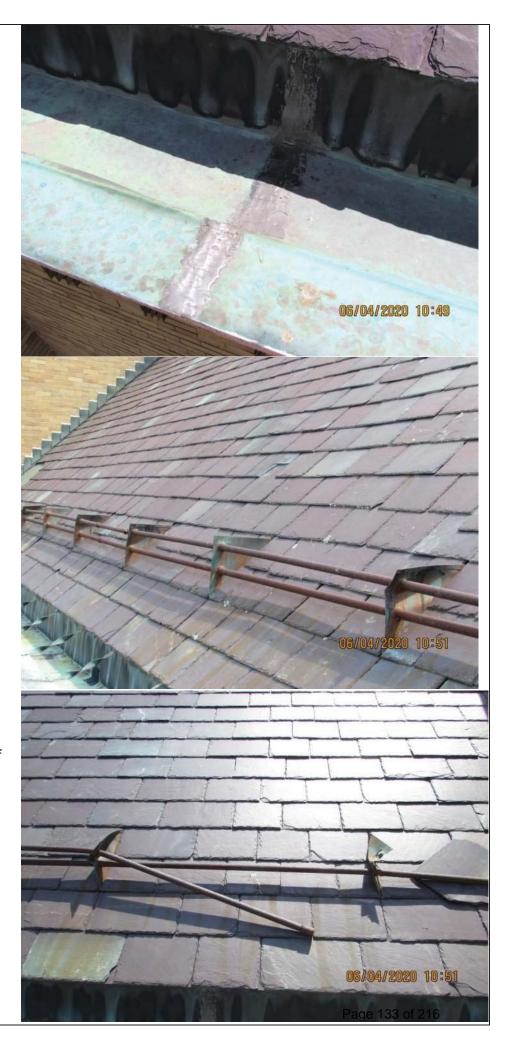
View of damaged section of the pipe snow guard fence.

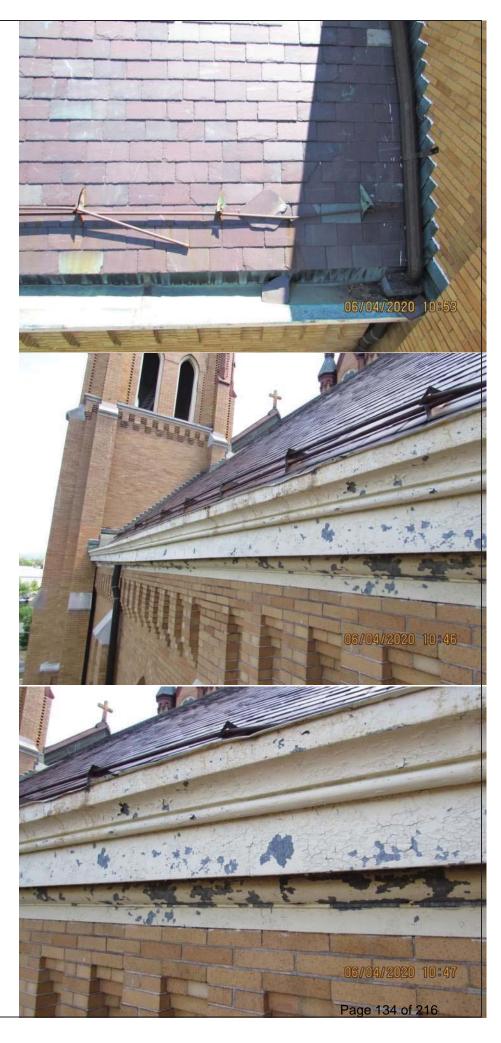
View of peeling paint on the cover. Condition also at other locations.

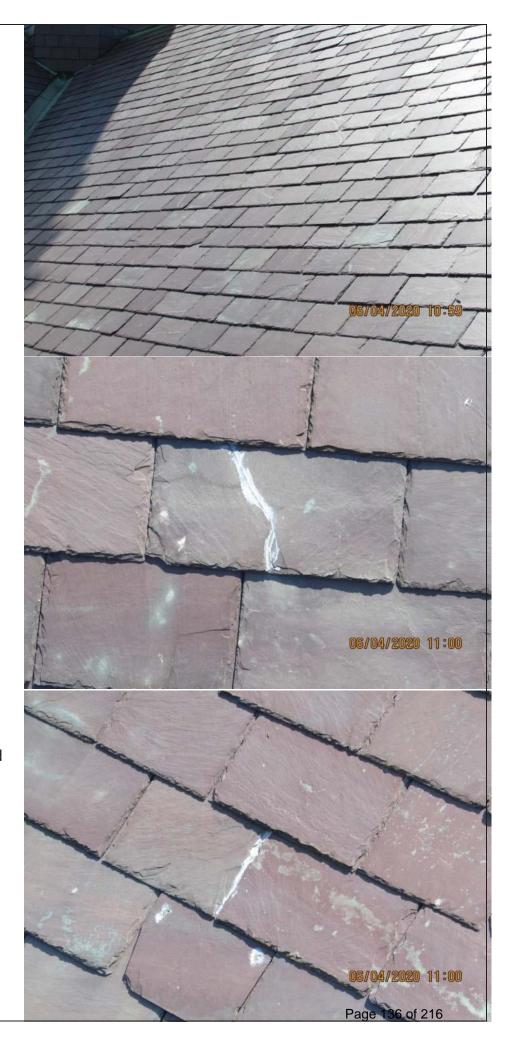
View of other slate repaired with white sealant. Sealant was also installed over nail fasteners. The sealant repair was improper.

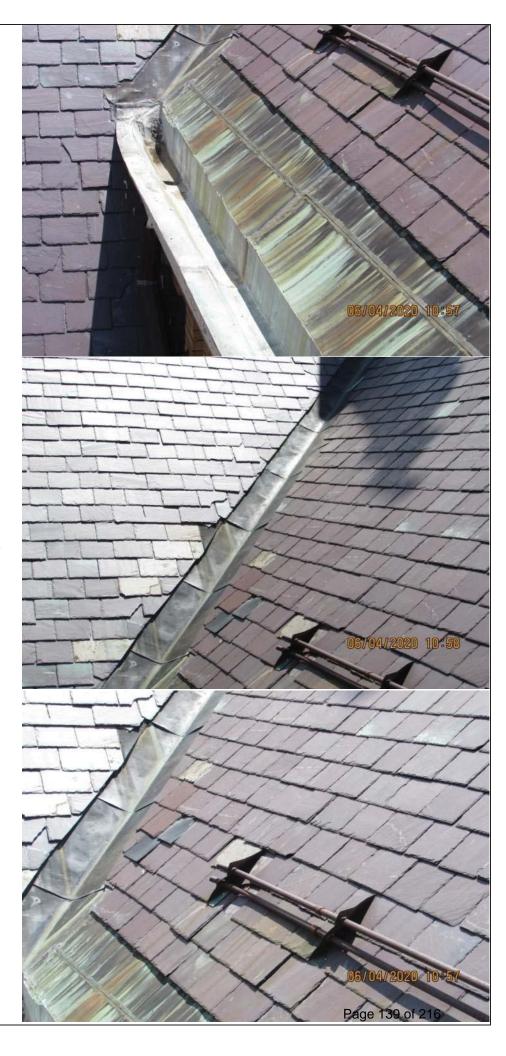
View of the pipe snow guard fence condition on the north dormer roof. Several slate were missing or had been repaired.

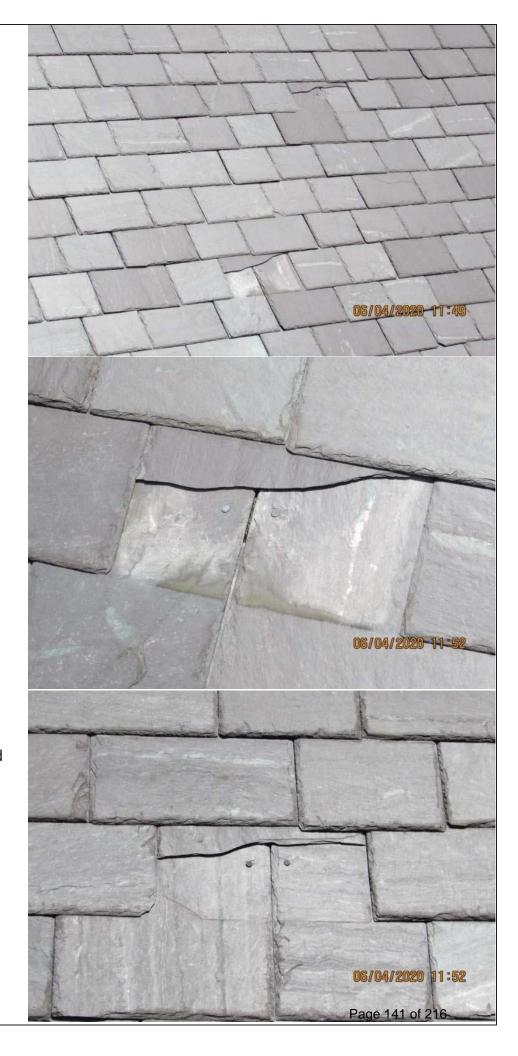
View of the other damaged slate. Water can enter the exposed nails.

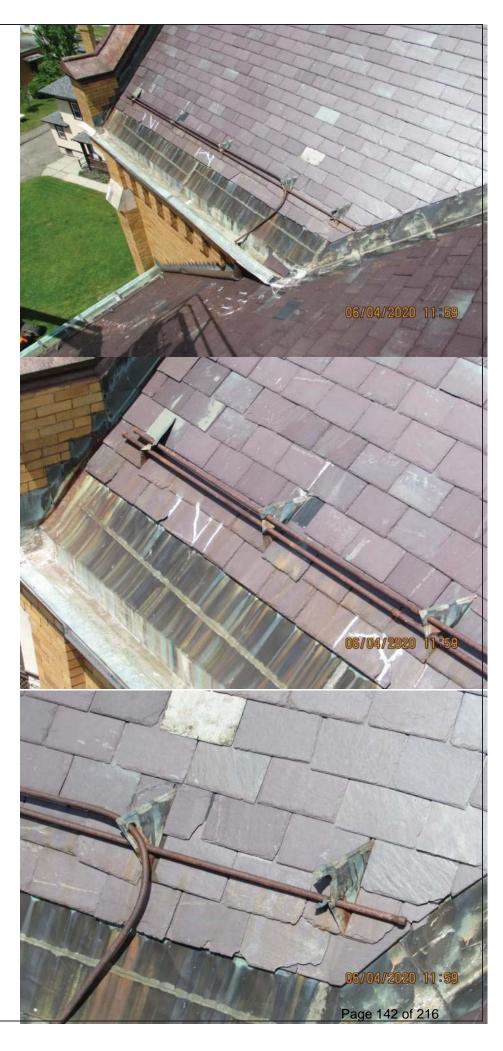
View of damaged brackets for the pipe snow guard fence.

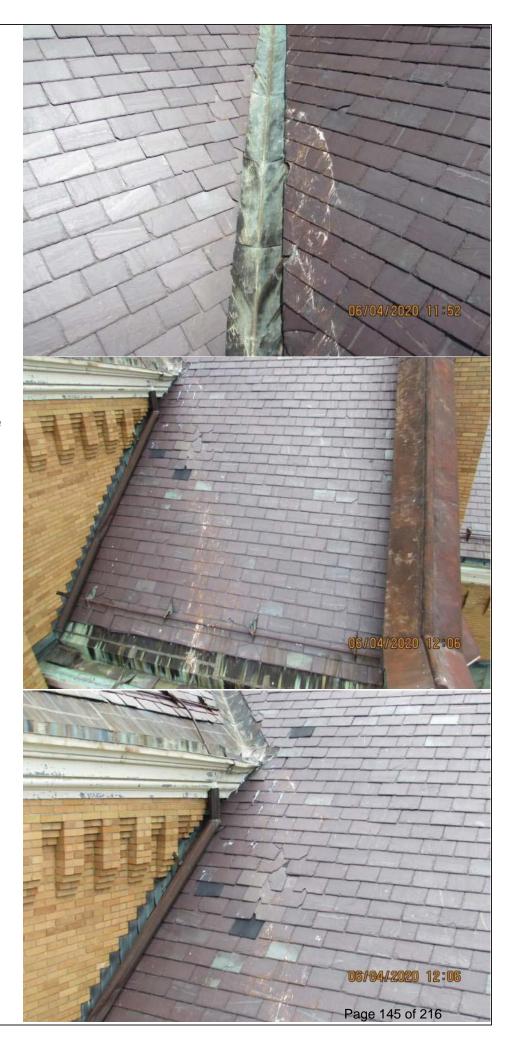
View of some of the damaged and repaired slate. This area was below the dormer valley and roof of the south facing dormer.

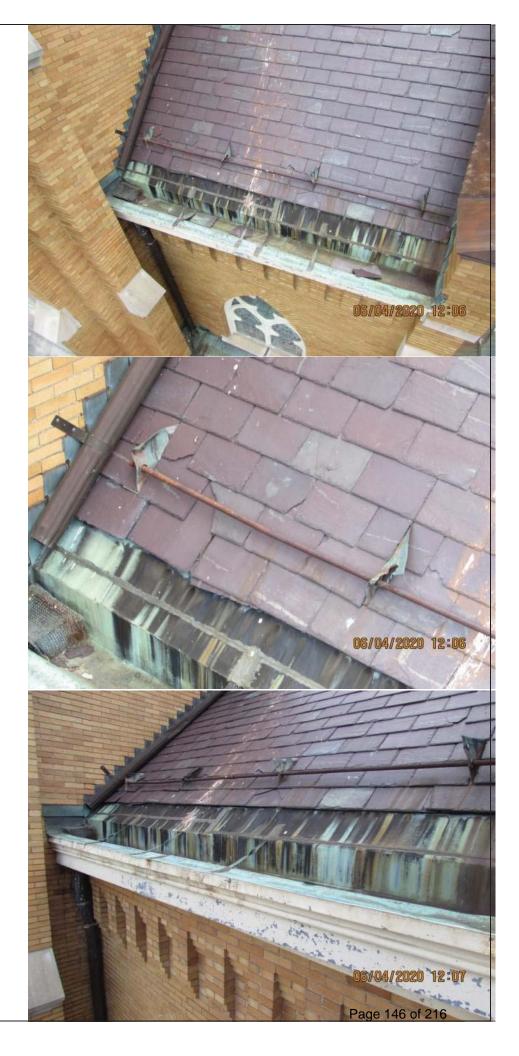
View of condition of the painted ornamental galvanized cover of the large built-in gutter. The paint was peeling at many cover locations.

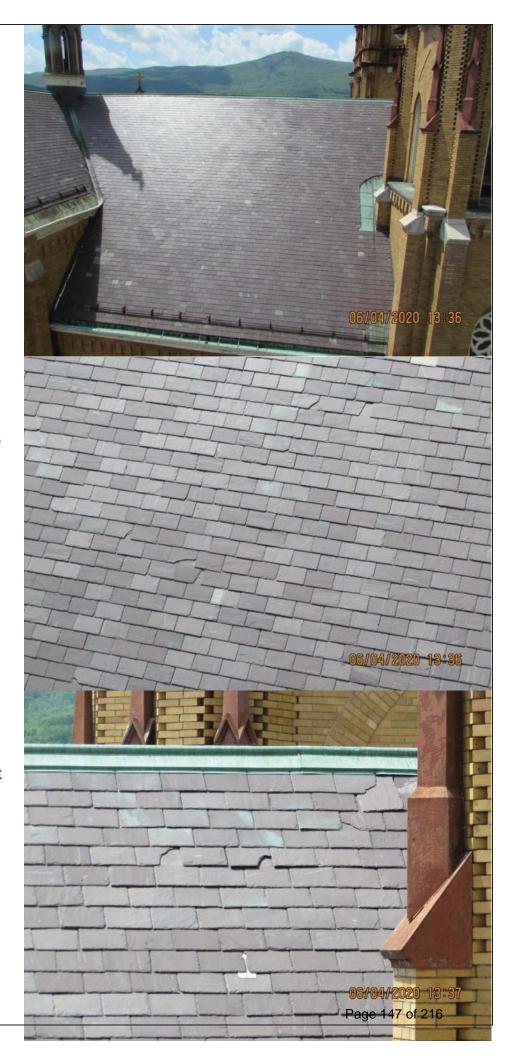
View of other broken slate below the ridge on the East Main steep sloped roof. One (1) slate contained a metal bib repair.

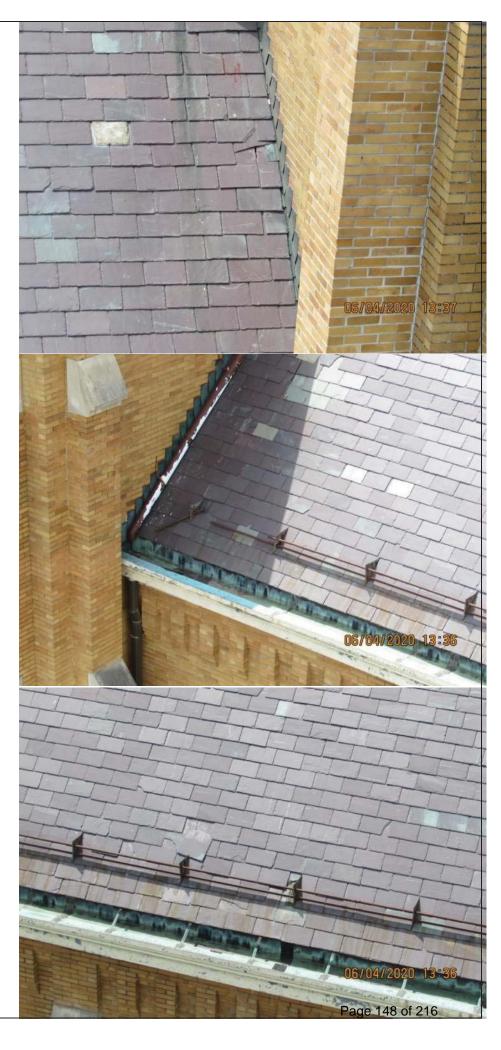
View of few damaged and cracked slate above the pipe snow guard fence. Note EPDM repair in the large built-in gutter.

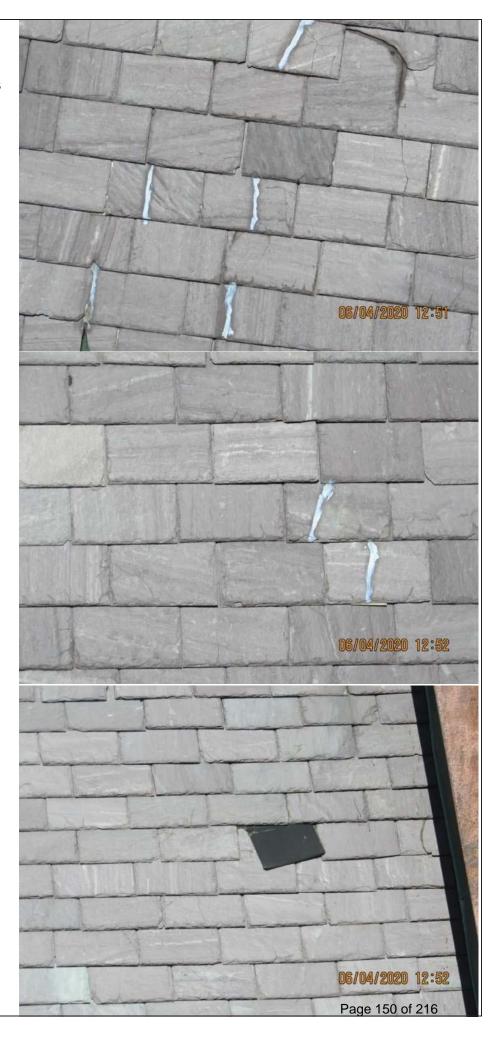
View of improper slate repair made on the south roof of the East Dormer.

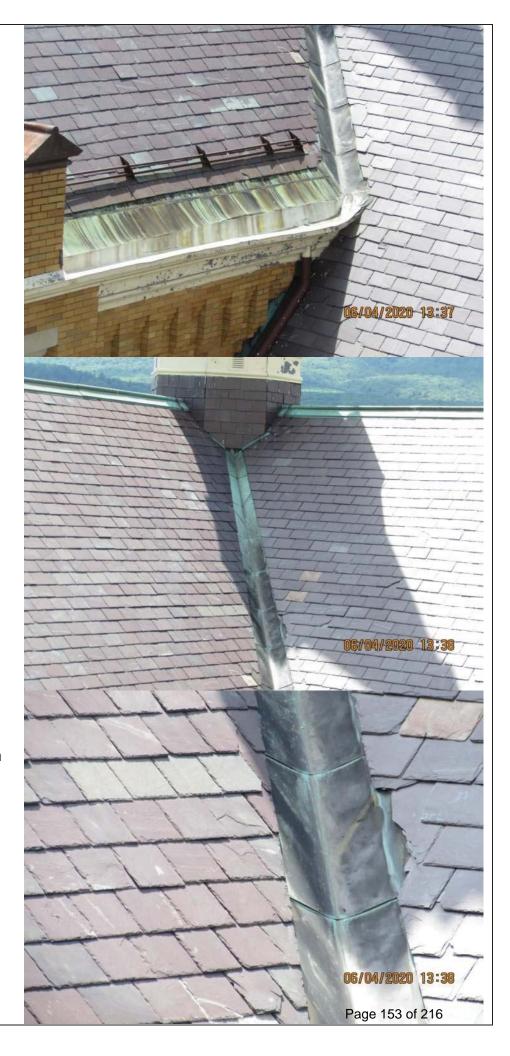
View of some of the broken and chipped slate adjacent to the valley.

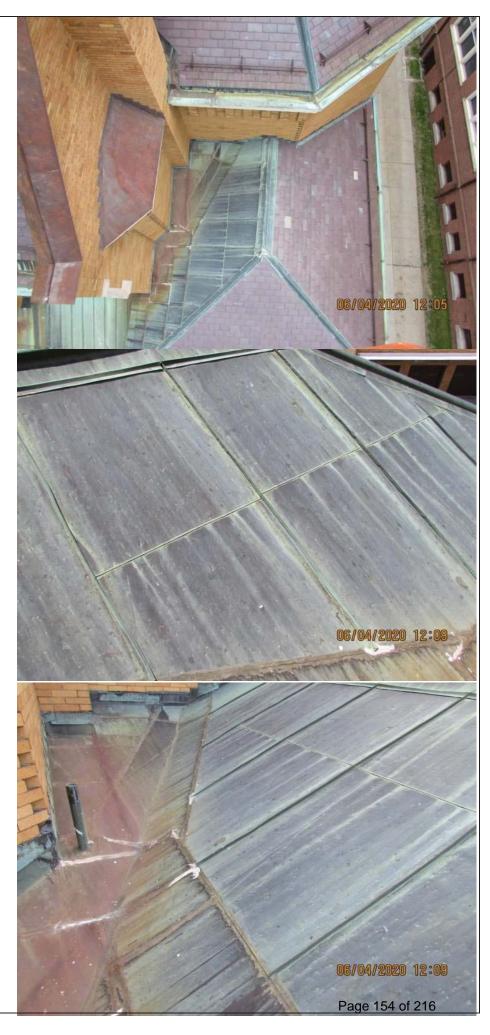
View of old prior sealant repairs made to some of the wide standing seam panels where they lock onto a copper apron flashing. The sealant repair was improper.

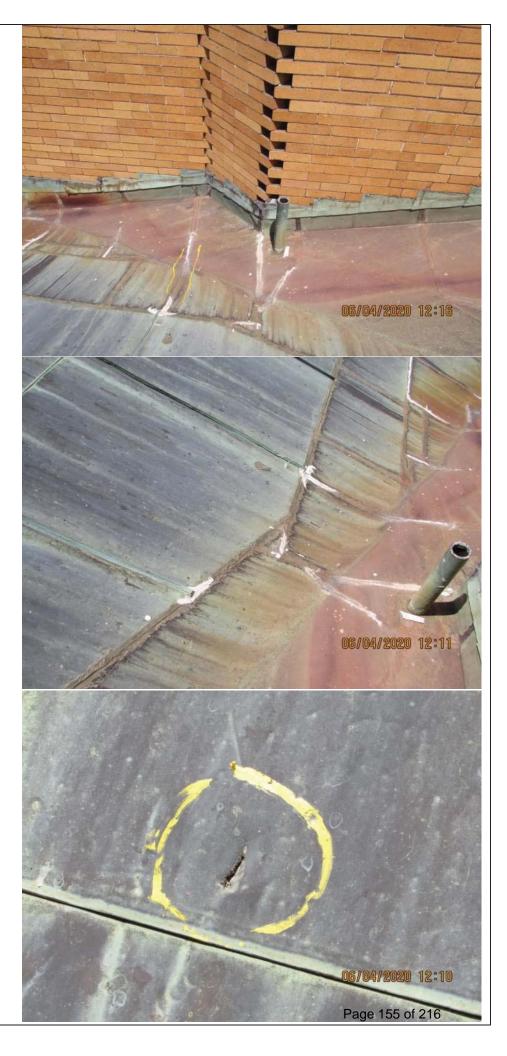
View of large hole in one (1) of the wide copper panels. Water can enter.

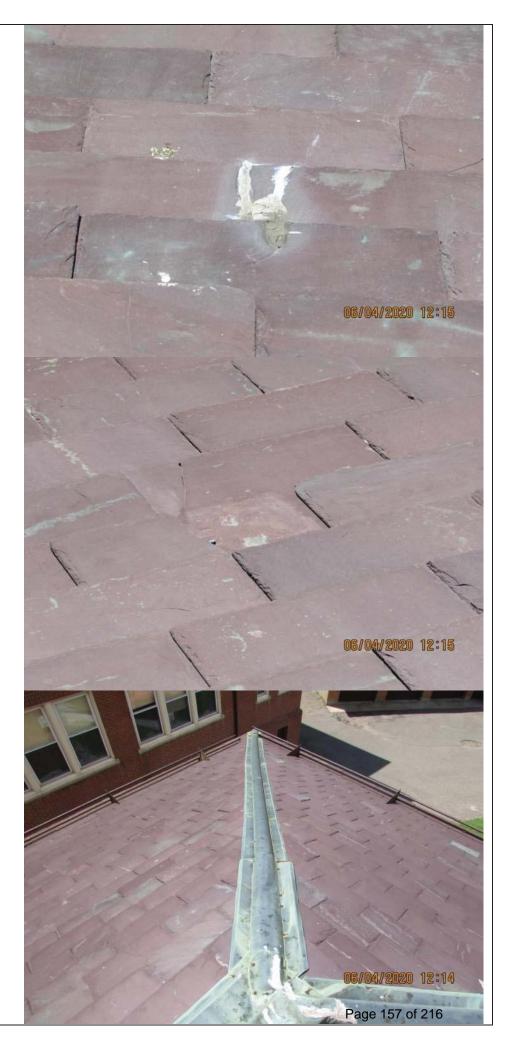
View of condition of the copper hip roll cover.
Exposed rusted nails retain the cover in place.

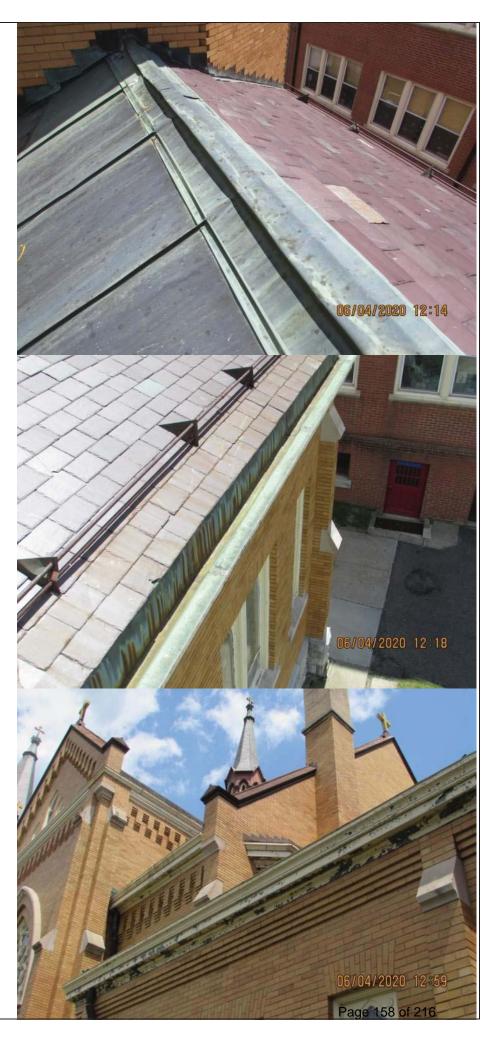
View of condition of the ornamental galvanized cover of the built-in gutter of the West Hip roof. Paint was peeling from the cover.

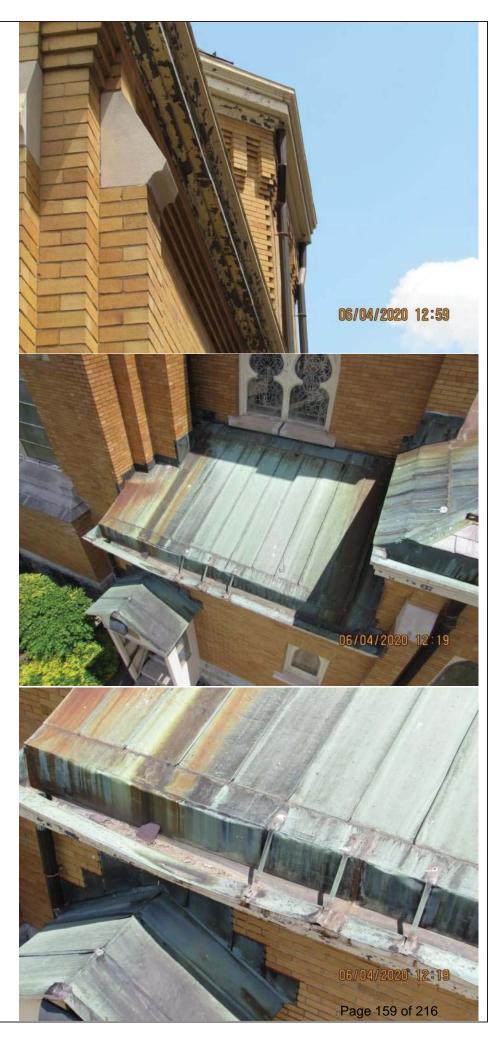
View of condition of the built-in gutter and copper liner. The liner acts as an apron for the copper roof panels. The gutter exhibited damage.

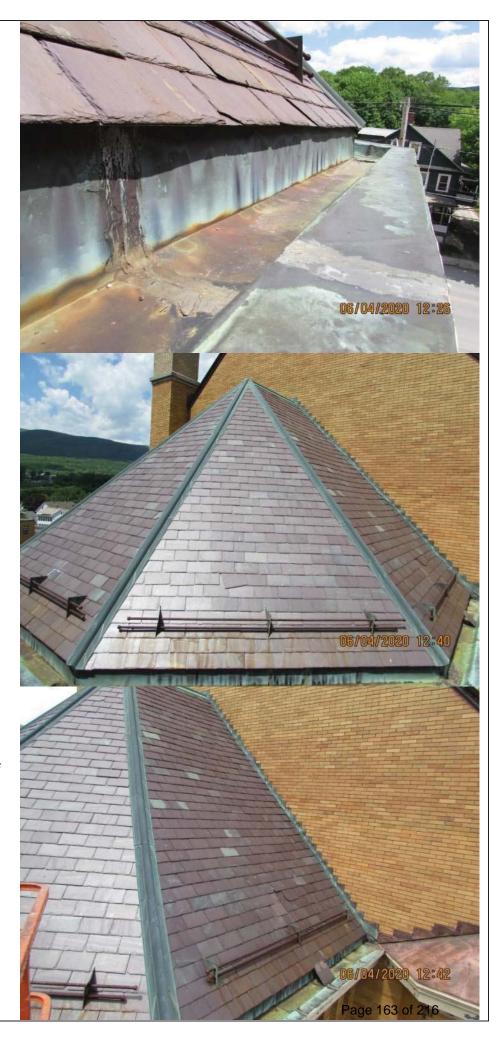
View of the east hip roof. One (1) slate had slid out of place. Several in the roof field had been repaired.

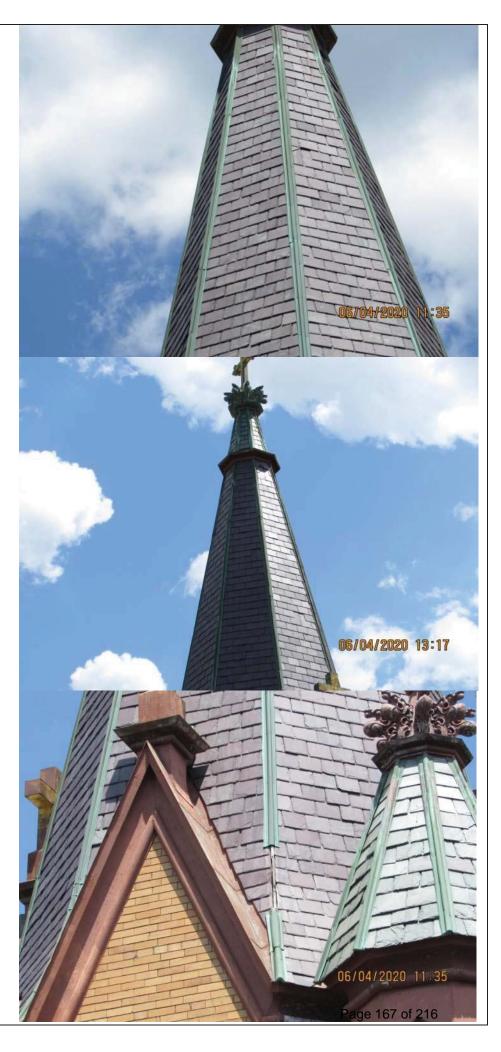
View of missing hip cover exposing wood at the Main Spire southeast corner. The wood was weathered. Water can enter. Note the south dormer roof was clad with terne metal.

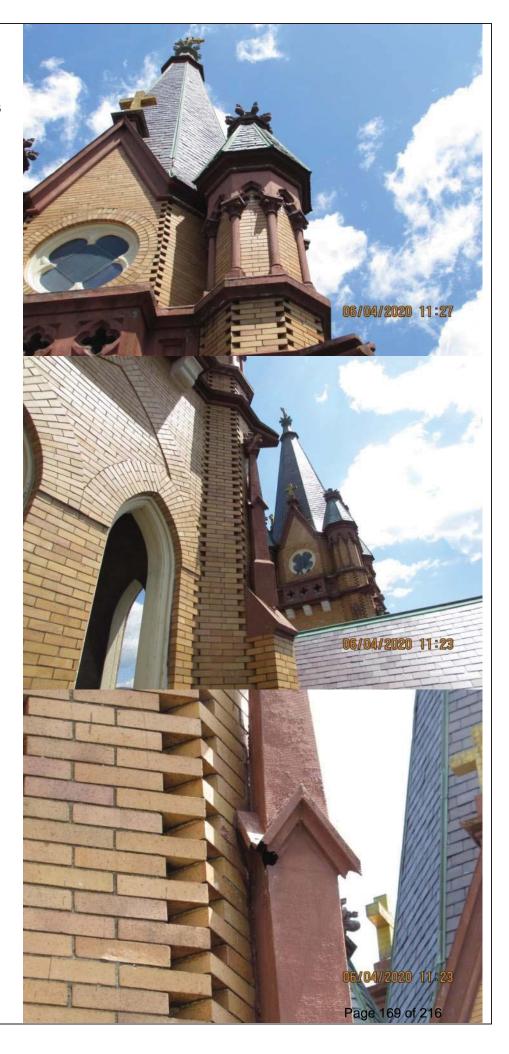
View of areas of corroded terne metal of the pinnacle. Water can enter.

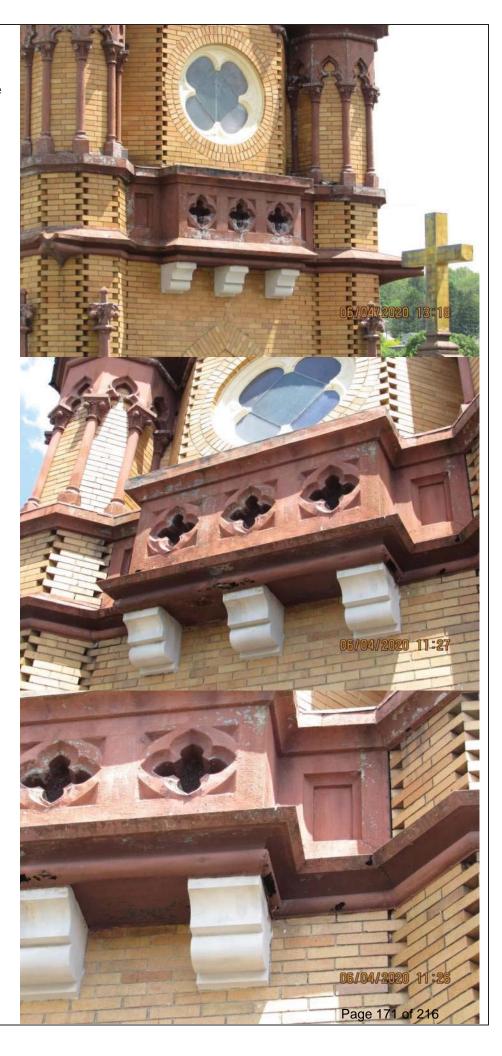
Another view of the severely corroded metal of the ornate balcony. Water can enter.

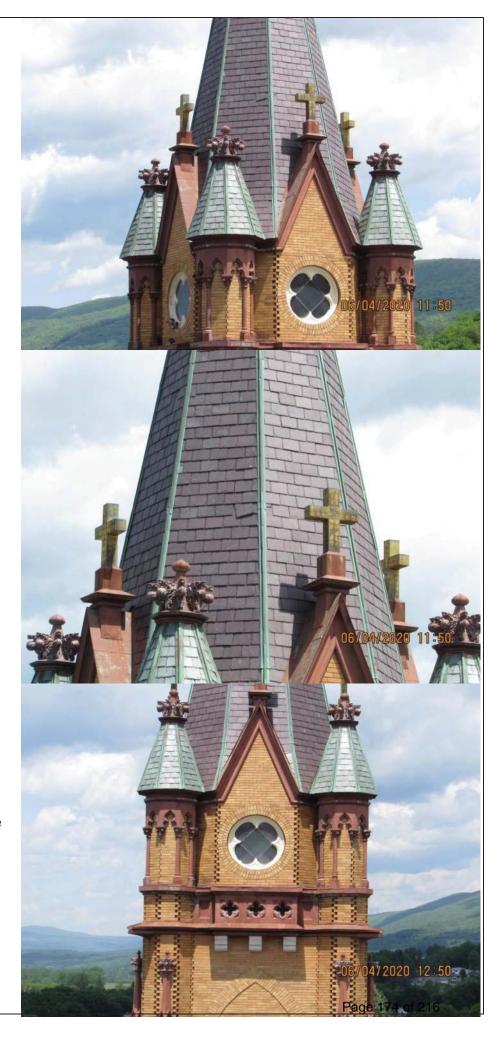
View of the ornate terne metal architrave, pilasters, upper and lower ledge, and the ornate balcony. Note two (2) of the pilasters were missing at the southeast and southwest turrets.

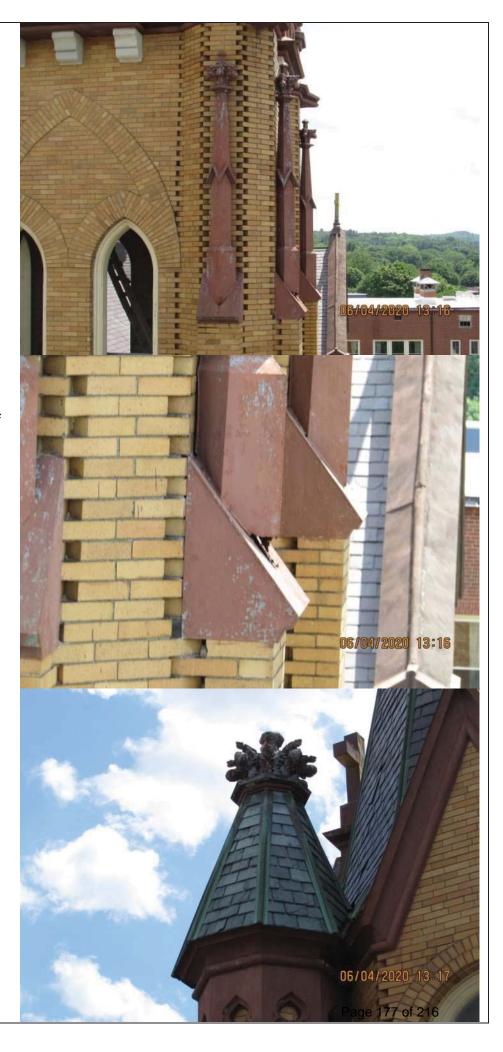
View of the northeast small spire roof. Note missing and disturbed slate on the Main Spire roof above.

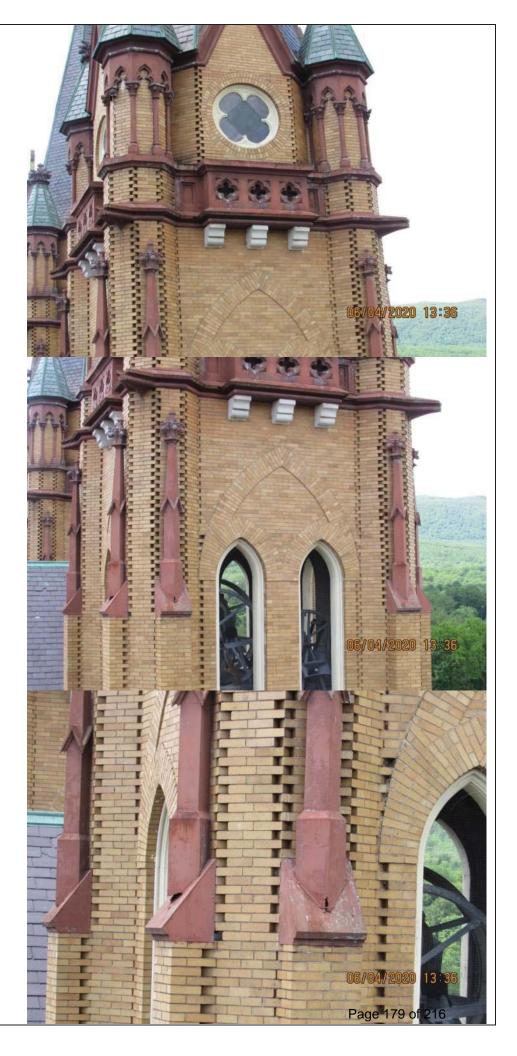
Another view of the corroded bottoms of the ornate metal pilasters. Water can enter.

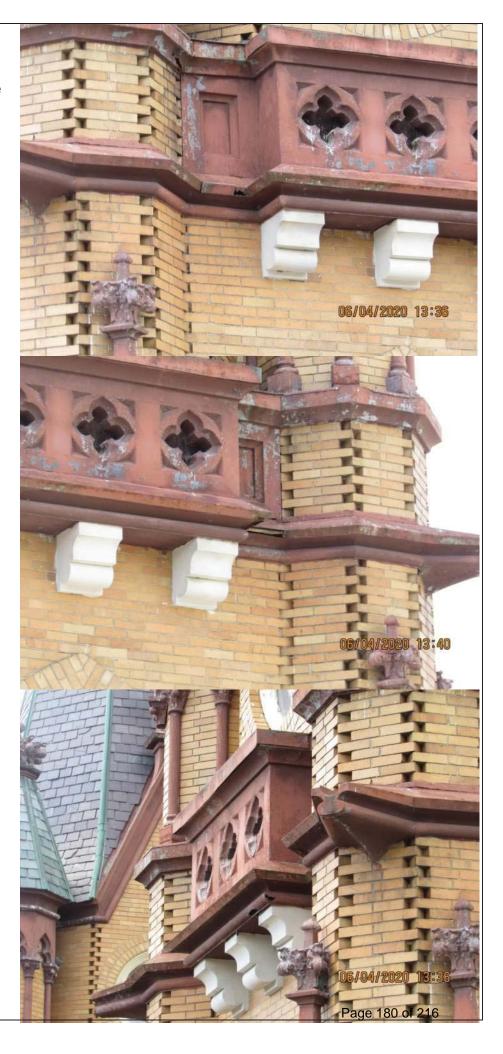
View of the south ornate balcony. Areas on the balcony underside were severely corroded. Water can enter.

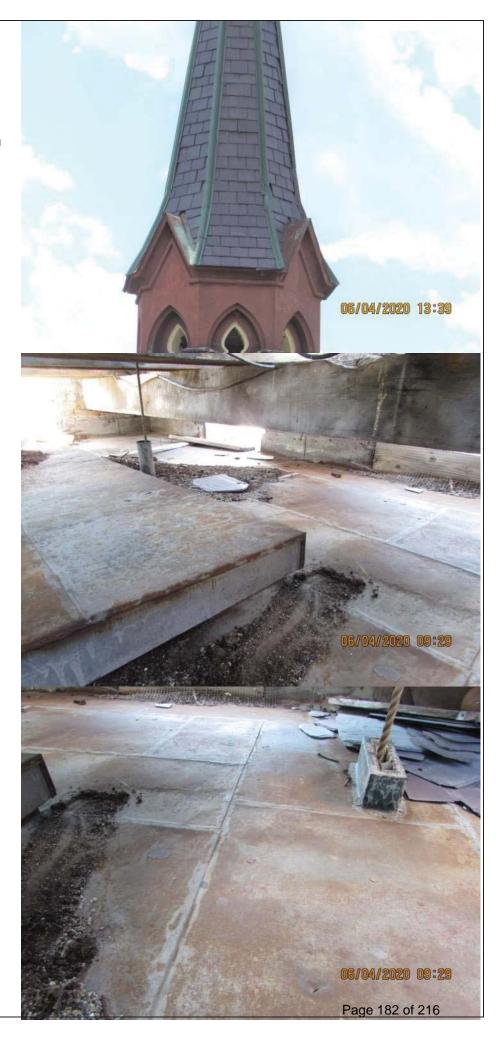
View of condition of some of the terne metal flat seam panels. Condition of the panels was poor.

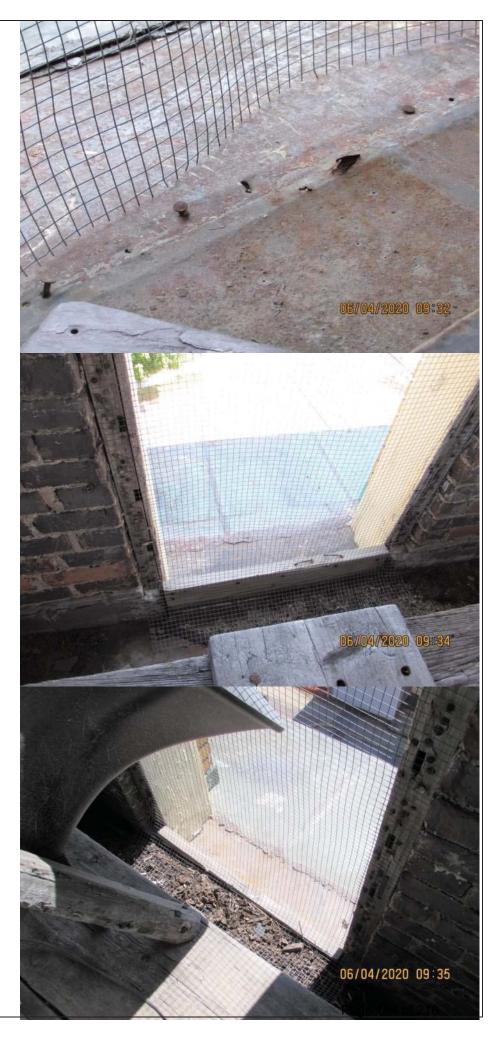
View of another drainage opening within the Belfry. Note debris and pigeon feces was against the wood blocking drainage.

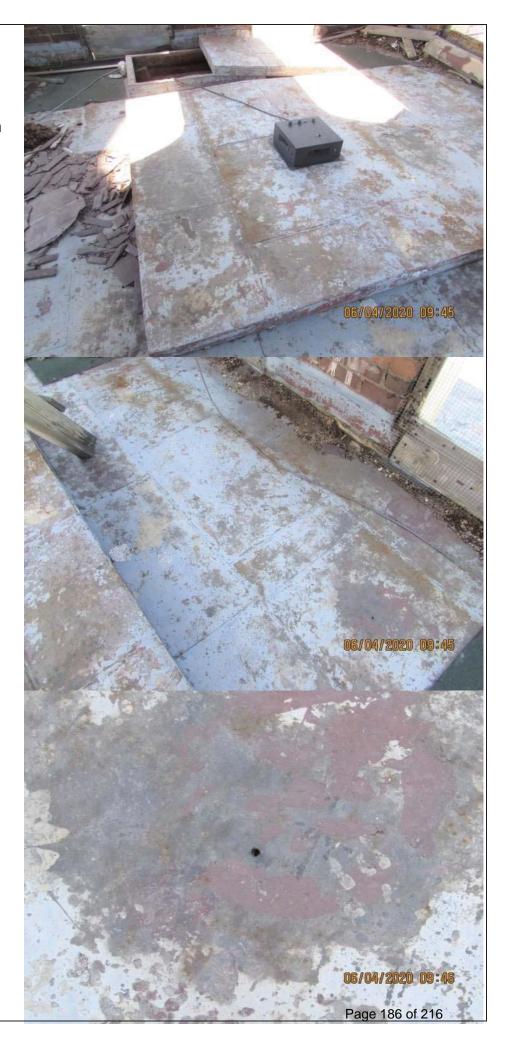
View of hole in one (1) of the panels. Water can enter.

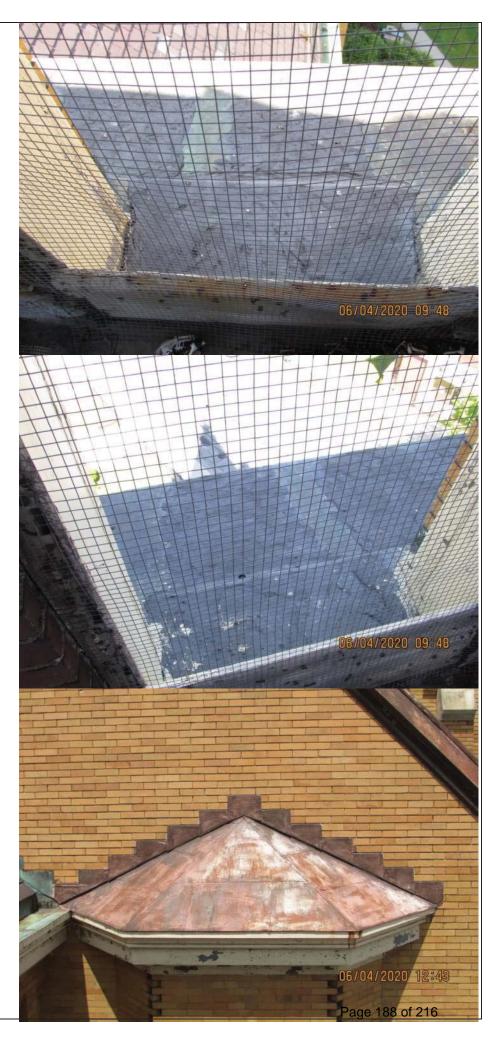
View of one (1) of the flat seam roofs at the building south end. Condition of the terne metal panels was poor to less than fair.
