## *Existing Tree Inventory and Assessment Report*

***DAVID C. HAWKINS, CONSULTING ARBORIST***  
***URBAN FORESTRY SOLUTIONS, INC.***

Thirteen trees in Pittsfield's Park Square were assessed for health, risk and safe useful lifespan after a November 8, 2022, onsite meeting with James McGrath from Pittsfield Community Development Office, members of Pittsfield's Park's Department and a representative of Pittsfield Beautiful. In addition to the tree assessment, there were discussions on the future plans for this park including a suitable replacement elm for the center of the park, a permanent versus temporarily annual Christmas tree, possible transplanting of two weeping cherries from the west section of the park to the east garden area, a suitable crabapple variety for the eastern most section of the park's 'tear drop' design (see Site Illustrations Page 4), and the benefits of installing composted woodchip mulch around the base of the larger shade trees. These topics, in addition to the assessment data are included in this report.

# Pittsfield Park Square

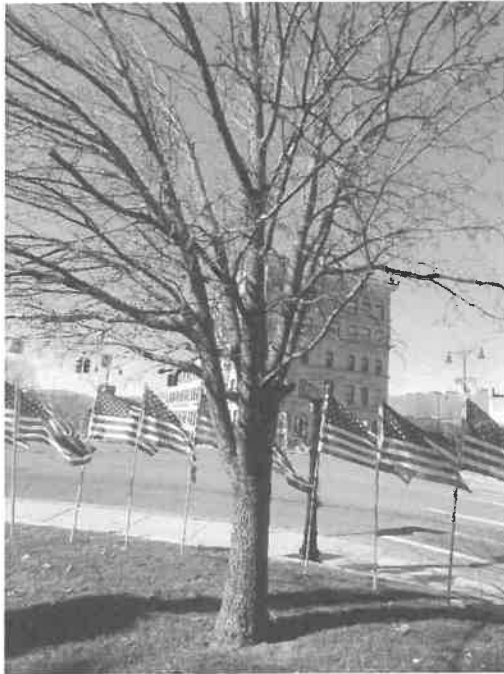
| No. | Location | DBH | Cond | Defects | Maint Needs | Notes |
|---|---|---|---|---|---|---|
| 1 | Callery Pear (Pyrus calleryana) | 12.0 | Dead | | Remove | Tree is dead |

**Tree #1.** Dead pear

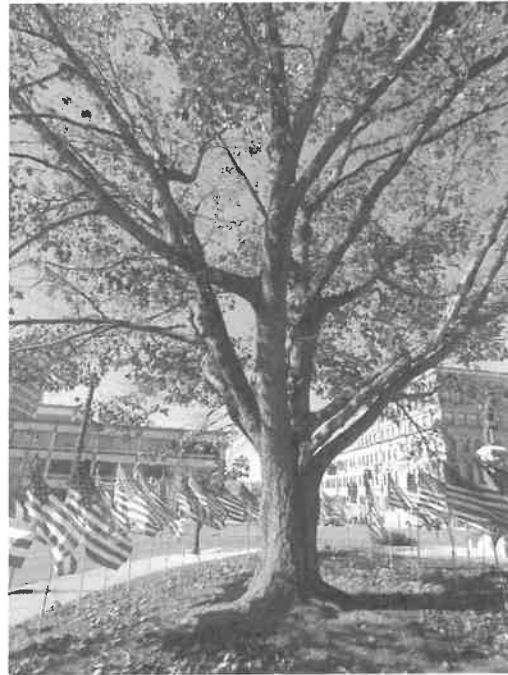
| No. | Location | DBH | Cond | Defects | Maint Needs | Notes |
|---|---|---|---|---|---|---|
| 2 | Red Oak (Quercus rubra) | 42.0 | Good | Deadwood | Prune | Small to large deadwood throughout crown - some over road |

**Tree #2.** Red oak in good condition.

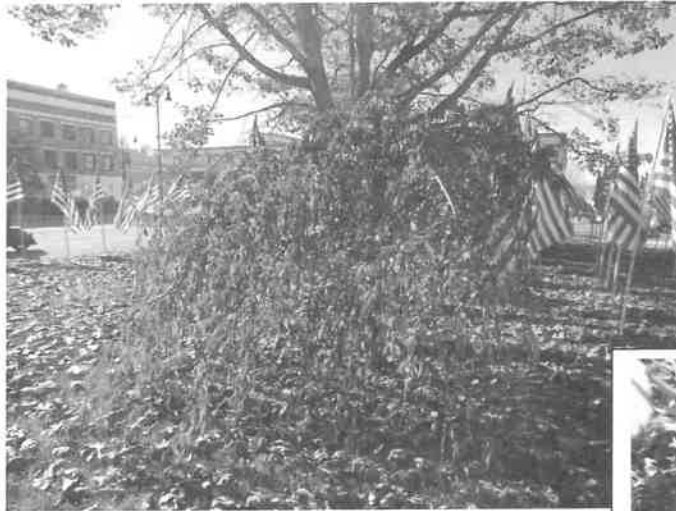
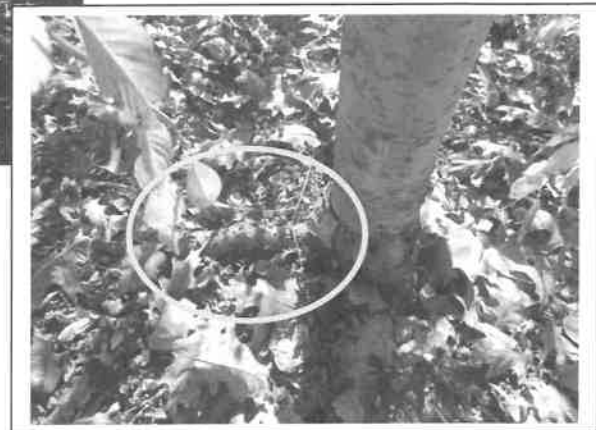
**Tree #3.** One of 2 cherries proposed for Transplant. Circled is the large root referred To earlier.

| No. | Location | DBH | Cond | Defects | Maint Needs | Notes |
|---|---|---|---|---|---|---|
| 3 | Weeping Flowering Cherry (Prunus pendula) | 4.5 | Good | None | None | Consider transplanting to east garden area. Recommend bare root transplant method using water and compressed air excavation |

It was originally discussed that using a tree spade to transplant the trees might be the best option. After inspecting the trees, I would recommend bare root transplanting. Both trees have a root system dominated by one large root that spreads well beyond the drip line and into the lawn area. A tree spade would sever this at or inside the drip line leaving a significant portion of the root behind – possibly enough to cause the tree to dieback over time. Underground utilities at the present and proposed location may also impede this process.

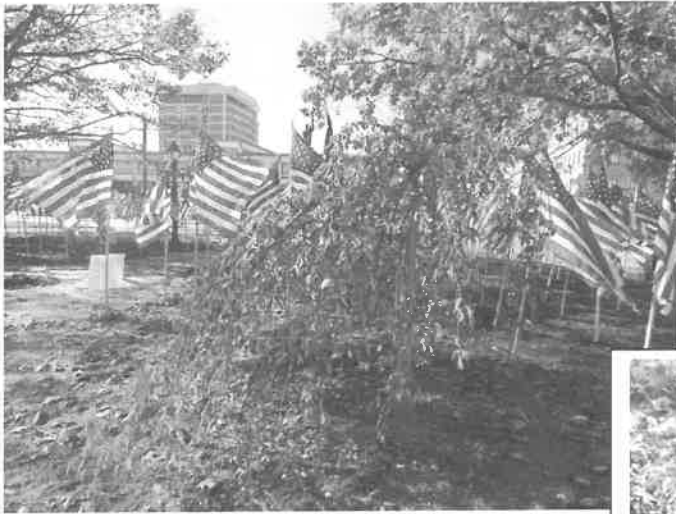
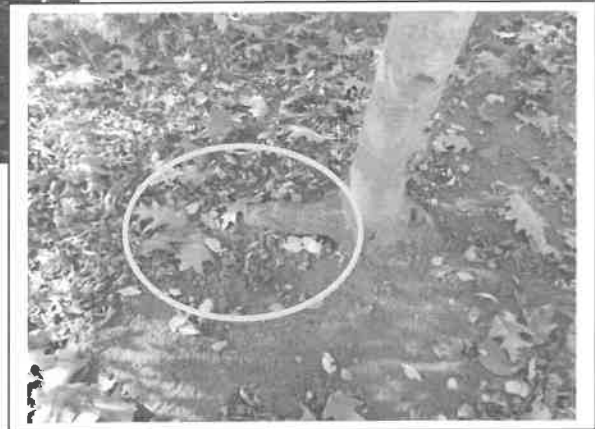
**Tree #4.** Second cherry proposed for Transplant. Circled is the large root referred To earlier. Note right side of the tree is Sparse due to the canopy of the adjacent Tree.

| No. | Location | DBH | Cond | Defects | Maint Needs | Notes |
|---|---|---|---|---|---|---|
| 4 | Weeping Flowering Cherry | 3.5 | Good | None | None | Consider transplanting to east garden area. Recommend bare root transplant method using water and compressed air excavation |

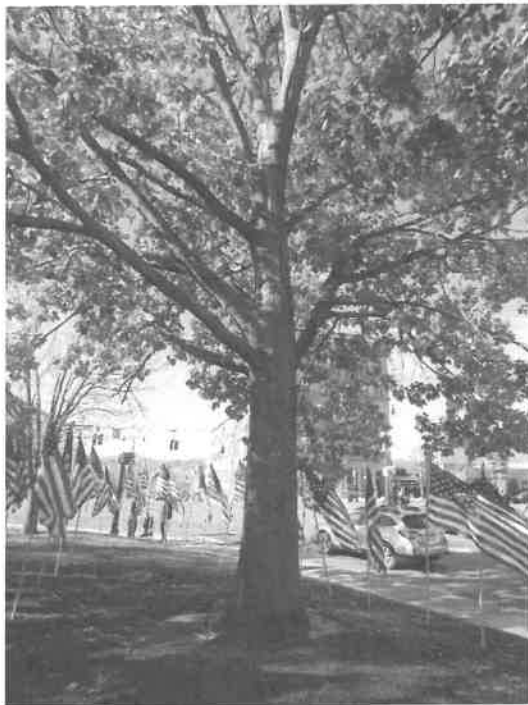
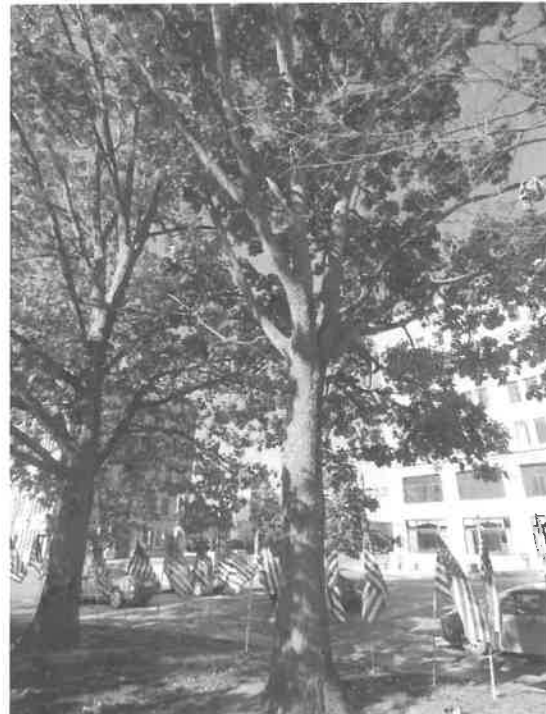
| No. | Location | DBH | Cond | Defects | Maint Needs | Notes |
|---|---|---|---|---|---|---|
| 5 | Red Oak (Quercus rubra) | 29.0 | Good to Excellent | Deadwood; trunk seam | Prune | Small deadwood throughout crown. Trunk seam 7 to 20 ft. high on east side. Appears superficial. Sounded solid |
| 6 | Red Oak | 25.5 | Good to Excellent | Minor deadwood | Prune | Small deadwood throughout crown. |

**Tree #5.** Red oak in good/excellent condition **Tree #6.** Red oak. Good/excellent condition

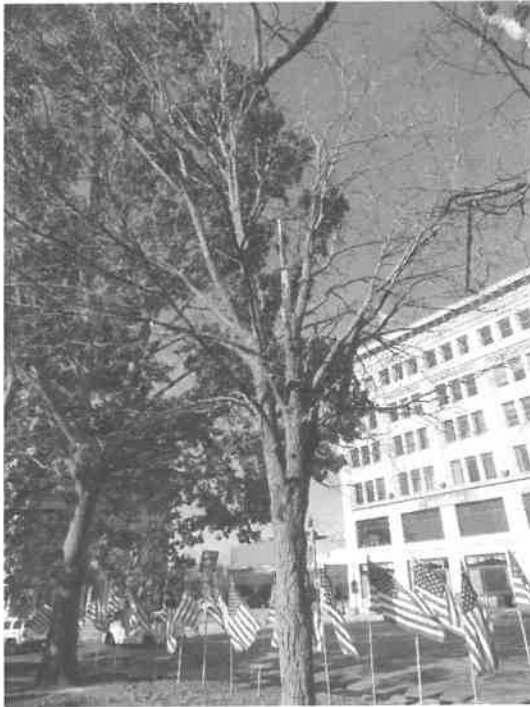
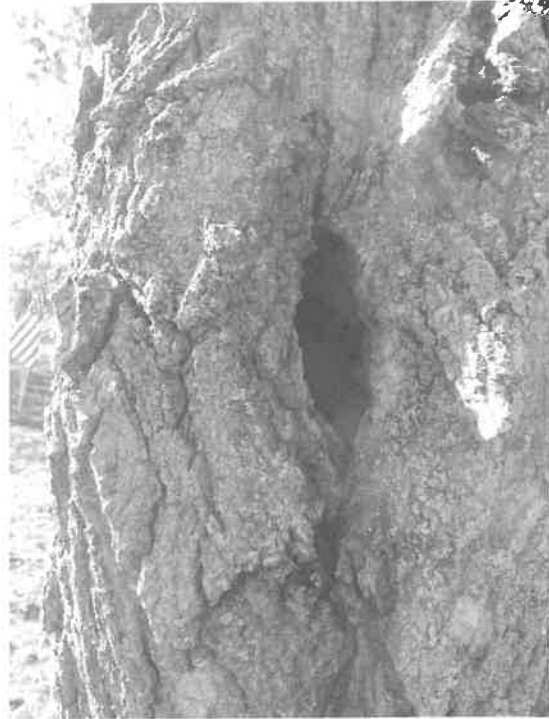
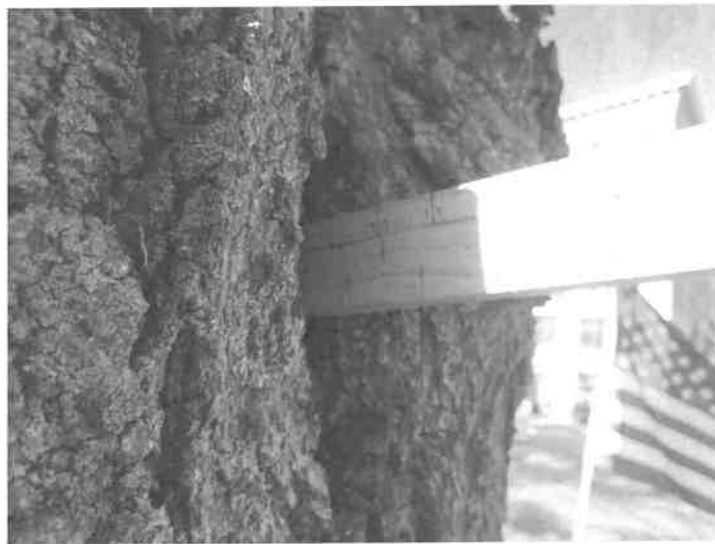
| No. | Location | DBH | Cond | Defects | Maint Needs | Notes |
|---|---|---|---|---|---|---|
| 7 | Sugar Maple (Acer saccharum) | 19.0 | Fair to Poor | Deadwood; cavity; decay | Remove | Trunk decay and cavity east side. Poor tree architecture - deadwood, dieback on east leader. Prune deadwood if retained. |

**Tree #7.** Sugar maple in fair to poor condition. Open cavity and decay in main trunk which extends 8 inches deep.

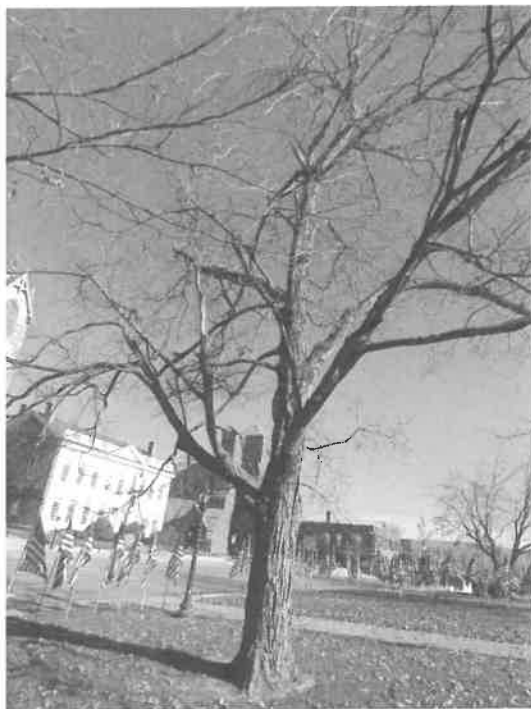
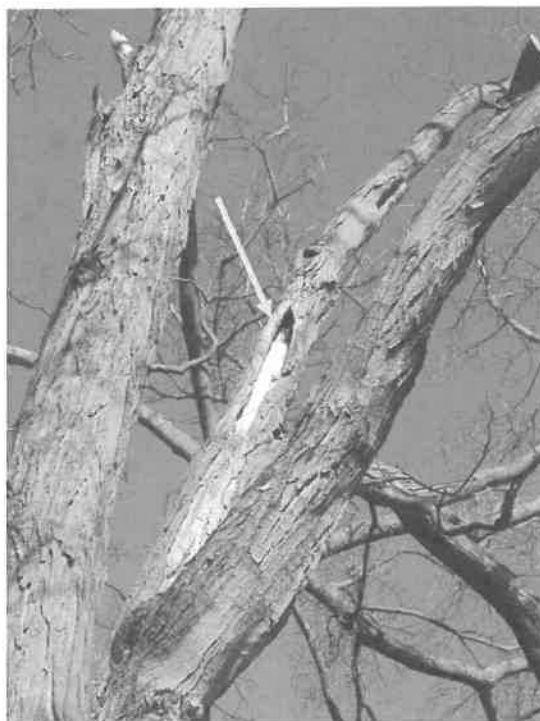
| No. | Location | DBH | Cond | Defects | Maint Needs | Notes |
|---|---|---|---|---|---|---|
| 8 | Sugar Maple | 28.0 | Fair | Deadwood; decay; dieback | Prune; Fertilize | Deadwood. Low vigor. Decay in 8" branch east side at 25'. Clear light |

**Tree #8.** Sugar maple in fair condition. Deadwood and some decline. Note branch with a cavity and decay over walkway (right).

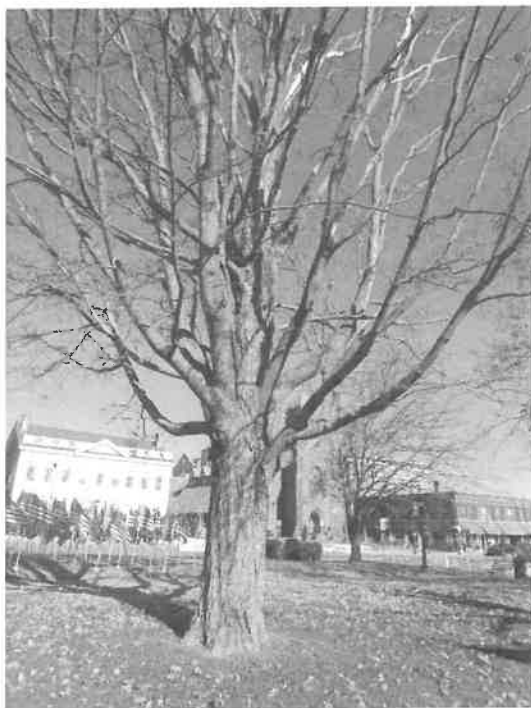
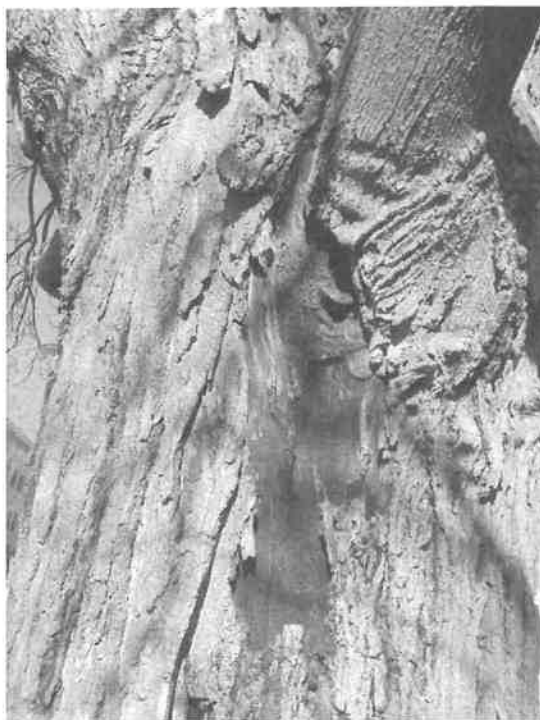
| No. | Location | DBH | Cond | Defects | Maint Needs | Notes |
|---|---|---|---|---|---|---|
| 9 | Sugar Maple | 32.5 | Fair to Good | Large deadwood | Prune; Fertilize | Deadwood. Low vigor. Some top dieback |

**Tree #9.** Sugar maple in fair/good condition. Deadwood and some decline. Also, minor decay on the main trunk (right).

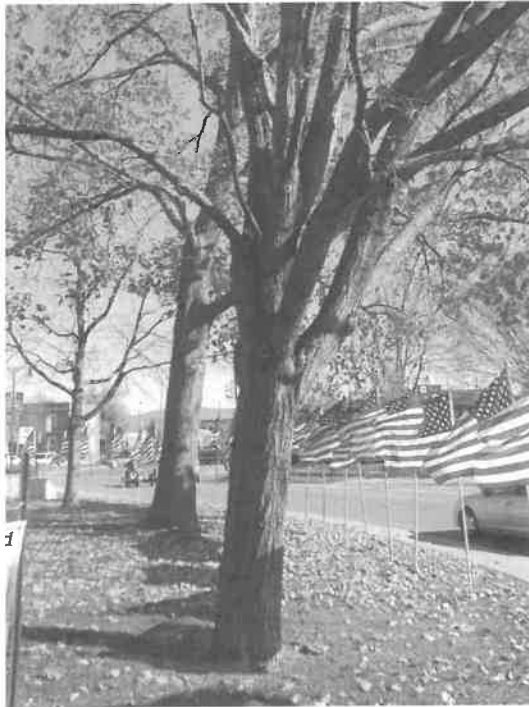
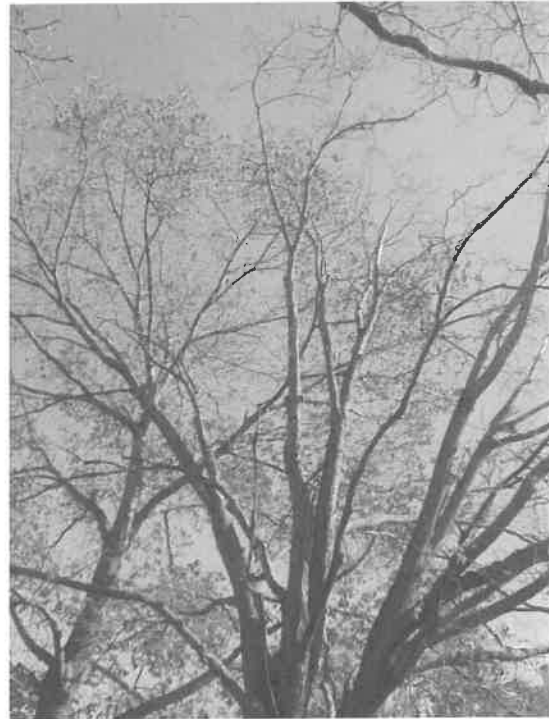
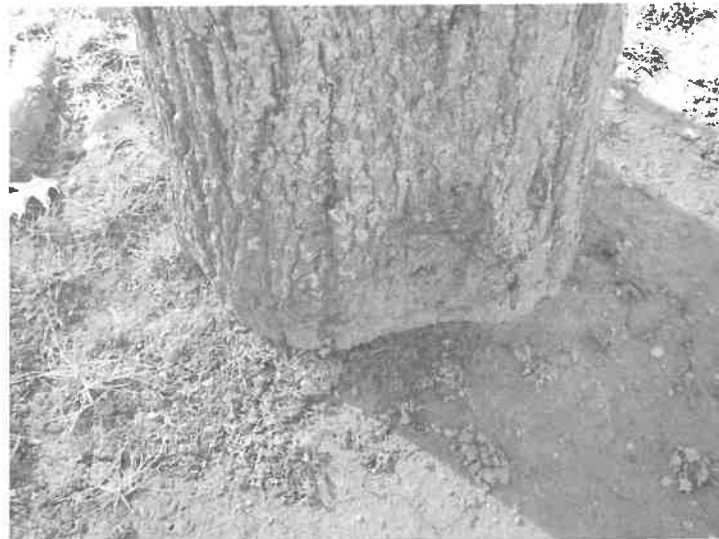
| No. | Location | DBH | Cond | Defects | Maint Needs | Notes |
|---|---|---|---|---|---|---|
| 10 | Sugar Maple | 19.0 | Fair to Poor | Deadwood; dieback; no root collar | Prune, fertilize, and airspade or remove tree | 30 to 40 percent dead. In decline. No root flare. If retained, airspade to expose root collar, prune and fertilize. Possible girdling roots below surface |

**Tree #10.** Sugar maple in fair to poor condition. Deadwood and top dieback. Tree appears to be in decline. The presence of no root flare (below) could indicate girdling or encircling roots that may be restricting nutrient transport. This usually occurs when a tree is planted too deep.

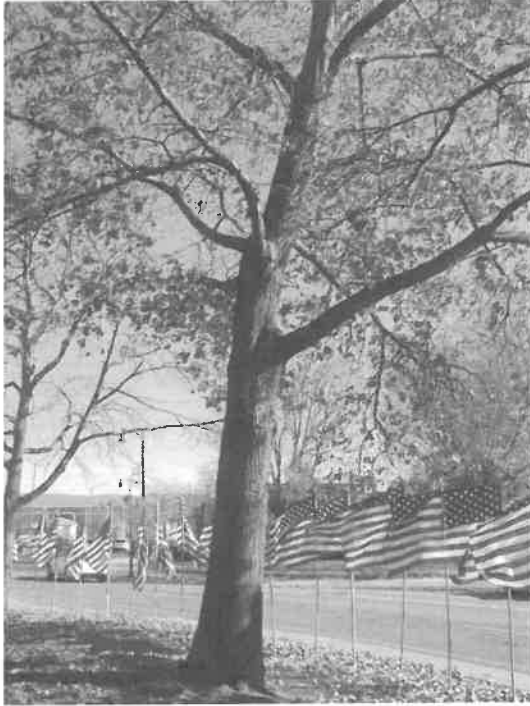
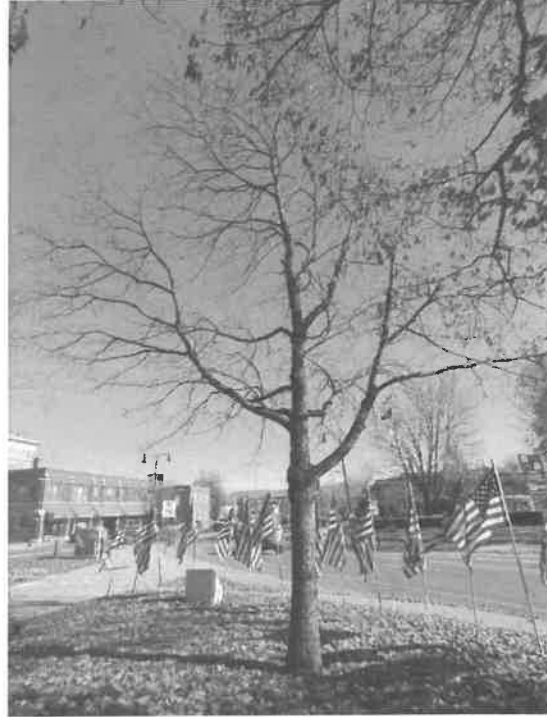
| No. | Location | DBH | Cond | Defects | Maint Needs | Notes |
|---|---|---|---|---|---|---|
| 11 | Red Oak | 25.0 | Good to Excellent | Minor lean | Prune | Prune low limbs over road. Weight and lean to road. |
| 12 | Red Maple (Acer rubrum) | 11.0 | Good | Small deadwood. No root crown | Airspade to expose root crown | Suppressed by Tree #11. Possible girdling roots below surface |

**Tree #11.** Red oak in good/excellent condition. **Tree #12.** Red maple in good condition.

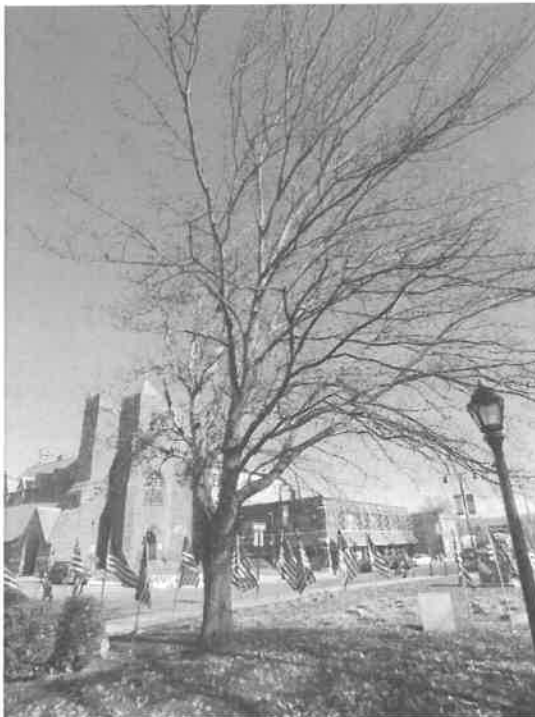
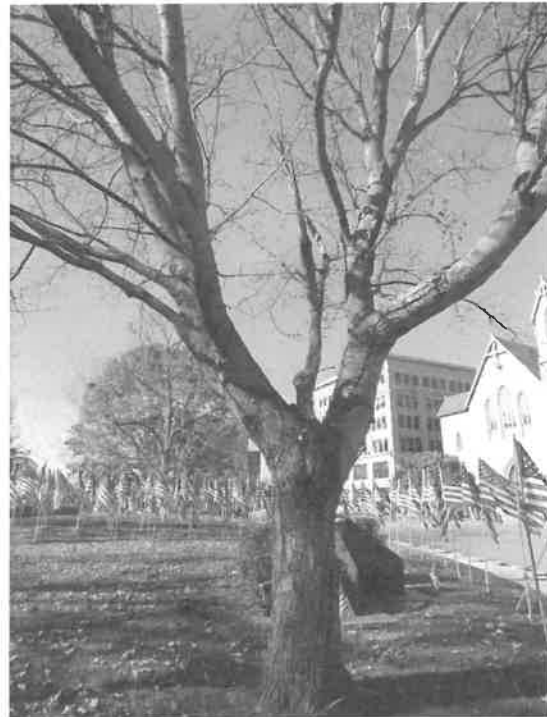
| No. | Location | DBH | Cond | Defects | Maint Needs | Notes |
|---|---|---|---|---|---|---|
| 13 | Red Maple | 20.0 | Fair to Good | Deadwood; Large lateral leader. Excessive weight | Prune | Prune deadwood and to reduce weight of south leader. Clear light |

**Tree #13.** Red maple in fair/good condition. Some deadwood and dieback. Note left leader (right) appears dominant with a lean and weight to the south. This could be problematic as the tree grows and the limb gets heavier. Weight reduction pruning on the branch ends would reduce the risk of failure.
