## OWNER-ENGINEER AGREEMENT

**Re: Proposal for the Brookside Road Bridge over the Housatonic River  
Superstructure Replacement**

| CITY/TOWN<br><b>GREAT BARRINGTON</b> | B.I.N.<br><b>04K</b> | BR. DEPT. NO.<br><b>G-11-008</b> | 8.-STRUCTURE NO.<br><b>G11008-04K-MUN-NBI</b> | INSPECTION DATE<br><b>JUN 8, 2021</b> |

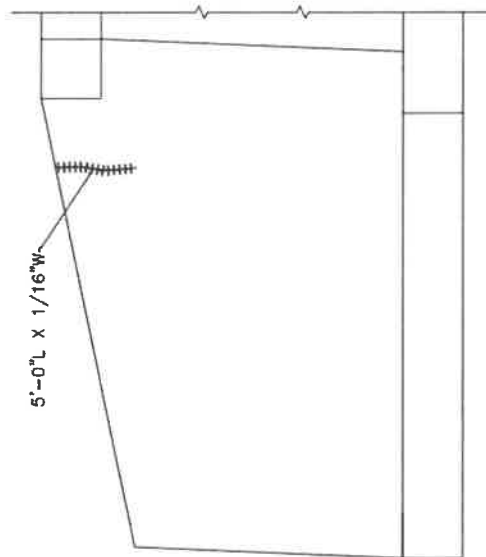
NORTHEAST WINGWALL

GENERAL NOTES:  
- WINGWALLS GAVE RANDOM VERTICAL AND HORIZONTAL CRACKS WITH AND WITHOUT EFFLORESCENCE THROUGHOUT.  
- MOSS GROWTH ON NORTHEAST AND NORTHWEST WINGWALLS.  
- LIGHT TO MODERATE SCALING THROUGHOUT WINGWALLS.

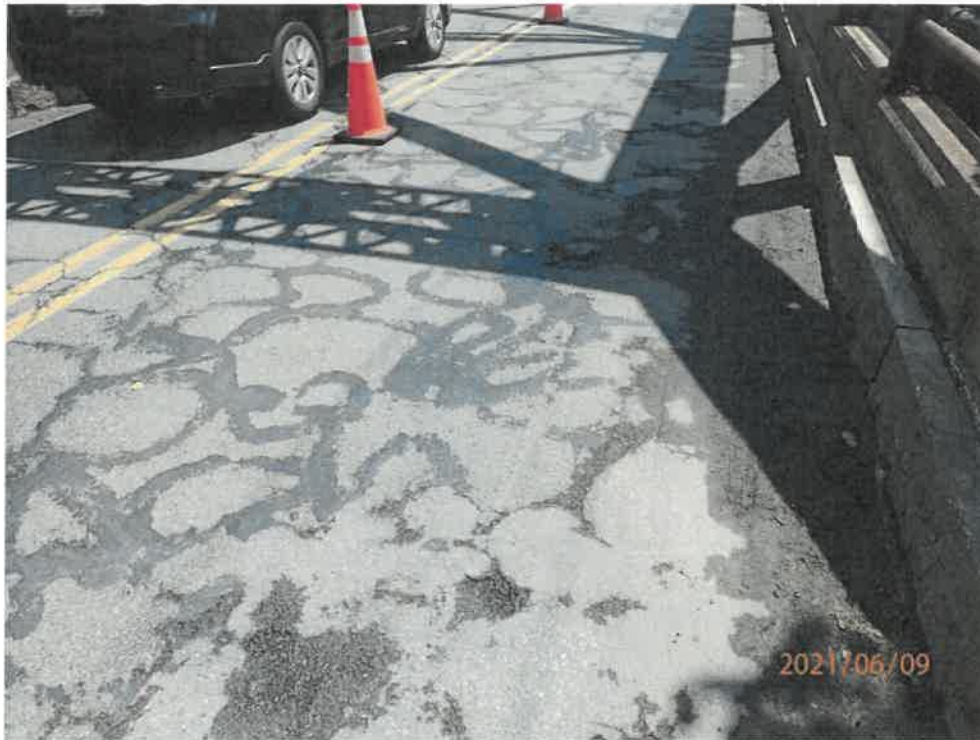
**Photo 5:** Eastbound travel lane wearing surface with sealed and unsealed cracks and potholes

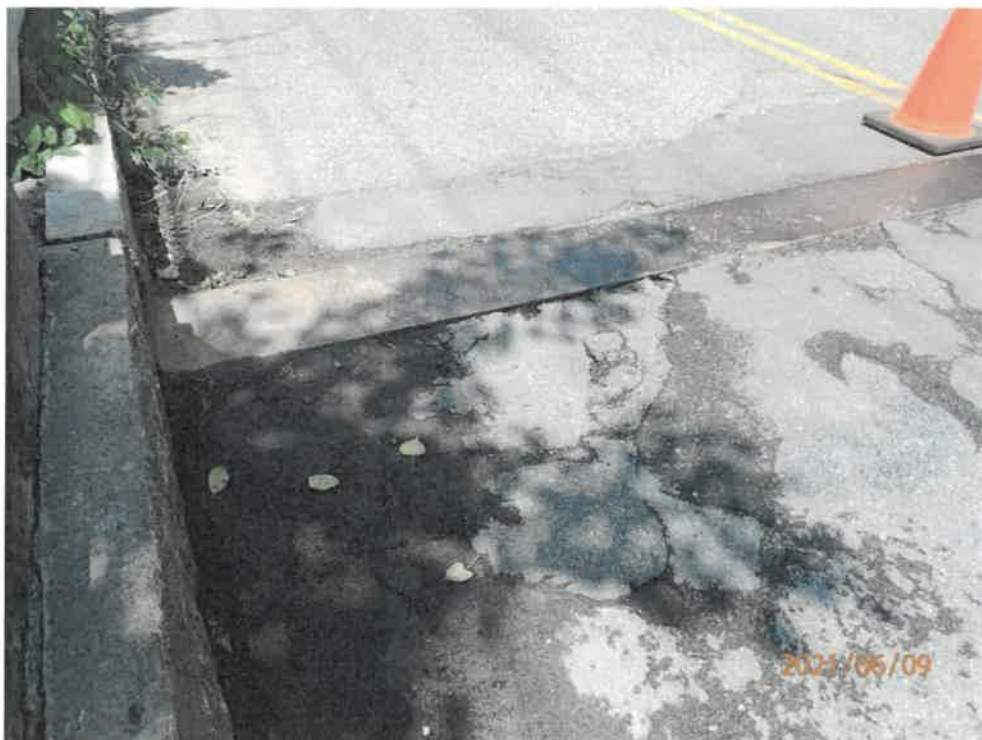
**Photo 6:** Eastbound Wearing Surface at the West Abutment deck joint, pothole with impacted sand and debris

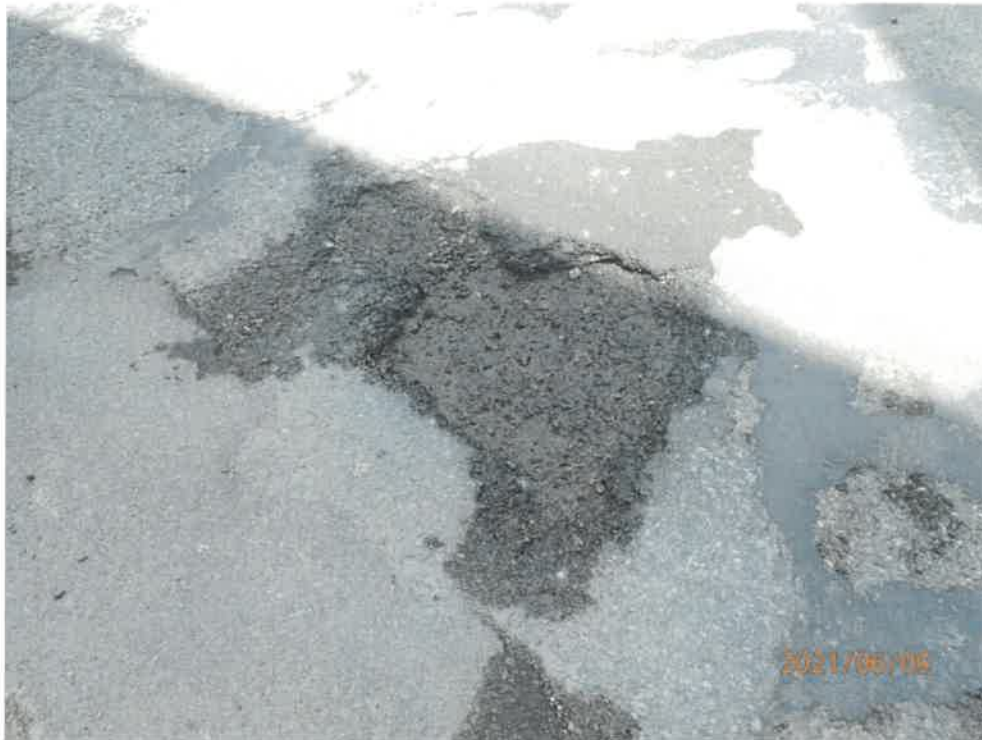
**Photo 7: Eastbound Wearing Surface near the 13th rail post with a pothole**

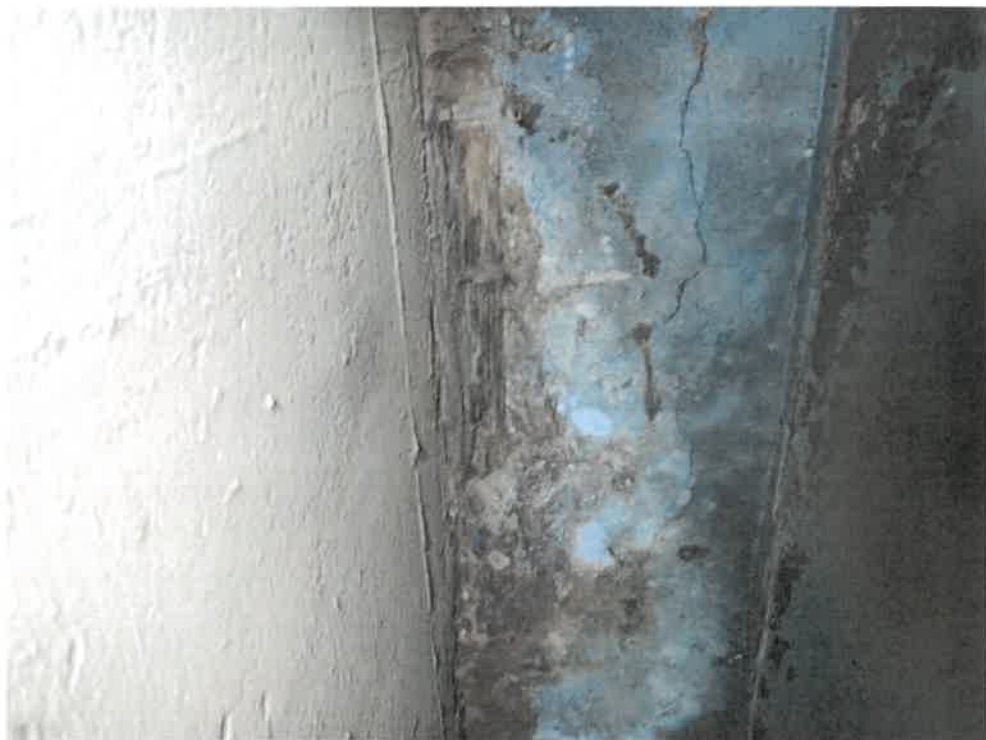
**Photo 8: Underside of deck at the West Abutment between Stringer S2 and S3, spall with exposed rebar**

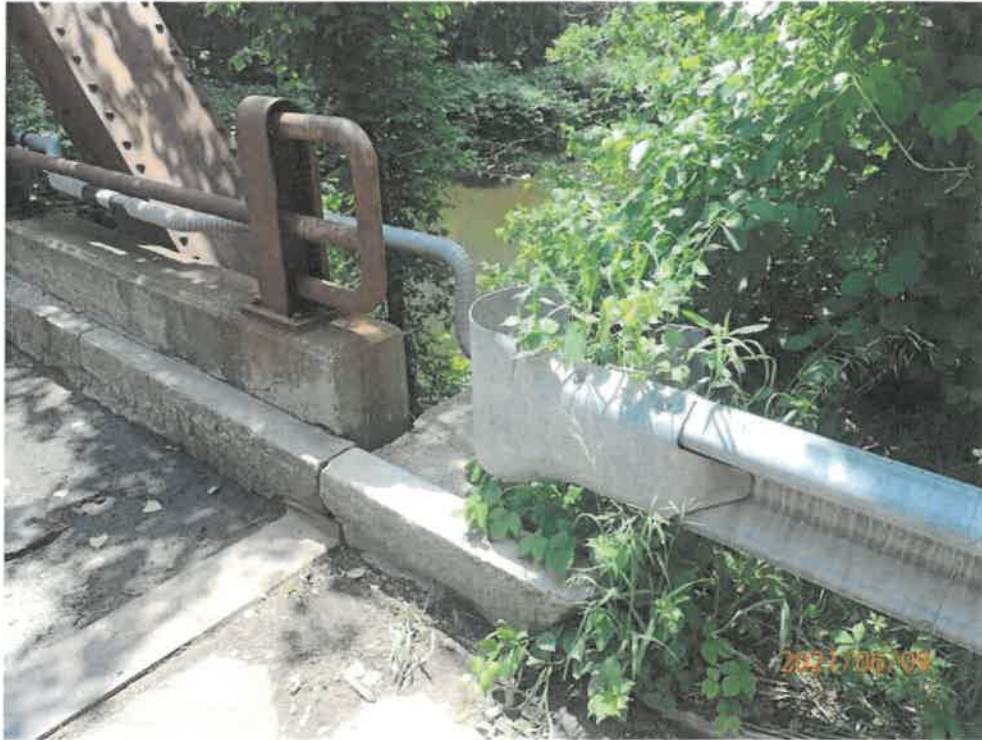
**Photo 9: Southwest Approach bridge and approach curb misalignment and missing guardrail transition**

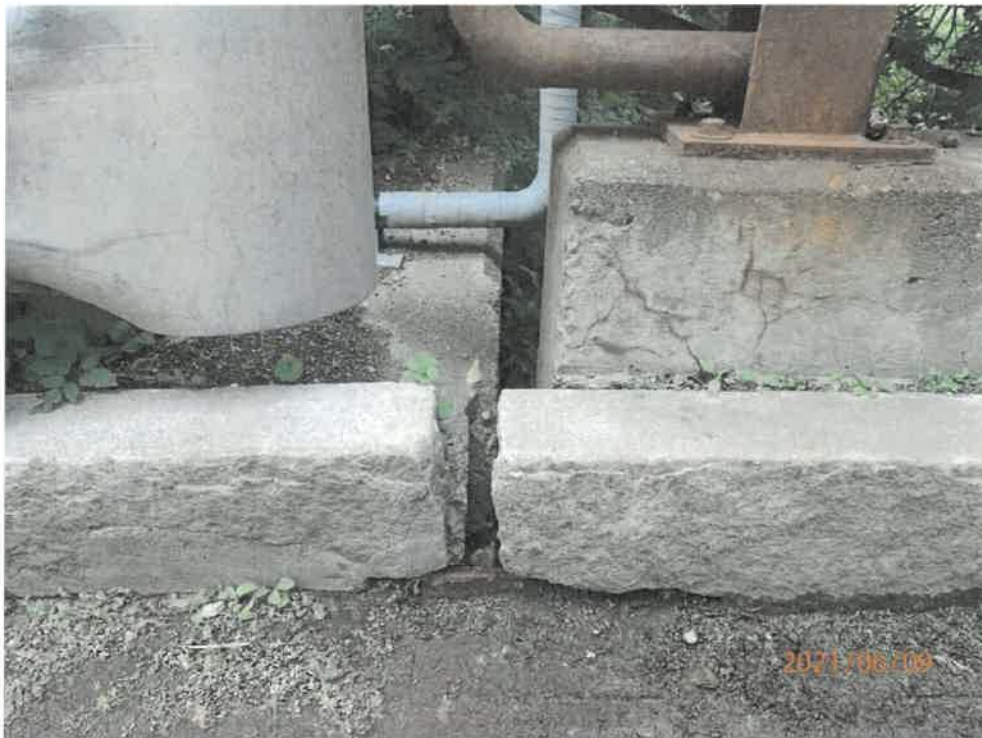
**Photo 10: South Curb at East Abutment with gap between bridge and approach curbs**

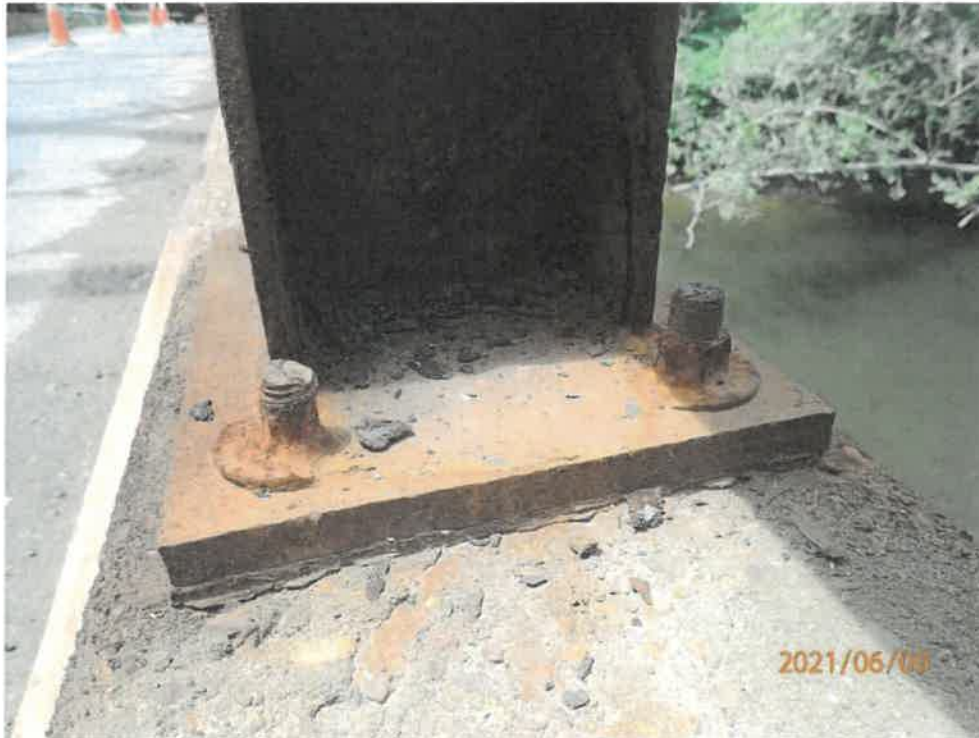
**Photo 11:** North Railing, 7th post from East Abutment, anchor bolt nuts with up to 100% section loss

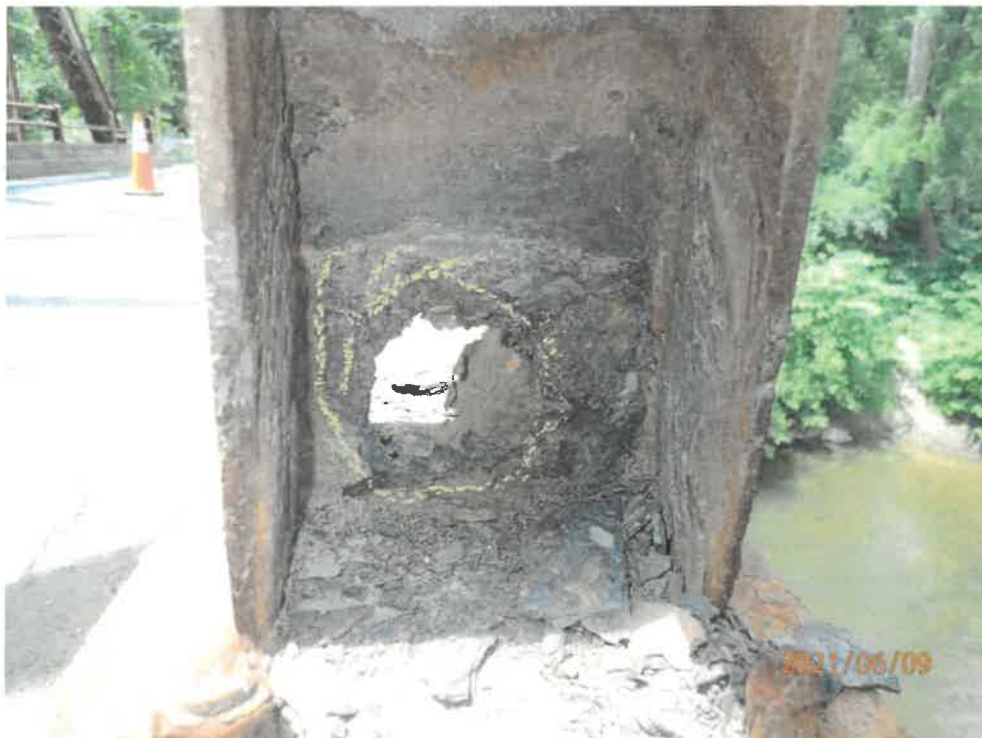
**Photo 12:** North Railing, 11th post from East Abutment with perforation in lower web

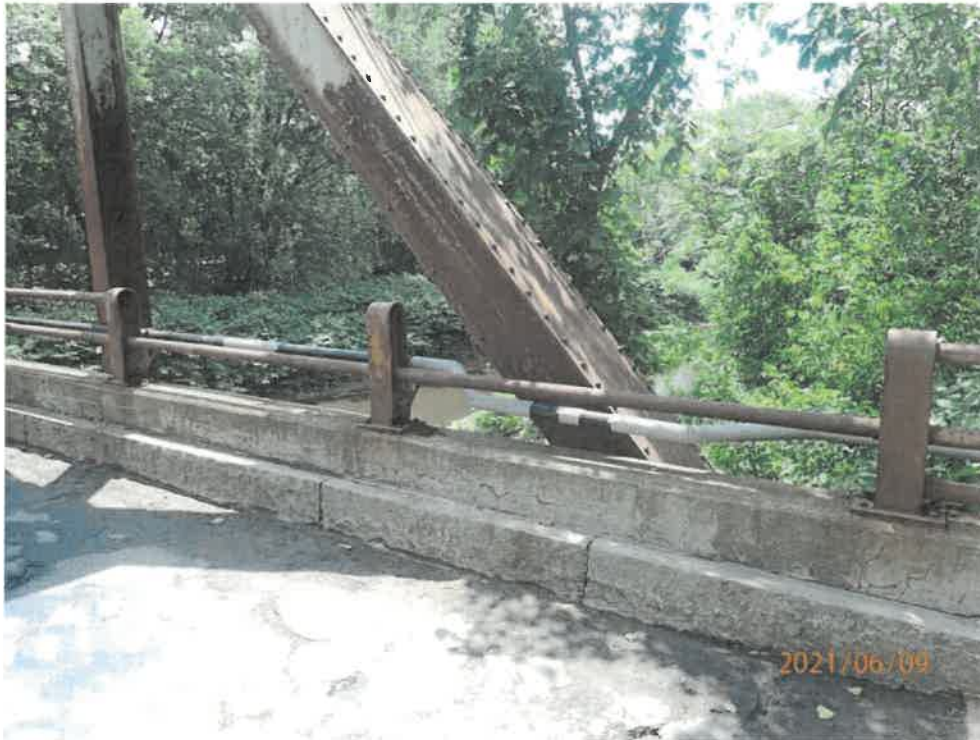
**Photo 13: South Railing, 1st and 2nd panel from West Abutment upper rail missing**

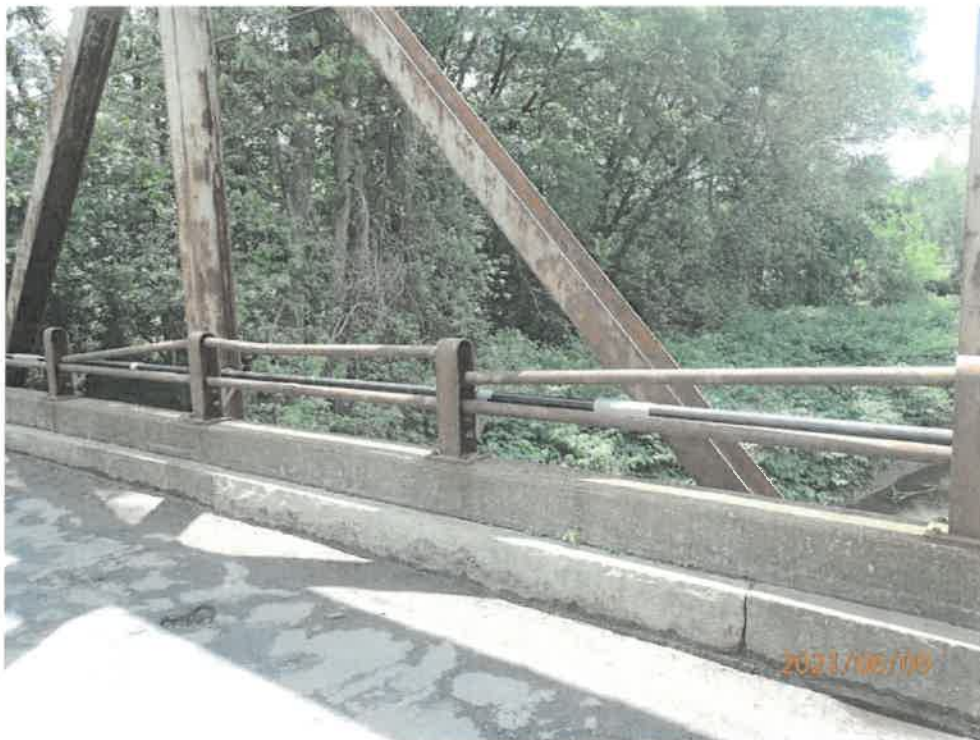
**Photo 14: South Railing, 10th and 12th panel from West Abutment upper rail disconnected**

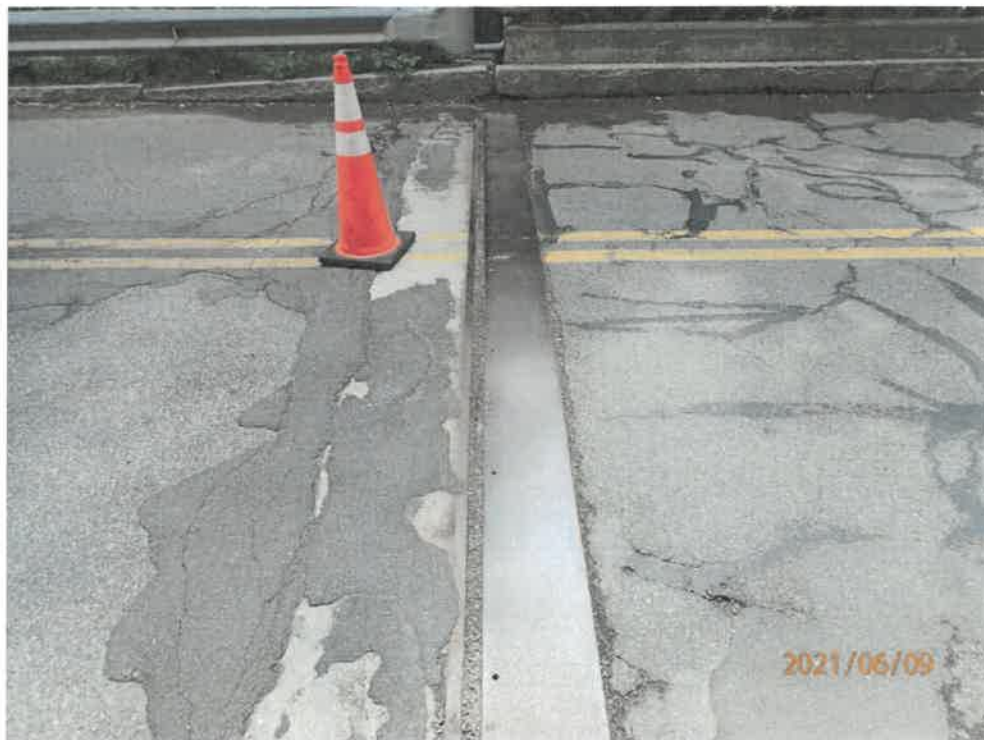
**Photo 16: East Abutment deck joint with partially patched header and approach pavement cracked with some break-up**

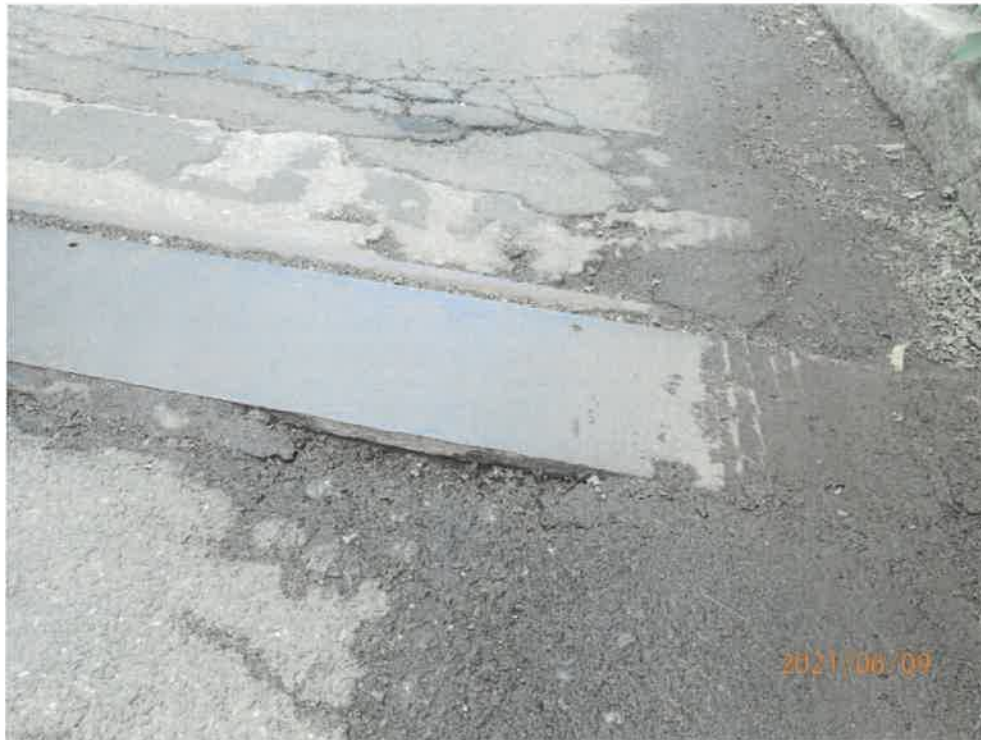
**Photo 17: East Abutment deck joint spall exposing joint armor edge and approach pavement cracked with some break-up**

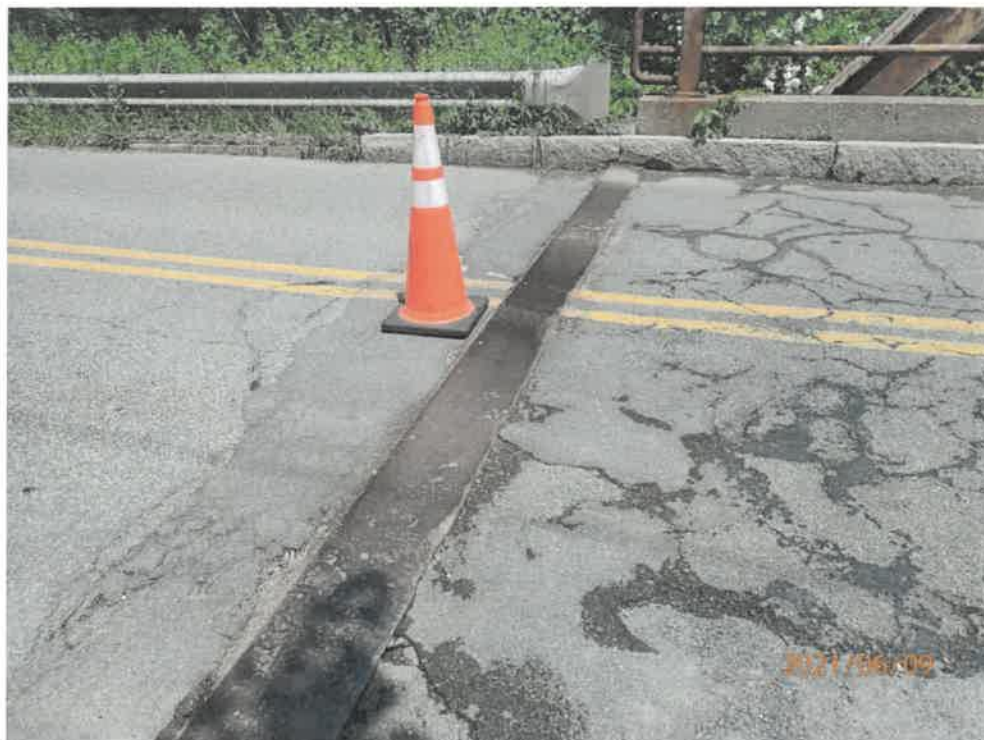
**Photo 18: West Abutment deck joint; note potholes/spalls along the joint.**

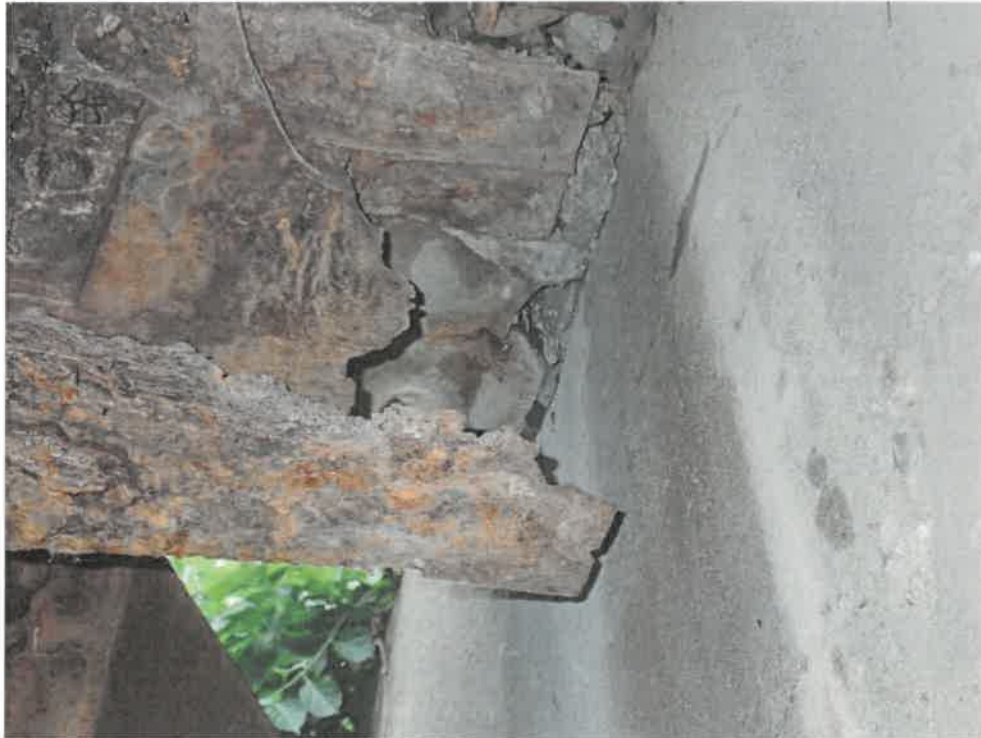
**Photo 19: Stringer S5 at Floorbeam FB0 (west end) with rust perforation at end**

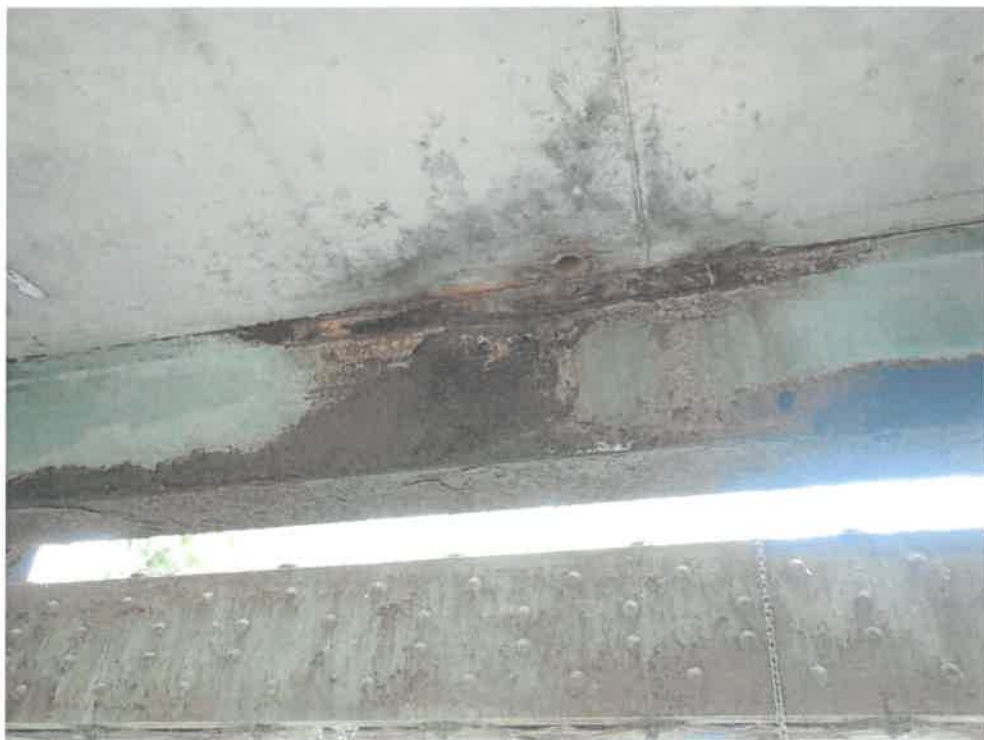
**Photo 20: Stringer S1 east of Floorbeam FB2 with rust and section loss at midspan**

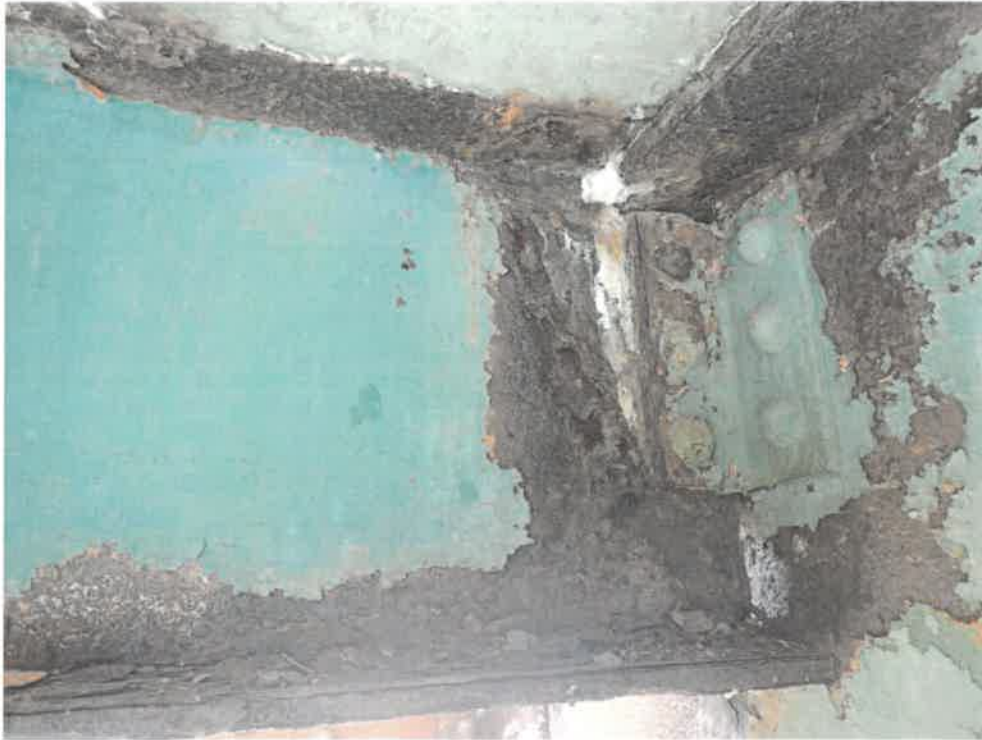
**Photo 21: Stringer S5 at Floorbeam FB3, north face with rust and section loss**

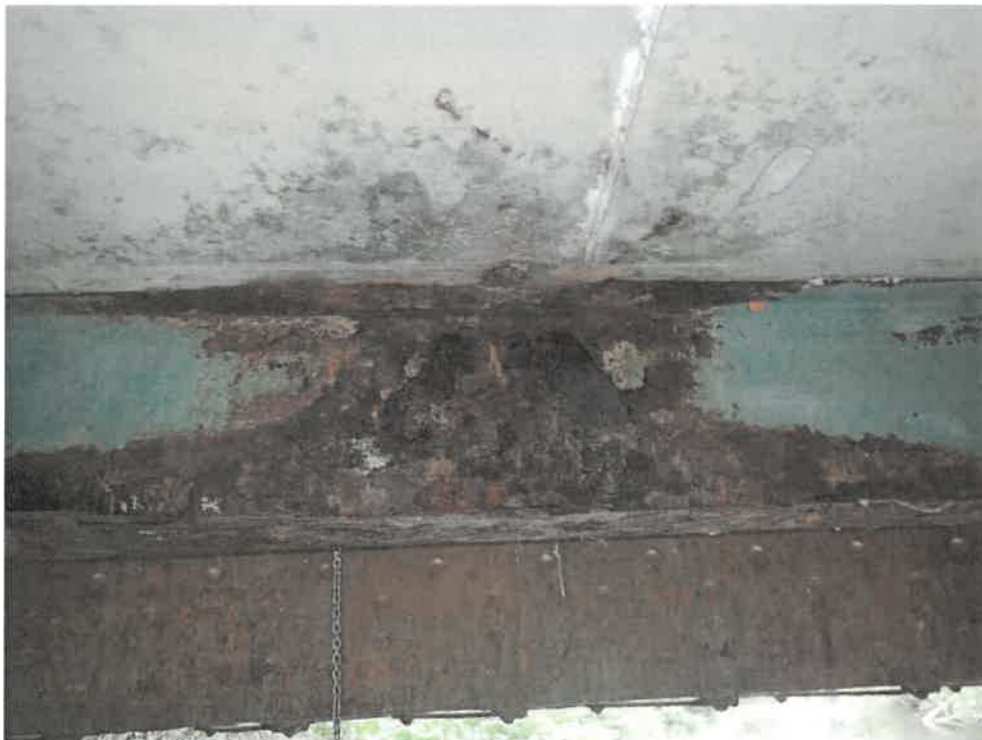
**Photo 22: Stringer S5 between Floorbeams FB5 and FB6 with rust and section loss**

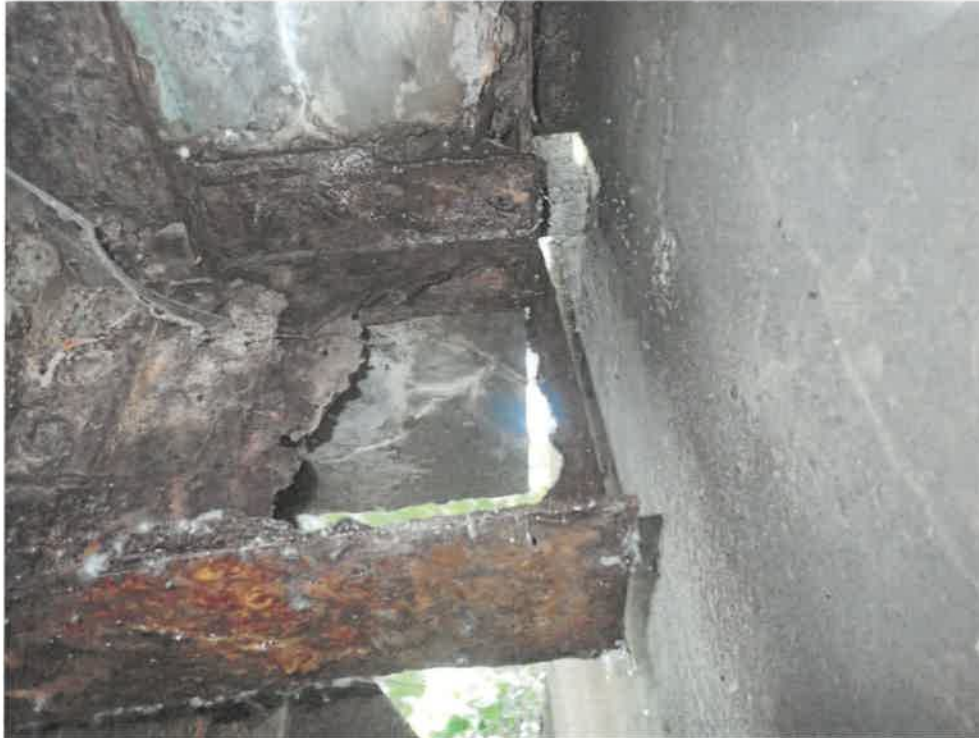
**Photo 23: Stringer S1 at Floorbeam FB8 with perforation at end**

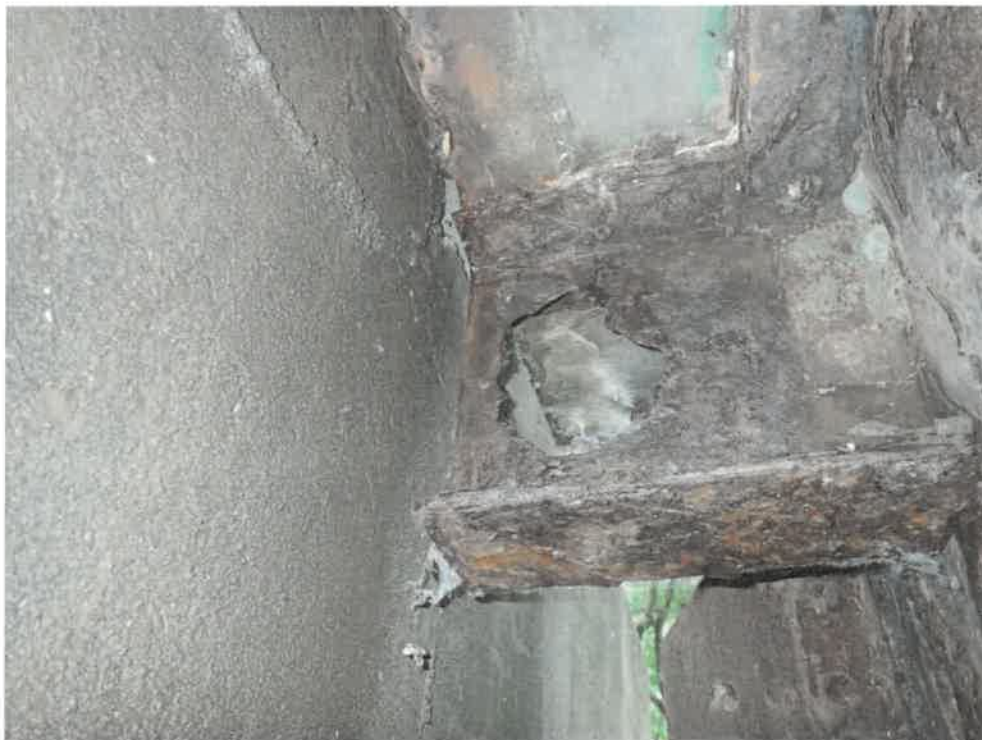
**Photo 24: Stringer S5 at Floorbeam FB8 with perforation at end**

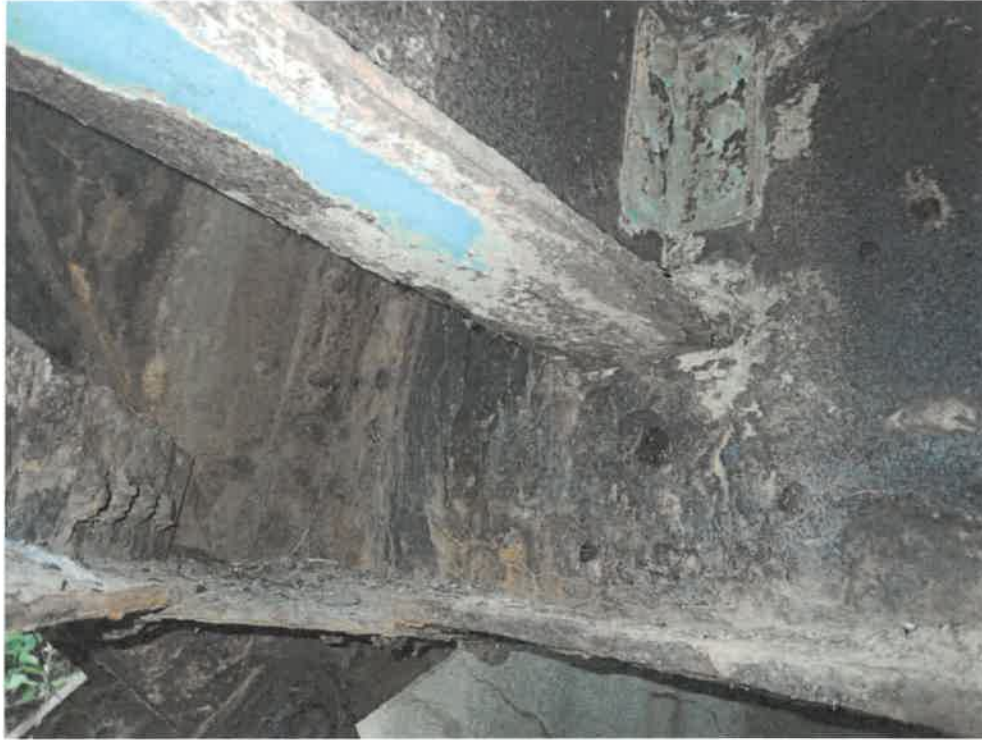
**Photo 25:** Floorbeam FB0 at Southwest Bearing, east face with heavy rust, perforations, and section loss

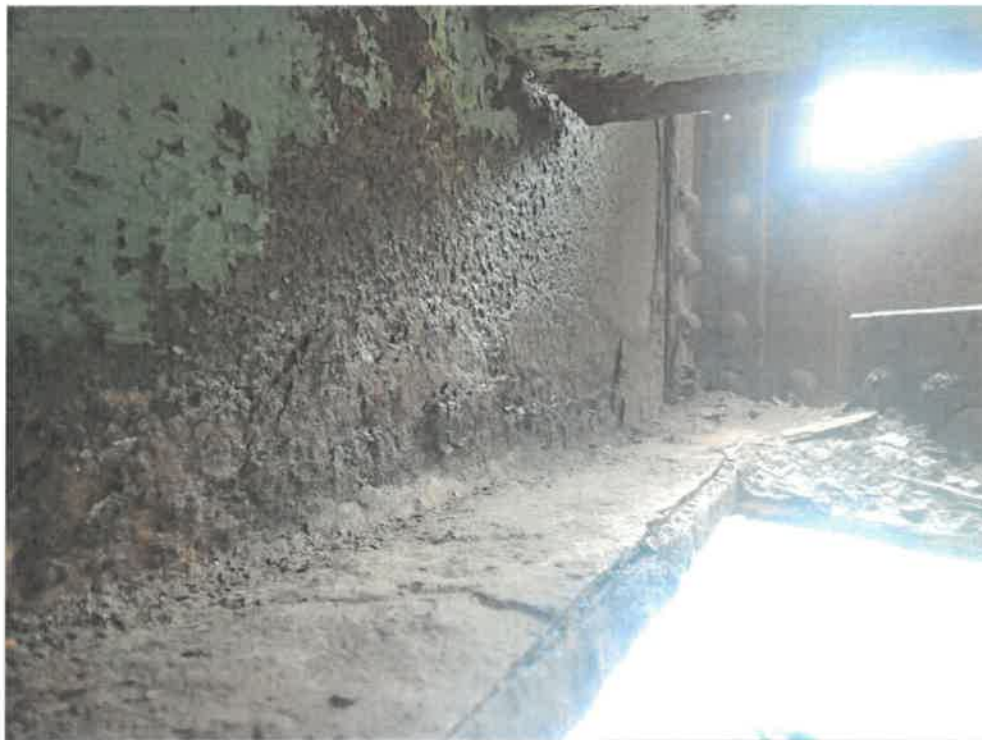
**Photo 26:** Floorbeam FB1 at south end, west face with heavy rust and section loss

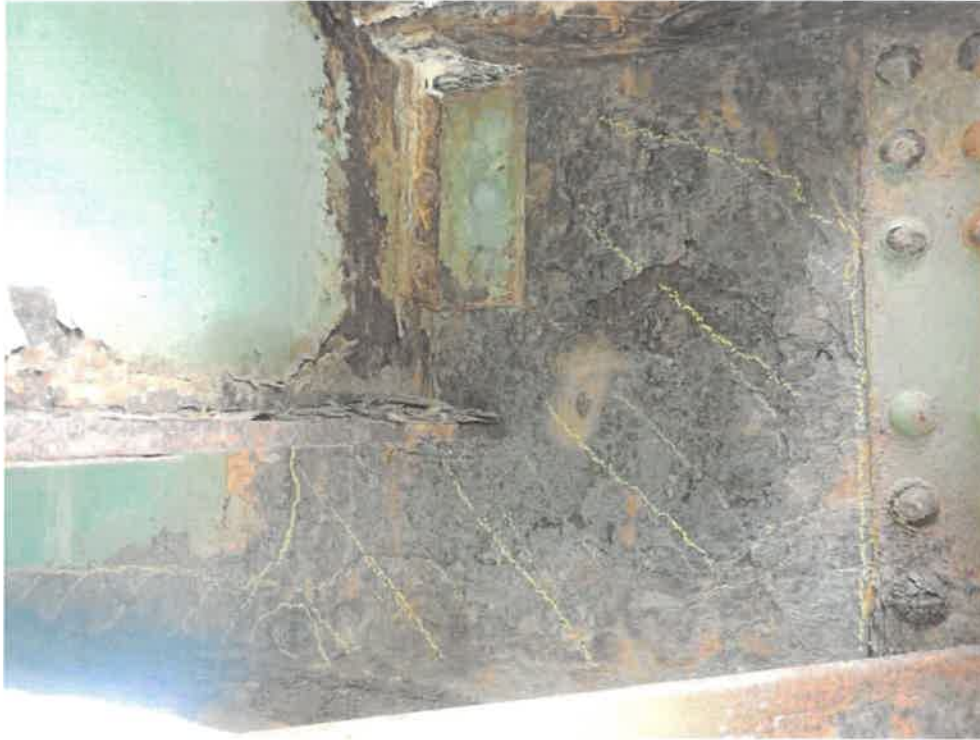
**Photo 27: Floorbeam FB2 at south end, west face with heavy rust and section loss**

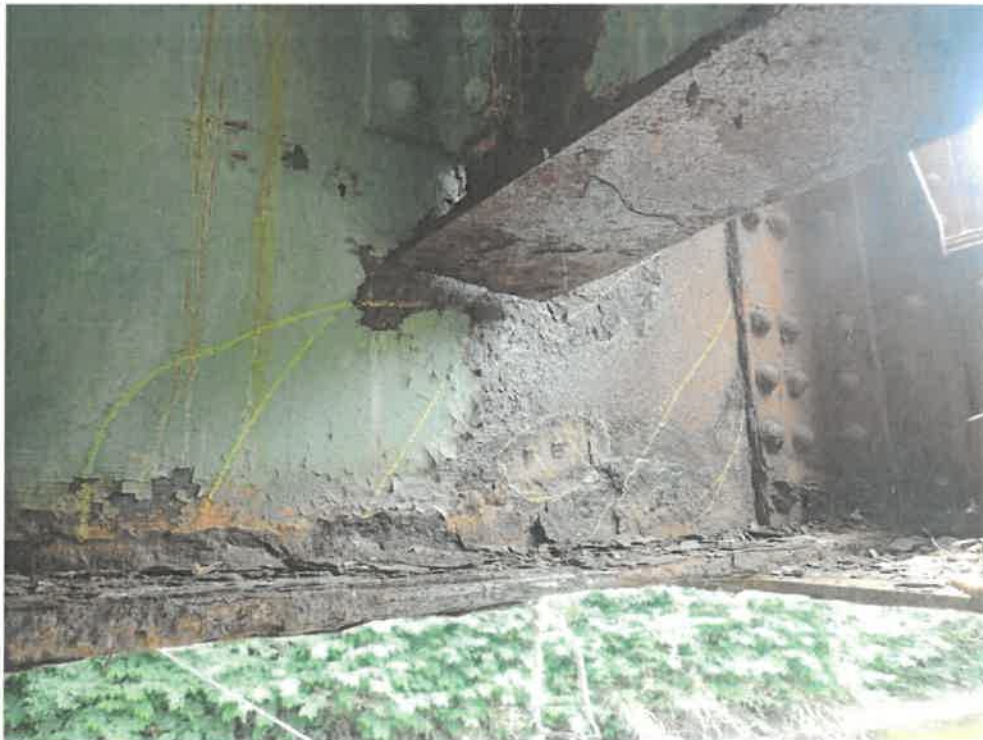
**Photo 28: Floorbeam FB3 at south end, west face with heavy rust and section loss**

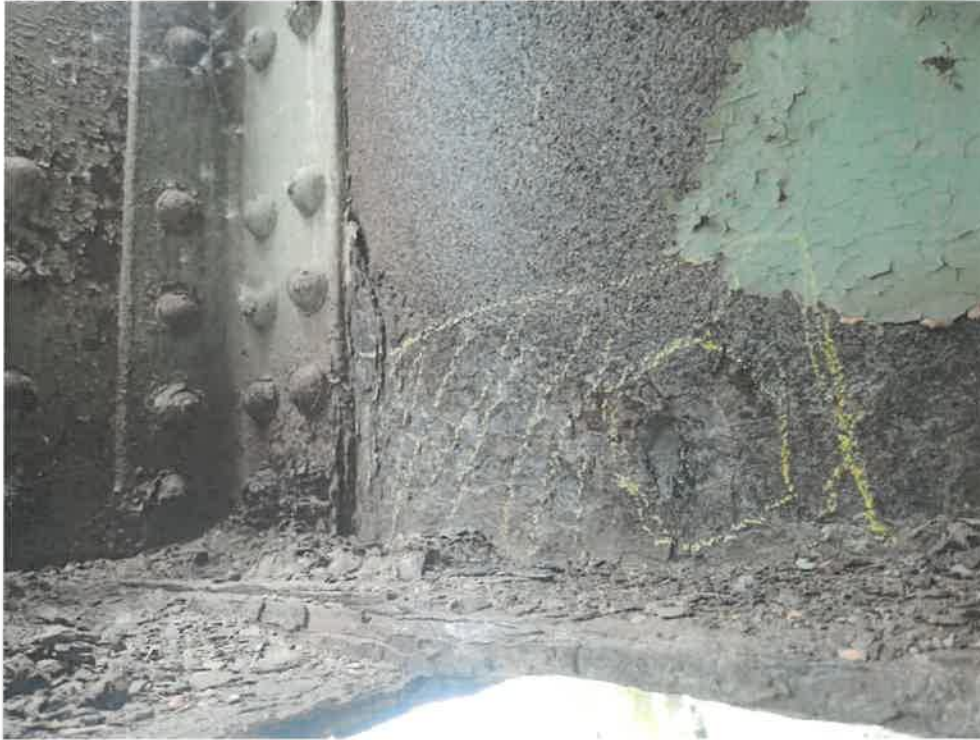
**Photo 29: Floorbeam FB4 at north end, east face with heavy rust and section loss**

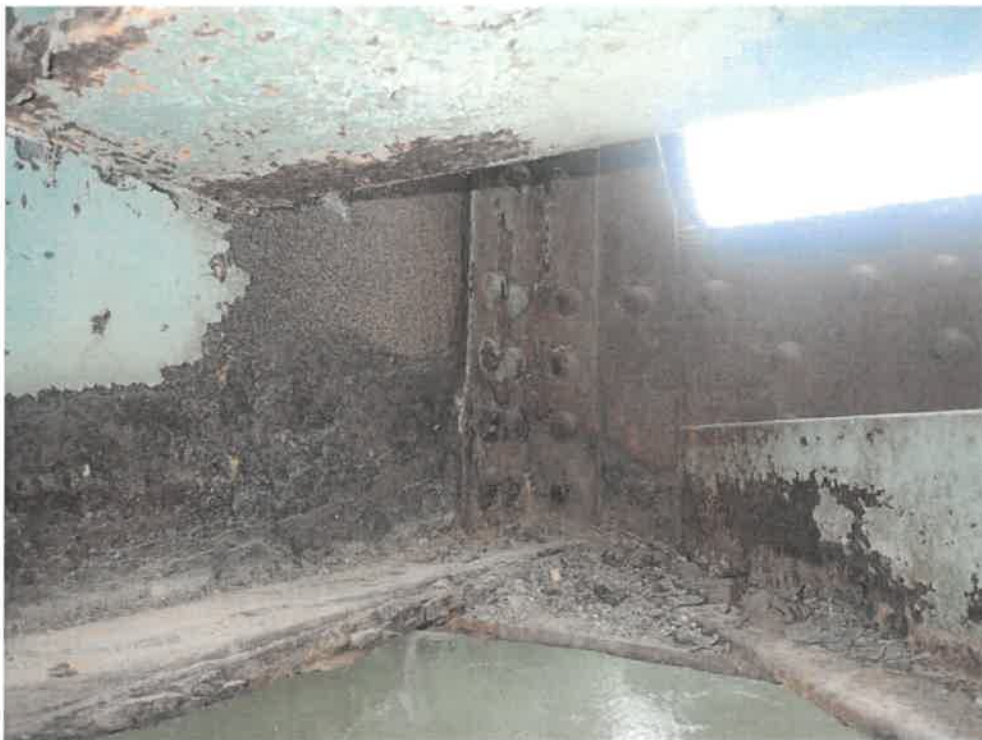
**Photo 30: Floorbeam FB5 at north end, east face with heavy rust and section loss**

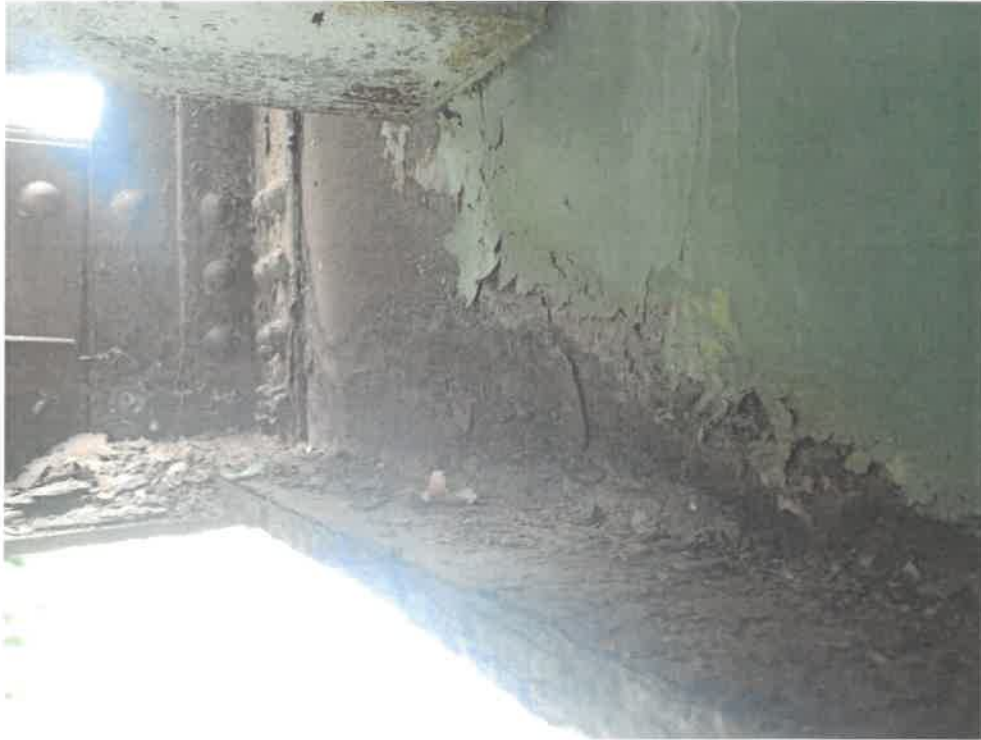
**Photo 31: Floorbeam FB5 at south end, east face with rust**

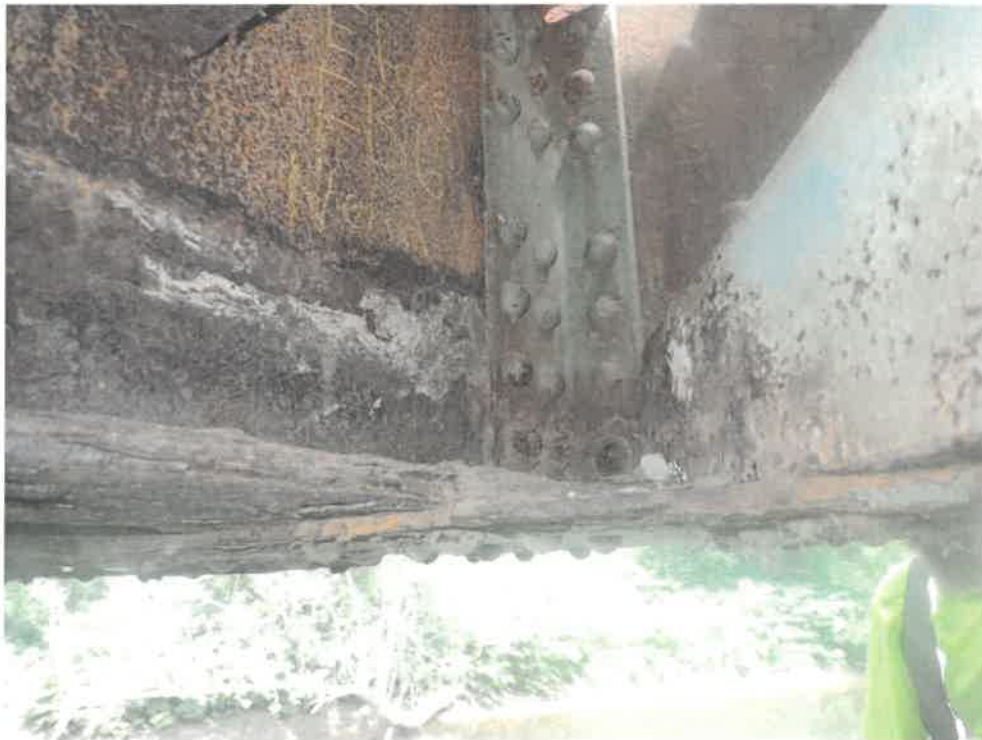
**Photo 32: Floorbeam FB6 at north end, east face with heavy rust and section loss**

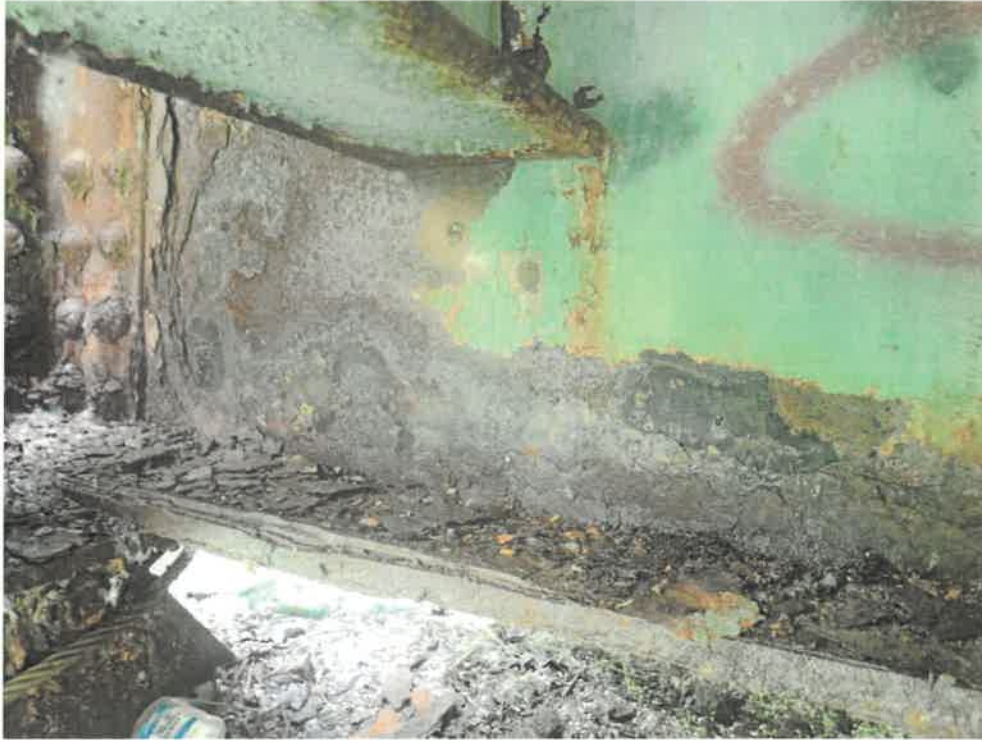
**Photo 33: Floorbeam FB8 at north end, west face with heavy rust and section loss**

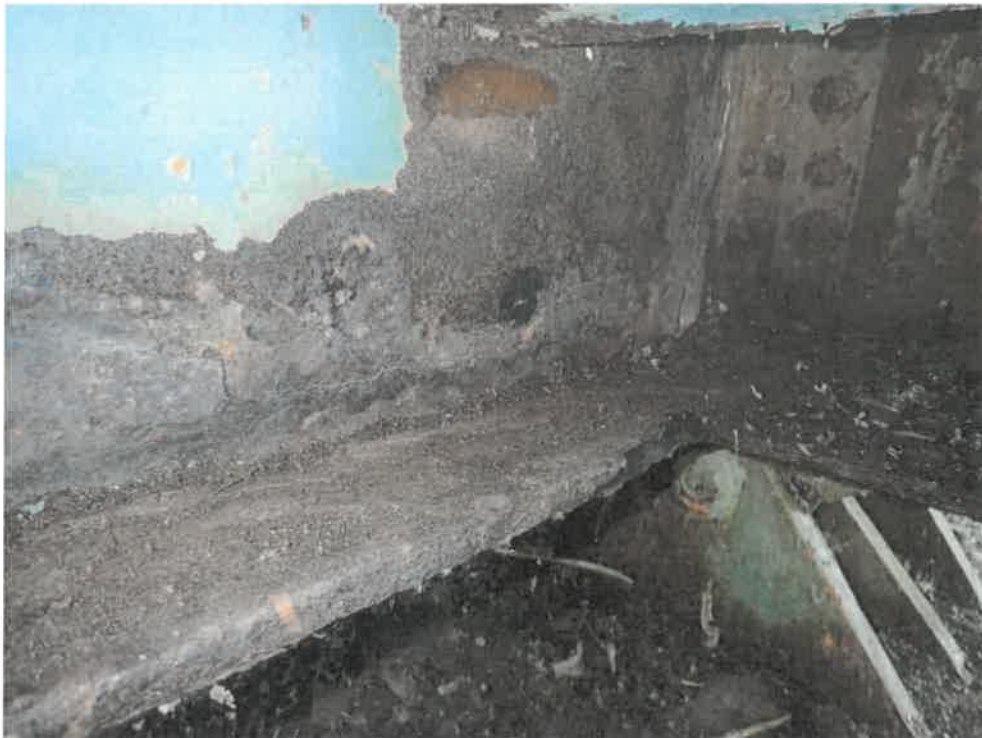
**Photo 34: Floorbeam FB8 at south end, west face with heavy rust and section loss**

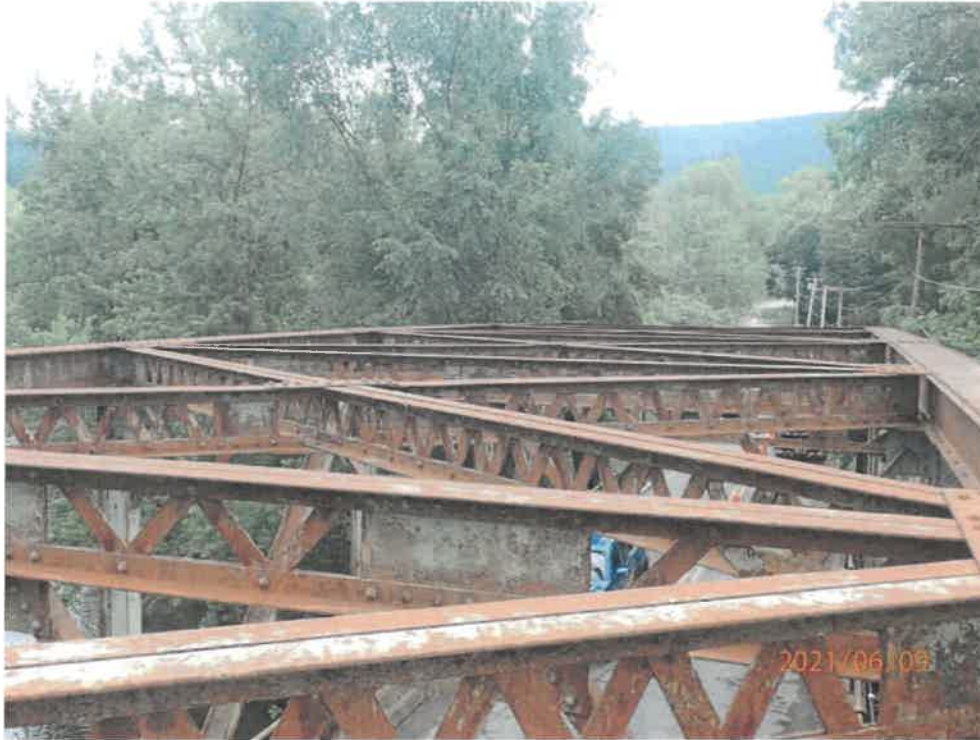
**Photo 35: Upper Chord with typical rust and peeling paint**
