## OWNER-ENGINEER AGREEMENT

**Re: Proposal for the Brookside Road Bridge over the Housatonic River  
Superstructure Replacement**

| CITY/TOWN<br><b>GREAT BARRINGTON</b> | B.I.N.<br><b>04K</b> | BR. DEPT. NO.<br><b>G-11-008</b> | 8.-STRUCTURE NO.<br><b>G11008-04K-MUN-NBI</b> | INSPECTION DATE<br><b>JUN 8, 2021</b> |

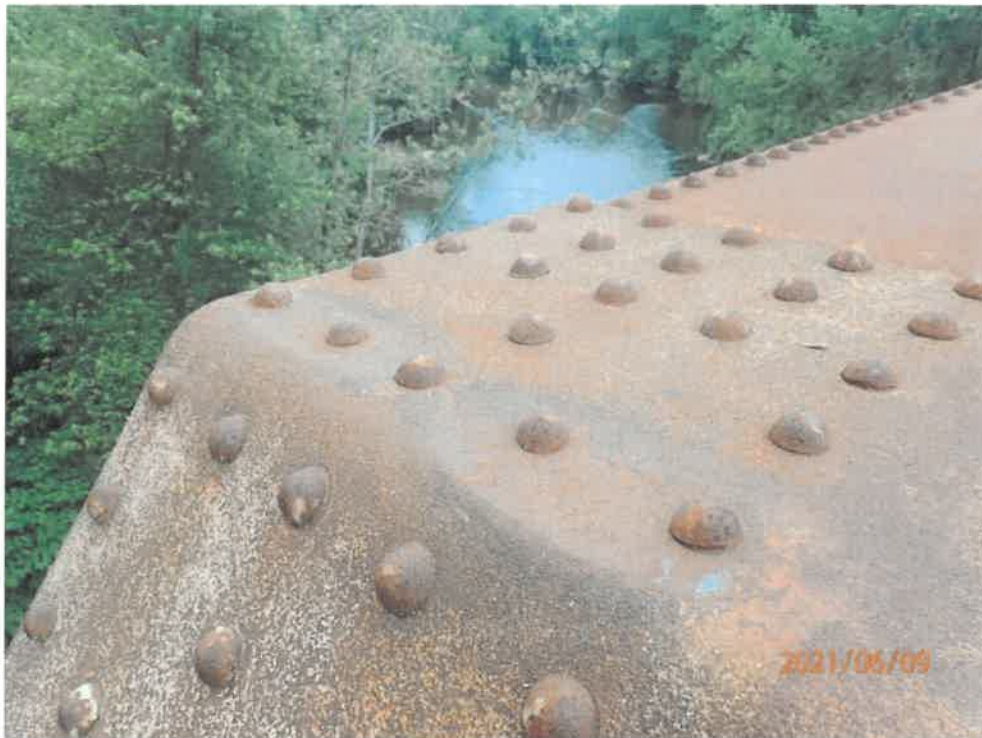
**Photo 36: North Truss, U1 upper chord gusset plate with depressions/cupping**

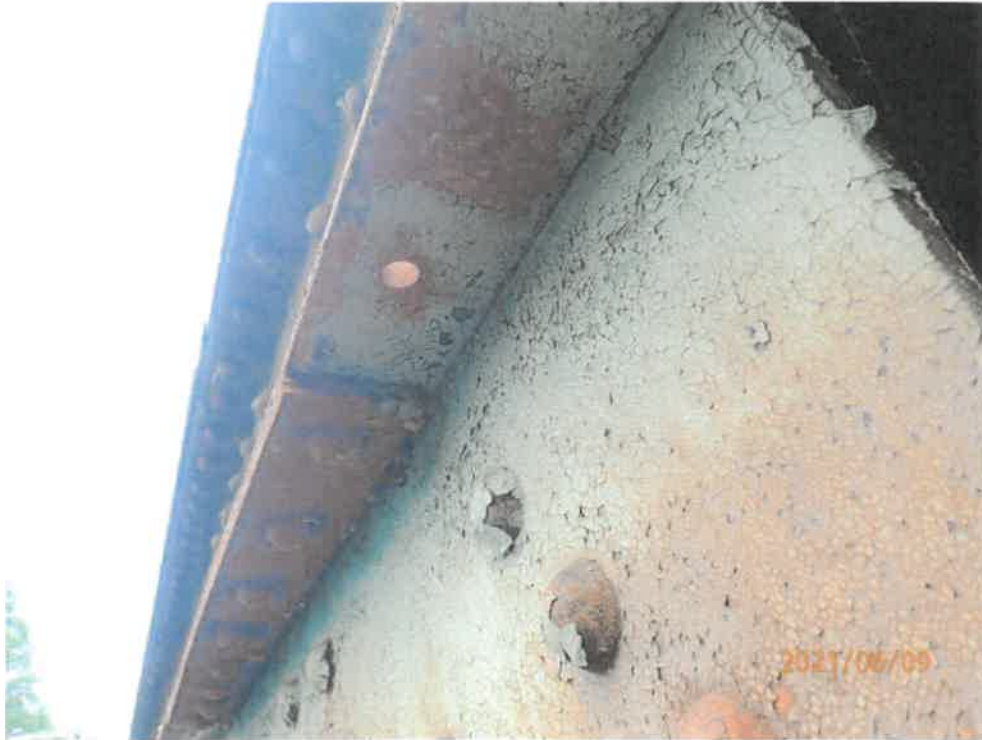
**Photo 37: South Truss, U3 south face with missing rivet at upper chord**

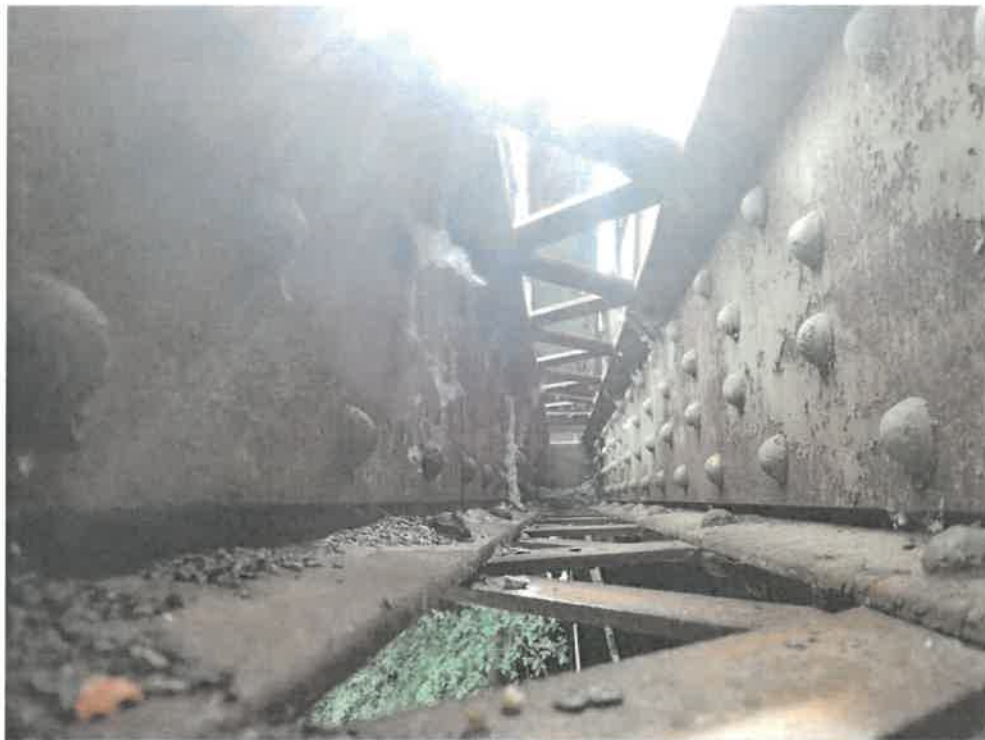
**Photo 38: Lower Chord with typical rust and paint loss**

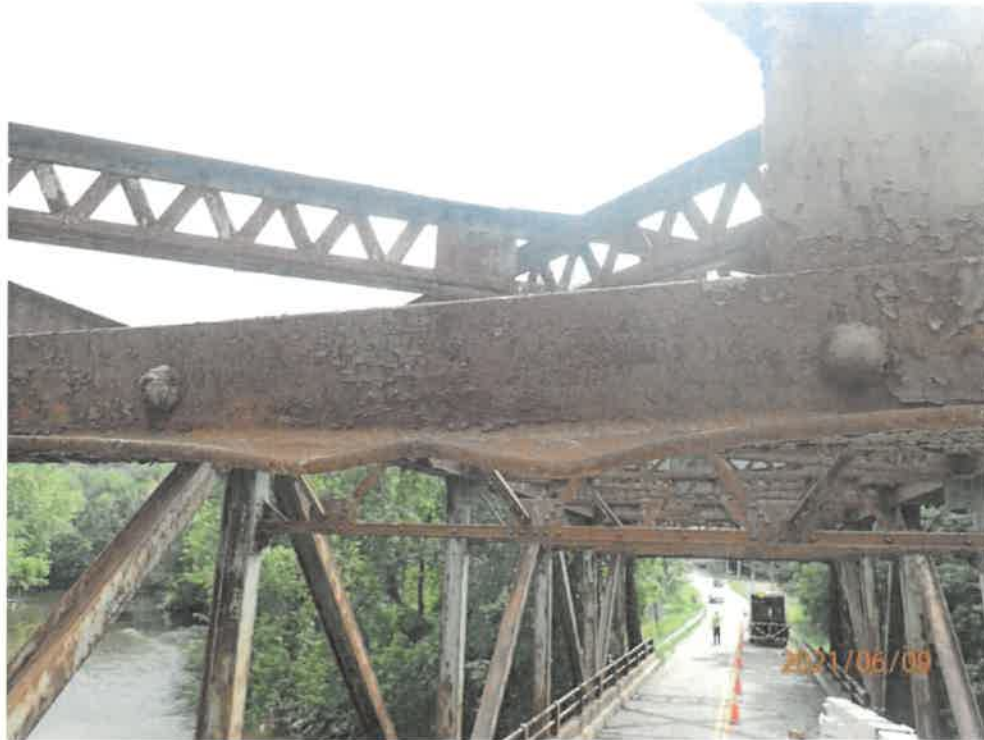
**Photo 39: U2 Sway Bracing with collision damage**

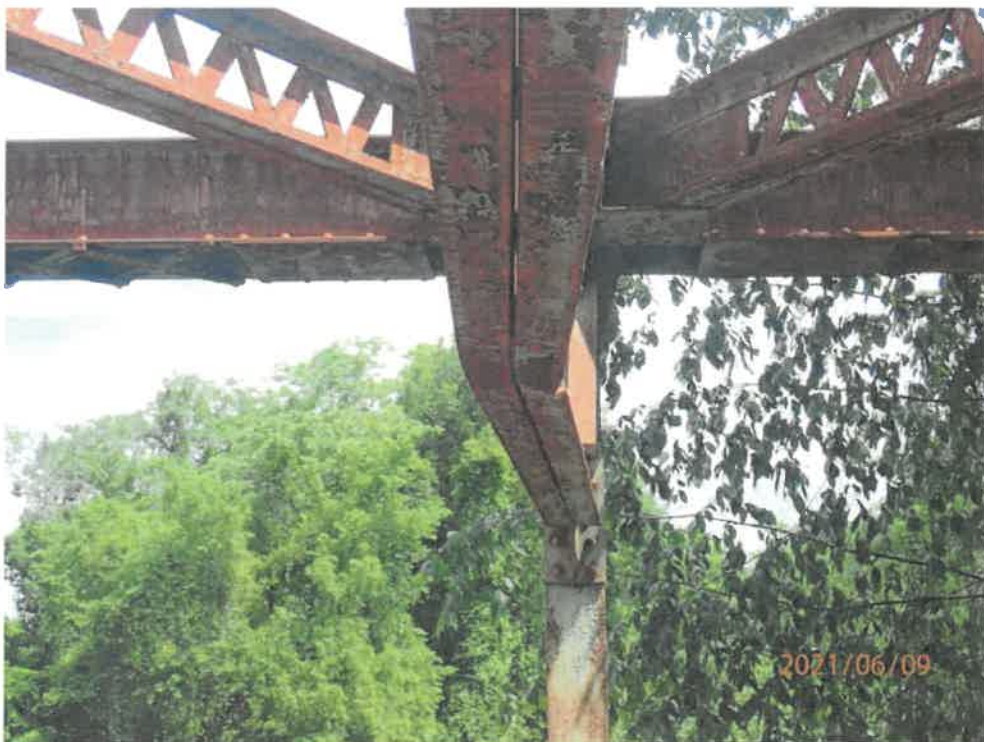
**Photo 40: U6 Sway Bracing with collision damage**

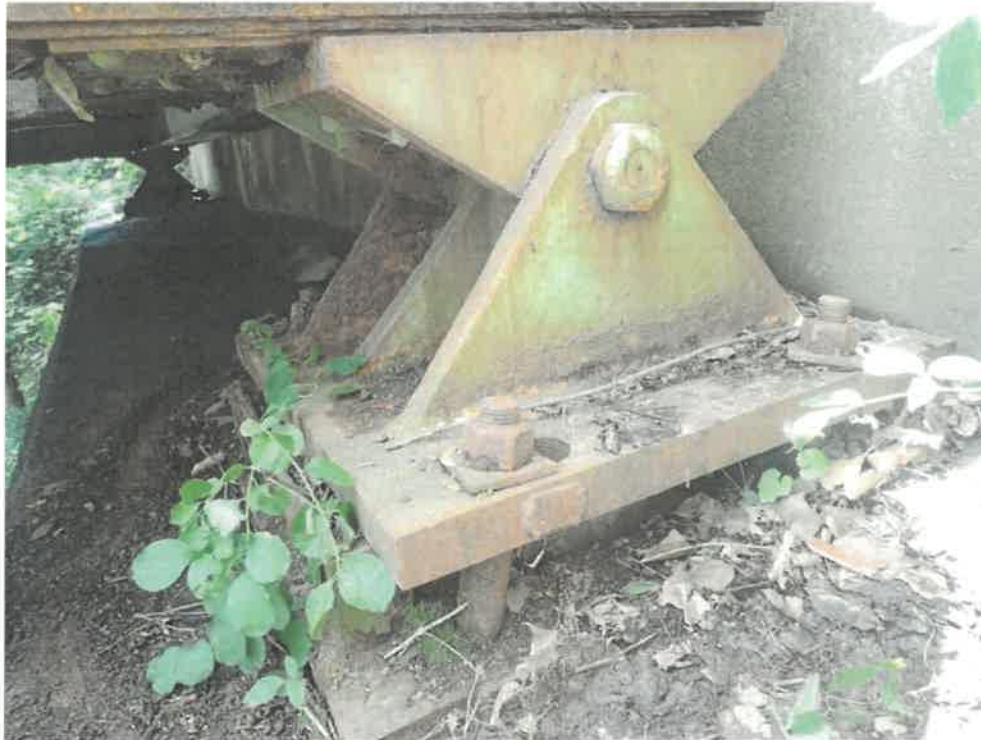
**Photo 41: Northwest Bearing with overexpansion and bent anchor rods**

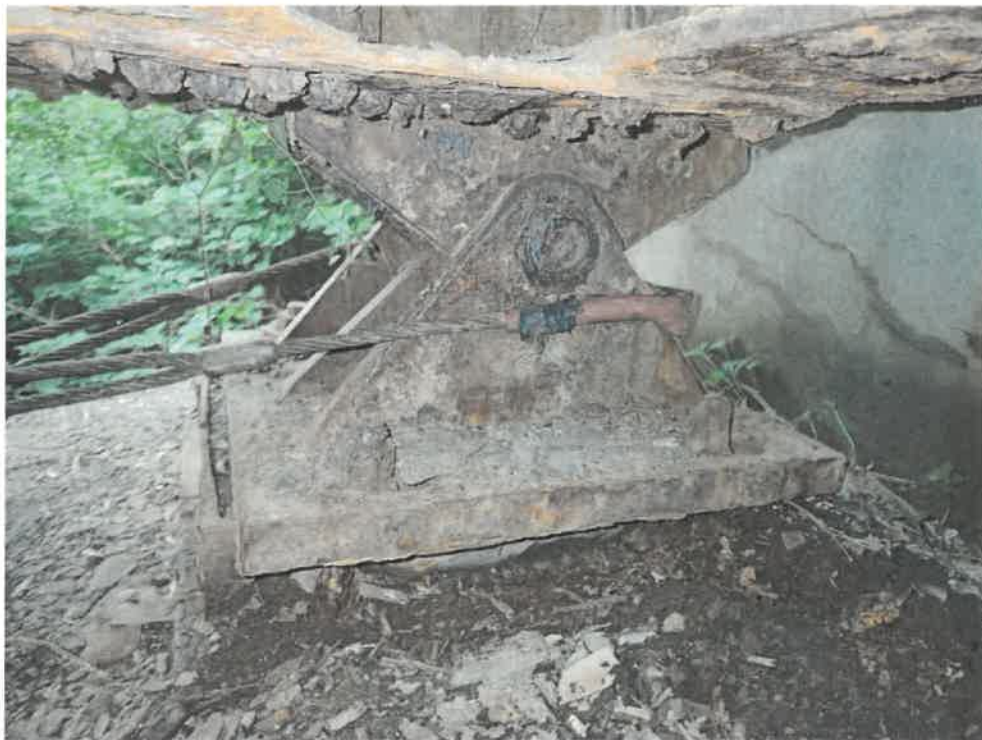
**Photo 42: Southwest Bearing with debris, rust, and anchor bolt nut section loss as well as overexpansion with bent anchor rods**

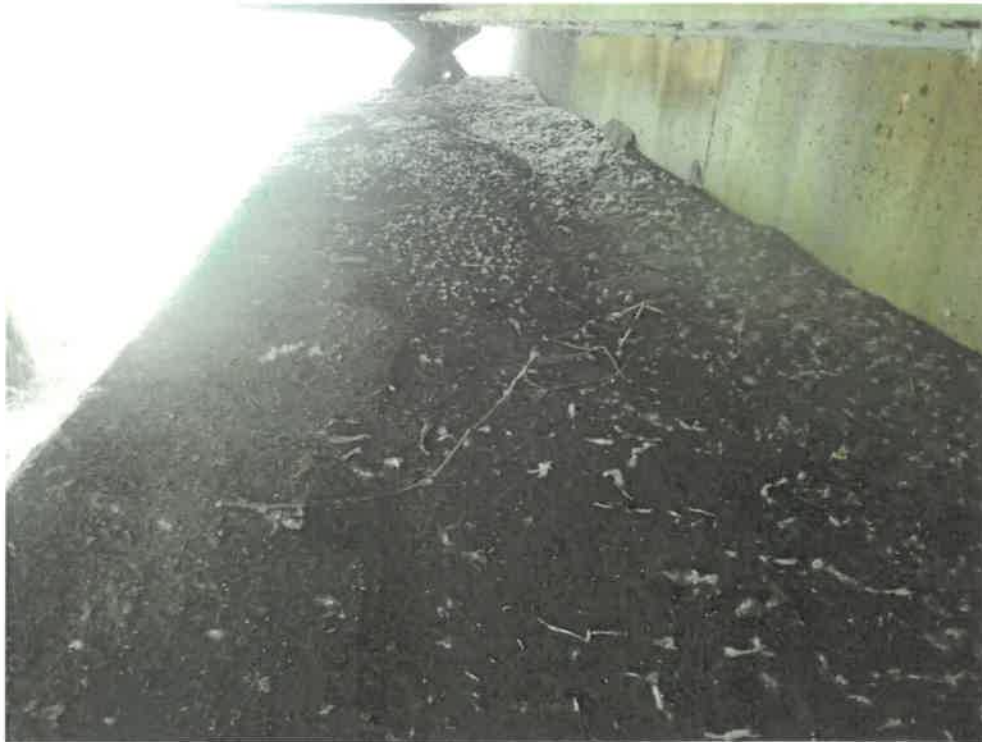
**Photo 43: East Abutment bridge seat with debris accumulation**

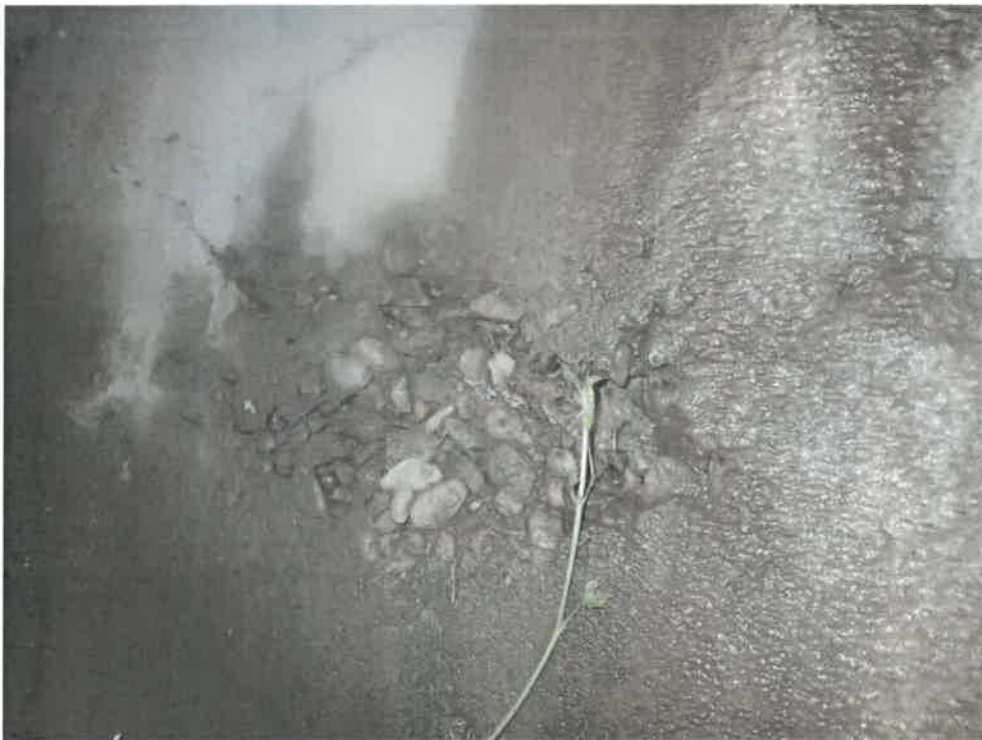
**Photo 44: West Abutment south of Stringer S4 with spall**

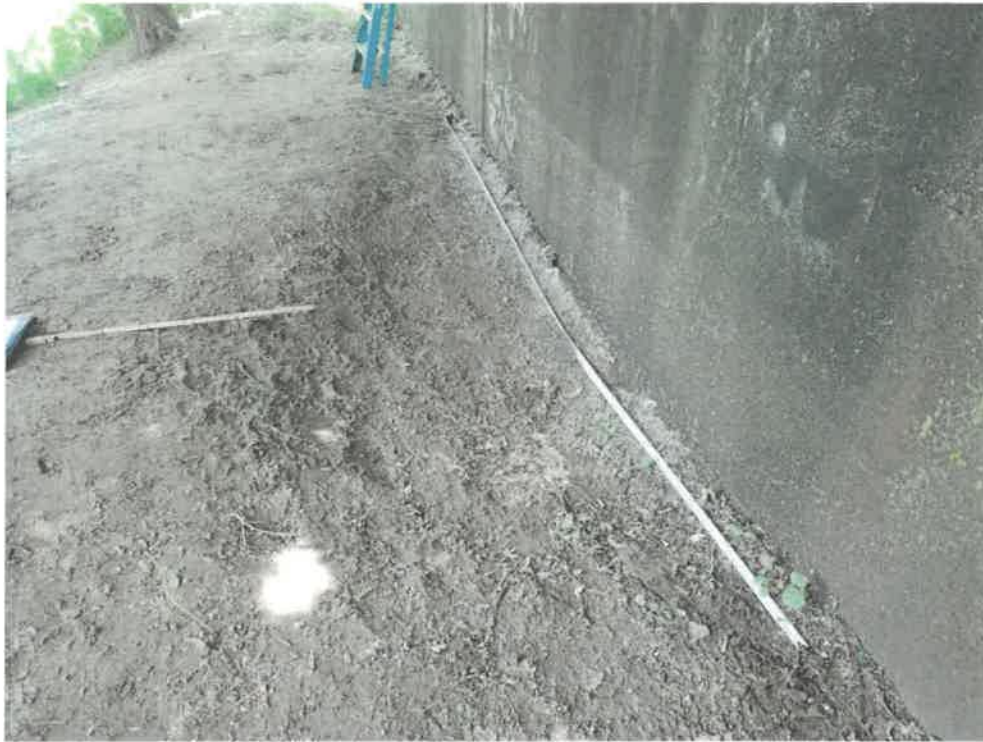
**Photo 45: East Embankment, south end of East Abutment with depression**
