School District of Bloomer Facility Audit

June
2019

BLOOMER HIGH SCHOOL

FACILITY ANALYSIS

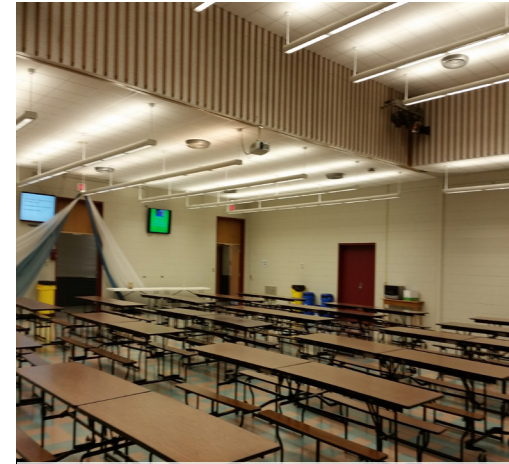
Commons used for Auditorium

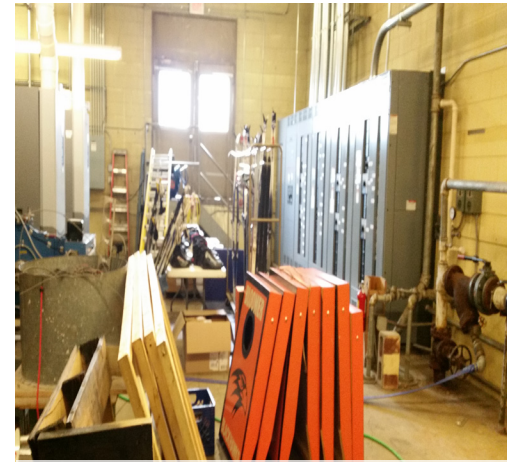
Improper mechanical room storage

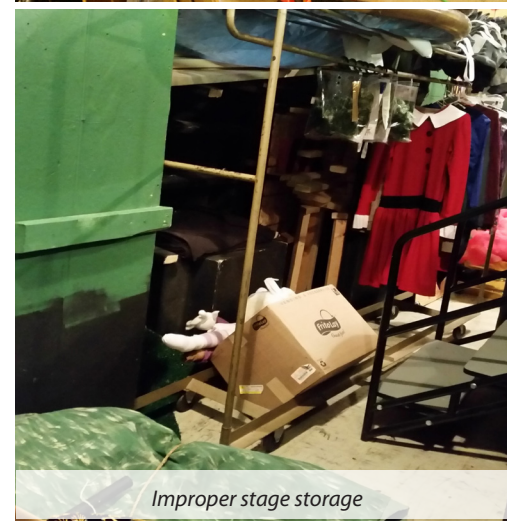
Improper stage storage

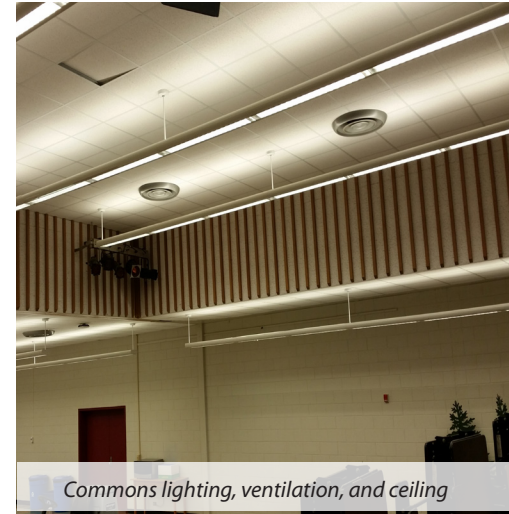
The stage lighting output is also considerably depreciated and inefficient to operate. The commons and stage area have limited ventilation volume and control for both areas. The areas are served by ventilation system requirements from the 1960s. The ventilation event demands during events are beyond the existing equipment capacity and operating conditions.

Commons lighting, ventilation, and ceiling

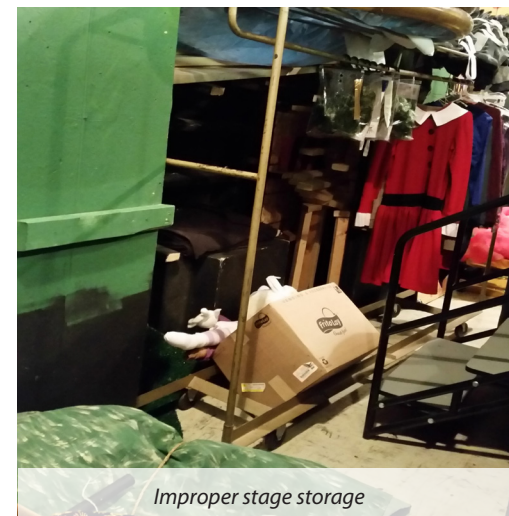
Improper stage storage

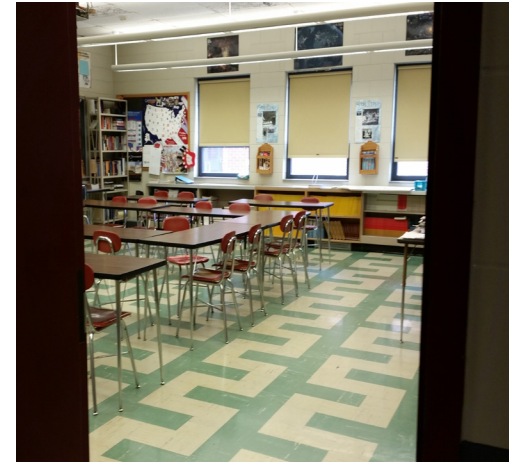
Asbestos tile in classrooms

- Remove asbestos flooring and mastic per required safe abatement practices.
- Replace removed vinyl asbestos tile with vinyl composition tile and non-hazardous mastic.
- Remove stains in terrazzo, clean cracks, fill cracks and patch missing material areas, and refinish.
- Remove wall stains and refinish or paint.
- Replace stained and damaged ceiling tiles
- Replace or paint damaged or stained ceiling suspension grid.

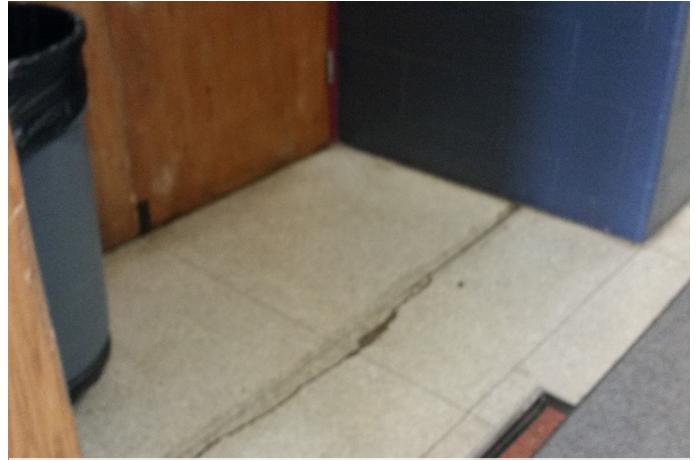
Cracked terrazzo flooring in corridor

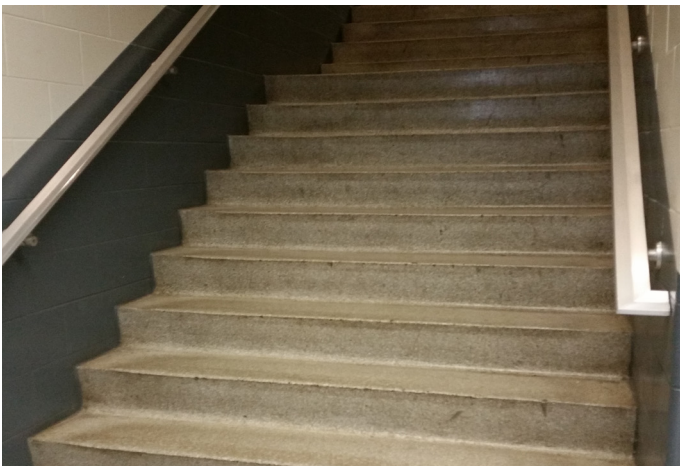
Dingy and stained terrazzo stairs and walls

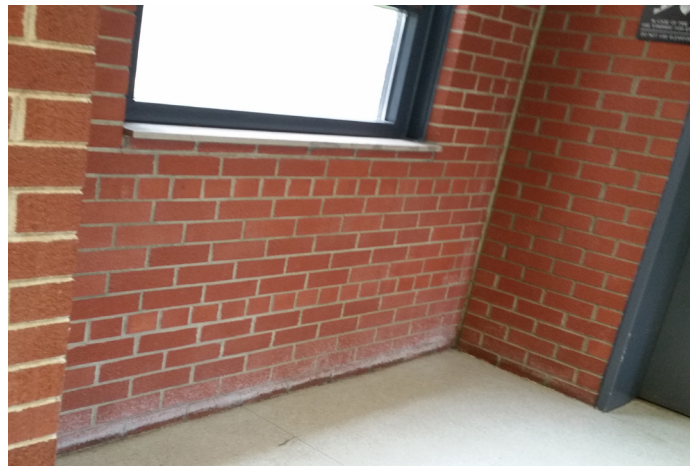
Stained brick walls in corridor

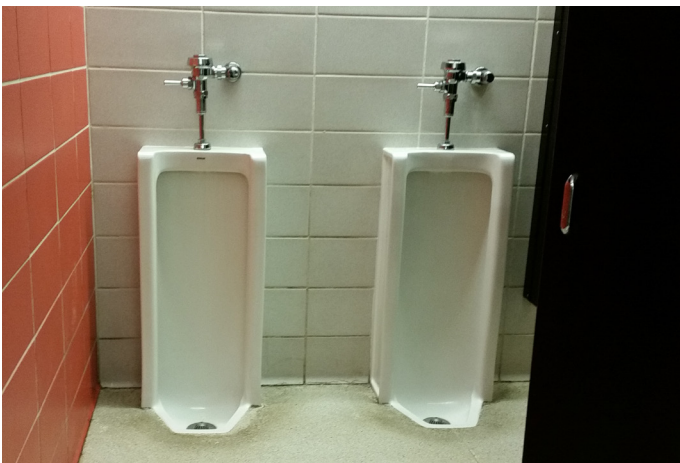
Stained terrazzo and block walls

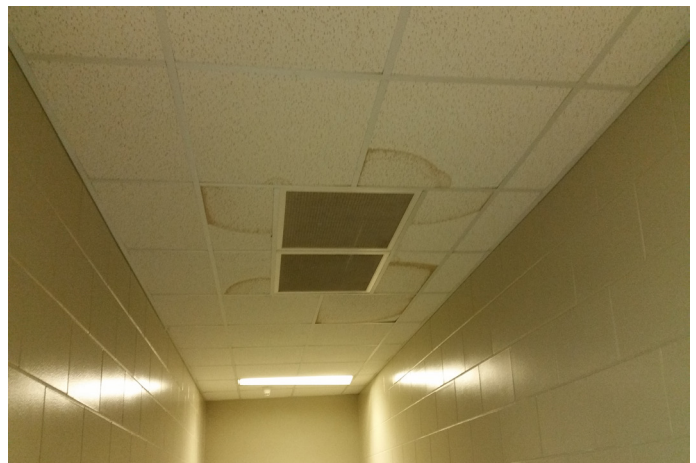
Stained ceiling tiles

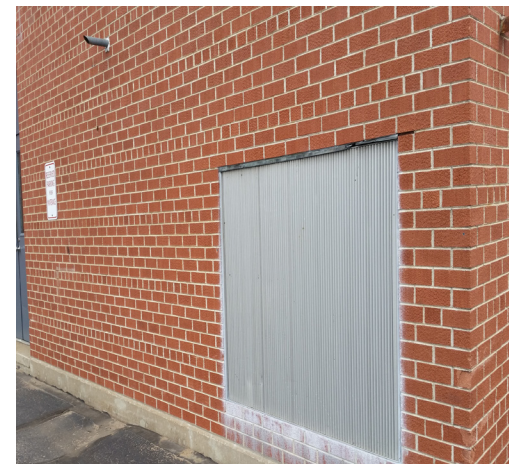
Boiler make-up air intake louver

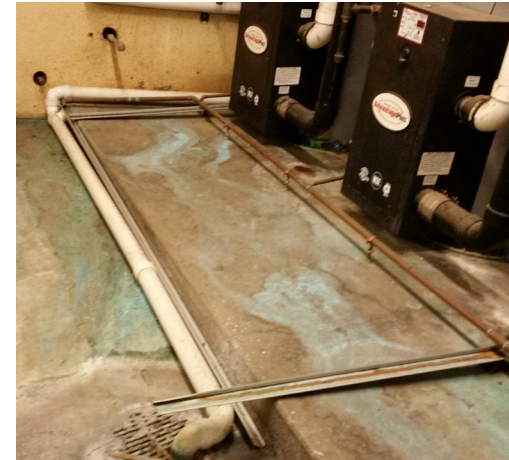
Interior condensate pipe and channels

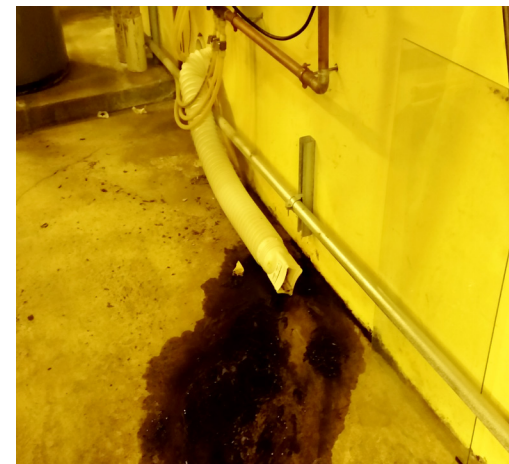
Infiltration pipe discharge

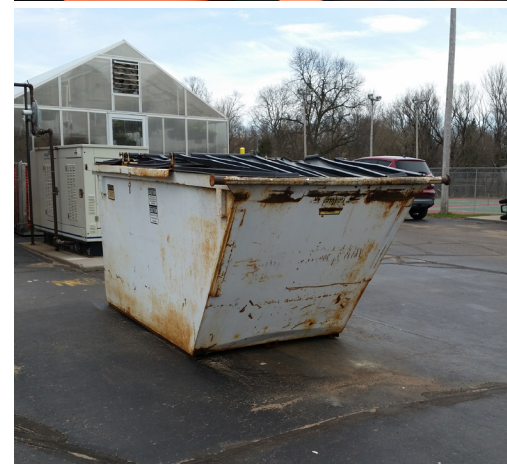
Unsecured dumpster

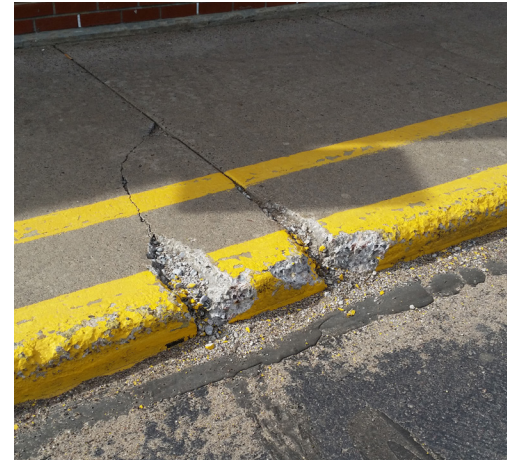
Broken out curbing in front of school

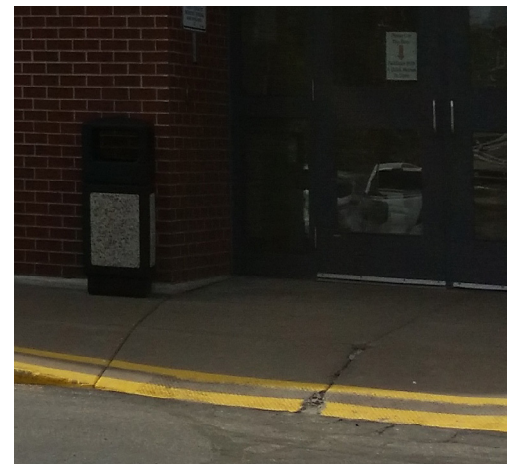
Deteriorating entrance landing and walk

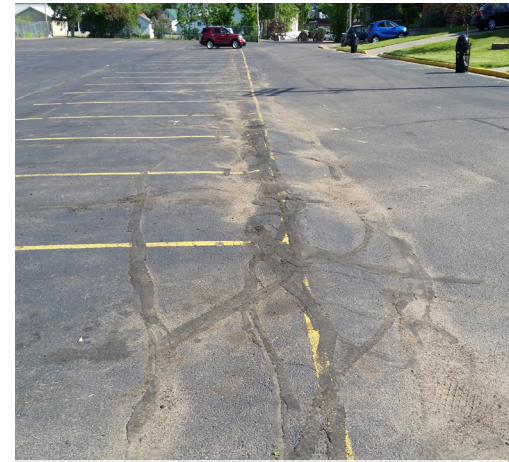
Asphalt cracked, worn, and faded paint

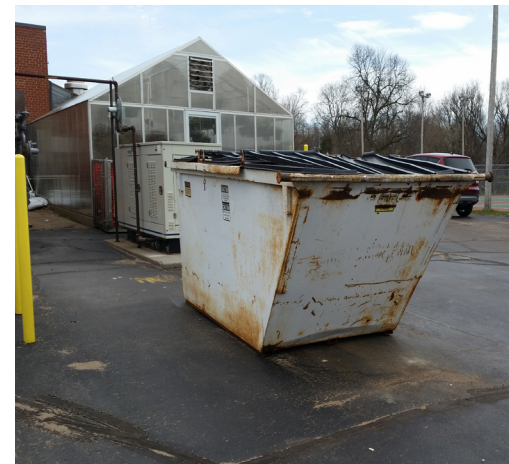
The dumpster is in asphalt, only causing excessive stress and wear on and around the dumpster. The planning for future concrete curbing and asphalt replacement in some areas should be anticipated as early as in another five years. Prior to replacement, specifications for improvements should be documented.

Asphalt dumpster area

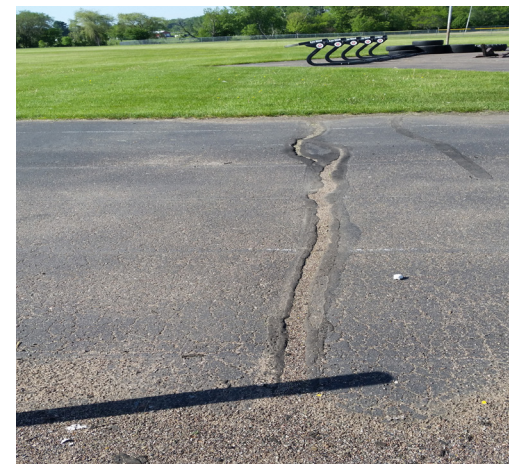
Lateral cracks in track

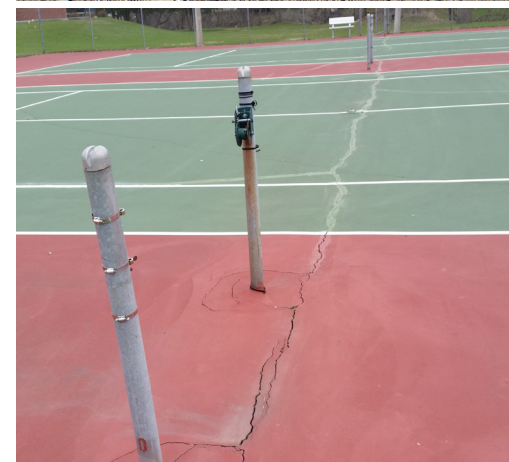
Cracks on tennis courts

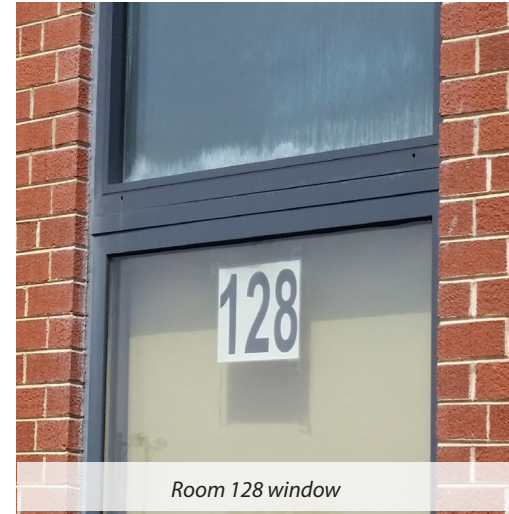
Room 128 window

The failed windows and window systems should be repaired or replaced. The tempered air leaking in and out of the window insulation area is causing occupant discomfort during the heating season, blocks window views, and looks dirty. The failed windows are also wasting energy. The cracked concrete exit door thresholds should also be repaired or replaced. The cracked thresholds allow for water infiltration into the door frames causing premature door replacement needs and potential door exiting failures. The water and air infiltration also create occupant safety hazards, occupant discomfort, and wastes energy.

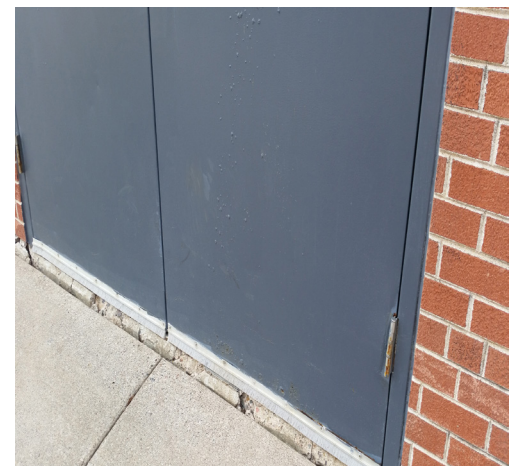
Cracked exit door threshold

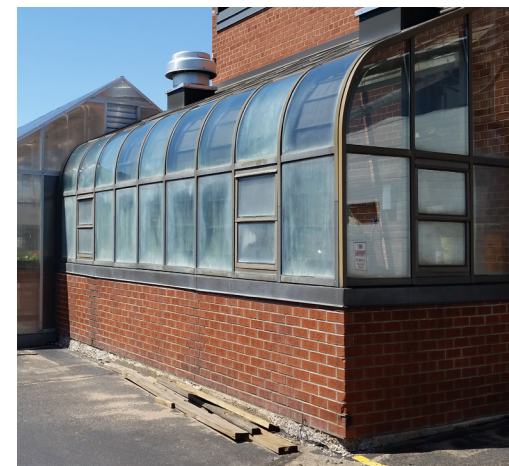
Deteriorating greenhouse wall base

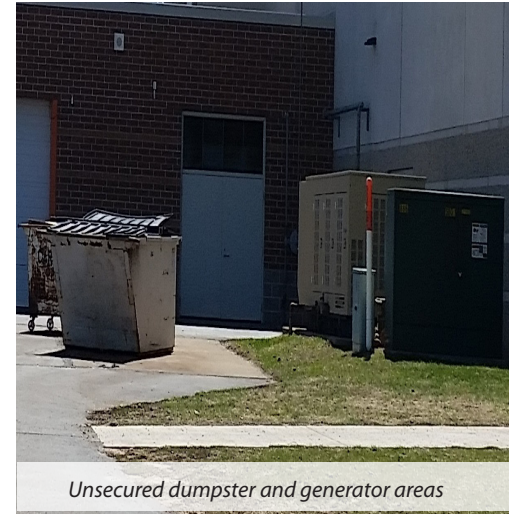
On the exterior of the building, there are several exposed equipment and hazardous operations areas. The dumpster, gas supply meter and distribution tree, electrical transformer, and emergency generator areas are all unsecured. As mentioned earlier in this report, the improperly stored items in the main electrical room are also a safety concern.

Unsecured dumpster and generator areas

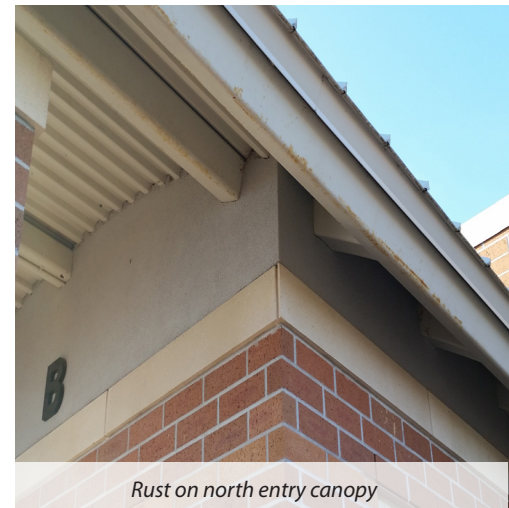
Rust on north entry canopy

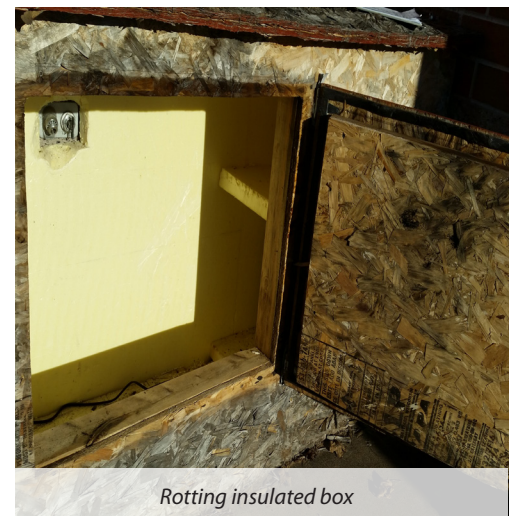
Rotting insulated box

The last recommendation is to remove the rotting insulated box. Inspect the wall and hose bib for proper operation and wall insulation and sealing to prevent freezing.

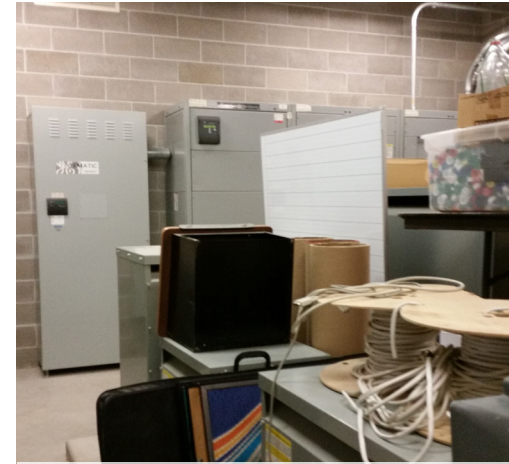
Main electrical room improper storage

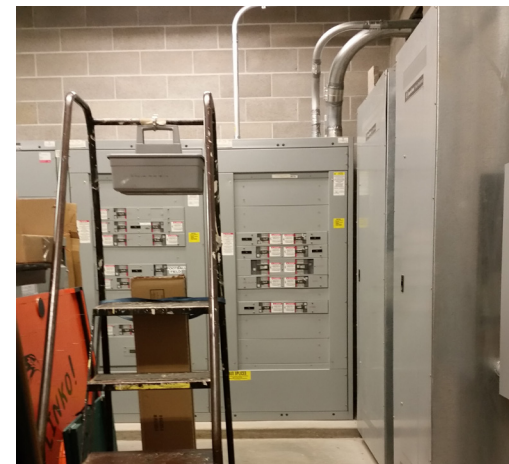
Main electrical room lack of clearance

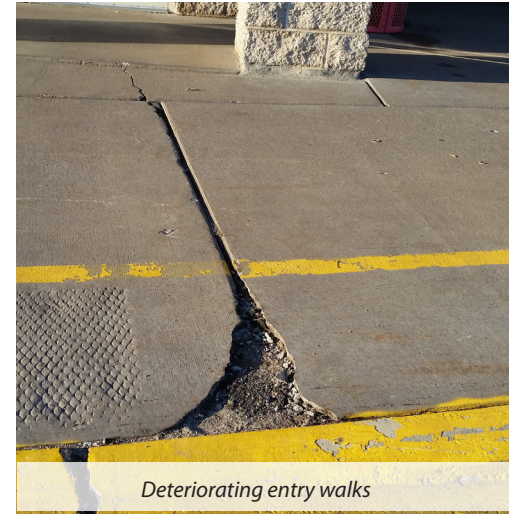
Deteriorating entry walks

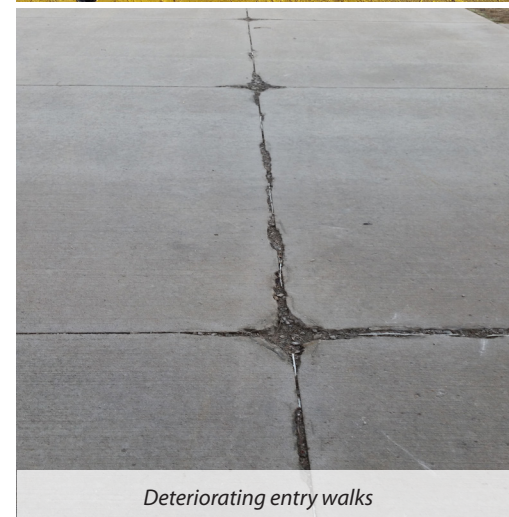
Deteriorating entry walks

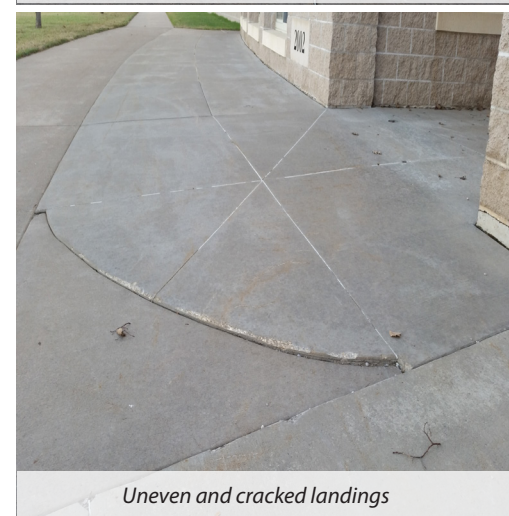
Uneven and cracked landings
