Incident Summary Report

Title: UW-Madison Swimming Pier Collapse

Date of Occurrence: Monday, September 4th, 2023

Location of Occurrence: 800 Langdon Street, at UW-Madison Swimming Pier along the Howard Temin Lakeshore Path

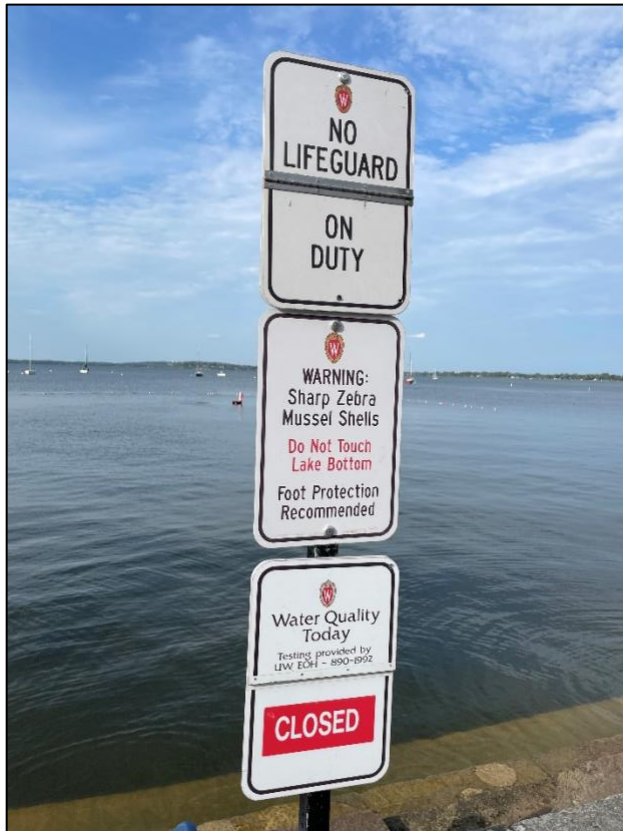
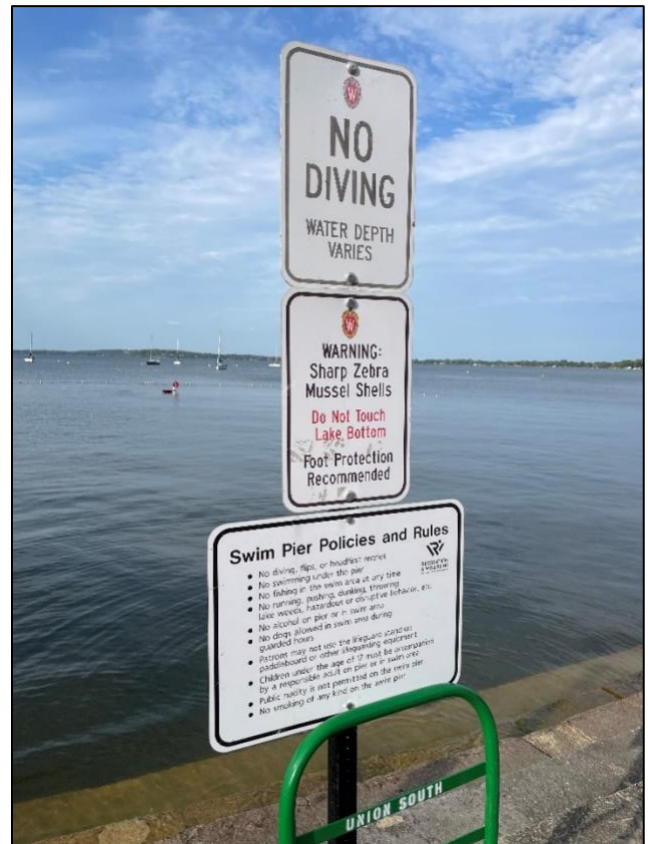
Signage at time of Incident (UWPD)

Flip signs denoting No Lifeguard on Duty and Water Quality

Swimming Pier Policies and Notice

- Review the current weekly inspection protocols to determine whether they are adequate to identify potential structural problems with the pier.
- Signage needs to be secured to prevent patrons from altering “open/closed” status notifications.

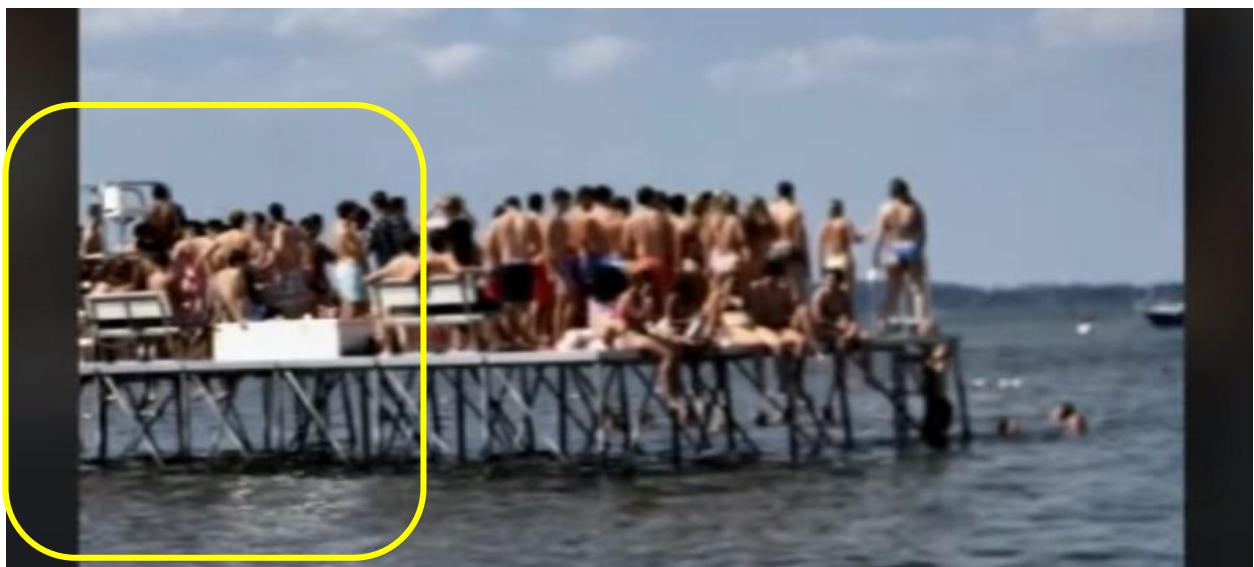
1) 1 Second before collapse all vertical support legs are currently vertical.

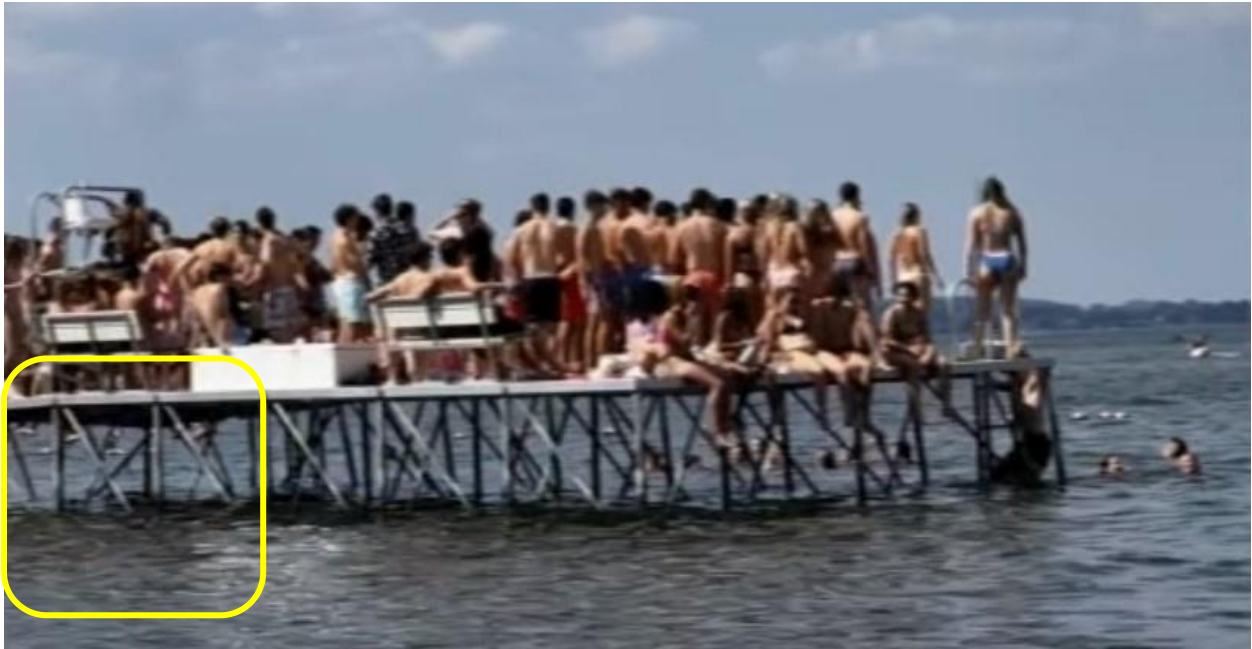
- Due to the number of people on numerous adjacent pier sections, the adjacent leg supports were likely already near maximum static load and experiencing latitudinal strain which they are not designed for. When one support leg buckled, others rapidly followed suit until weights on the pier stabilized from people falling into the water.

2) 0 Second. Failure begins. Notice bulge on the decking at the far left of this image, at the underside of the pier deck; the leg beneath that bulge appears to be buckling northward.

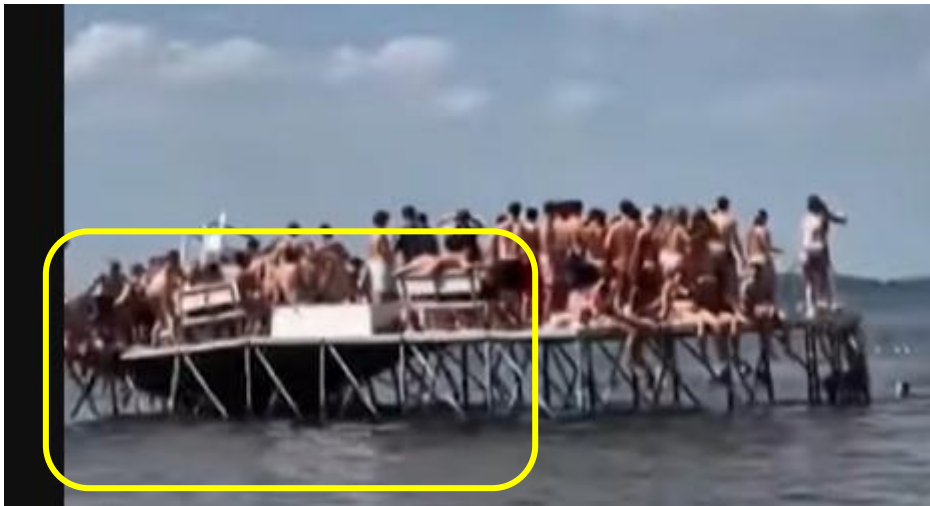
3) Less than .5 seconds later, multiple support legs have buckled in numerous directions and the horizontal edge of the pier decking is buckling across numerous sections. Occupants have begun falling into the water.

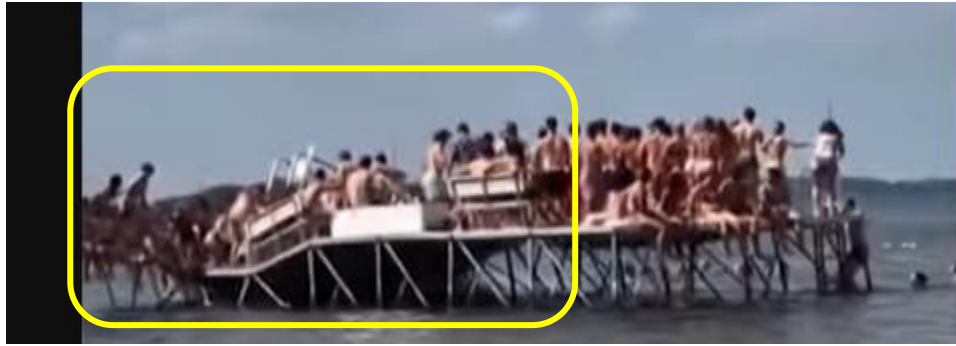
4) Continued cascade of support legs and deck edging failing northward.

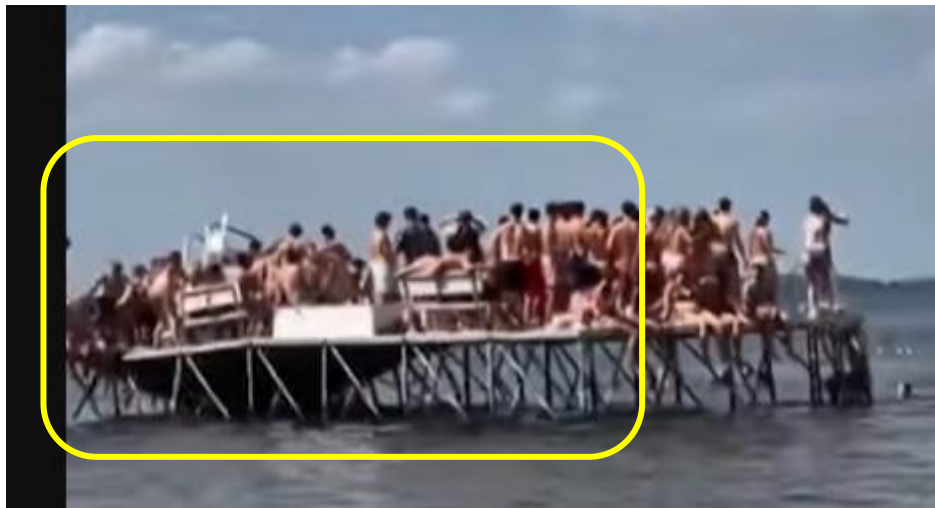
5) Support legs towards the south side are now failing. 1 second elapsed from initial buckling.

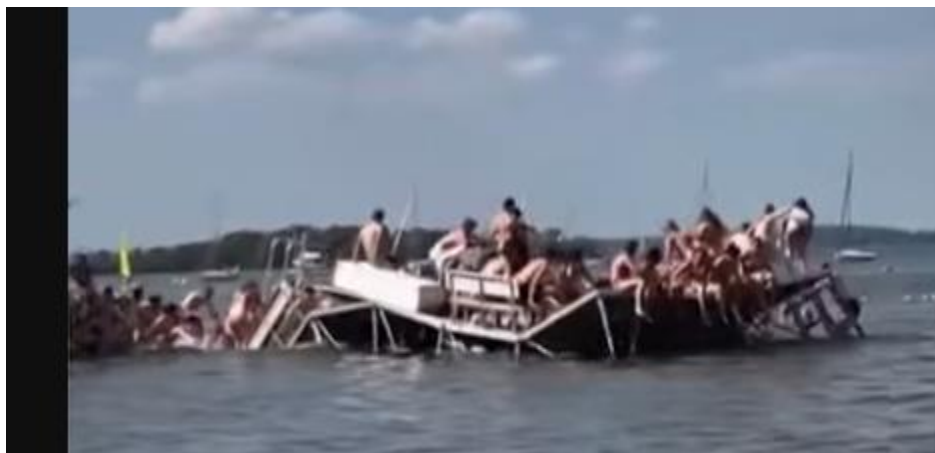
6) Extended failure continues across pier support legs and horizontal edging.

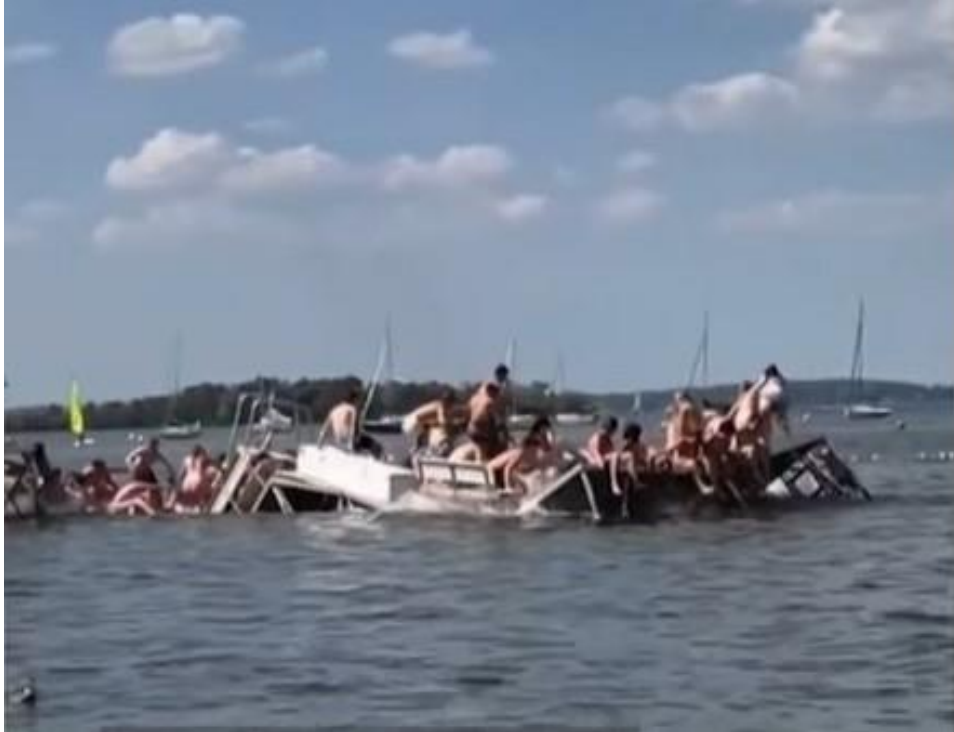
7) 2 Seconds in, pier support legs have finished failing in a cascade.

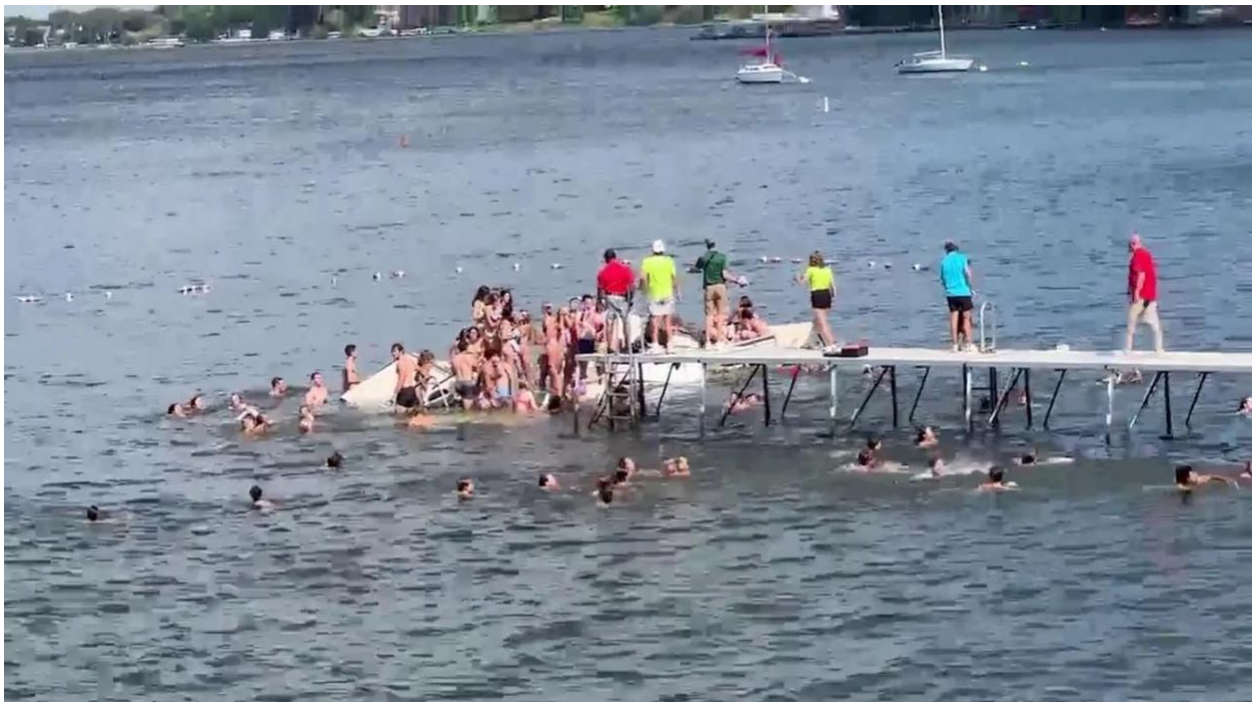
8) 5 Seconds in, people are swimming to shore or climbing onto remaining pier structures. Occupants climbing onto failed sections of the pier are causing those sections to sink deeper into the water. (Instagram)

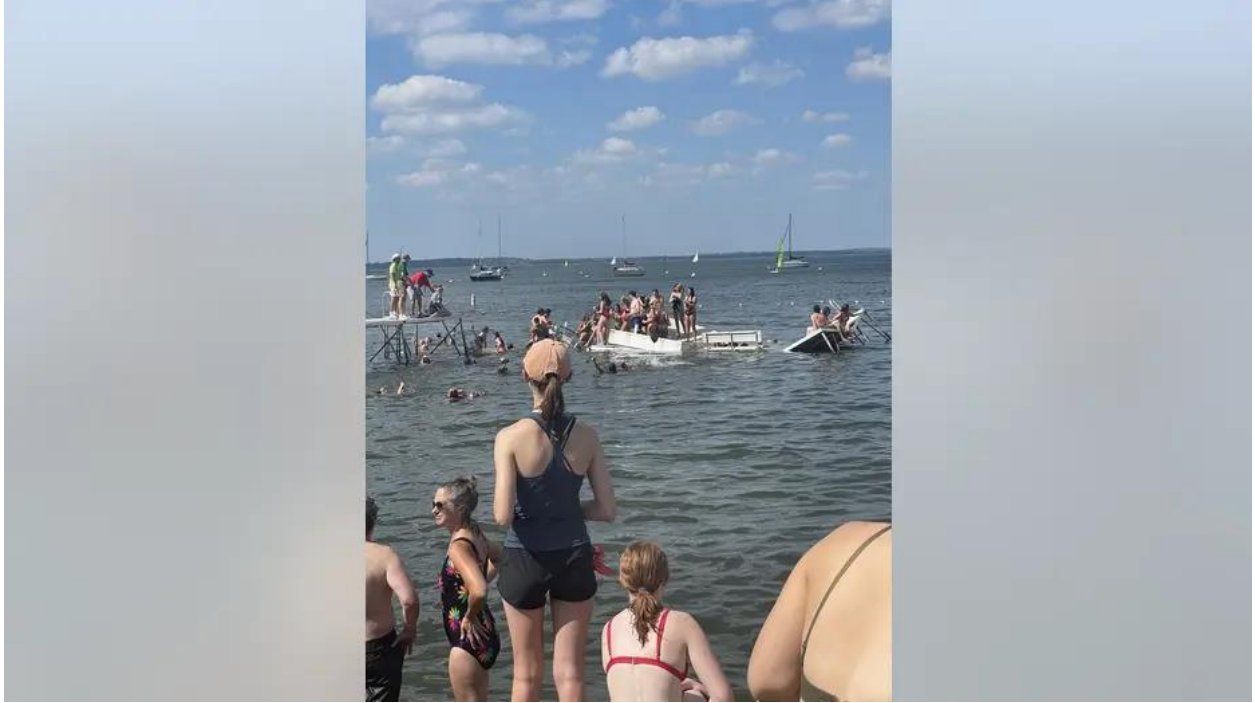
9) Numerous pier sections have completely gone under water by 10 seconds from moment of initial failure.
