# Aviation Investigation Final Report

| <b>Location:</b> | Janesville, Wisconsin | <b>Accident Number:</b> | CEN21FA130 |
| <b>Date &amp; Time:</b> | February 16, 2021, 09:17 Local | <b>Registration:</b> | N13VT |
| <b>Aircraft:</b> | Velocity Vtwin | <b>Aircraft Damage:</b> | Substantial |

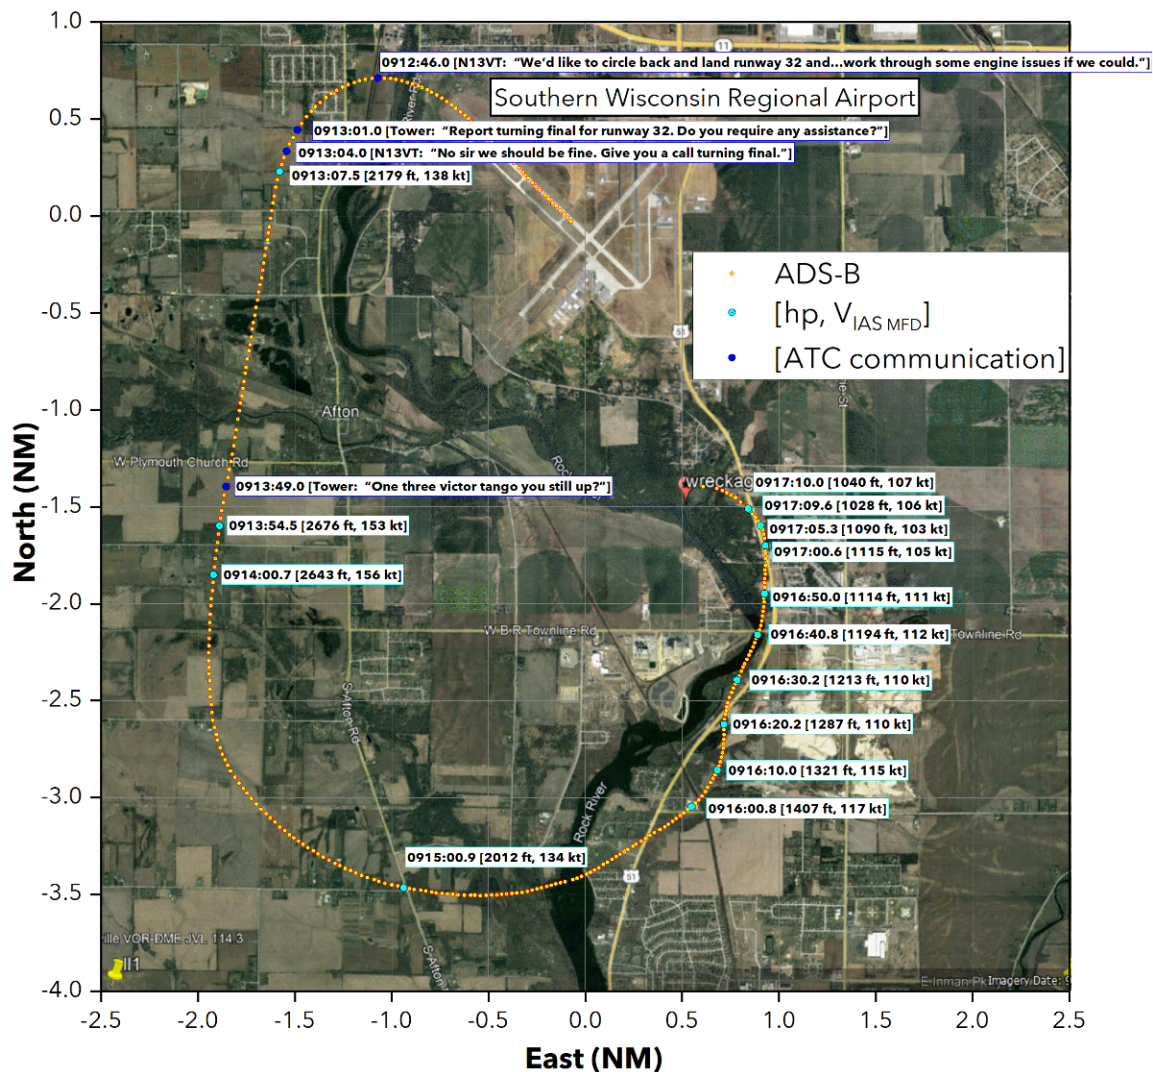
Figure 1: Position, Altitude and Airspeed for the Accident Flight

Around 0912:15, data showed right engine rpm decrease from around 2,600 to 2,100 rpm. Around this time, airspeed began to increase to a maximum of around 156 knots and altitude

to a maximum of around 2,850 ft. (Figure 1) During this interval, right engine rpm fluctuated above 2,100. The airplane appeared to stop its climb shortly thereafter, around 0913:25. The airplane continued around 2,800 ft until about 0914:00, when the rpm began to show a decrease. By 0914:10, the rpm had reached zero. The airplane continued to descend until the end of the recorded data. Indicated airspeed began fluctuating, but showed a decreasing trend for the remainder of the recording.

Rate-of-climb data from the MFD showed a significant decrease in climb rate shortly after the right seat pilot reported an engine concern. The rate-of-climb then increased about the time the MFD recorded a decrease in indicated airspeed, before decreasing to about zero climb rate. When the rate-of-climb decreased, the indicated airspeed increased to about 156 knots (kts), which was 16 kts above the maximum landing gear extended (VLE) speed.
