# Summary Report for Incident on 10-7-17

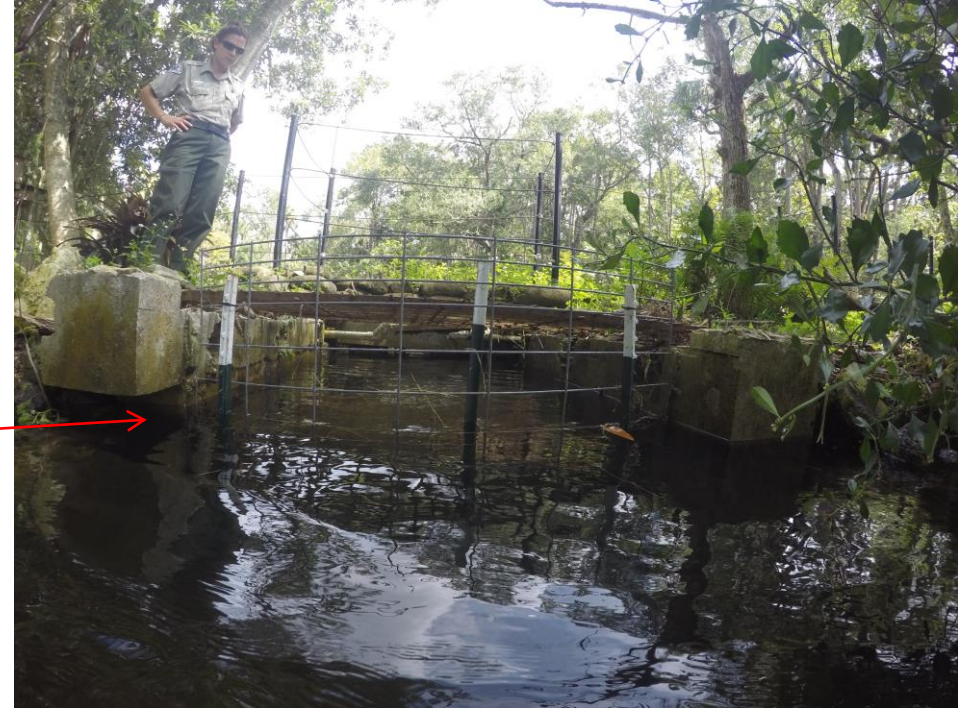
Picture taken 10/17

Water level difference from Hurricane Flooding. Picture.

Photo was not taken at highest tide. Water level would have been higher (see Tide Chart).

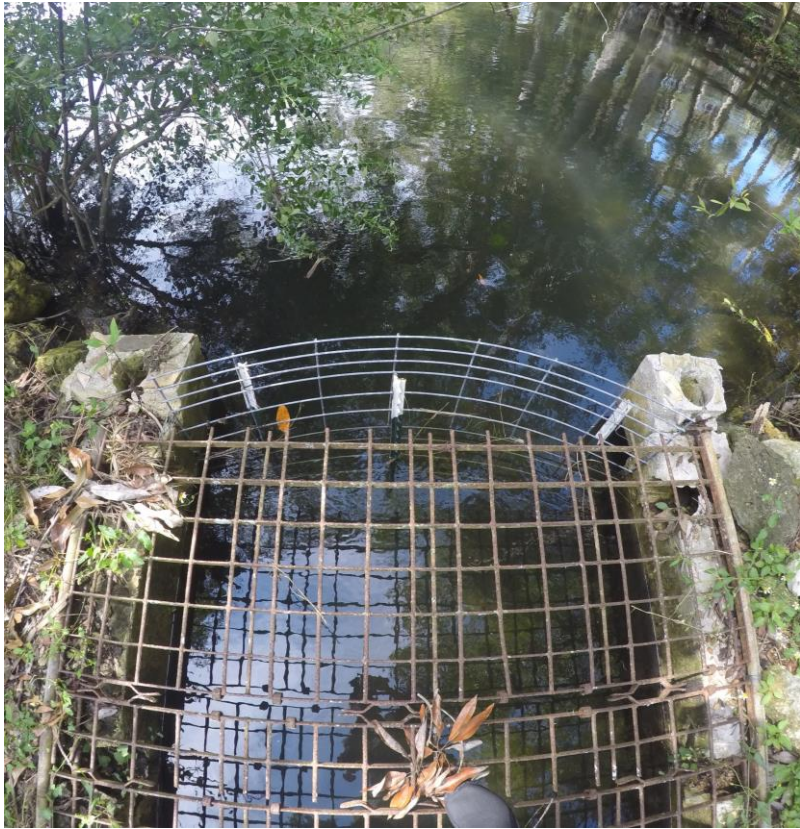
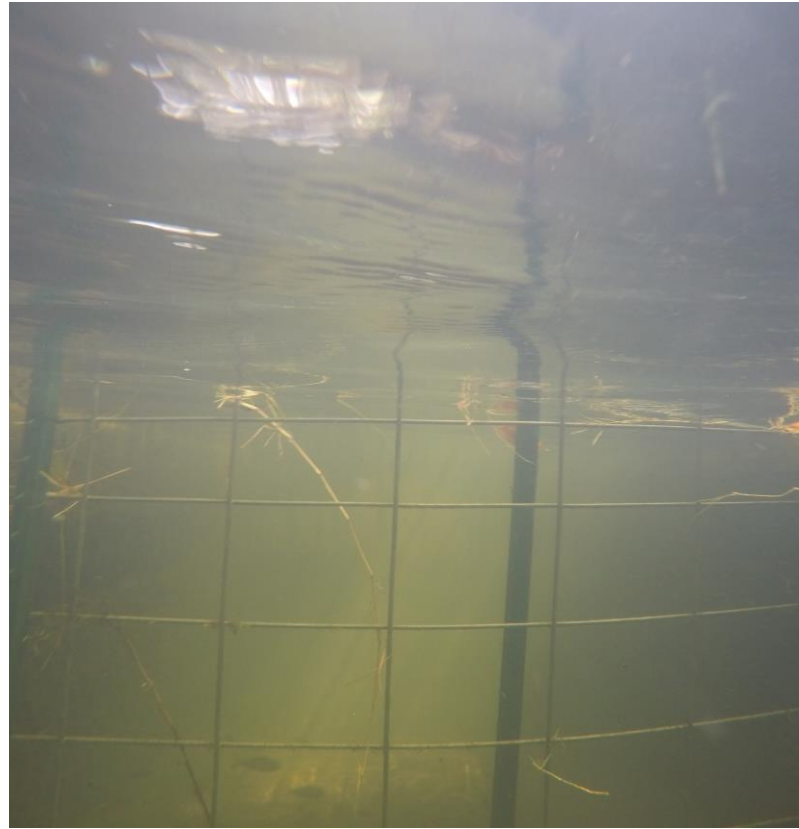
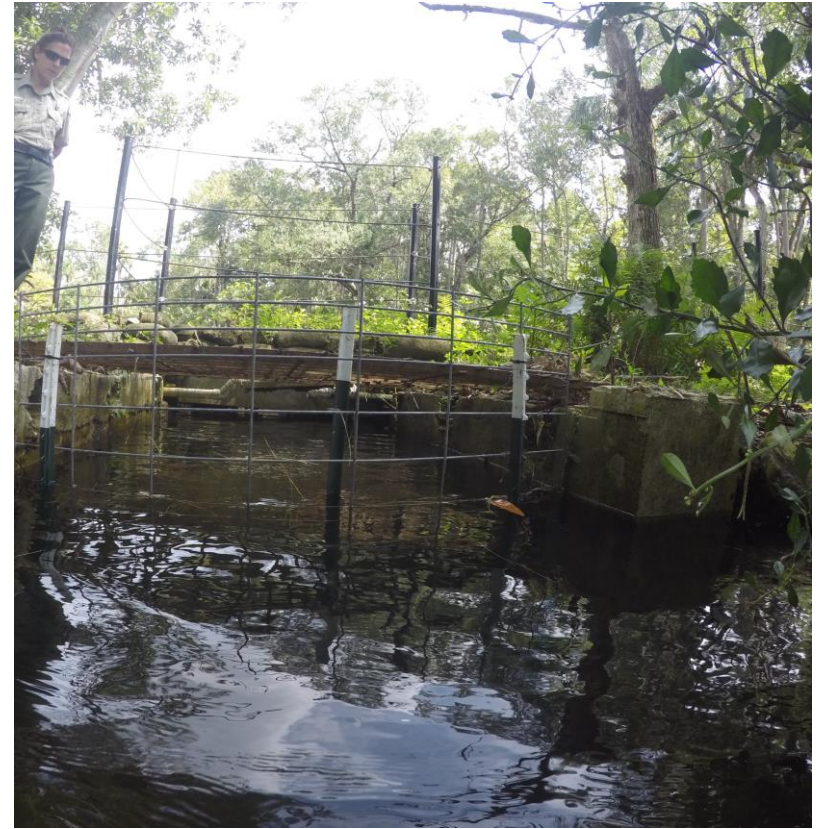
Gate #1, View From Spring  
Temporary panel installation 10-7-17

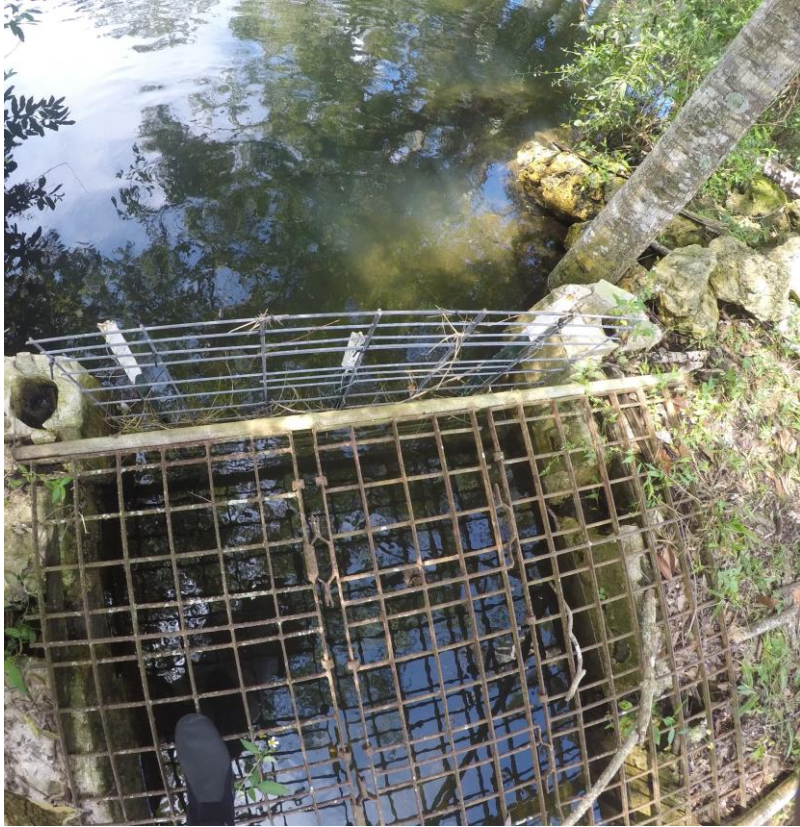
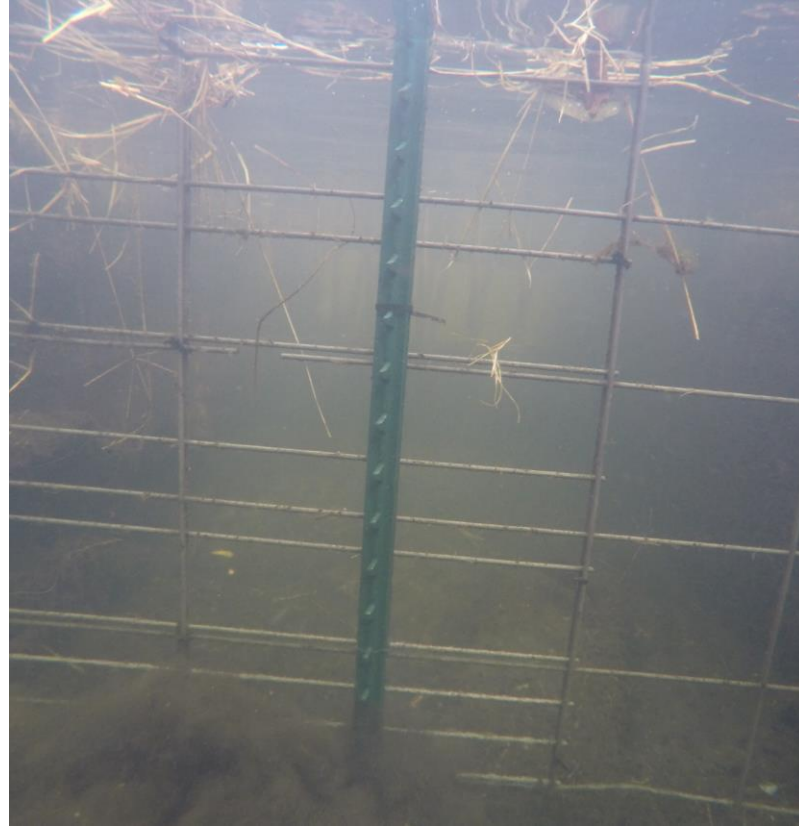
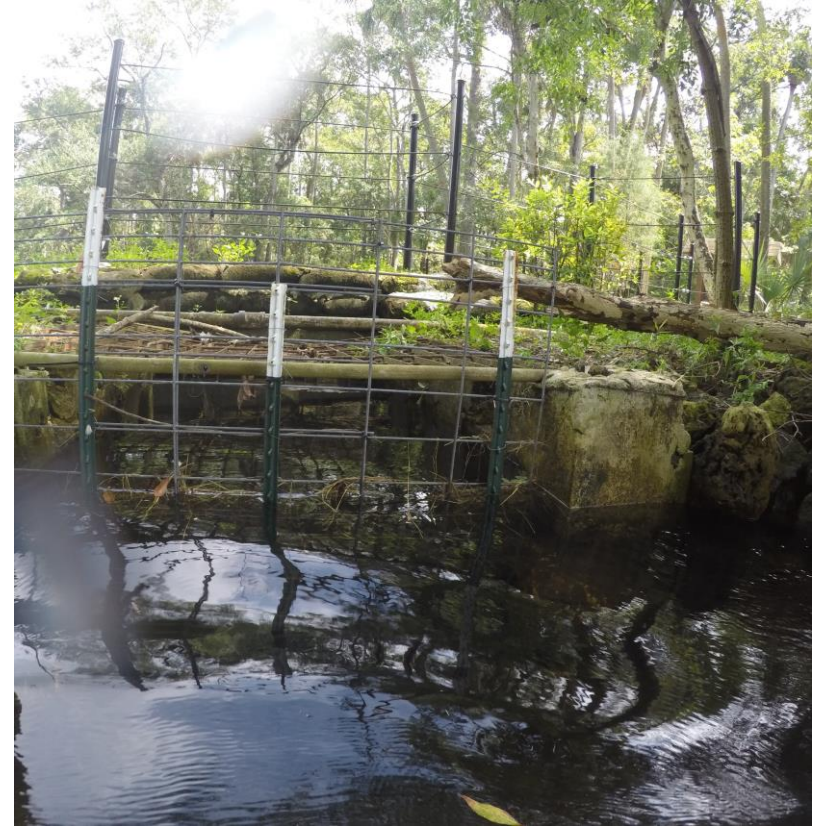
Gate #2, View From Spring  
Temporary panel installation 10-7-17

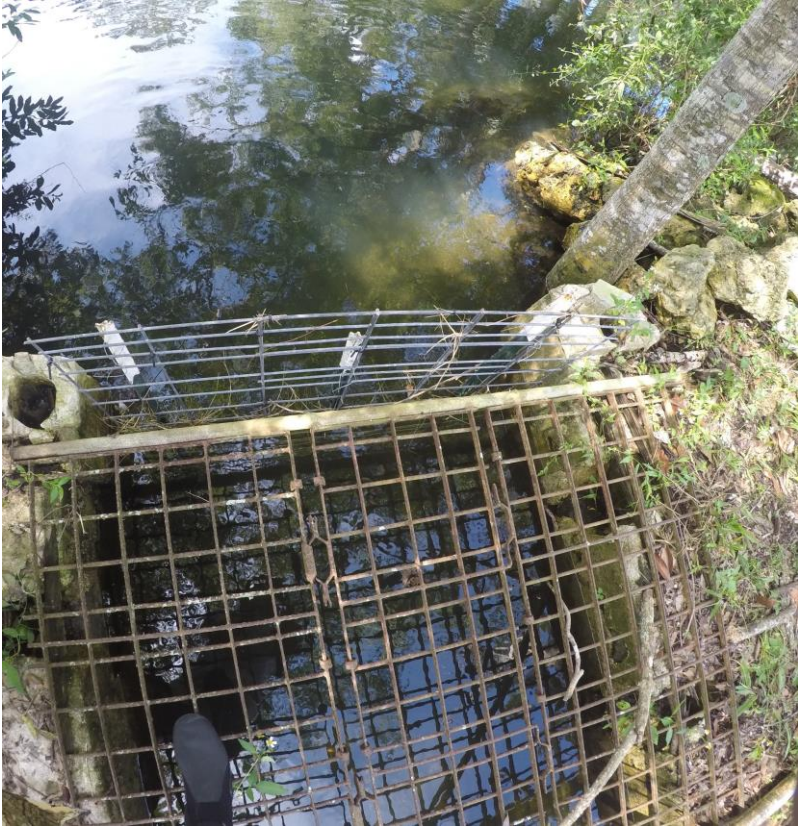
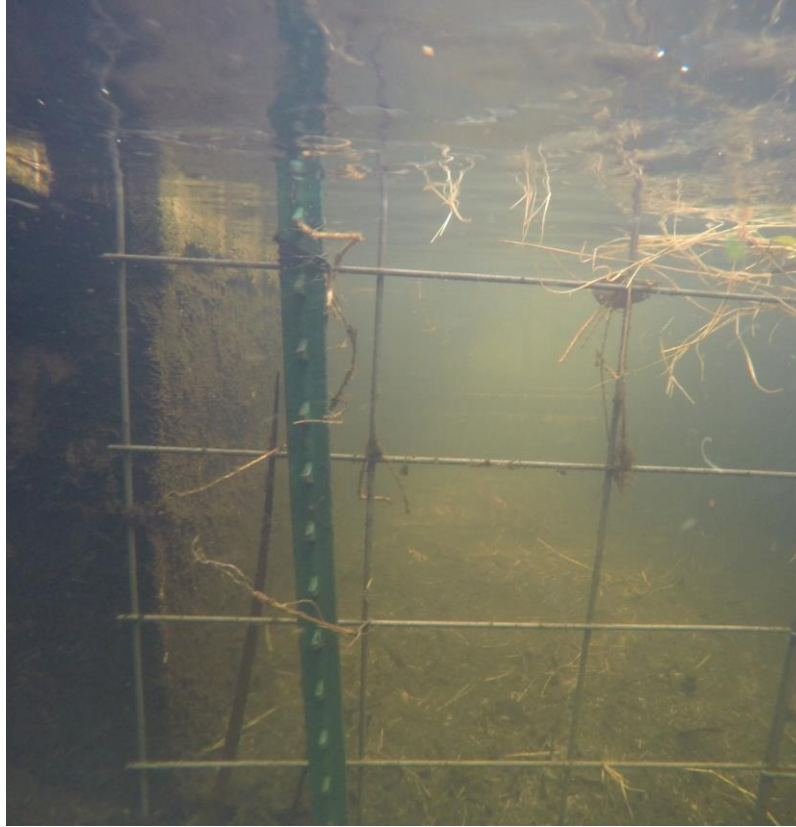
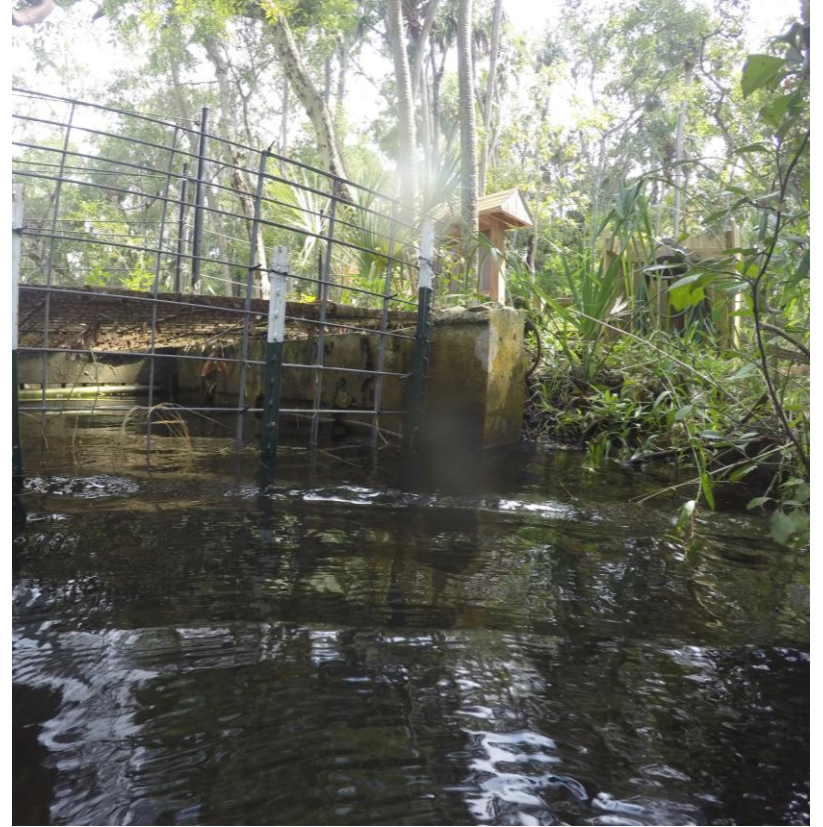
Gate #3, View From Spring  
Temporary panel installation 10-7-17

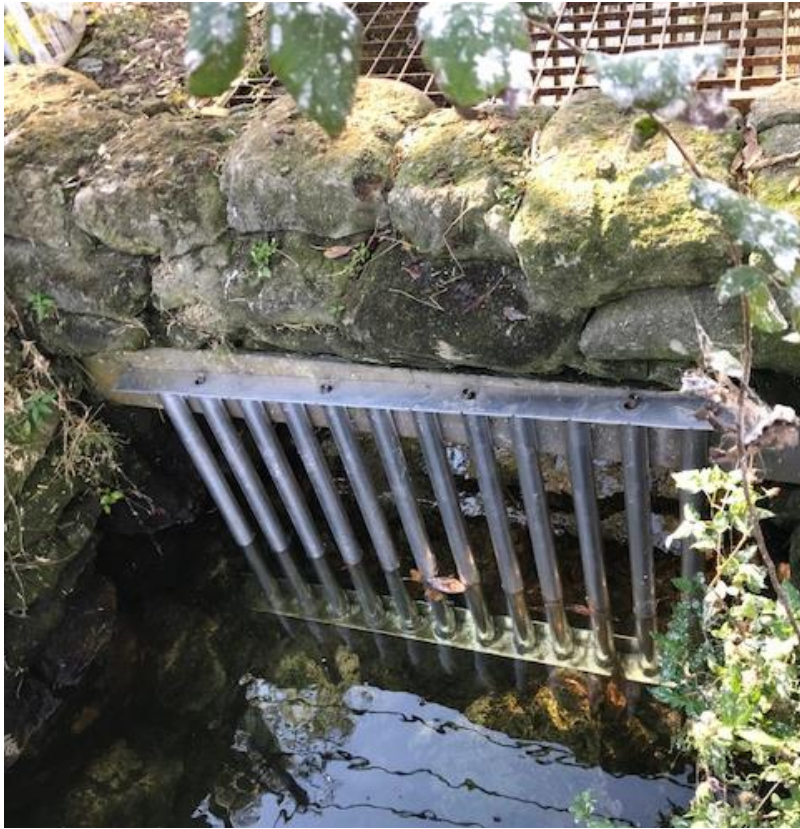
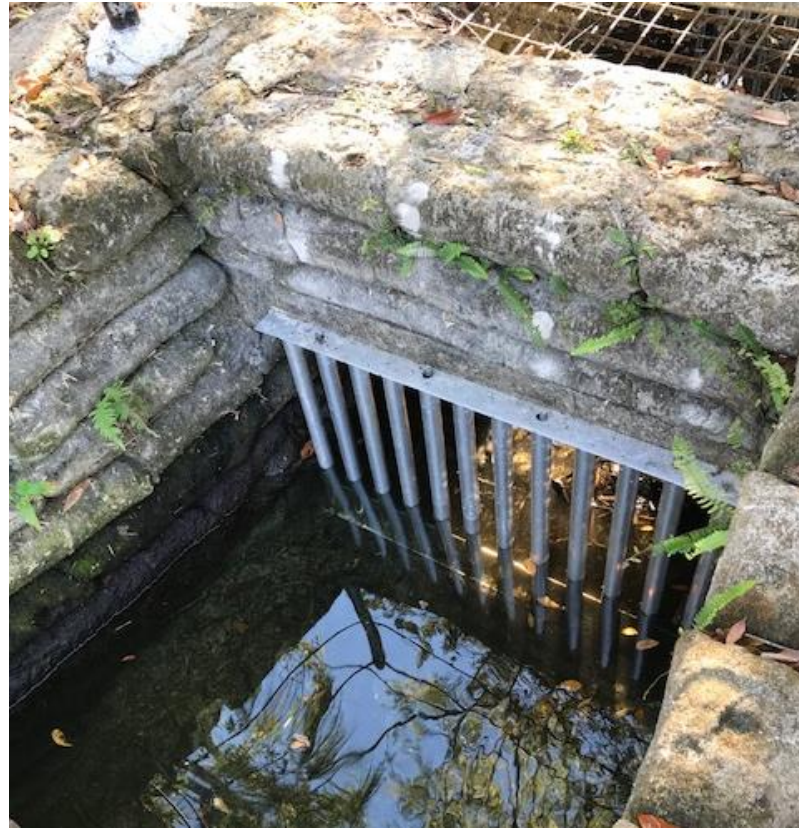
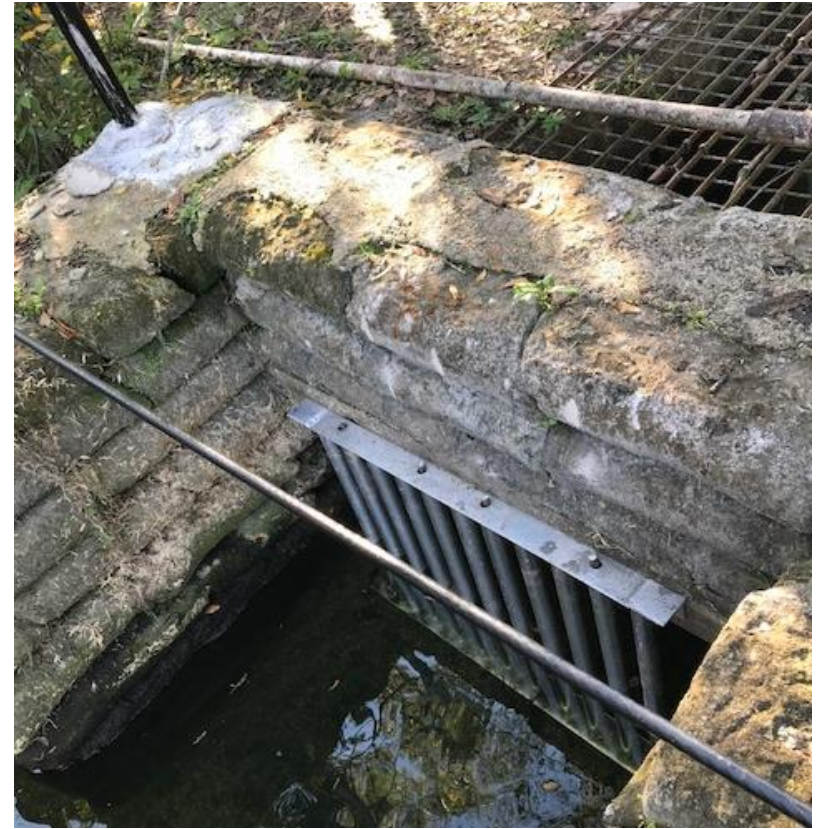
View From Hippo Enclosure Side  
Weir panel installation in December 2017

- In December, the new grates were installed on both sides of the Weir System (see photo pages 7-8). The new grates are made of 6101t Aluminum Construction Grade. The bars are 1 7/8" thick schedule 40 pipe, 0.14" thick with a tensile strength of 37,000 LBs and a deflection of 30,000 LBs. The angle is 2"x2"x1/8" with a tensile strength of 45,000 lbs. The bars are spaced no greater than 2 1/2" apart. In addition, the new weir bars have been reinforced with 5/8" steel rebar by running the rebar through the aluminum and driven into the river rock 3-4feet. To further reinforce the Spring side of the Hippo Habitat and prevent any digging under the bar systems in the times of flood, two courses of concrete bags were added and all anchored with 5/8" steel rebar in 8-10" sections. The park is currently awaiting a final review from USDA on the Weir System improvements.

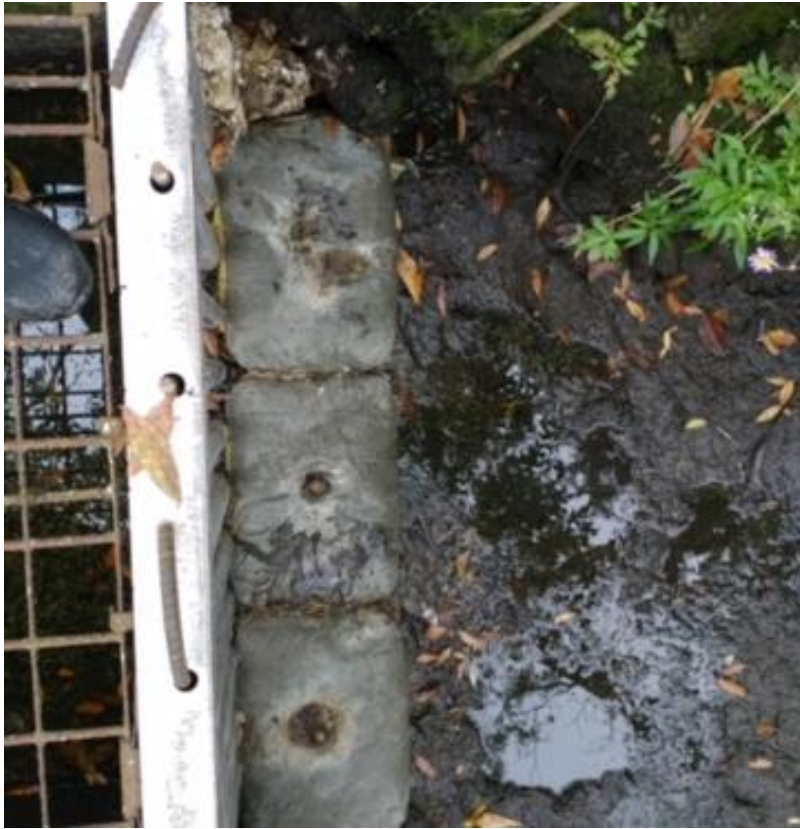
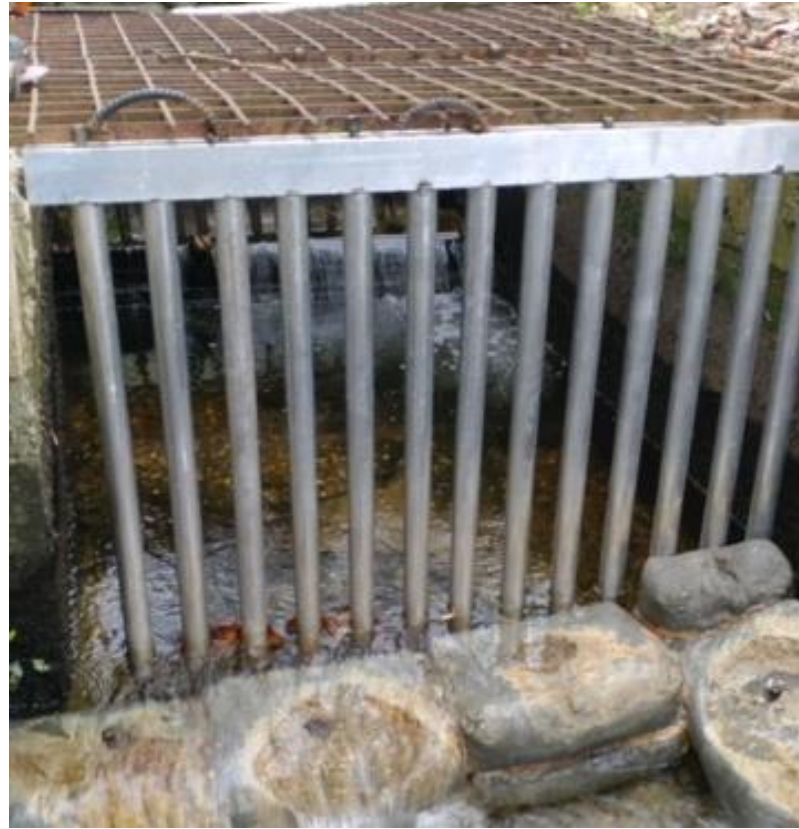
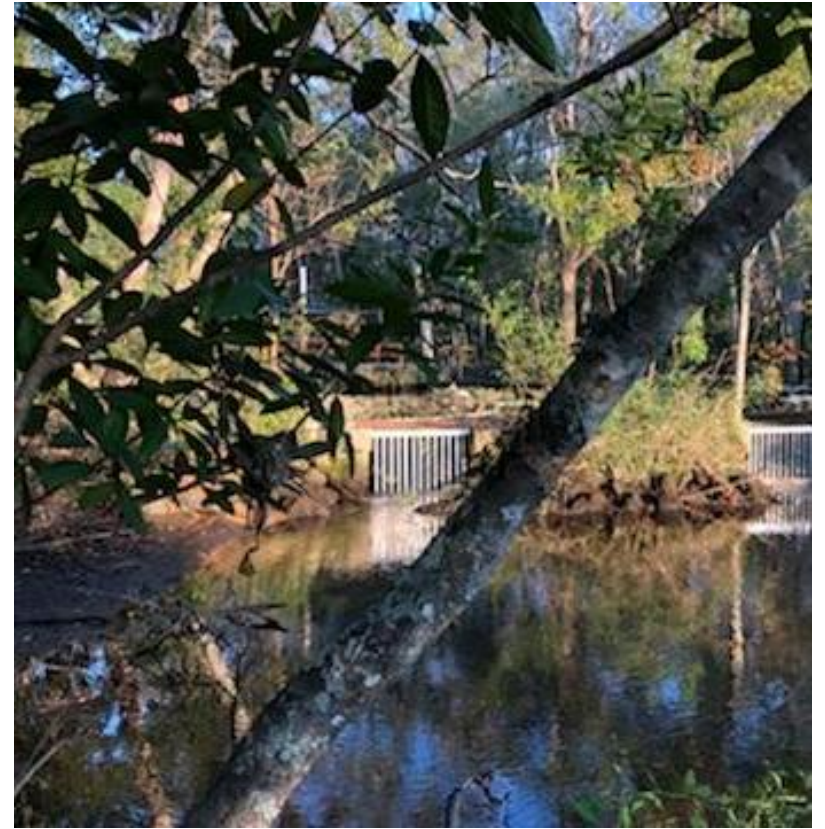
View From Spring Side  
Weir panel installation in December 2017
