October 29, 2015

***Sikeston R-6 School District
Preliminary Earthquake Findings & Observations***

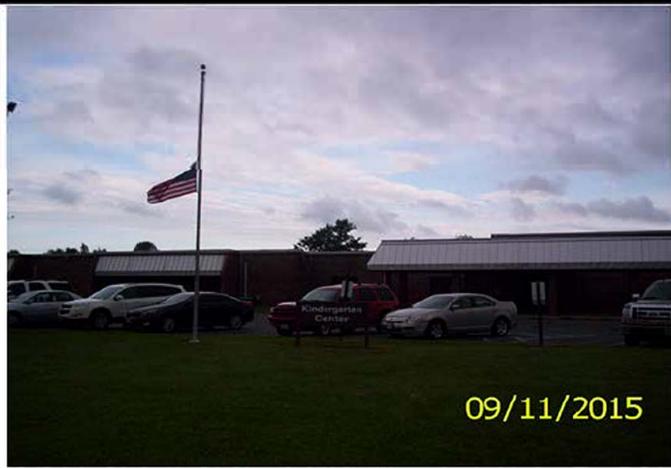
- Falling hazard at interior fire wall, CMU partition walls
- Book case not secure to wall
- Lights safe-tied

Comments: Bookcases unrestrained. CMU partition walls not braced OOP. Metal roof deck attachment to perimeter CMU parallel to roof joists very questionable.

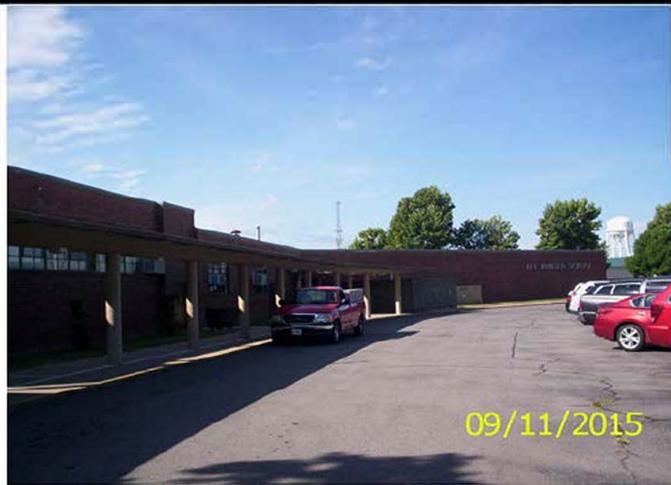
COMMENTS:
- Roof appears to be lite gypsum on bulb-tees.

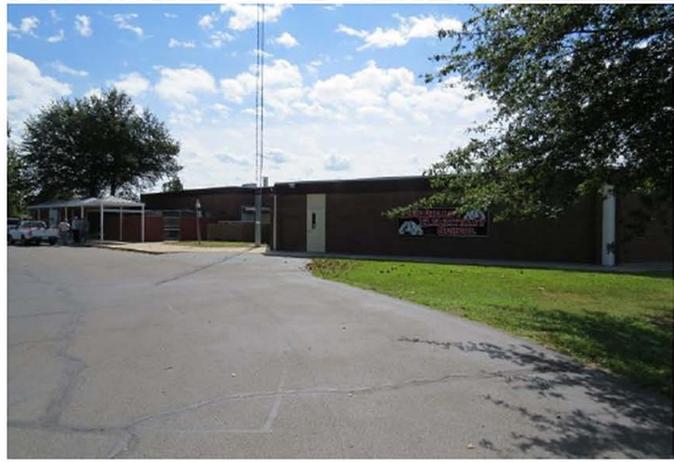
COMMENTS:
- Natural gas boiler, water heater & stove unanchored
- Interior bookshelves unanchored
- Lights anchored to structure
- Office area w/unanchored bookshelves, file cabinets & copy machines
- Unanchored items near egress

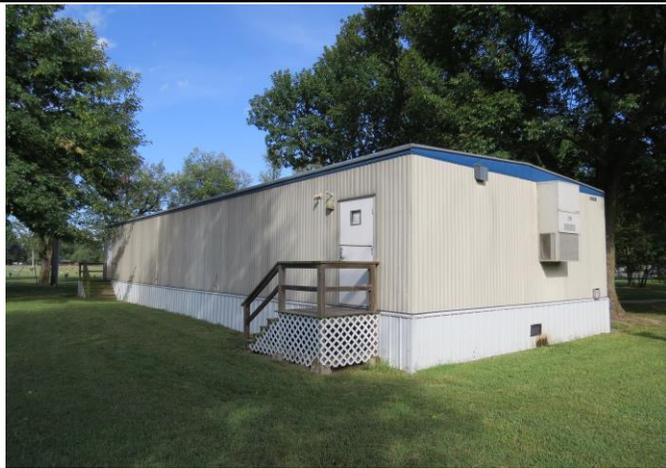
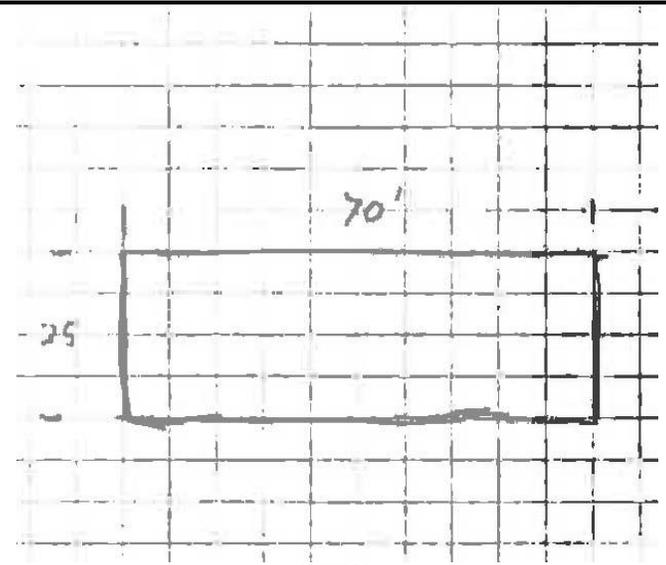
COMMENTS:
- Interior contents are tables w/computers
- Hard ceilings
- Contact indicated there was supplemental anchorage – likely wind straps

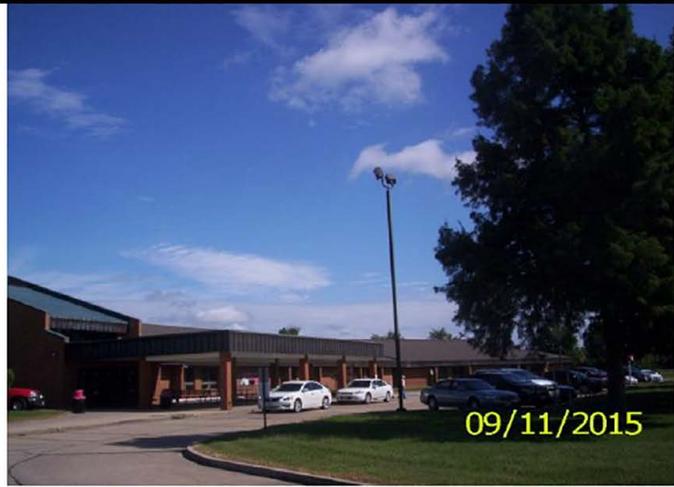
Comments: Lights sampled safe-tied. CMU partition walls not restrained OOP. Book cases, storage cabinets and electric water heater unrestrained.

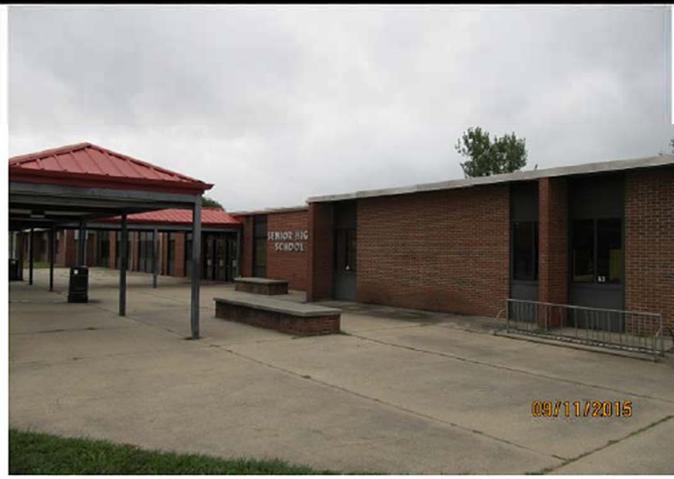
Comments: Gas header unbraced. Gas kitchen equipment unrestrained.

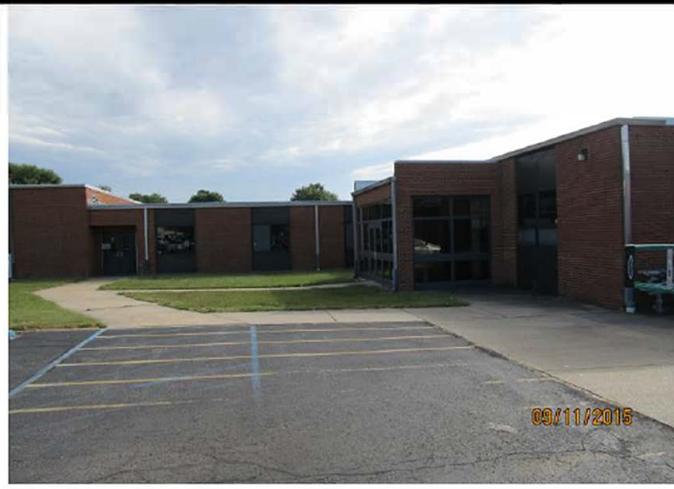
Comments: Tall storage cabinets UA. Boilers UA. Gas hot water tanks UA. Generally pretty clean in classrooms. Halls nice & clear.

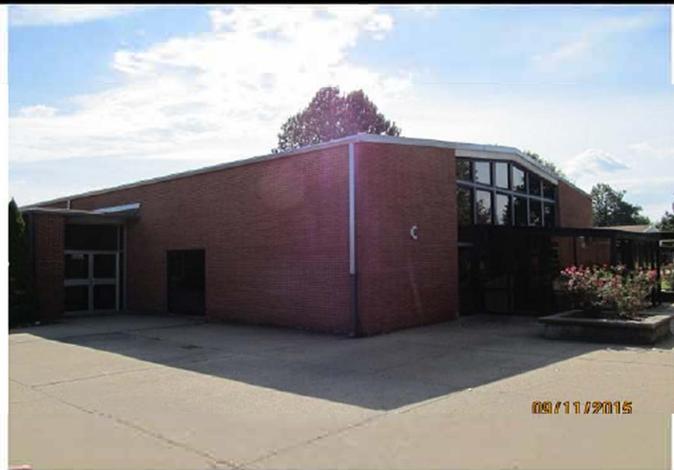
Comments: Minor interior contents, tall unrestrained bookshelves near classroom exists. Other small misc. contents as well. Generally clear.

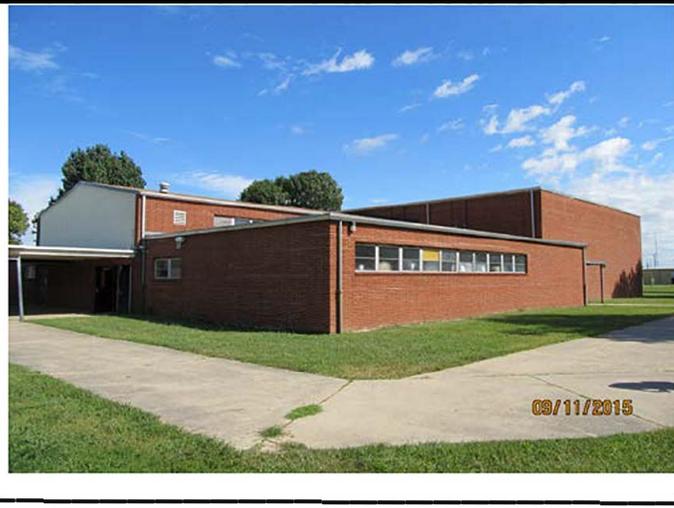
Comments: Minor issue with masonry interior partition walls.

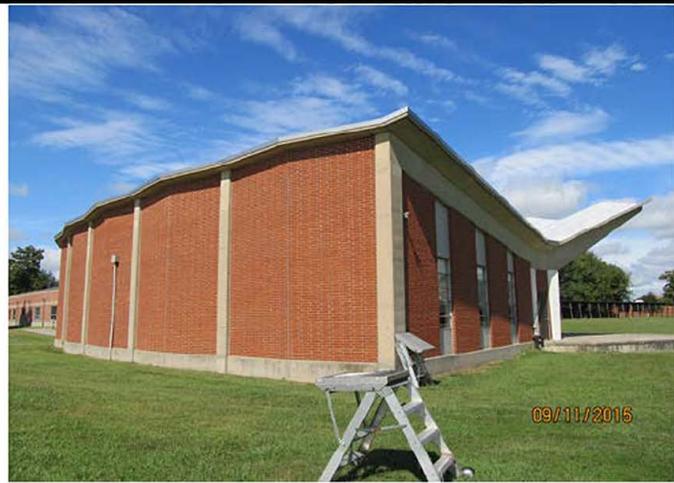
Comments: Shelving on wheels, locked at back of room. Shelving, tall, unrestrained to walls. CMU partition walls with no OOP bracing.

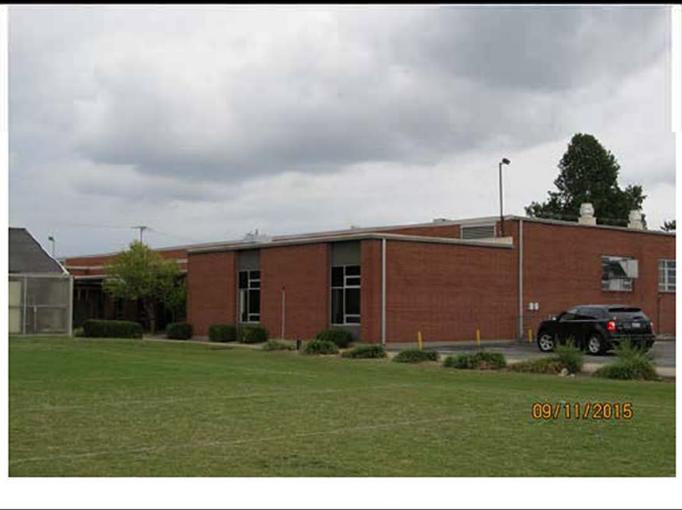
Comments: Hard drywall ceilings & suspended. Tall URM CMU partition walls. Questionable girder end connection to Brg wall. Inadequate gas bottle chain Supts.

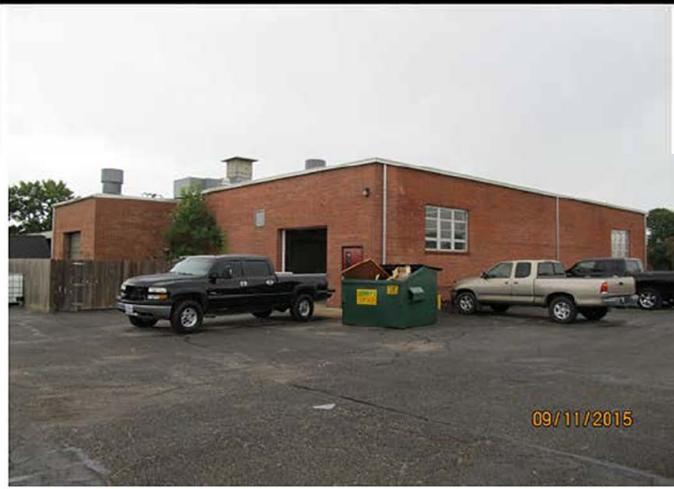
Comments: Overhead HVAC units without bracing. CMU partition walls unreinforced. Parts storage shelving unrestrained.

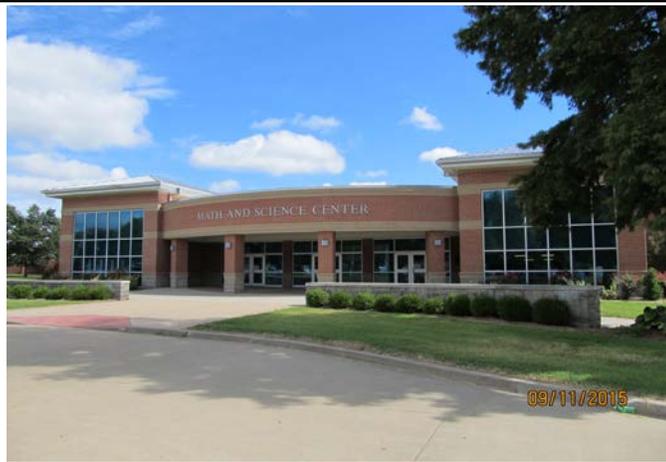
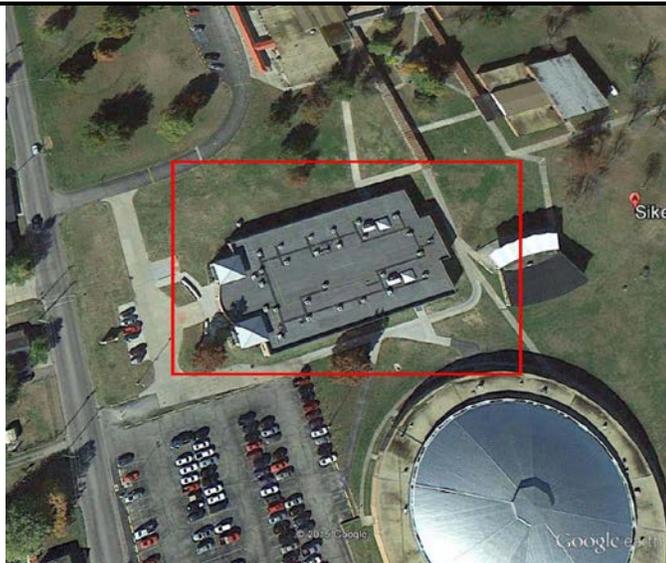
COMMENTS:
 - 2003 IBC
 - SE; Tahiliani Assoc., Memphis TN
 - Seismic '96 BOCA
 $A_v = 0.280$ $A_a = 0.264$
 Sheg = Group 1 ; SPC = D
 Soil type = S2
 Concentric steel braced frame
 Brace gussets detailed per buckling criteria

Comments: Lights safe-tied. Ceiling unbraced. Metal stud partition walls full height. Sprinkler braces attached to bottom of joist chords OOP. Chemical shelves restrained.

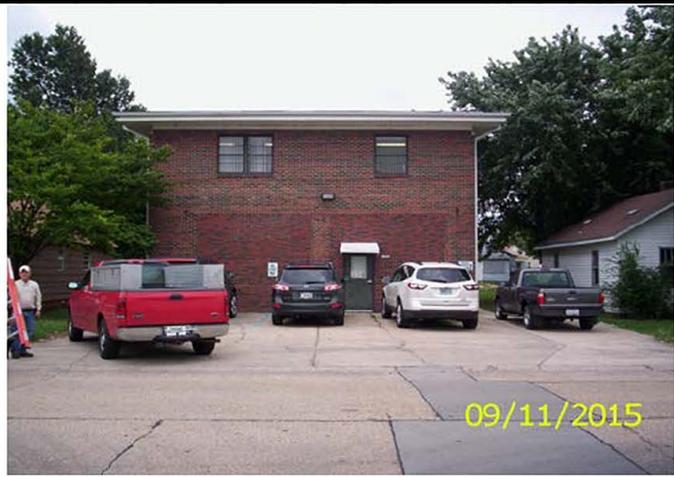
Comments: Lower level appears to have been a garage, but has been infilled.
