# Aviation Investigation Preliminary Report

| <b>Location:</b> | Hartsburg, MO | <b>Accident Number:</b> | CEN24FA160 |
| <b>Date &amp; Time:</b> | April 16, 2024, 12:05 Local | <b>Registration:</b> | N451MA |
| <b>Aircraft:</b> | PIPER AIRCRAFT INC PA 46-350P | <b>Injuries:</b> | 1 Fatal |

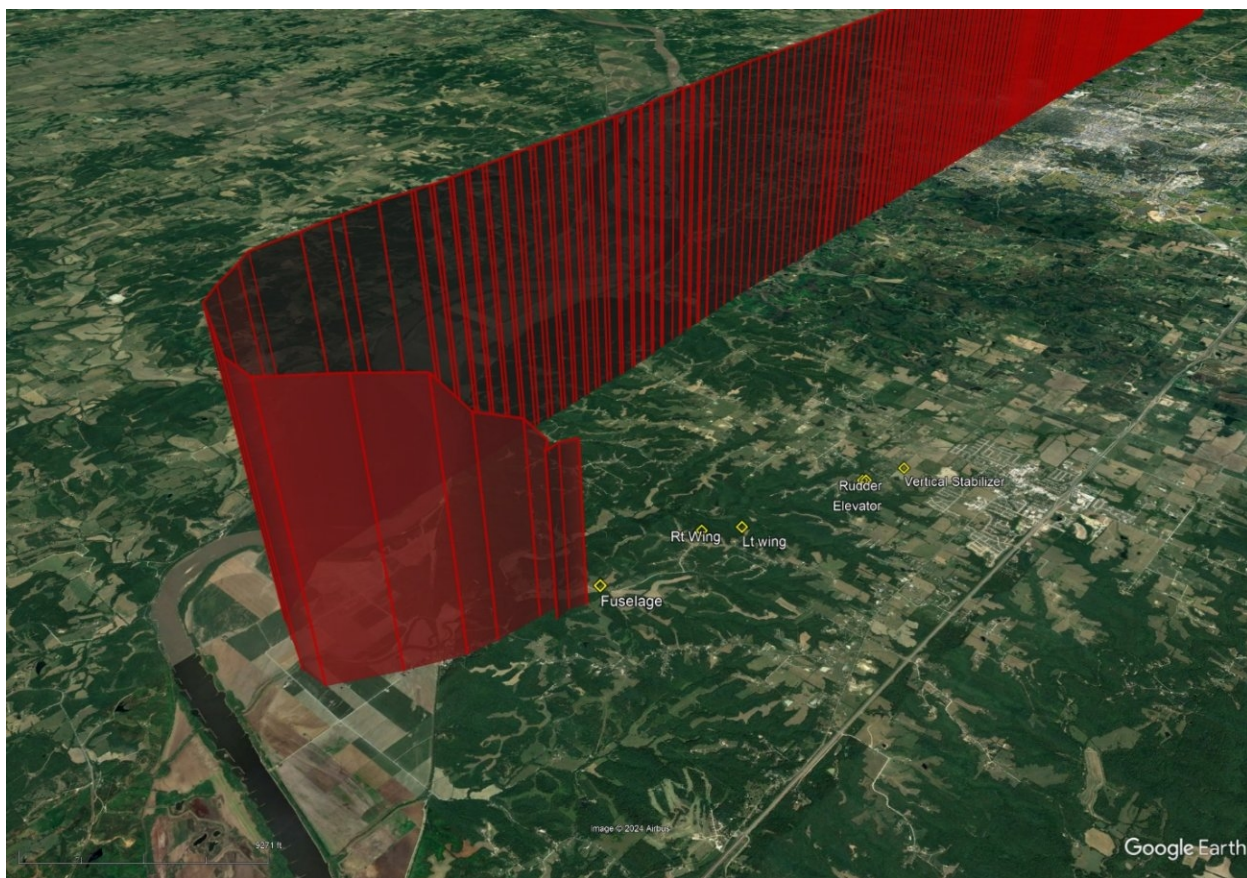
Review of flight track data provided by the Federal Aviation Administration (FAA) revealed that after departing MSN, the airplane turned to the southwest and climbed to about 16,000 ft mean sea level (msl). The airplane's course was a direct line to SLG. The airplane remained on this course and altitude until 1149 when it turned left to a south-southeast direction, and a few minutes later made a right turn to the south. The airplane continued south until 1204 when it entered a descending left turn. At the end of the data, the airplane was heading north and had descended to about 9,400 ft msl. The calculated descent rate during the final portion of the turn was more than 16,000 ft per minute. The airplane's fuselage came to rest about 0.14 nm north of the last in-flight recorded position of the airplane.

FIGURE 1. Plot of the final portion of the airplane's flight path.
