MARYLAND DEPARTMENT OF THE ENVIRONMENT

Report of Observations

Type of Observations: Site investigation	Date: 12-18-2021
Site/Facility Name: DM Bowman	Facility ID #:
Address: 6816 English Muffin Way	Case #: 22-0276FR
City / County: Frederick/Frederick	Permit #:

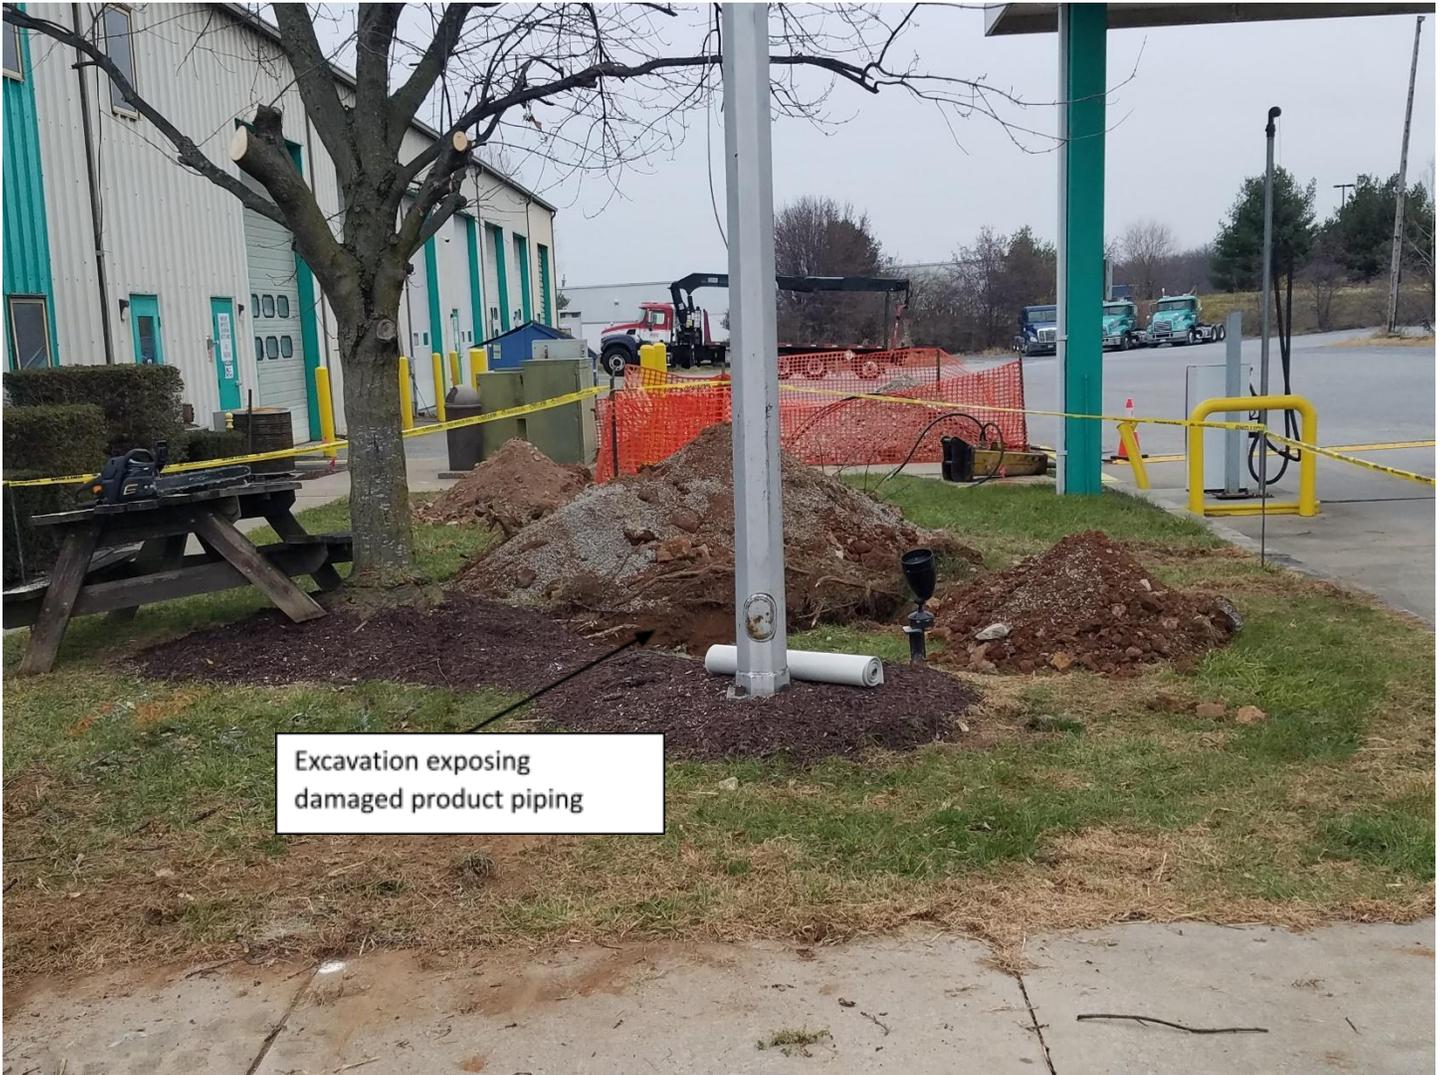
DM Bowman, 6816 English Muffin Way, Frederick- View looking north towards flagpole behind which is the excavation to expose the damaged diesel fuel product piping (running left/west to the UST and running right/east to the dispenser). Exposed bit of the horizontal drill rod is behind the flagpole near to the yellow bollards (towards large truck) in background. No visible or olfactory evidence of a petroleum release at this area of excavation on 12-18-21. Jim Richmond 12-18-21

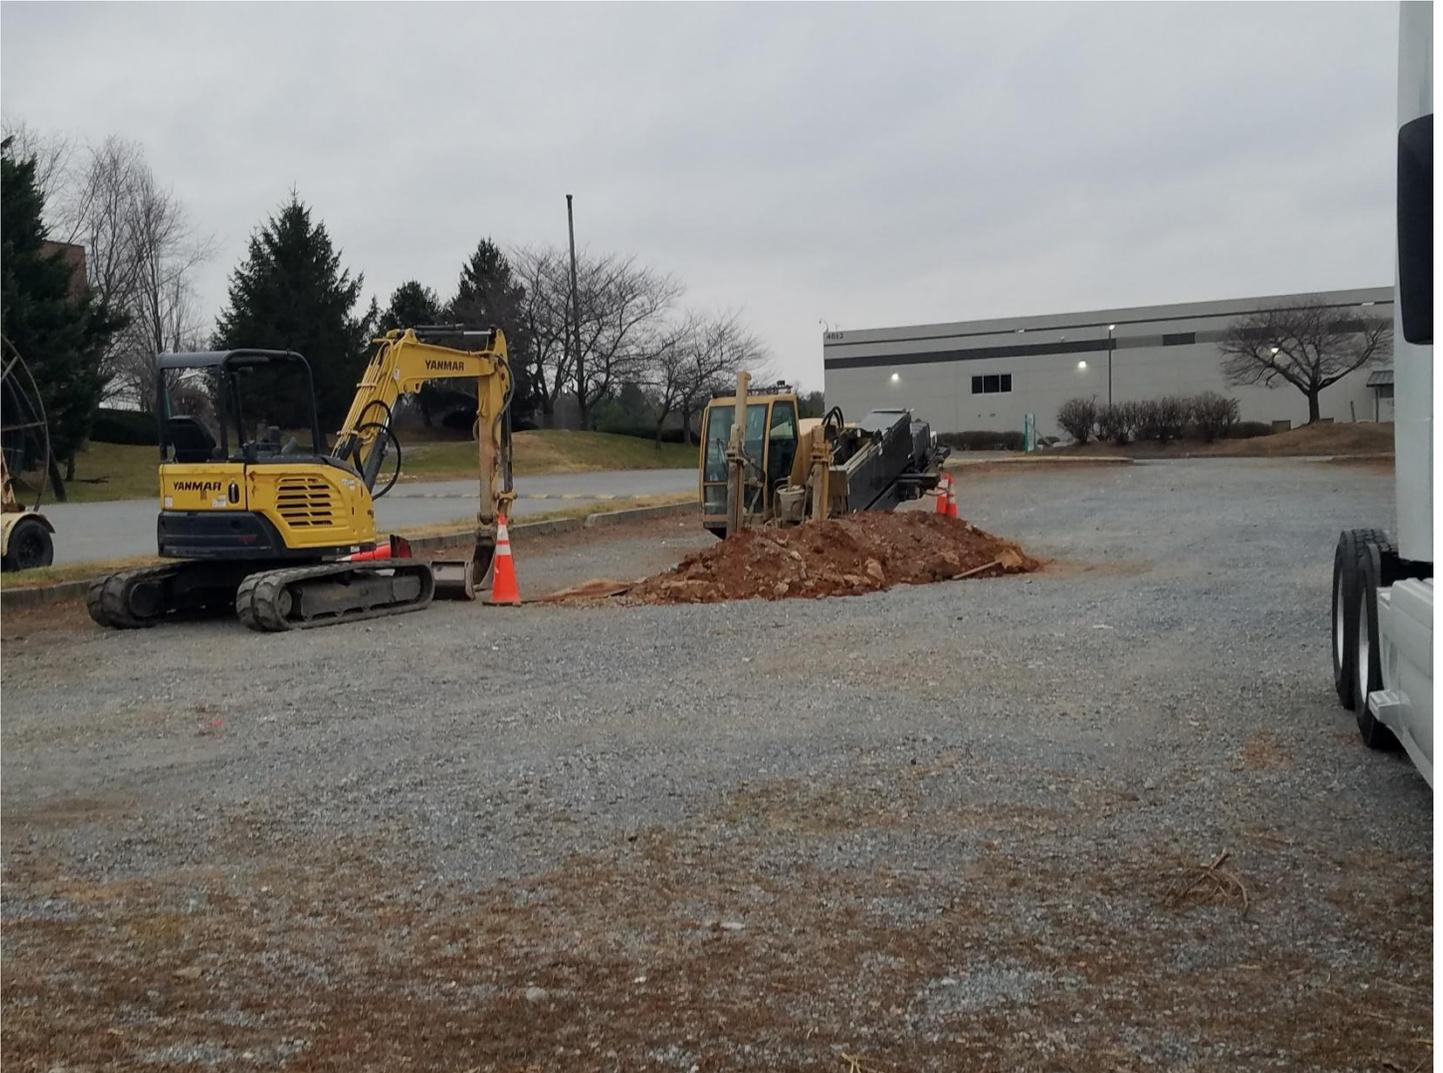
DM Bowman, 6816 English Muffin Way, Frederick- View looking south towards English Muffin Way and the machine end of the horizontal drilling equipment. No visible or olfactory evidence of a petroleum release at this area of excavation on 12-18-21. Jim Richmond 12-18-21

1. The horizontal drilling equipment remains on-site as of 12/18/21. OCP personnel must be on-site to observe the removal of the horizontal drilling rod.
2. The product piping from the dispensers to the diesel fuel UST will likely need to be replaced. OCP personnel must be on-site to observe the excavation of the diesel fuel product piping to determine if there is evidence of a release at other locations along the piping run.
3. Continue to coordinate with the OCP Compliance Division pertaining to any directives regarding the operation and maintenance of the active UST systems at this location.

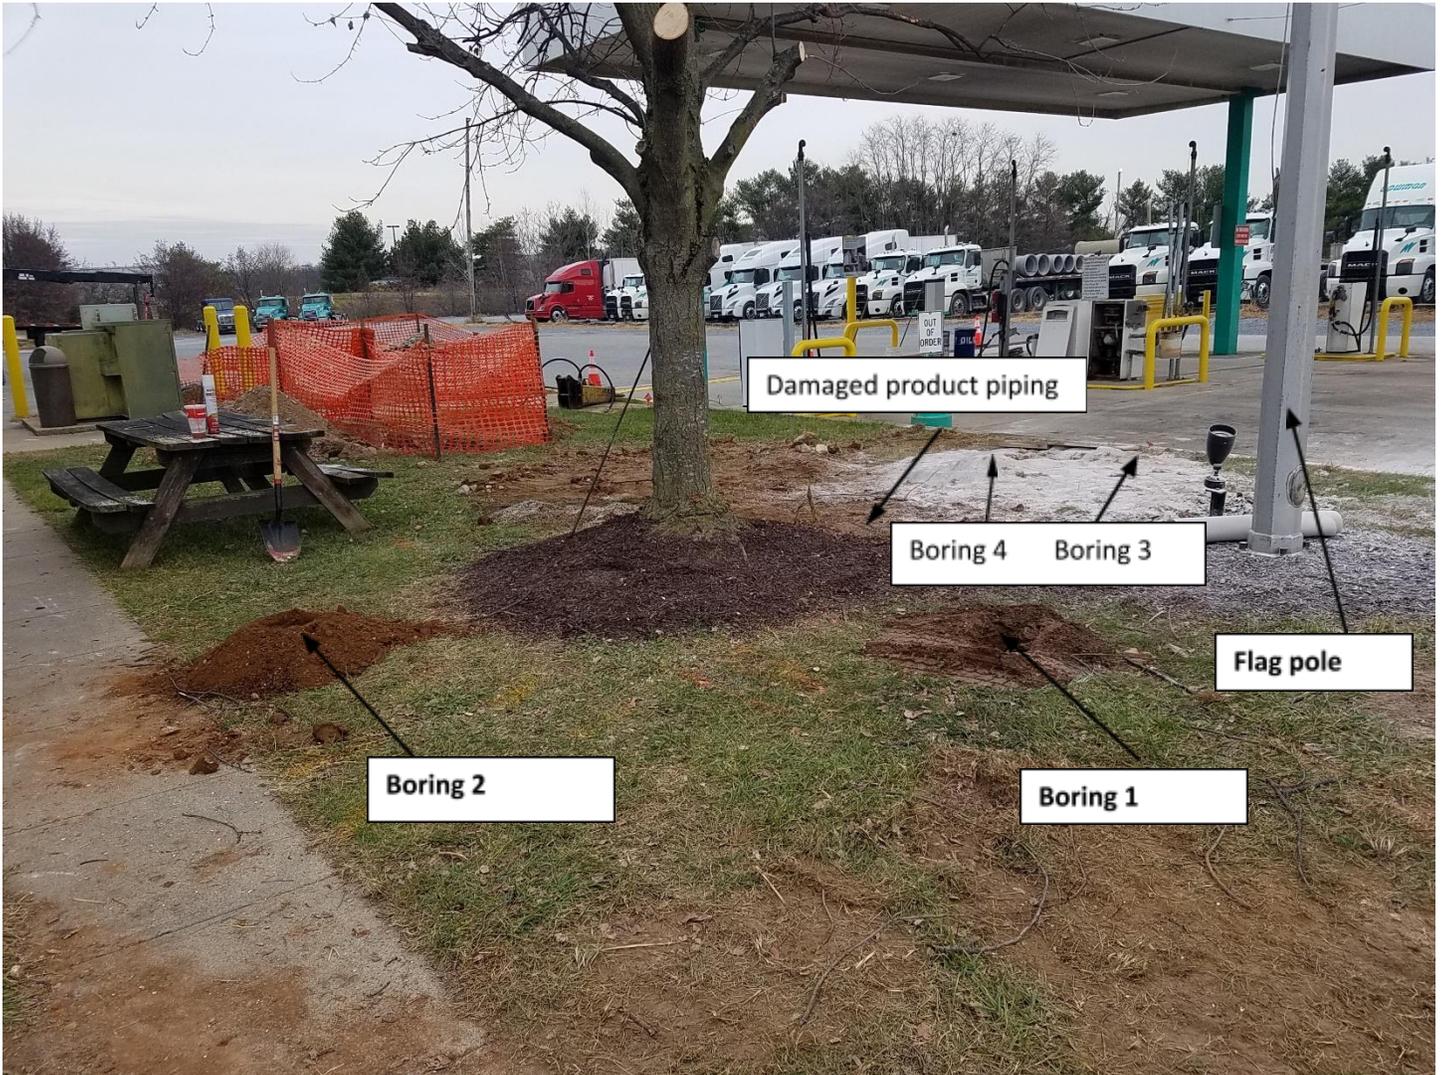
Boring 4 was installed approximately 8 feet to the northeast of the damaged piping. Using the auger rig, Boring 4 was completed to a depth of approximately 6 feet bgs. The soil profile was generally weathered rock (limestone) almost immediately below the several inches of reddish brown sand/soil. The initial boring terminated at 6 feet bgs. Neither groundwater nor liquid phase hydrocarbons were observed in Boring 4 in the 0 to 6 foot interval. It was decided to further investigate the vertical extent of petroleum impact and Earth Matters personnel switched the rig over to air rotary capability. Using air rotary, Boring 4 was extended to a depth of 23 feet 7 inches bgs (measured). The lithology of Boring 4 was limestone. Prior to leaving the site on 12/18/21, this writer used a flashlight to observe groundwater entering Boring 4- near to the bottom. Earth Matters personnel gauged approximately 6 inches of water in Boring 4 on 12/18/21. There was no evidence of liquid phase hydrocarbons observed in Boring 4 on this date. A petroleum odor was noticeable in the water when the interface probe was removed. Boring 4 was left as an open borehole and the area secured. **OCP personnel will return to the site on Monday December 20, 2021 to gauge Boring 4 to check the depth to water/depth to product (if encountered).**

DM Bowman, 6816 English Muffin Way, Frederick- View looking north towards dispenser area No visible or olfactory evidence of a petroleum release with the exception of petroleum odors in groundwater in Boring 4 and in the open excavation that exposed the damaged product piping. Jim Richmond 12-18-21

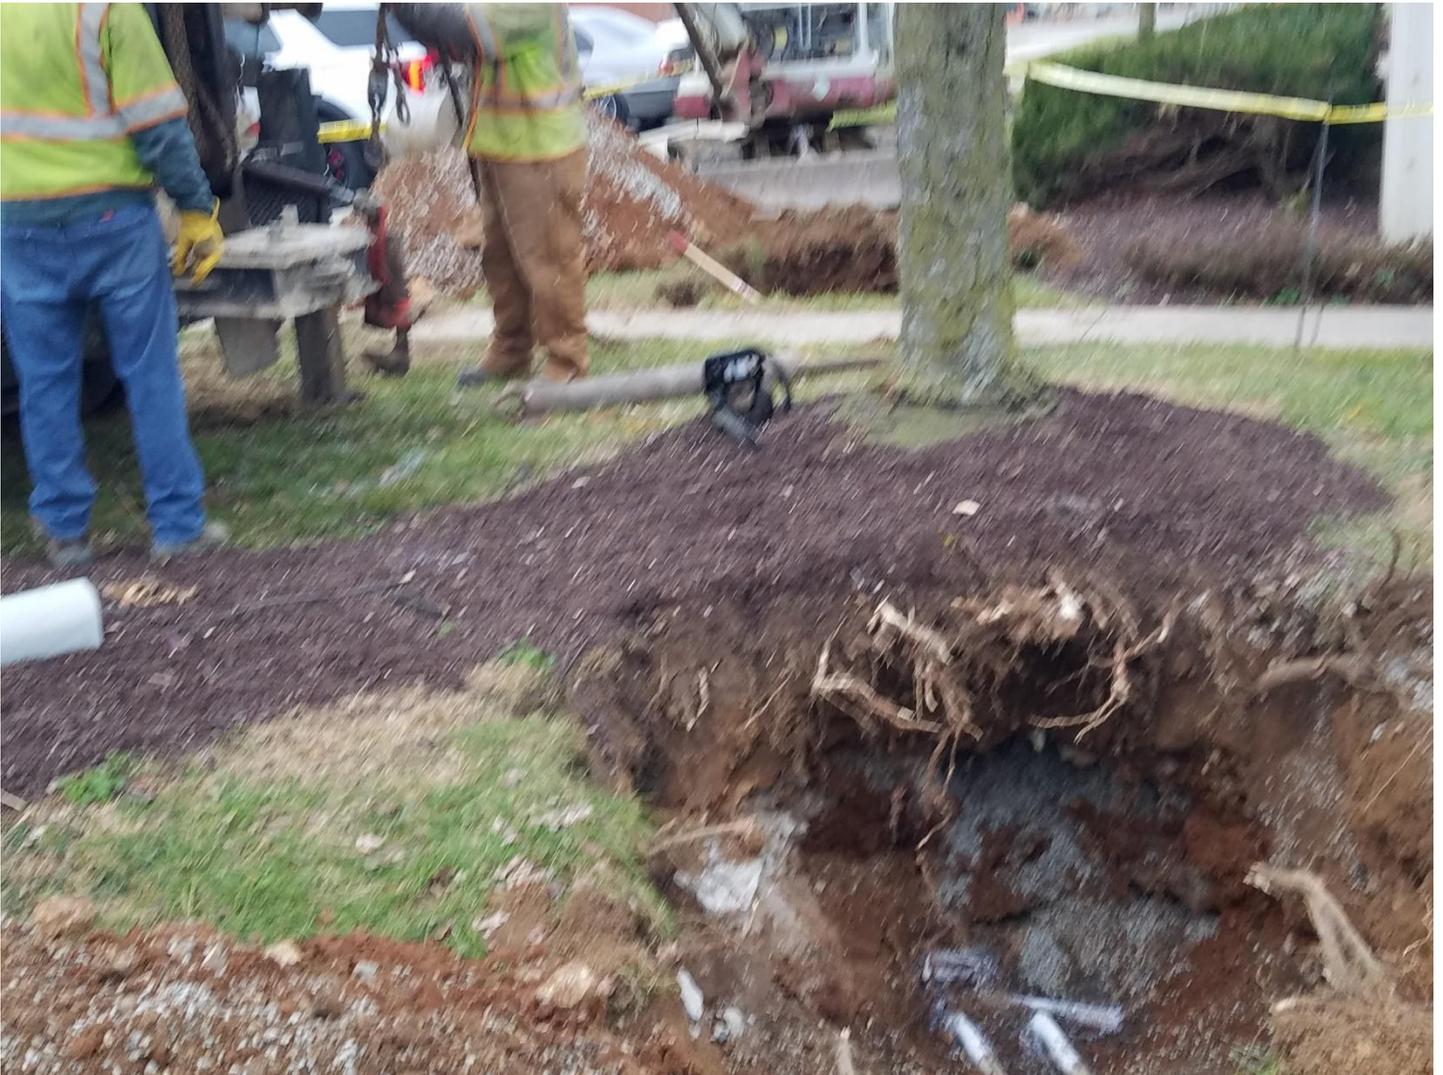
On 12-17-21, several test pits were excavated (this writer was not on-site) in the area of the release including the exposure of the broken product piping with the horizontal drill visible (picture taken by this writer on 12/18/21). An area near the drill rig was excavated (picture 12/18/21). An area near the electrical transformer has also been excavated and exposing the bit of the horizontal drill (picture 12-18-21). The areas of excavation were generally completed to depths ranging from 3 to 5 feet bgs. This writer did not observe any liquid phase hydrocarbons in the referenced areas of excavation. This writer noticed a slight petroleum odor in the excavation exposing the damaged product piping/horizontal drill rod. **The depth of the damage piping was measured at 4.5 feet bgs on 12/18/21.**

DM Bowman, 6816 English Muffin Way, Frederick- View looking at the exposed damaged product piping adjacent to the horizontal drilling rod at a depth of approximately 4.5 feet bgs. Olfactory evidence of a petroleum release noted on 12-18-21- no liquid phase hydrocarbons observed. Jim Richmond 12-18-21

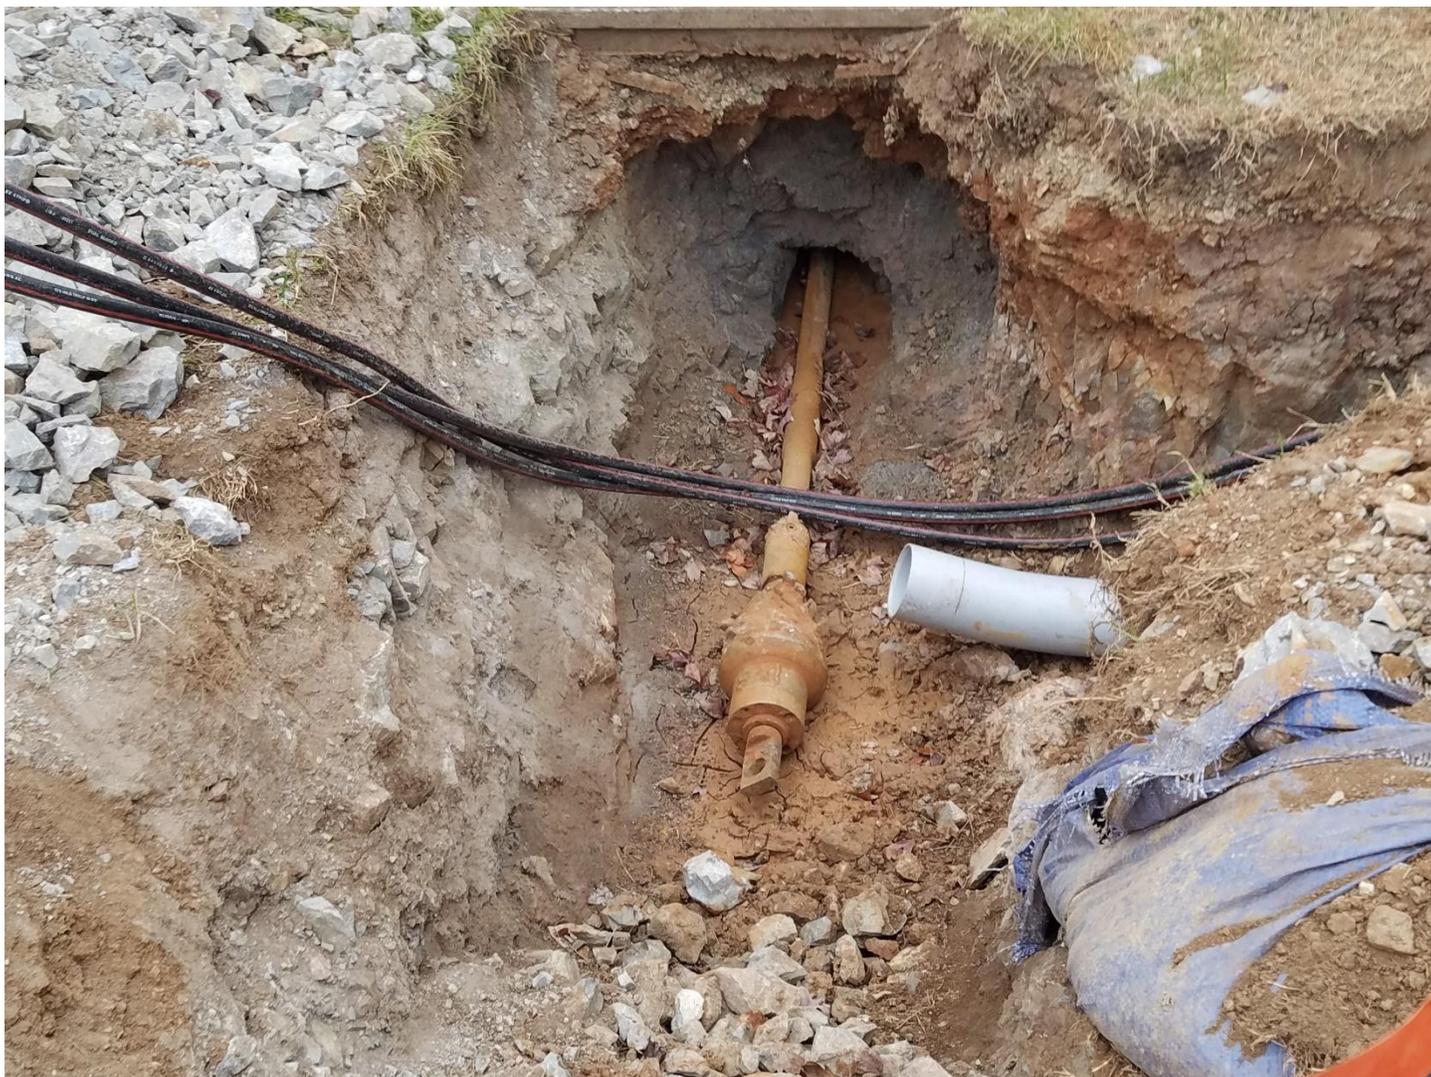
DM Bowman, 6816 English Muffin Way, Frederick- View looking generally south – this is the bit of the horizontal drill that is exposed near to the electrical utility box. No visible or olfactory evidence of a petroleum release at this area of excavation on 12-18-21. The limestone rock is visible on the left side of photo.
