RE: Corrective Action Plan for Rock Spillage at Snyder  
Quarry.

Your file NO.: M-77-210

## CORRECTIVE ACTION PLAN

### SNYDER QUARRY

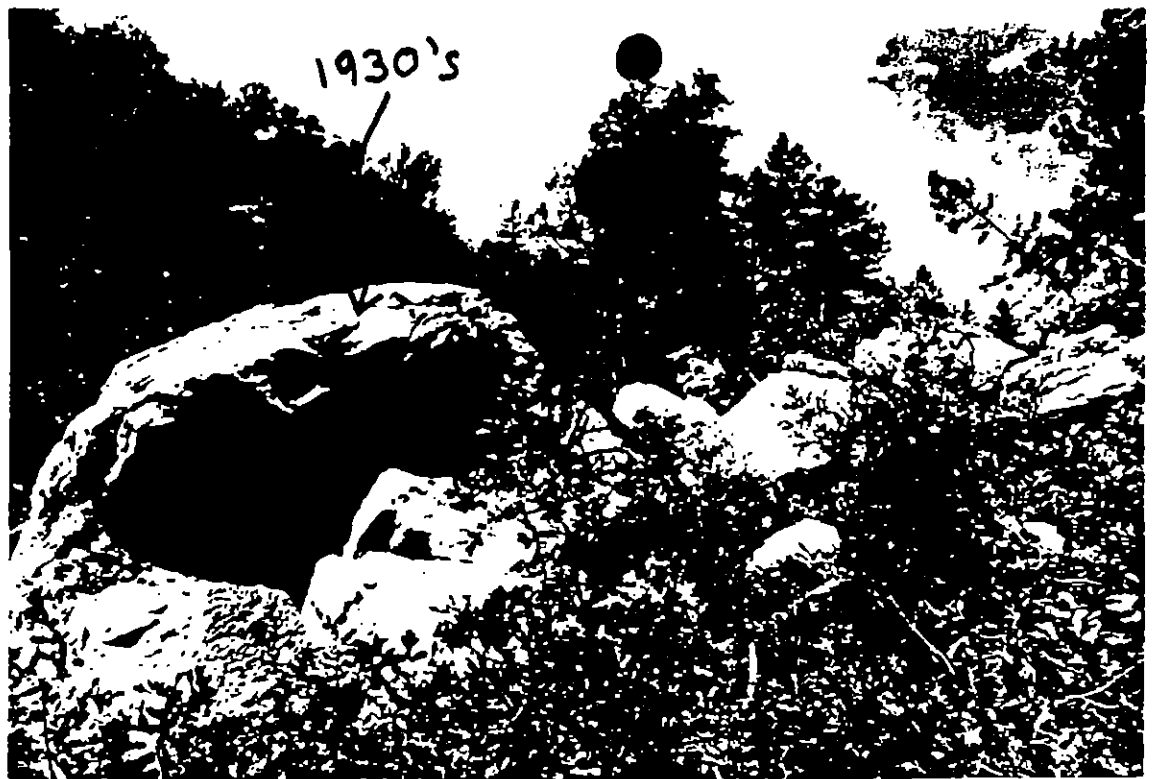
Near the top of the drainage a number of moderate to large rocks were noted just below the mining limit but at least 200 feet inside the permit boundary. These rocks were already known to exist and when Phase 1 nears completion it was planned to remove these rocks and any trees which had died as a result of damage. One very large, old rock (indicated by the dark gray color and the grass growing in cracks) on the side of the hill was noted to have a drill hole in the side of it. However, the dimensions of the hole was too small to have been produced by Castle Concrete. Therefore, it appeared this large rock had fallen to this location during previous mining, probably during the 1930's when excavations occurred above this area. It became clear, as a result of this find, that at least three classes of rocks would be found.

PHOTO 4: ROCKS LOCATED NEAR PHASE 1 BOUNDARY. OLD 1930'S ROCK IS NOTED. REST OF ROCKS ARE RECENT.

However the large rocks and any damaged trees which are located near the mining limit will be removed as this would not cause severe damage to areas which have not already been affected by nearby mining. This cleanup was planned to be done prior to leaving the Phase 1 area anyway and therefore could be considered as

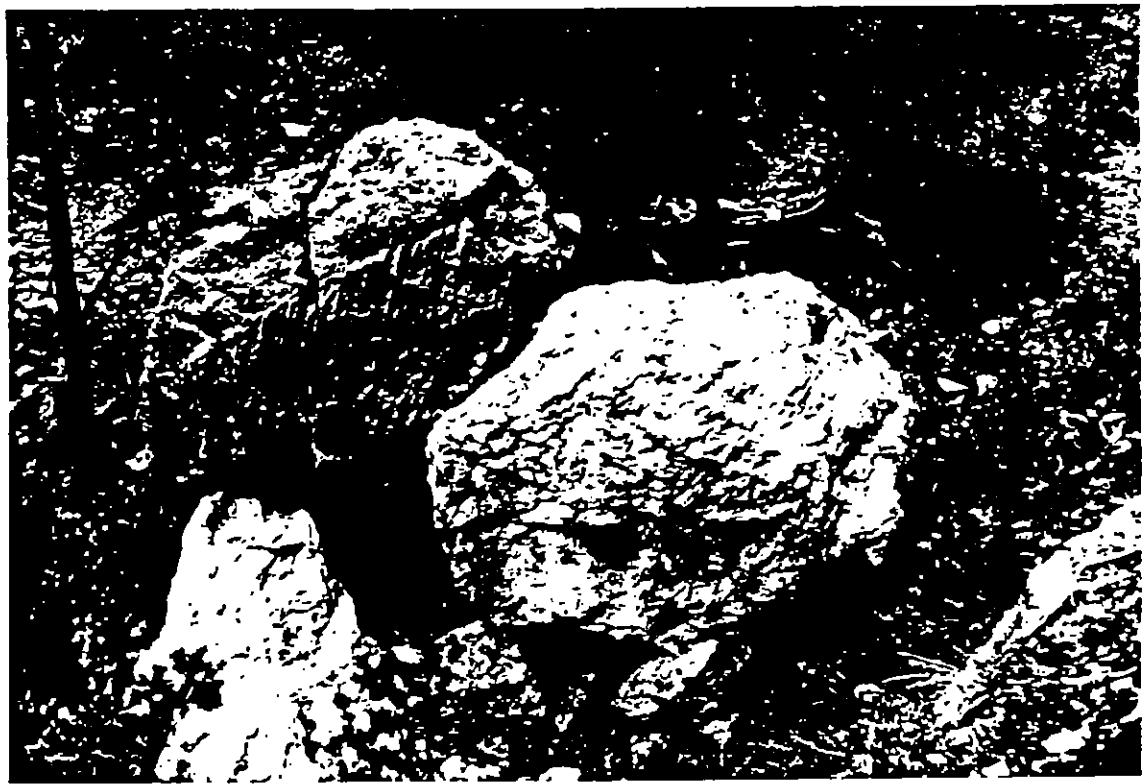
PHOTO 6: RECENT ROCK LODGED UNDERNEATH OLD ROCK. NOTE SHRUB GROWING OUT THE TOP OF THE OLD ROCK.

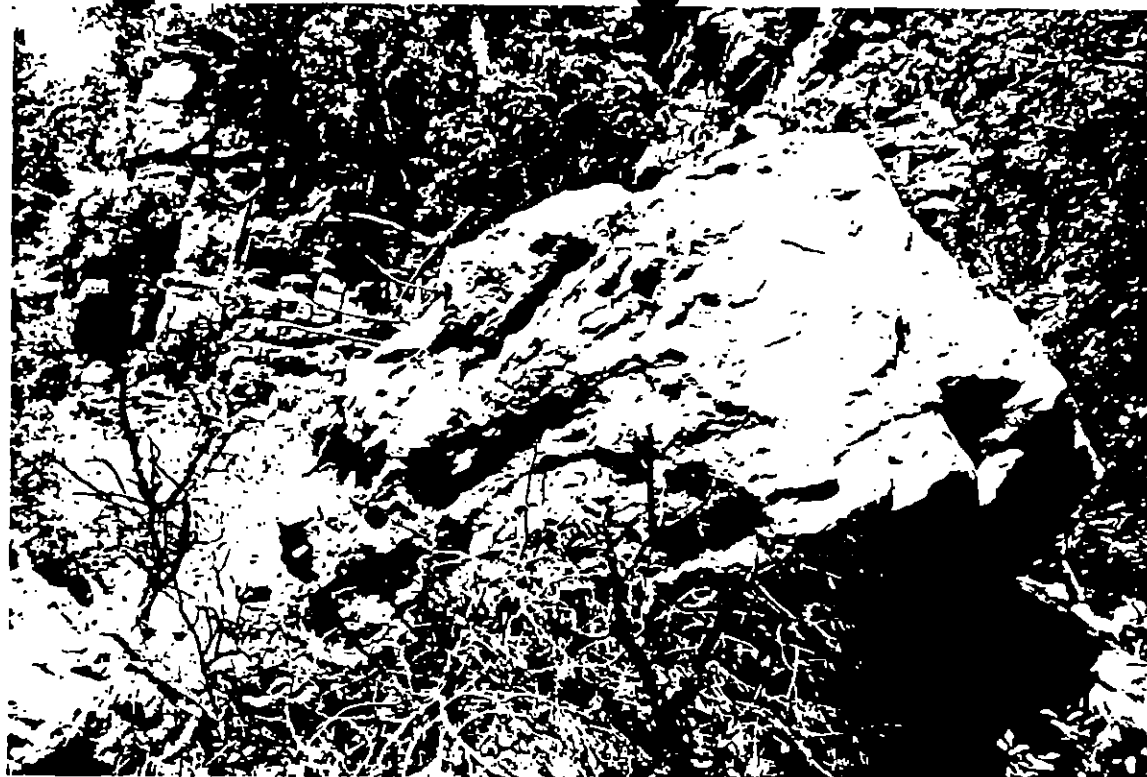
Further down the drainage the zone of large boulders abruptly ends, except for one large rock which rolled down the drainage to a location about 50 feet on to Cave of the Winds property. It is estimated this rock weighs between 5 and 10 tons.

PHOTO 8: VIEW OF ROCK ON CAVE OF THE WINDS  
PROPERTY. ROCK ESTIMATED AT 5 TO 10 TONS.
