# COLORADO GEOLOGICAL SURVEY

April 19, 2019

**Subject: Gold Hill Mesa Filing No. 11,  
Final Plat-AR FP 19-00201; and Development Plan-AR DP 19-00198;  
City of Colorado Springs, El Paso County, CO; CGS Unique No. EP-19-0132**

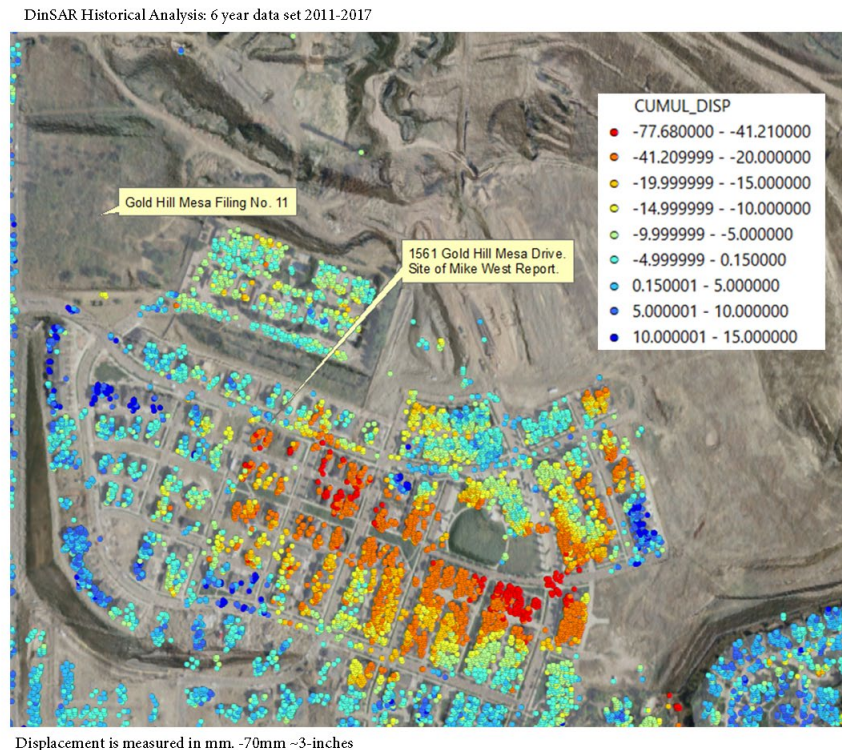
Following concerns raised by the city and local residents CGS commissioned this type of satellite study for Gold Hill Mesa. The study was performed on a stack of 162 images covering the period from June 24<sup>th</sup>, 2011 to October 14<sup>th</sup>, 2017. This work shows 3-inches of cumulative vertical settlement around the area of concern in the Mike West reports. This area generally corresponds with some of the deep, saturated slime deposits outlined in the reports. The cumulative movement recorded in the Satellite study is shown in the following figure. (The data is collected on fixed points associated with houses, streets, etc., so no points are in the undeveloped areas. The movement is relative movement and may not be exact at specific locations.)

Three-inches of movement can result in cracking of walls, floors, and hard finishes such as tile or rock. Doors and windows can stop operating properly and floors can become uneven. We observed external and internal evidence of structural distress on each floor and throughout the subject house of the Mike West reports at the time of our visit. This included cracks; in the concrete basement floor, around doors and window openings, along ceiling panels and within exterior finishes. The first floor above basement level was noticeably out-of-level throughout the house. Additionally, evidence of differential movement was observed in the street and sidewalk adjacent to the structure.

The geotechnical reports on file for Gold Hill Mesa do not fully characterize the slimes versus the sands, but typically treat the mill tailings as a relatively homogenous unit. The area of greatest measured settlement as depicted in the DinSAR image corresponds to deep saturated slimes beneath tailing sands. Borings historically drilled in this area tend to be shallow and not drilled to bedrock. Minimal or no sampling and testing of the slimes was done.

**CGS cannot recommend approval of Filing No. 11 until: the underlying mill tailings are fully characterized in terms of fines versus sands both laterally and vertically; sampling and testing is completed of the fines and saturated fines, to their full depth; settlement calculations are performed for the actual materials located beneath Filing No. 11; a liquefaction analysis for the entire Gold Hill Mesa is conducted.**
