FORCON INTERNATIONAL - NC, LTD.
1730 Mt. Vernon Road, Suite H, Atlanta, GA 30338
770/390-0980 • 770/390-0981 FAX • www.forcon.com
Firm License #: C-1617

RE: City of Hickory (Plaintiff) vs. Neill Grading and Construction Company, Inc., Dane Construction, Inc., and Western Wood Structures, Inc.
Preliminary Report – **Attorney Work Product**
CASE #: 22-CVS-804 (North Carolina, Catawba County, Superior Court)
FORCON CASE #: NC22003-1

As Counsel for Neill Grading and Construction Company, Inc. (Neill), you have requested that I (Dara Thomas, P.E., a FORCON International Corporation (FORCON) Professional Forensic Structural Engineer), provide services as an Expert and prepare a Preliminary Report on this matter. **The purpose of the report is to express my opinions, to-date, about the catastrophic failure of the Iconic Arches at the City Walk Project, Hickory, NC.**

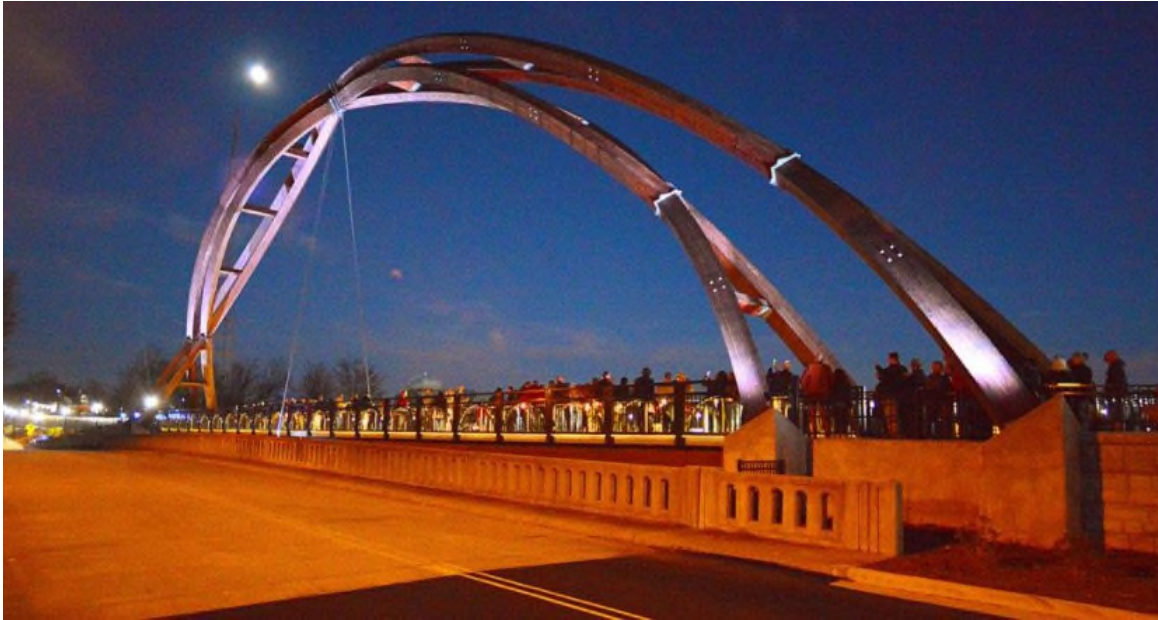
The completed Iconic Arches and adjacent bridges (Credit: Robert C. Reed)

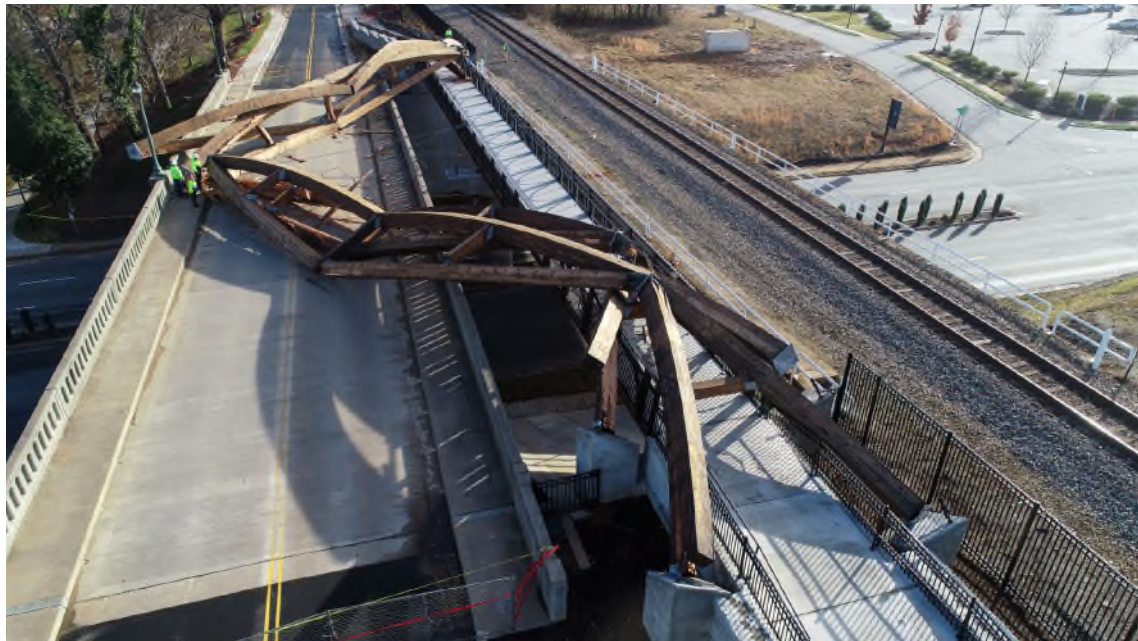
The collapsed Arches and all three bridges. (Credit: from Neill's files – image DJI_0039)

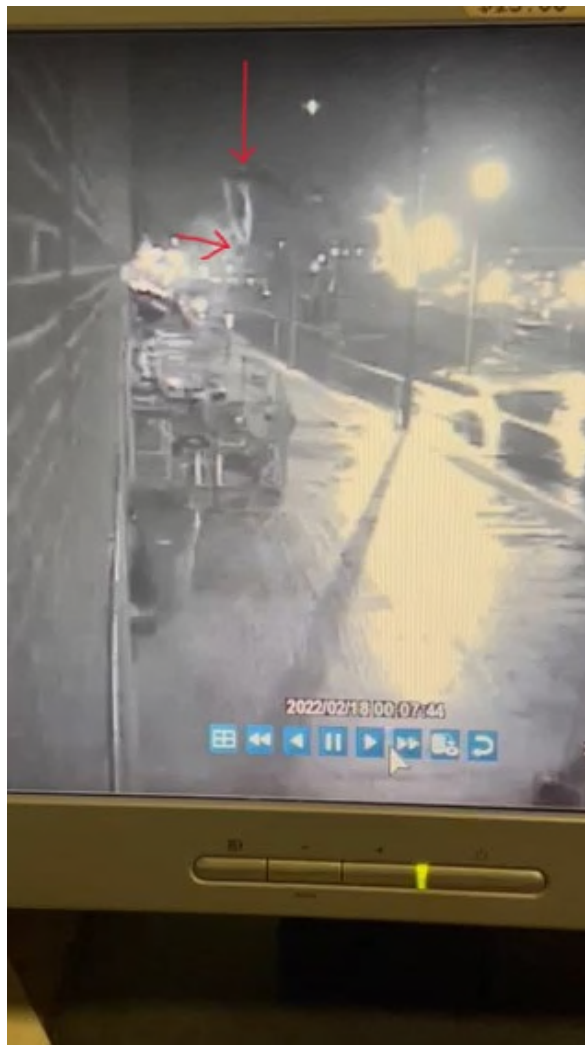
The lower red arrow is pointing to the node where the arch began to pivot to the north. This is node 4 or 22 of the computer analysis model, depending on which side one is viewing. The upper arrow points to the apex (top) of the arch space frame – which is falling over to the north (left in this photo).

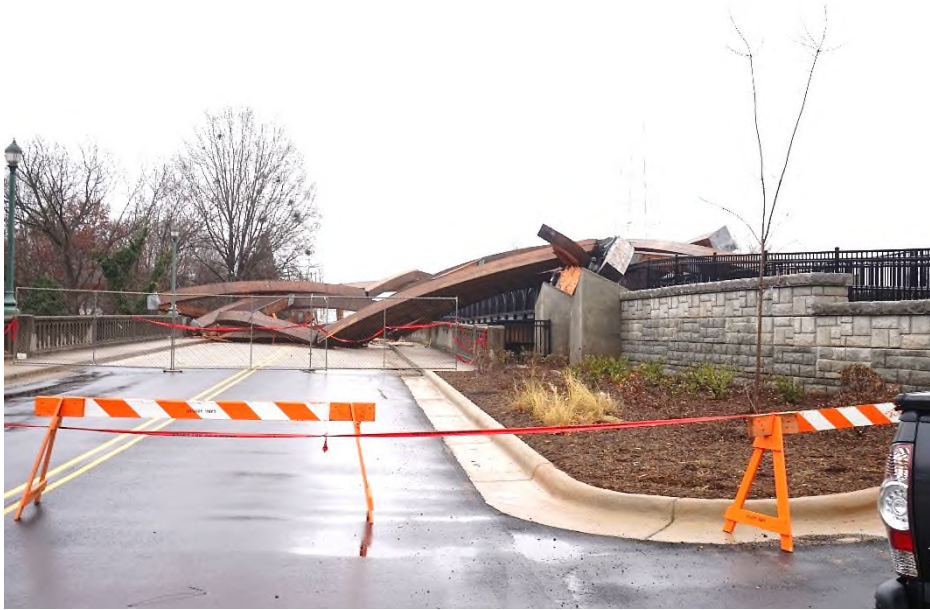
Photo 1 shows a view of the collapsed arches, approaching from the west end of Main Avenue bridge. The site was secured against pedestrians entering the area.

Photograph 1) – Overview of collapse taken from west end of Main Avenue bridge.

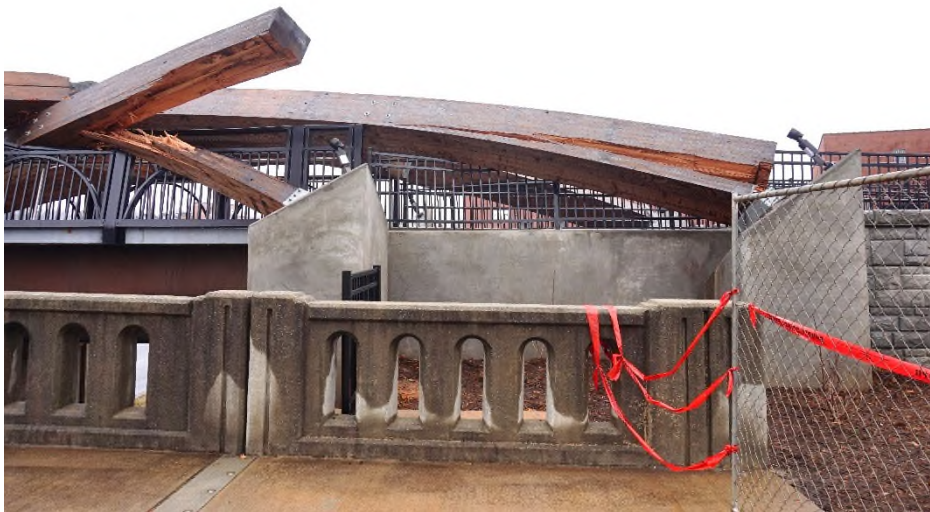
Photos 2-11 are images of the multiple base plate connections of the “legs” of the arches. Each connection has four ¾” diameter bolts through a base plate, into the concrete foundation. In all locations the base plate and anchor bolts were either deformed or completely pulled away from the foundation.

Photograph 2) – Northwest foundations for the arch base connections.

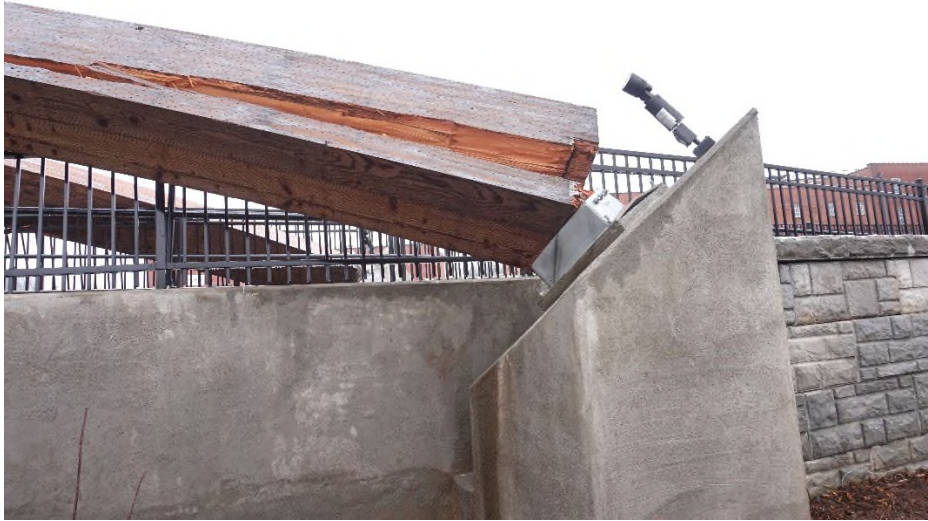
Photograph 3) – Closer view of the NW base connection of the upper arch.

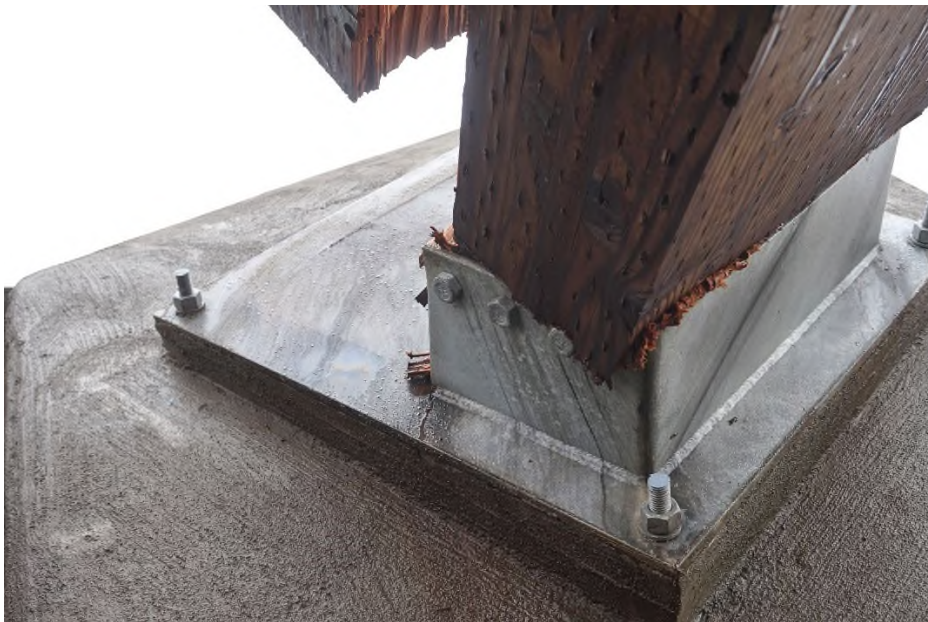
Photograph 4) – Closer view of Photo 3.

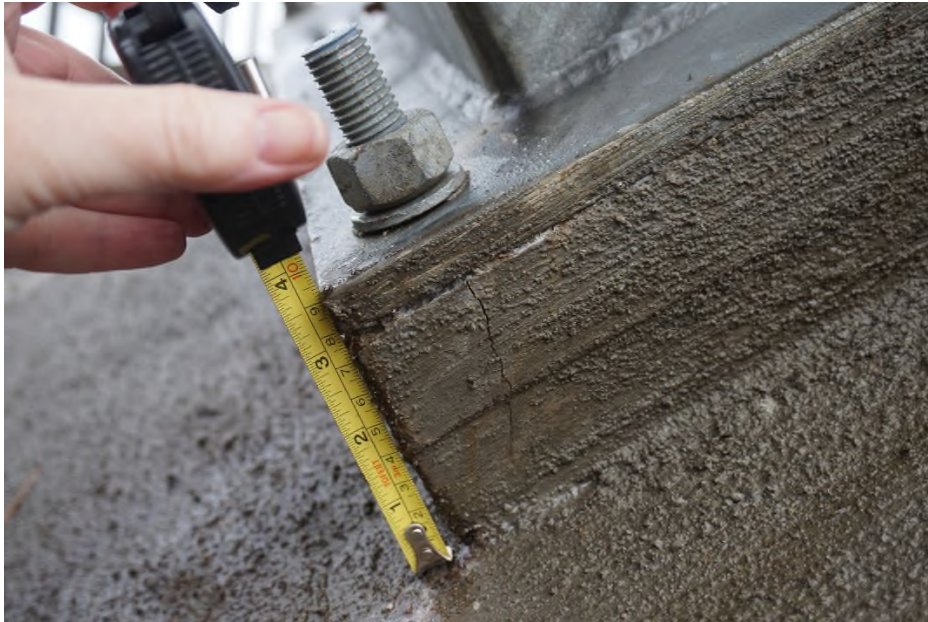
Photograph 5) – Grout below base plate at NW base connection is 3” thick. There were also steel bearing plates within. Each base plate had four $\frac{3}{4}$ ” diameter anchor bolts.

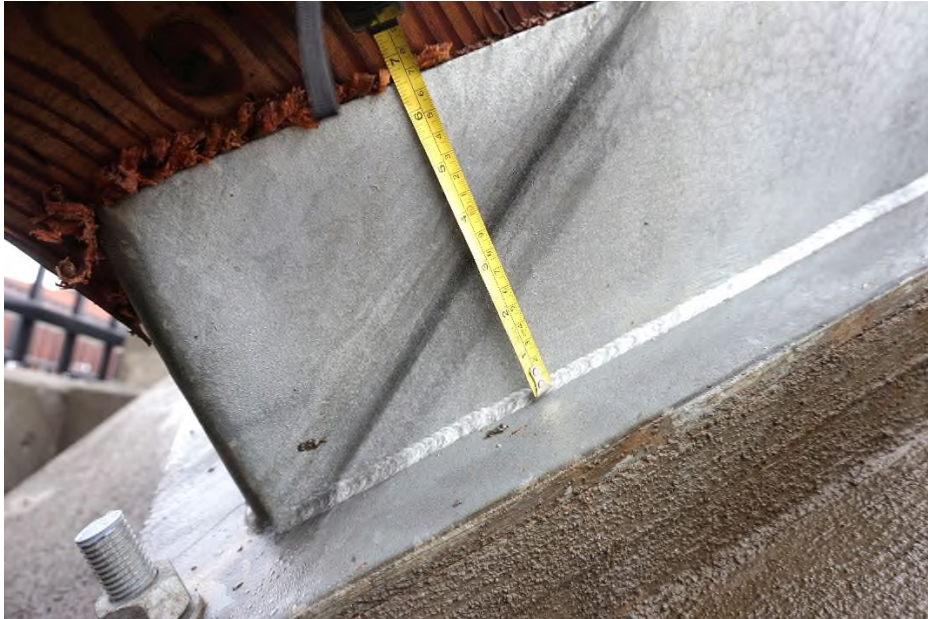
Photograph 6) – The steel base connection.

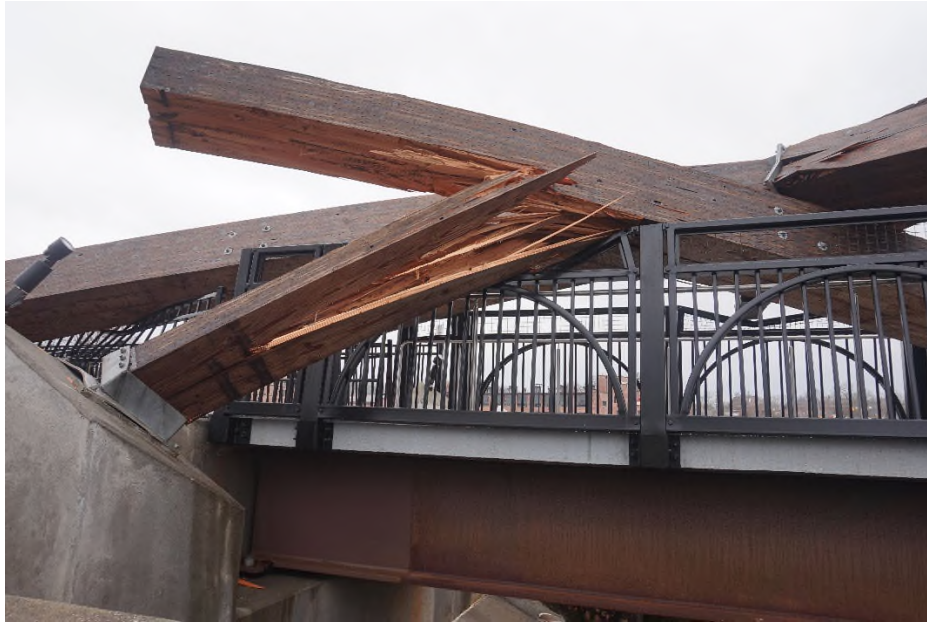
Photograph 7) – The lower arch base connection at the east end. The steel “shoe” pulled off of the base plate. The GluLam member splintered.

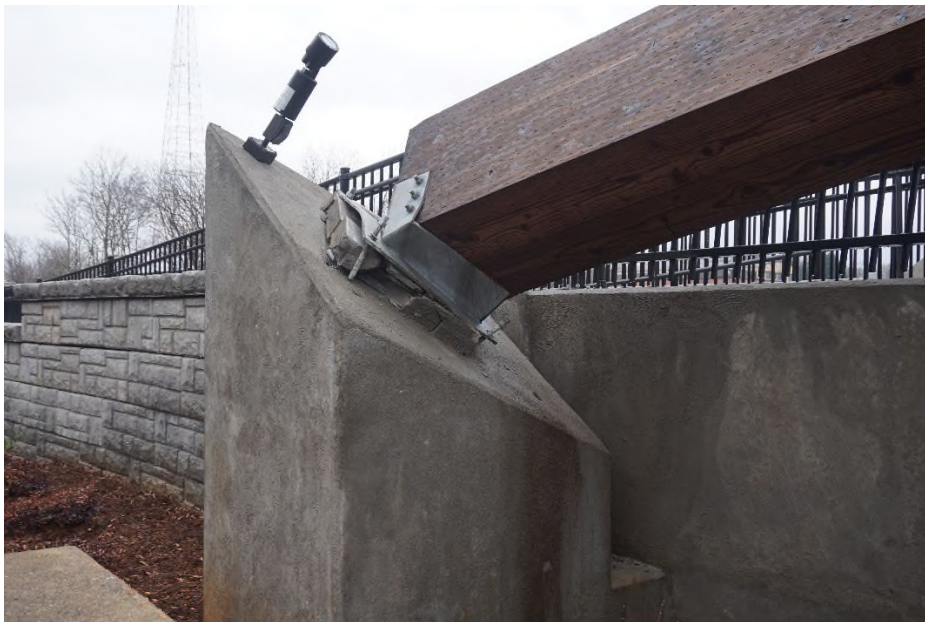
Photograph 8) – The upper arch base connection at the east end. The steel “shoe” pulled off of the base plate and base plate yielded.

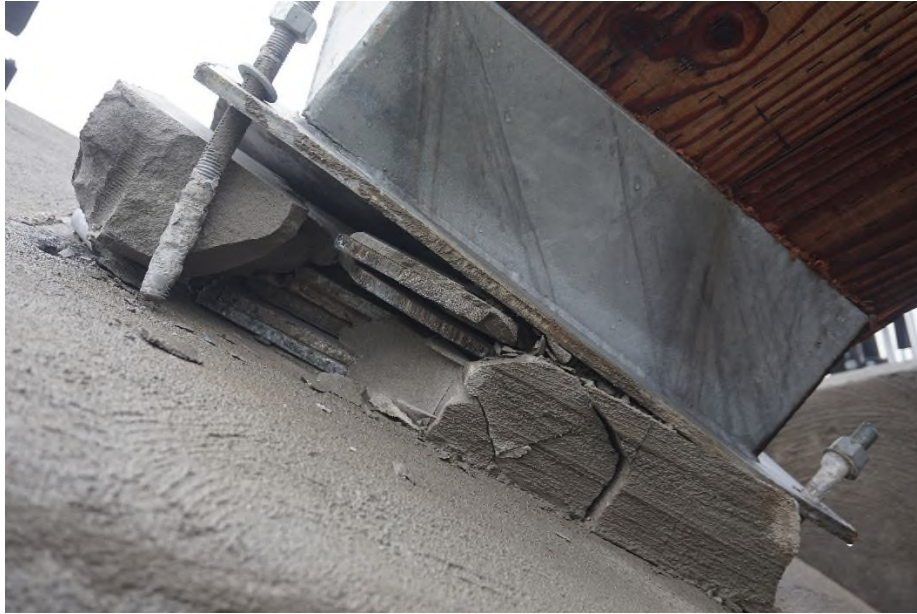
Photograph 9) – Closer view of Photo 8.

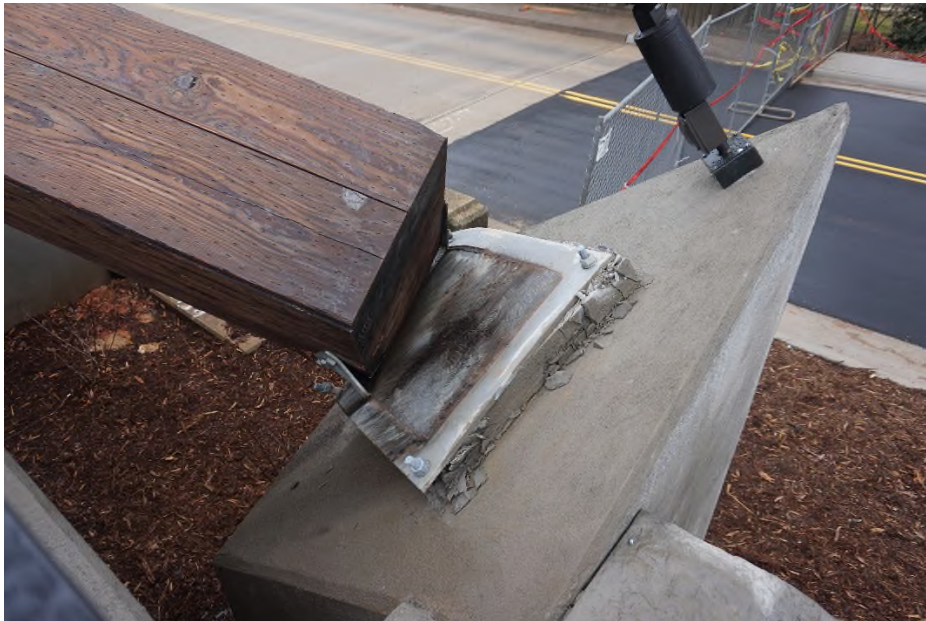
Photograph 10) – View of opposite face of Photo 8.

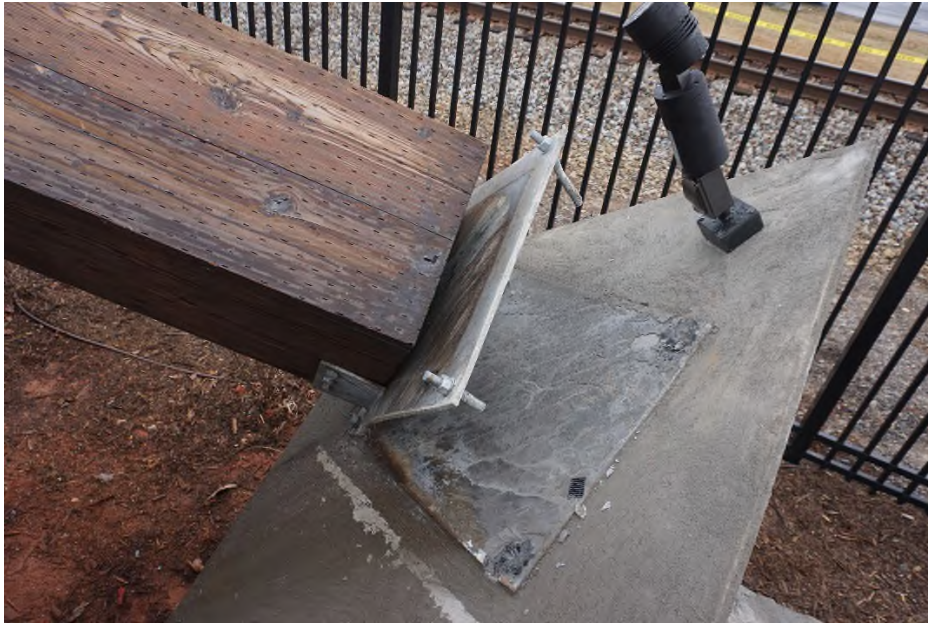
The reason that nodes 4 and 22 and then the base plate nodes failed is because they were not designed to resist the complete wind force on the structure. The only wind-resistant components were the cables.

Photograph 11) – Southwest base connection. Anchor bolts pulled out.

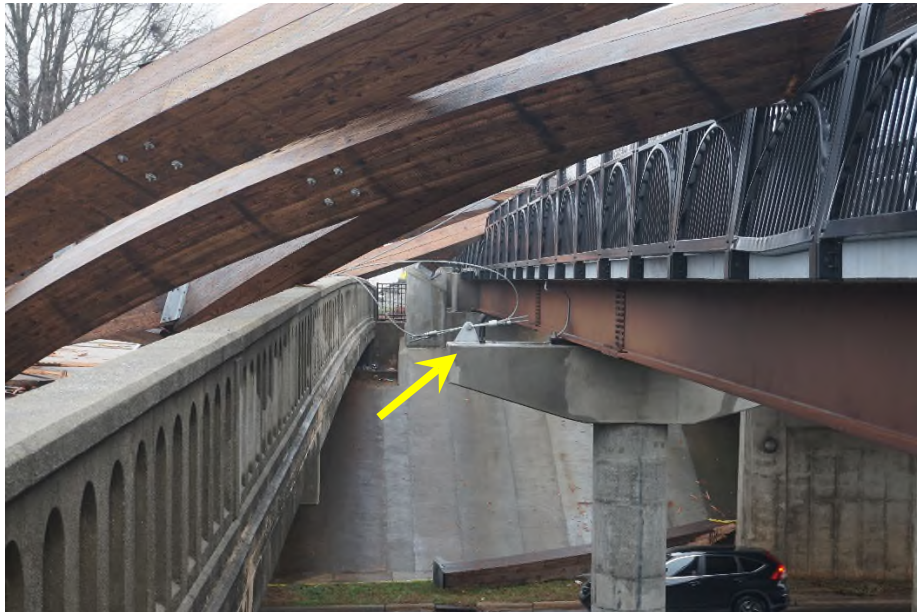
Photos 12-22 are images of the 7/8” diameter guy cables that were anchored to the apex of the arch space frame. There were two cables on each side of the arch structure. These cables were anchored at the bottom to concrete *bents* which support the pedestrian bridge. At the apex of the arch, four cables were affixed to two steel brackets which were connected to the arch assembly. The steel bracket at the bottom of the lower arch is of interest because it was discovered during the inspection that the steel bracket (known as S15 in the Western Wood shop drawings) had pulled apart. It broke at a welded seam. Part of the bracket S15 was still attached to the bottom of the apex of the arch and part of S15 was lying on the Main Avenue bridge. Also, the cable still attached to the part lying on the bridge was nearly pulled completely apart from tensile forces.

Photograph 12) – Example connection of the double guy wires on the north face.

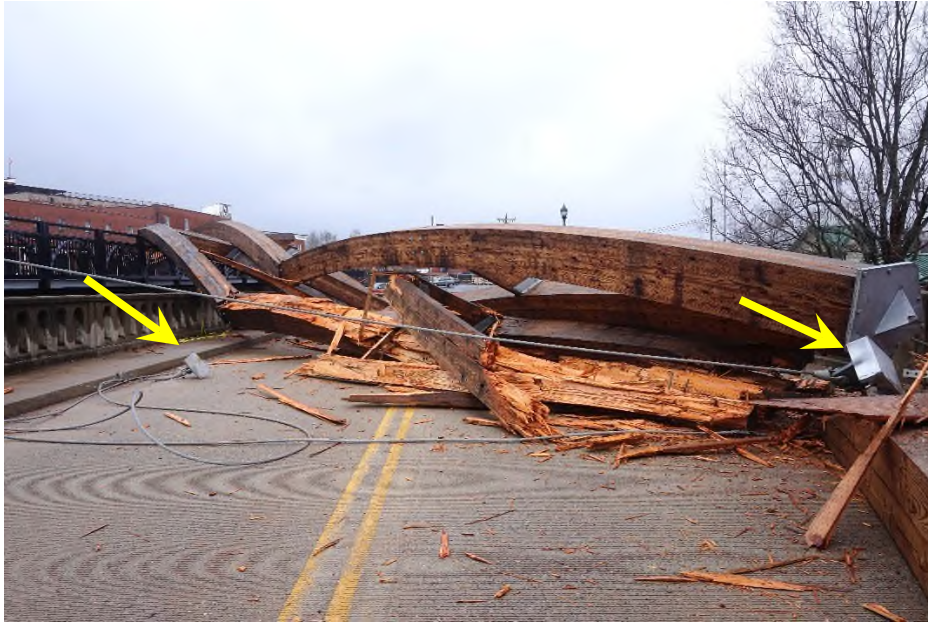
Photograph 13) – Cable connector on the left appears to be part of Steel Weld Assembly Mark S15. The one on the right is an intact steel cable bracket.

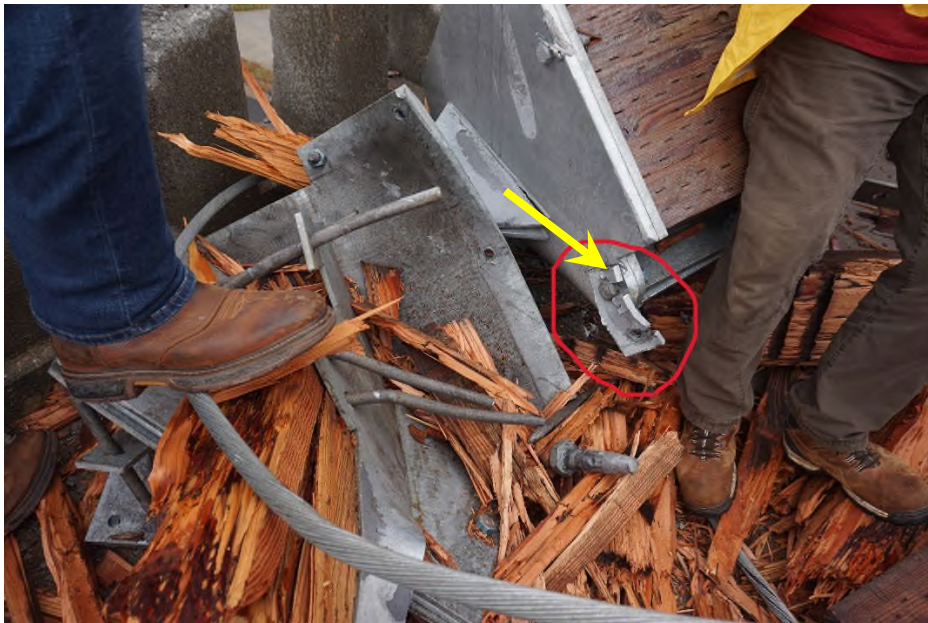
5. **Regarding the cable connector steel bracket S15 (shown in the Western Wood shop drawings), which pulled apart at a welded joint, I could not locate any calculations of the required weld size or length. There is no indication that the welds were designed at all for the reaction forces.**

Photograph 14) – Circled in red is part of Mark S15. Welds failed and this part detached from the part shown in Photo 13.

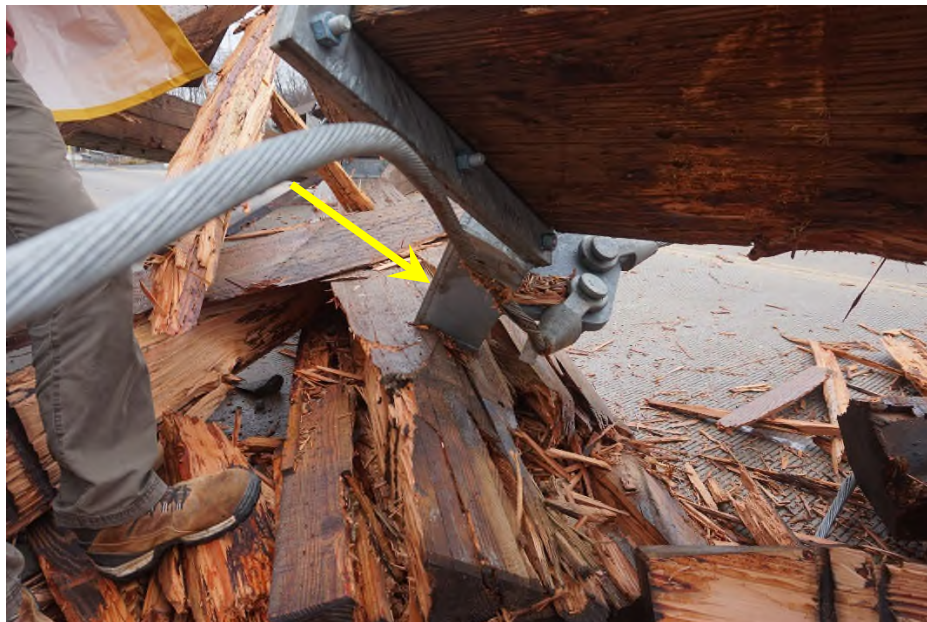
Photograph 15) – View of the intact steel cable bracket, which partially detached from the connection.

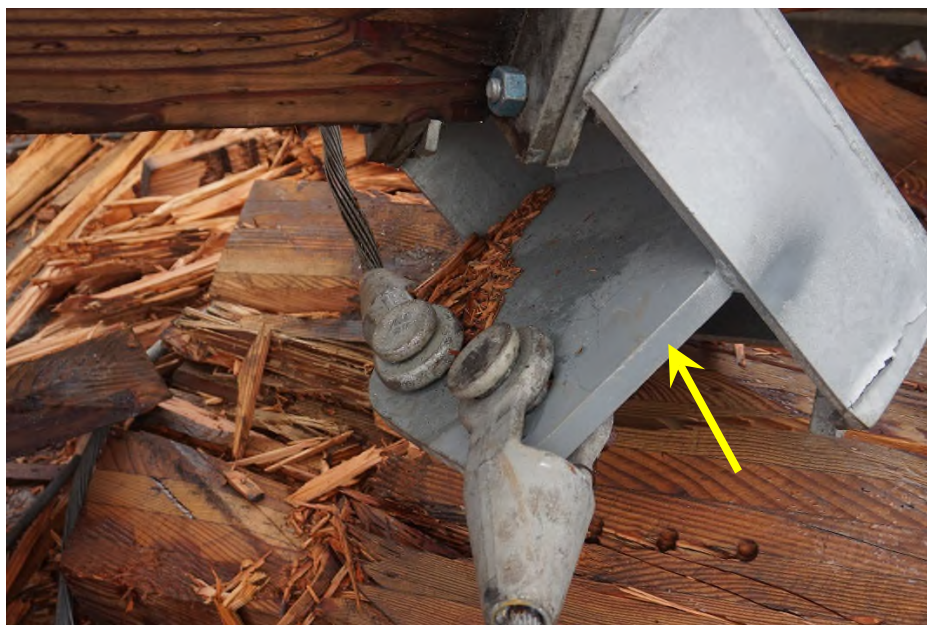
Photograph 16) –The intact cable bracket.

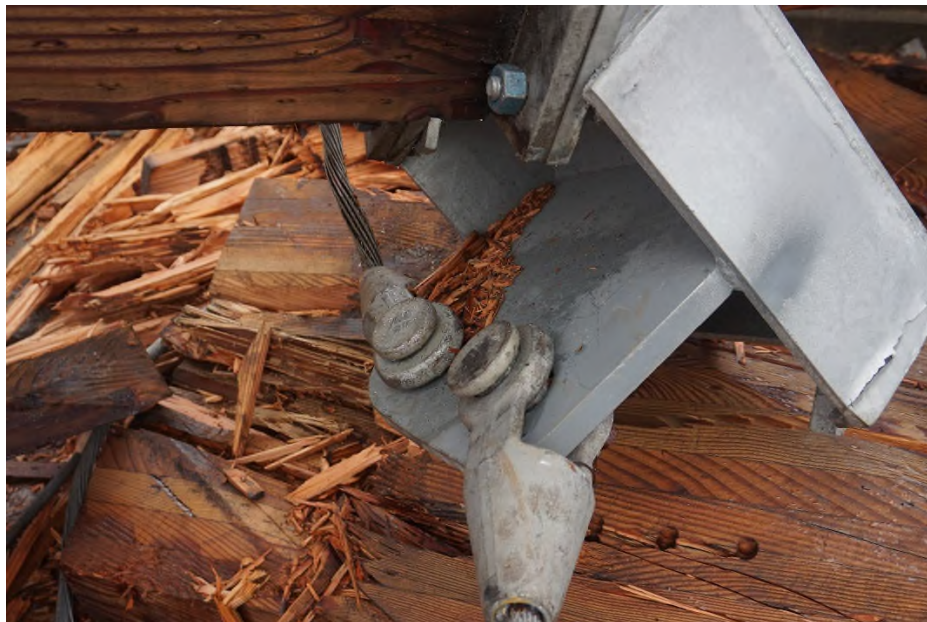
Photograph 17) – Another view of the intact cable bracket.

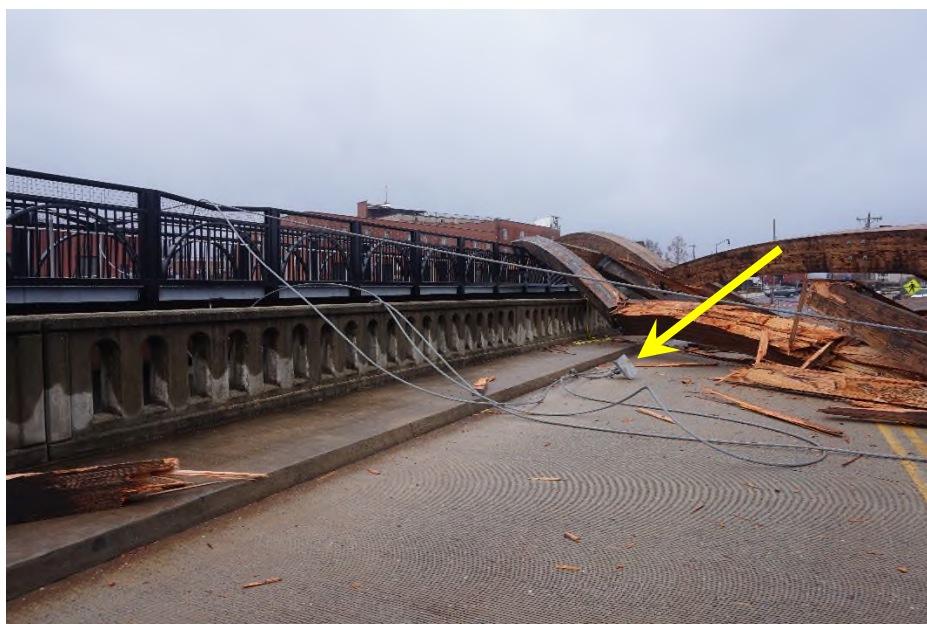
There is evidence to suggest that the guy cables were over-stressed, as one of them was nearly pulled apart due to tension. But before it snapped completely, the connector Mark S15 came apart at the welds. This cable situation most likely also suffered due to the P-Delta effect. The dead weight causing additional twisting load to the north likely overcame the cable and connection design and it failed. Once that happened, lateral forces were then transferred to nodes 4 and 22. Once those connections began to come apart, the twisting load to the north was transferred to the base plates, which were not designed to resist such twisting moment. We know this because they were defined in the computer model analysis as *pinned connections*.

Photograph 18) – Part S15. This would have been connected to the lower part of the arch. It pulled apart from the piece shown in Photo 14.

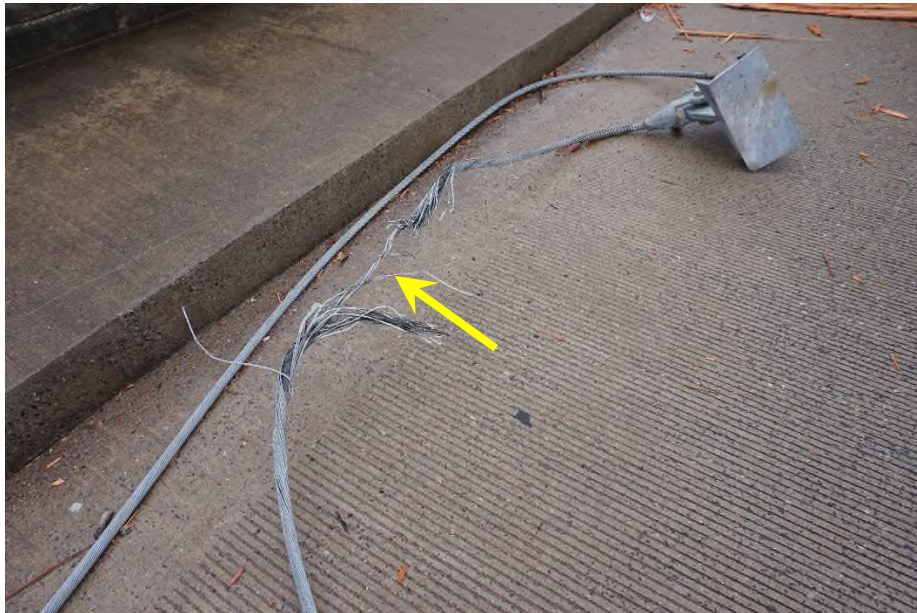
Photograph 19) – The 7/8” diameter cable that connected to the lower arch with Part S15, was nearly shredded from tensile force. The adjacent cable which was unharmed as it went slack during the failure.

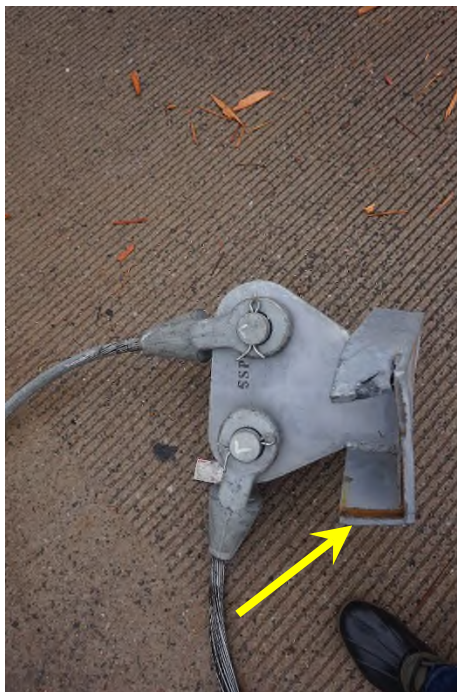
Photograph 20) – Part S15. The piece circled in Photo 14 detached from the end of this Part.

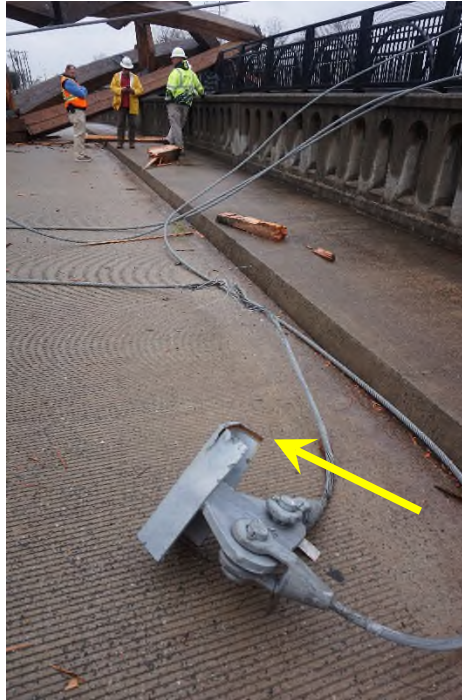
Photograph 21) – Another view of S15. The part in Photo 14 detached from this end.

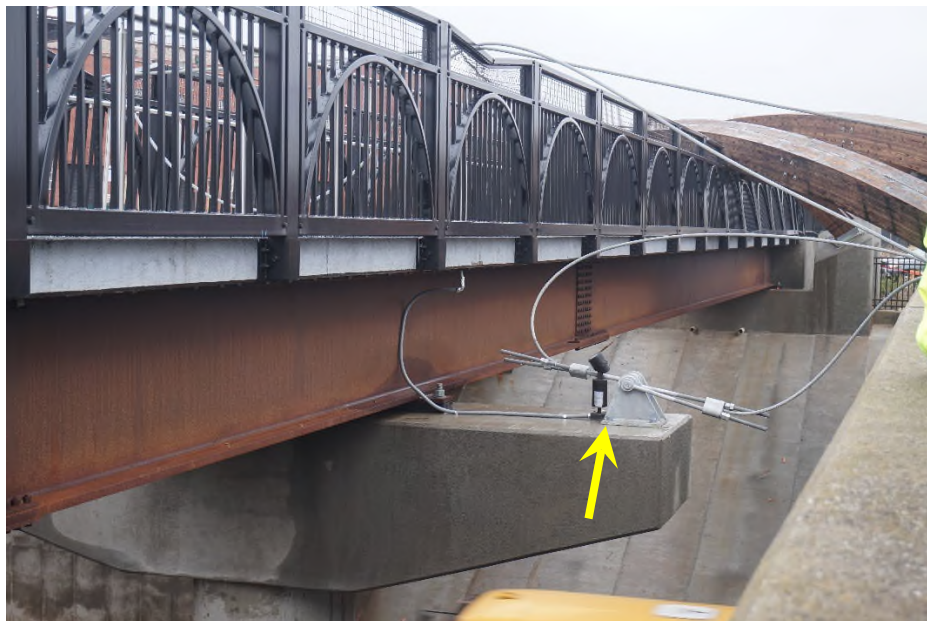
Photograph 22) – The anchorage of the two cables on the north face.

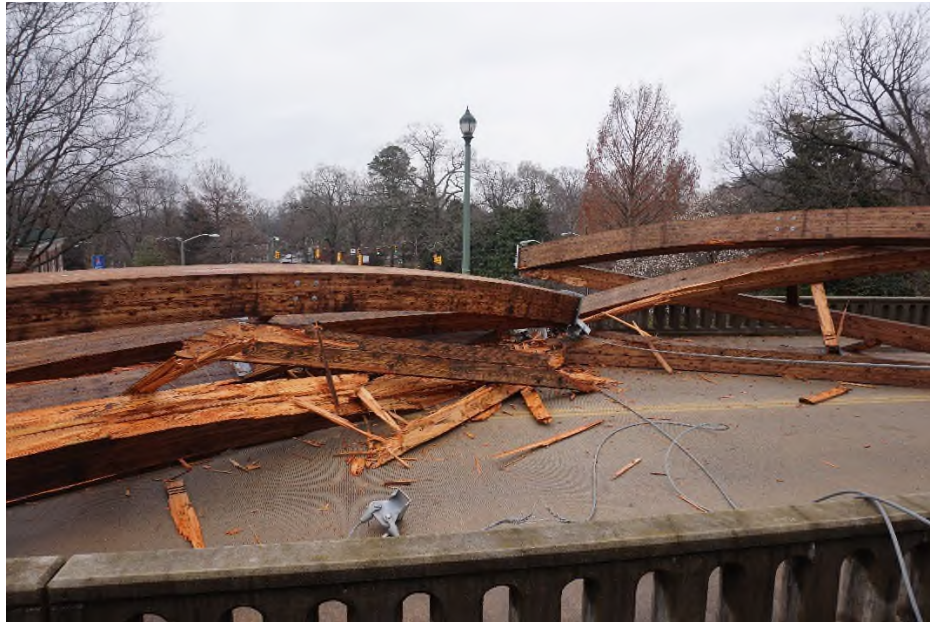
Photos 23-28 focus on the connection assembly at the apex of the arches.

Photograph 23) – Overview of the top node of the arch. The upper and lower arch connected at node 13. The two sets of dual cables connected to the bottom arch and also to the upper arch.

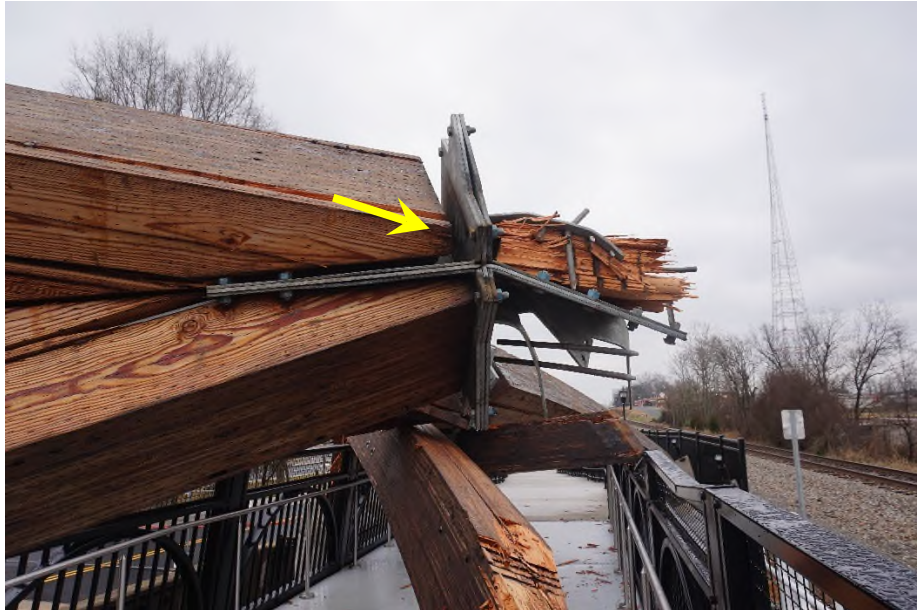
Photograph 24) – The connection of node 4 (or 22 which is identical). From the security videos we see that the arch began to pivot and fall over at this node.

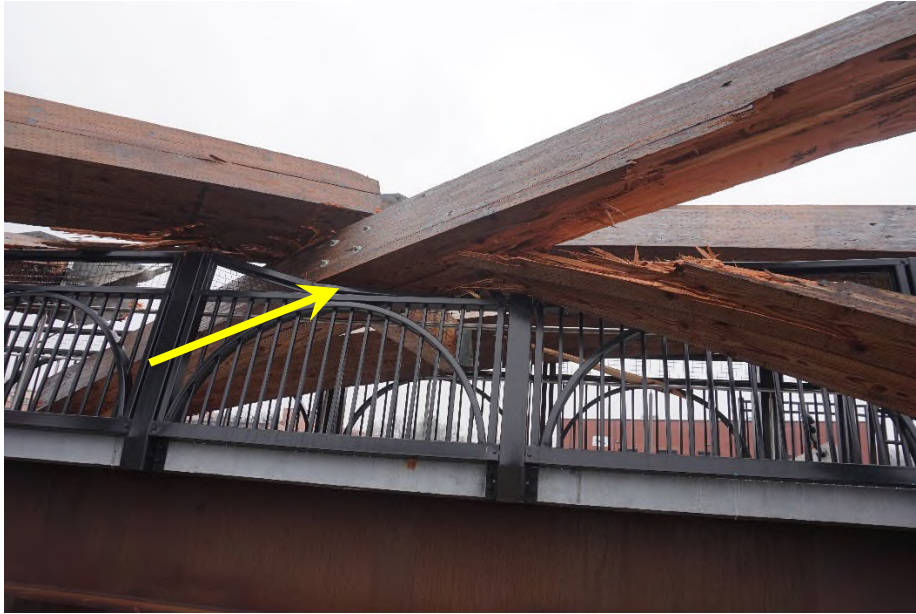
Photograph 25) – View of the lower arch.

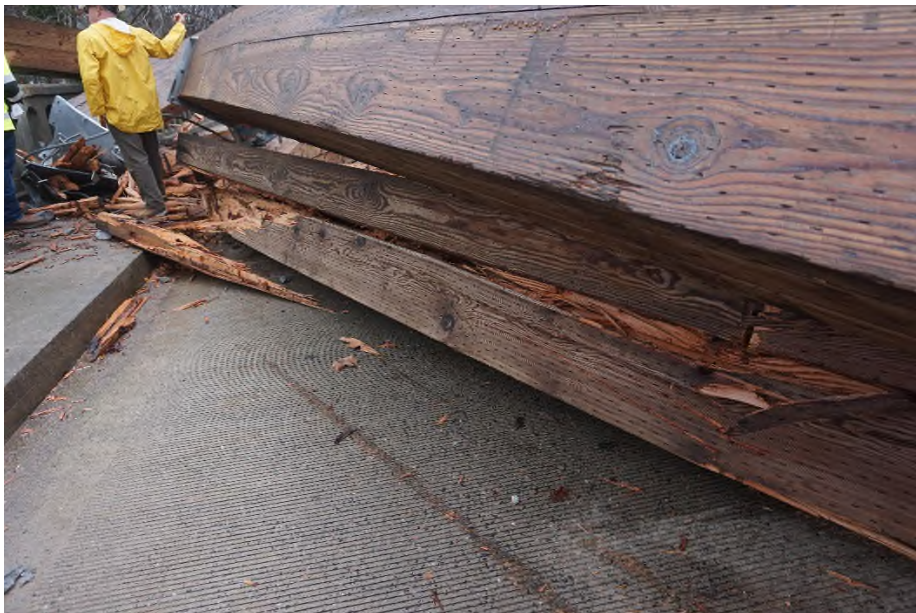
Photograph 26) – The connection at the apex.

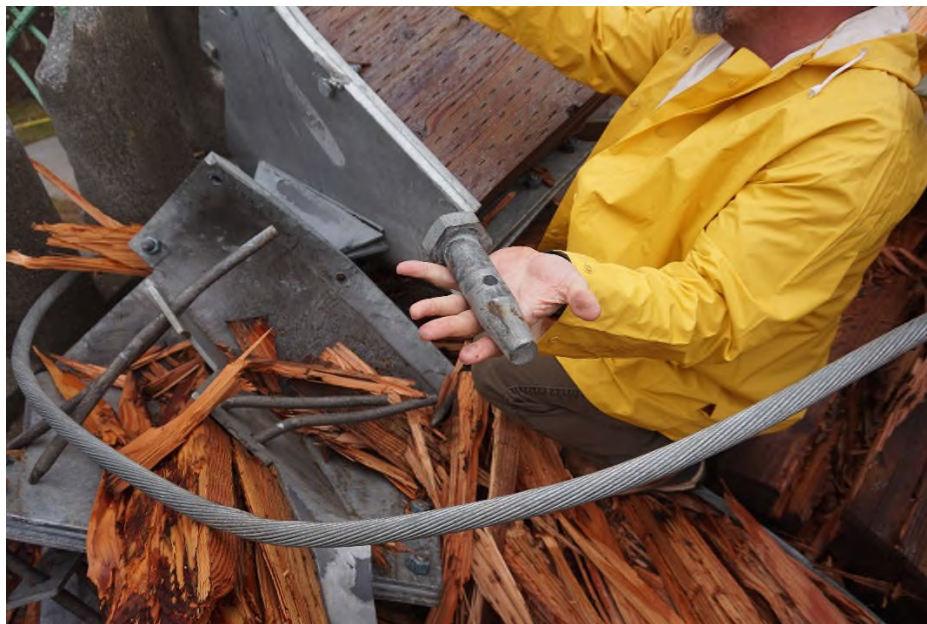
Photograph 27) – The connection at the apex.

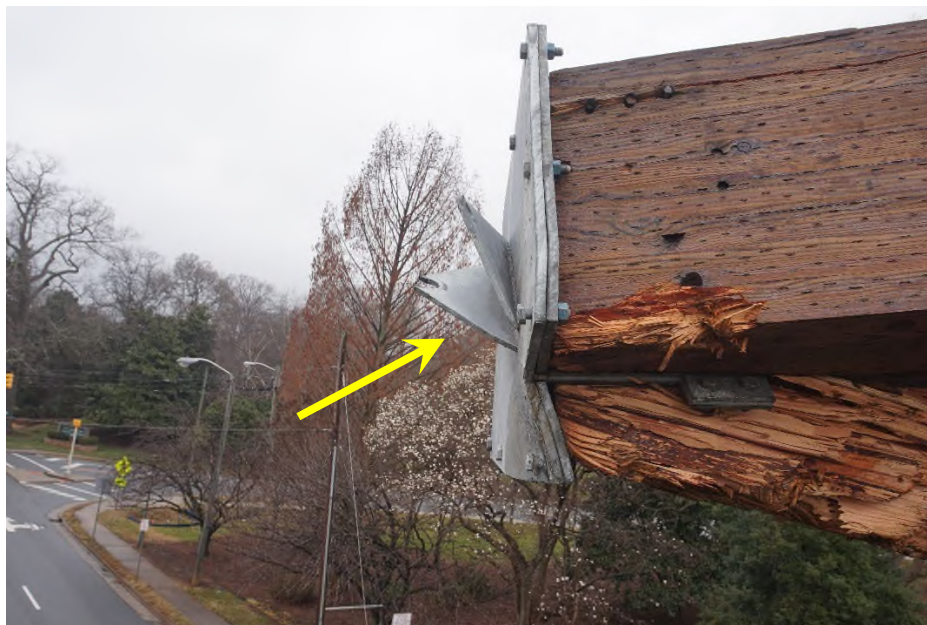
Photograph 28) – Part of the connection at the apex.

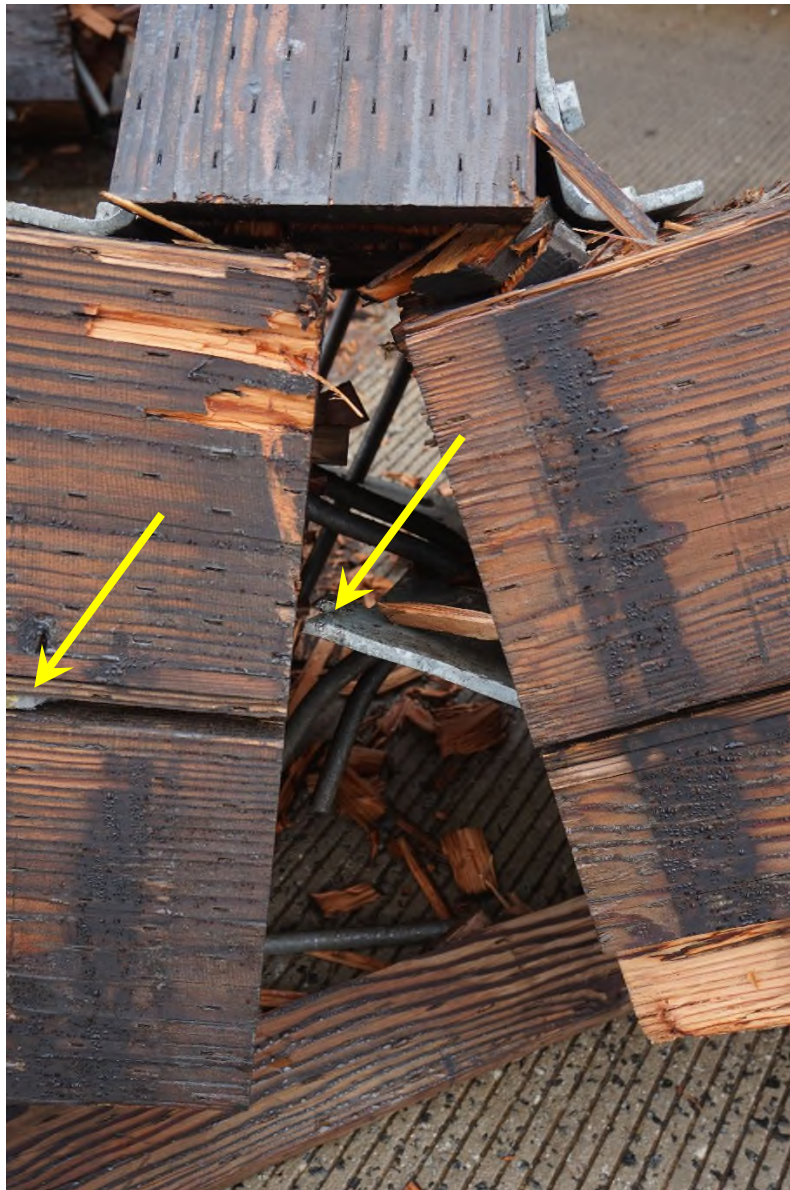
Photo 29 shows a view of the failure of a kerf plate at a connection node.

Photograph 29) – Failure of the kerf plate at a connection.

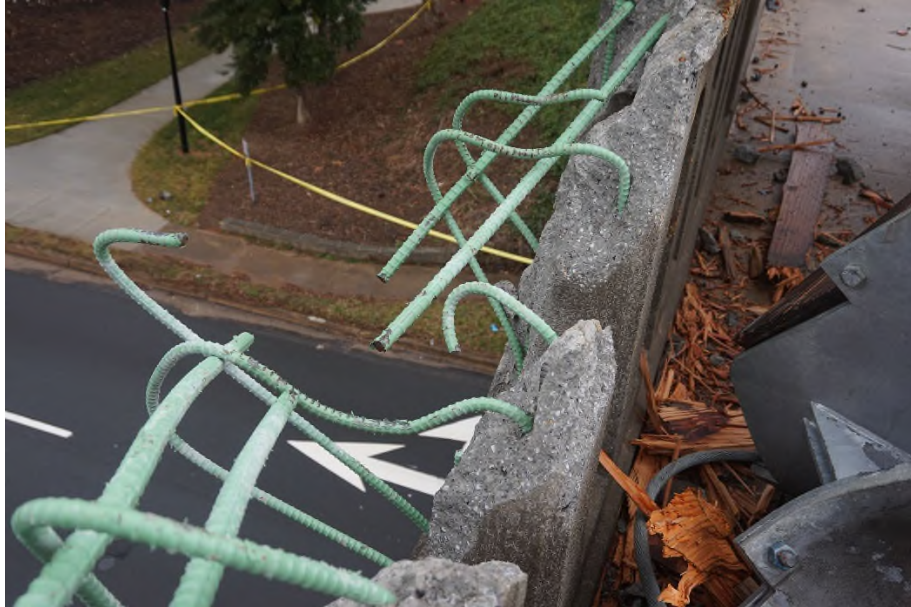
Photo 30 documents the collateral damage to the concrete guardrail of the Main Avenue bridge. Part of the Arches crushed the guardrail.

Photograph 30) – Damage to the concrete guardrail system on the Main Avenue bridge.

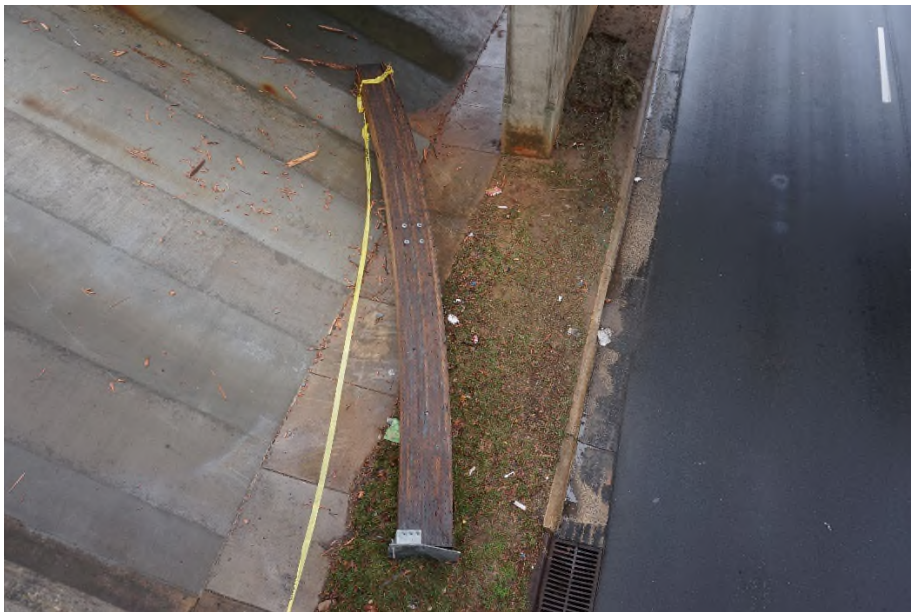
Photo 31 shows some debris of the arch which fell to NC Hwy 127 below. Some debris fell between the pedestrian bridge and the Main Avenue bridge.

Photograph 31) – Debris landed below on NC Hwy 127.
