# DUKE ENERGY PROPERTY

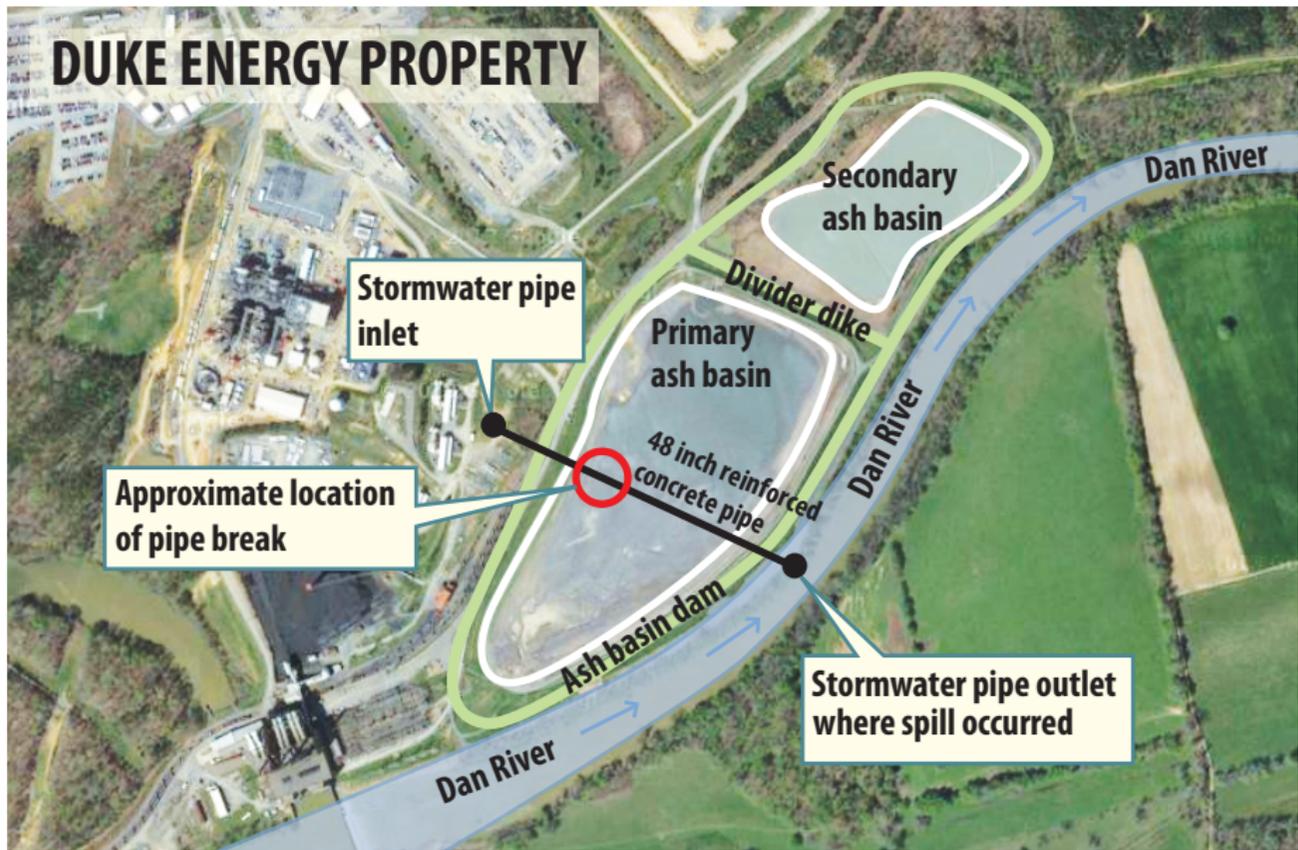
Approximate location of pipe break

Stormwater pipe outlet where spill occurred
