**RE: NOV/OC No. WPC26-001 REF. NO. GEPA- 22-0173 (B18001053)**  
**NOTICE OF APPEAL / NOTICE OF DEFENSE**

This letter is prepared by Duenas Camacho and Associates at the request of the development owner to document the Engineer of Record's opinion of events that occurred on October 15, 2025. This memorandum reflects DCA's findings to date. The project site is defined as the Palisades Subdivision (~19 acres) covered under Department of Public Works (DPW) building permit number B18001053. The area of concern was the site of erosion and collapse (failure) of a portion of the slope at the cliff area adjacent to Marine Corps Drive (MCD). The area of concern is located between (and outside of) the project site boundary and MCD, see below.

**RE: DPW NOTICE OF VIOLATION, THE PALISADES, TIYAN, GUAM**

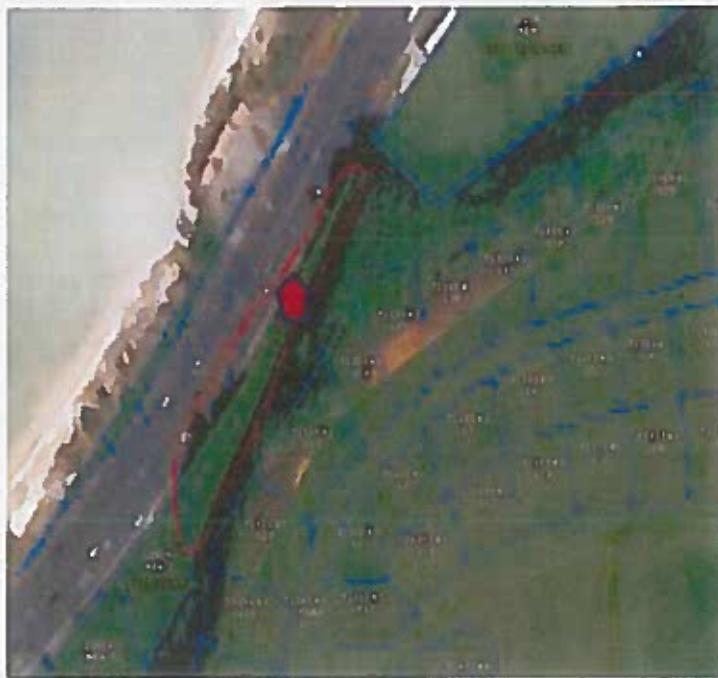
Photo1. Portion of Project site and Area of Concern

According to Guam International Airport rain gauge, 5.86 inches of rain fell on October 15, much of which fell in the early morning hours. Slope failure at the area of concern occurred during this early morning rainfall.

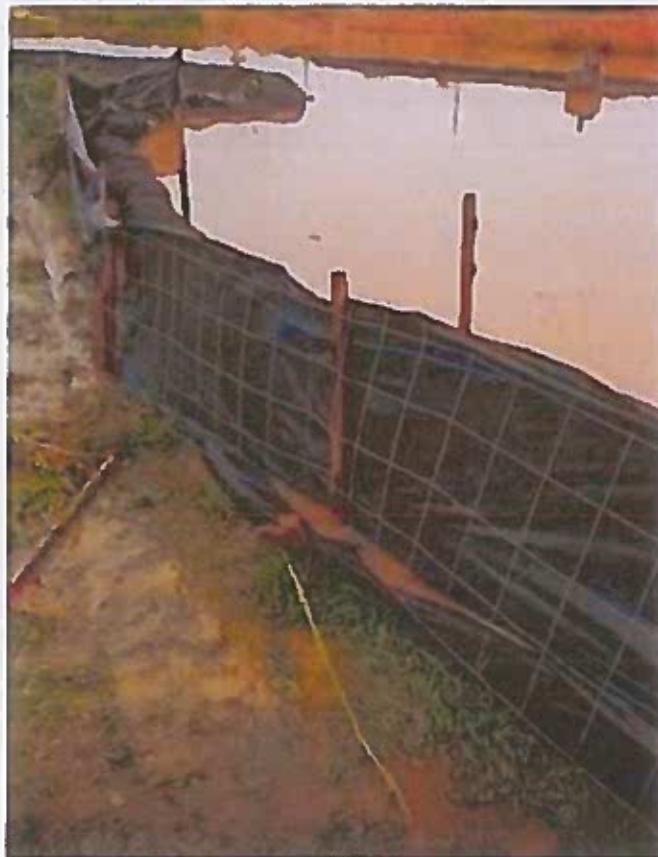
**Photo 2. Subject Site-1**

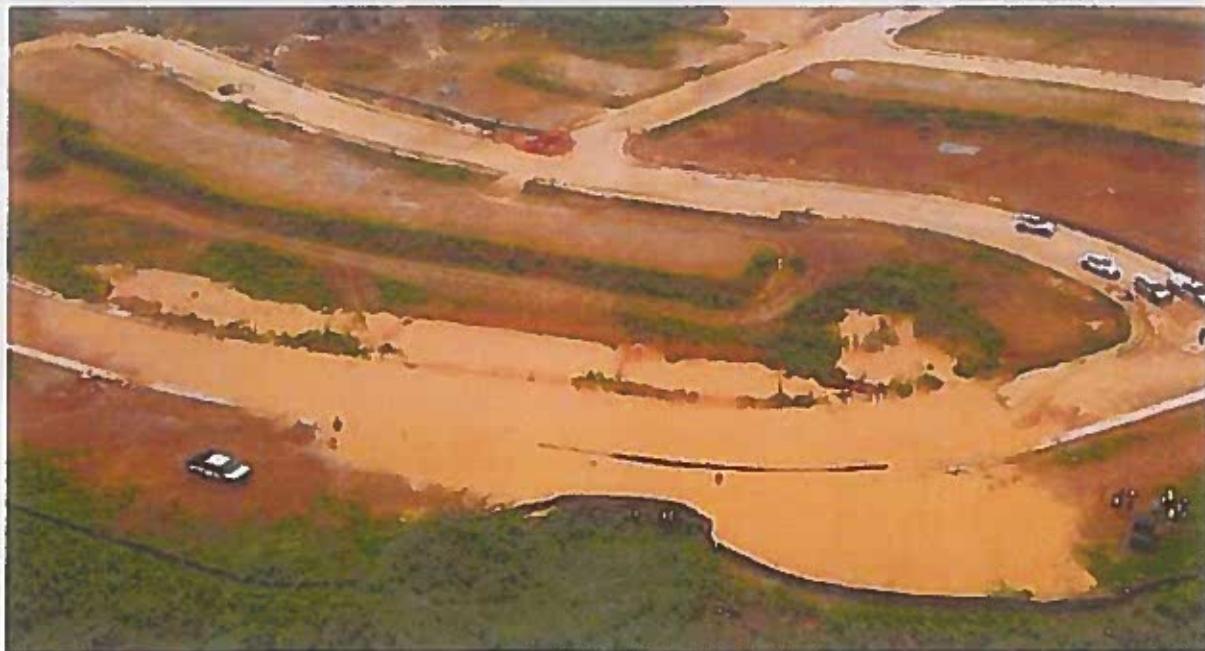
**Photo 3. Subject Site-2**

Vegetation between the subject site and the area of concern appears intact and does not show visible signs of scour (Photo 3 & 4). There has been discussion among government representatives that this is the portion of the cliff area/edge where alleged overtopping occurred from flows escaping from the Palisades project erosion control berm. The suspected overtopping has not been confirmed as no evidence of scour or staining of the berm geotextile is visible and the berm was intact. What can be confirmed however based on photos and interviews with on-site personnel, was the occurrence of limited seepage emanating from beneath the berm (Photo 2). This observed (brown in color) seepage was not free-flowing, even with the contained stormwater and does not appear to be in quantity enough to have caused the landslide.

A meeting on October 16, 2025 with DPW, GEPA, GCLB, the contractor, owner and EOR was called by DPW. At this meeting there was discussion that a contributing factor to this slope failure was seepage flows springing from the side of the cliff face. The basis for this theory was from video taken during the morning of the incident. An excerpt of this video is provided below (Photo 6). Note the water flow is much clearer than what is reflected in Photo 3. One would expect that water from the ponded stormwater contained with the berm would be silty brown in color as shown in Photo 3.

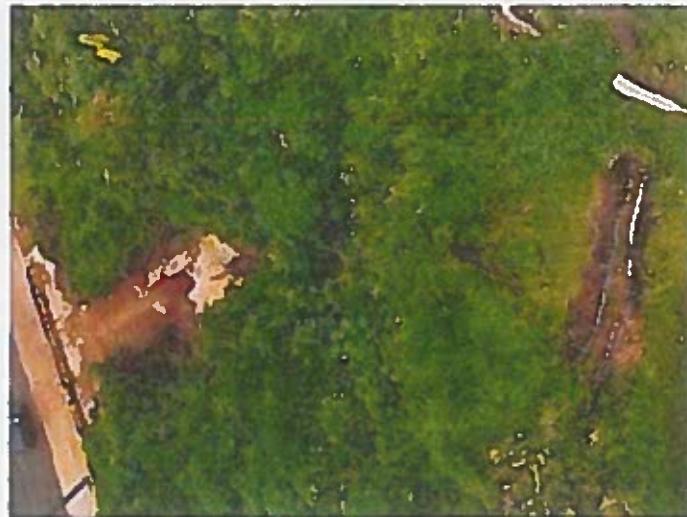
**Photo 4. Subject site on the right, MCD on the left and the area of concern in the center.**

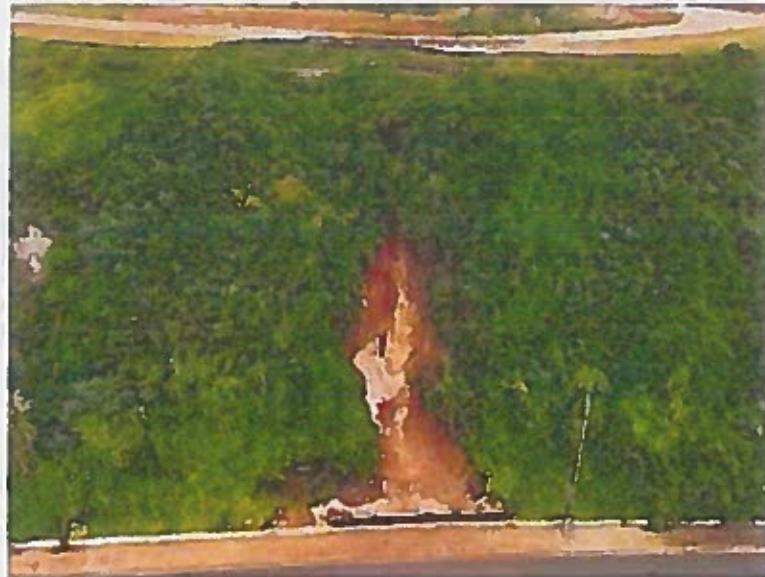
**Photo 5. Alternate view of image above.**

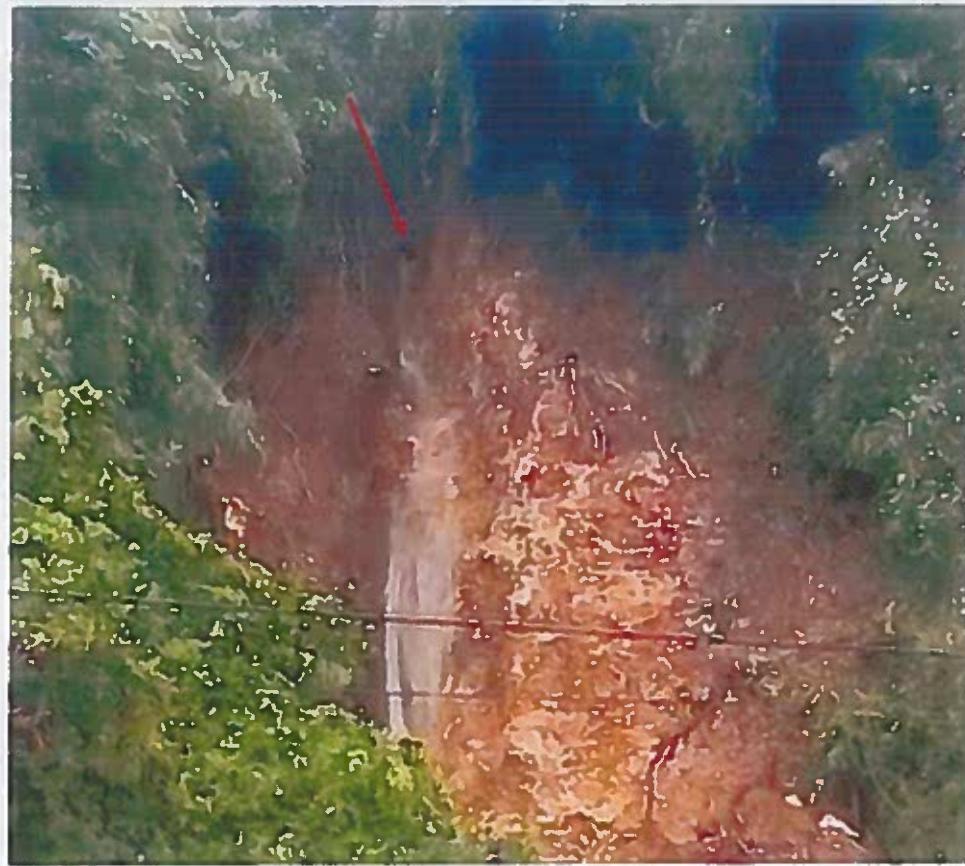
**Photo 6. Apparent point concentrated flow**

It is our opinion that the identified debris is the likely source of the concentrated flow observed in Photo 6. The source of the "clean" flowing water in Photo 6 is unknown as this time. The volume and quality

of this flow must be identified. One possible source is the existing stormwater outfall. Two possible scenarios are a breach (joint failure) in this line at or about the location of the occurrence or overtopping of the headwall caused by plugging of this outfall. If this outfall overtopped it would occur at or about the location identified in photos 11 and 12 and be of quantity to cause such an event. This same outfall has failed before.

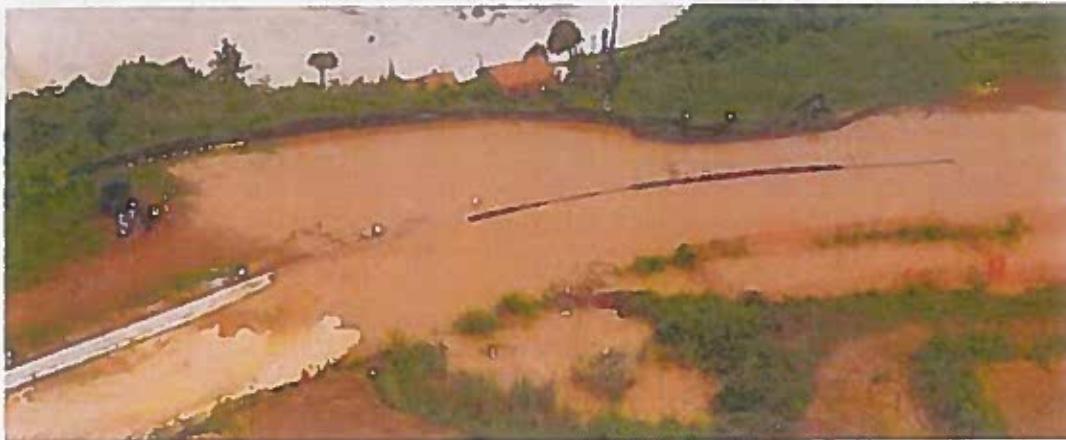
**Photo 9. Westerly aerial photo on day of occurrence.**

A review of photo 9 indicates the northern location of perimeter ESC berm/silt fence is the lowest top elevation of this ESC system and would be a point of overflow if such an incident were to occur. This was determined by reviewing the water surface and the visual distance to the top of the ESC berm and silt fence. These ESC measures were in place during the time of the occurrence. A second silt fence was under installation by the construction contractor immediately following the incident. The initial ESC system of sandbags and silt fencing was in place this time.

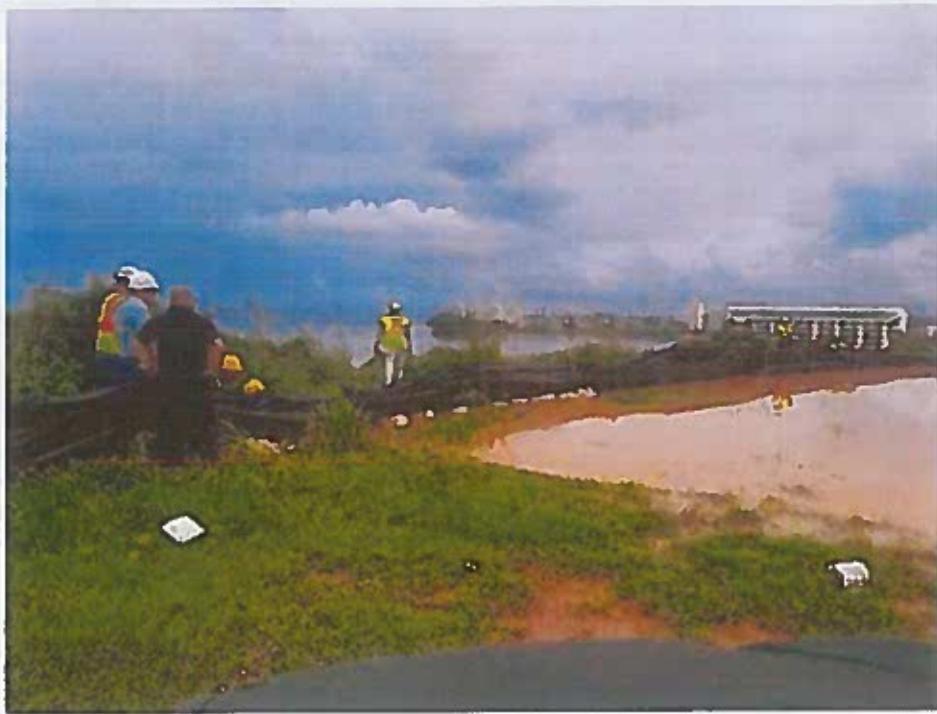
**Photo 10. Intact silt fence and sandbag system with second silt fence installation on day of occurrence.**

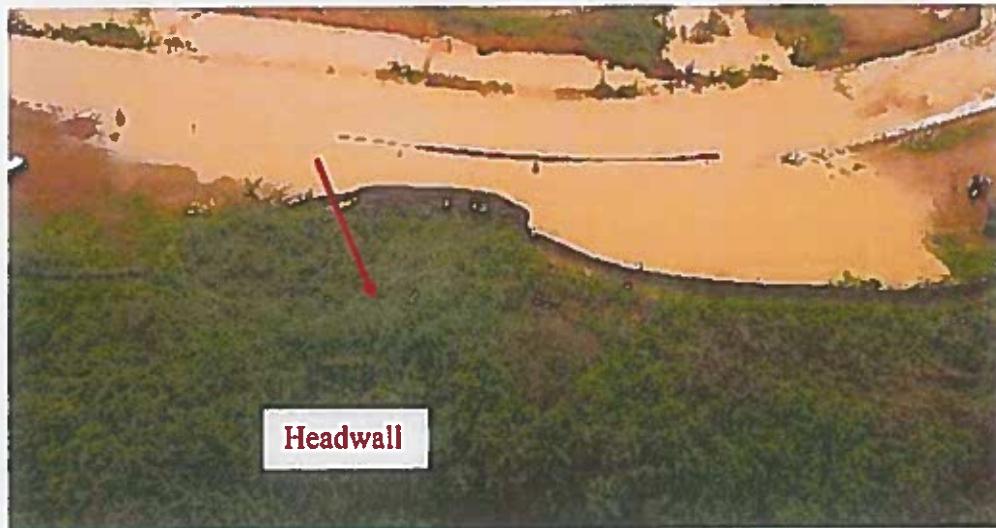
**Photo 11. Easterly aerial photo on day of occurrence.**

Photo 11 has been annotated to reflect flow direction from the low point in the ESC system to an existing head wall. This head wall is connected to the existing storm water drainage system. Open slots in this headwall would allow overtopped flow to drain into this pipe. See photo 11 reflecting this headwall.

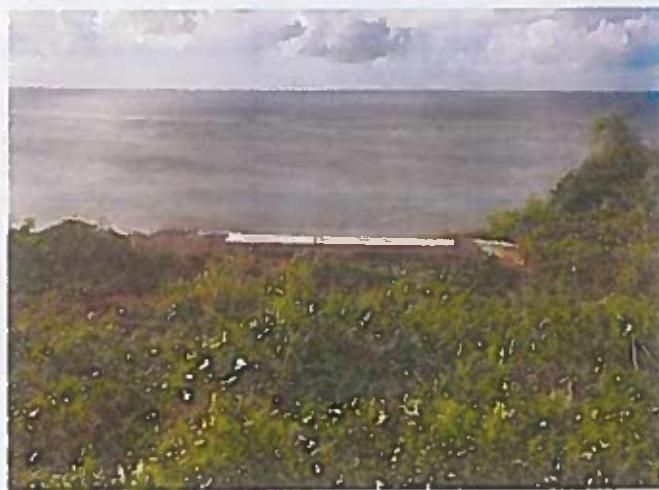
**Photo 12. Headwall Photo reflecting openings taken Oct 24**

If overtopping of the ESC were to occur it would have been directed to this headwall and out the existing discharged pipe rather than toward the area of concern.

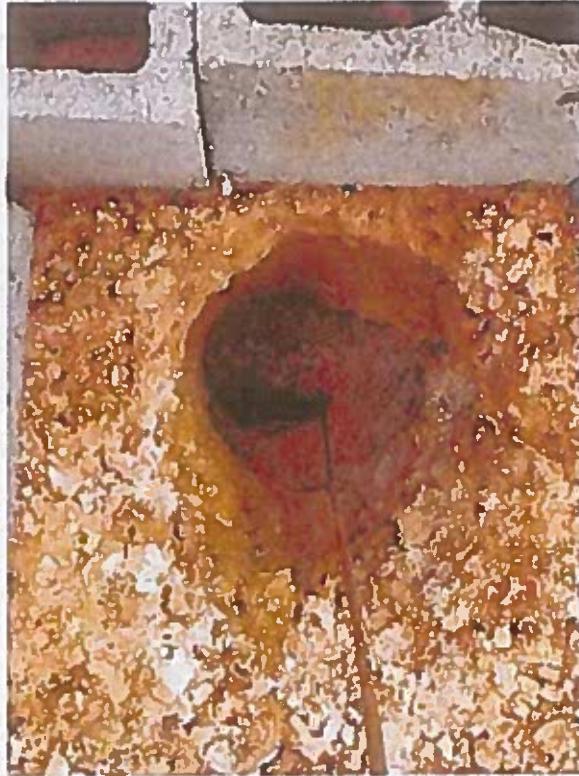
- Of note is a damaged stormwater collection line along this existing stormwater collection system immediately outside of the project site. This damaged line was found as part of the contractor's due diligence investigating possible sources of stormwater flow. The contractor was not previously aware of the damage, which appears to be caused by the removal of an old power pole within the Subdivision on October 10, 2025 by GPA. Photo 13 below reflects a depression where washout occurred.

Photo 13. Damage offsite stormwater collection line

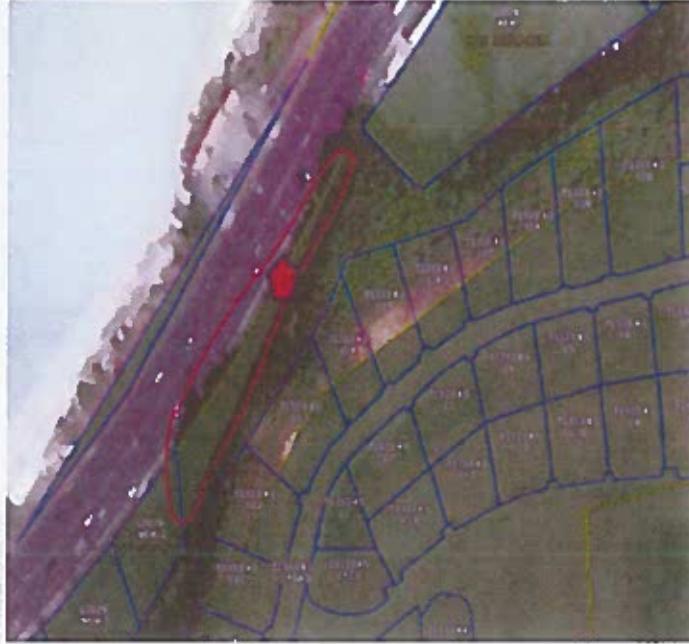
Photo1. Portion of Project site and Area of Concern

According to Guam International Airport rain gauge, 5.86 inches of rain fell on October 15, much of which fell in the early morning hours. Slope failure at the area of concern occurred during this early morning rainfall.

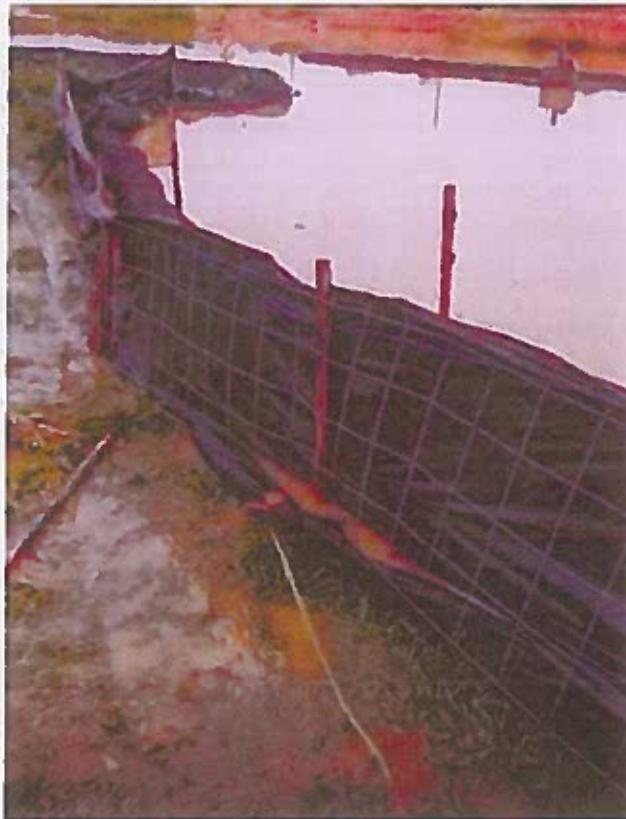
**Photo 2. Subject Site-1**

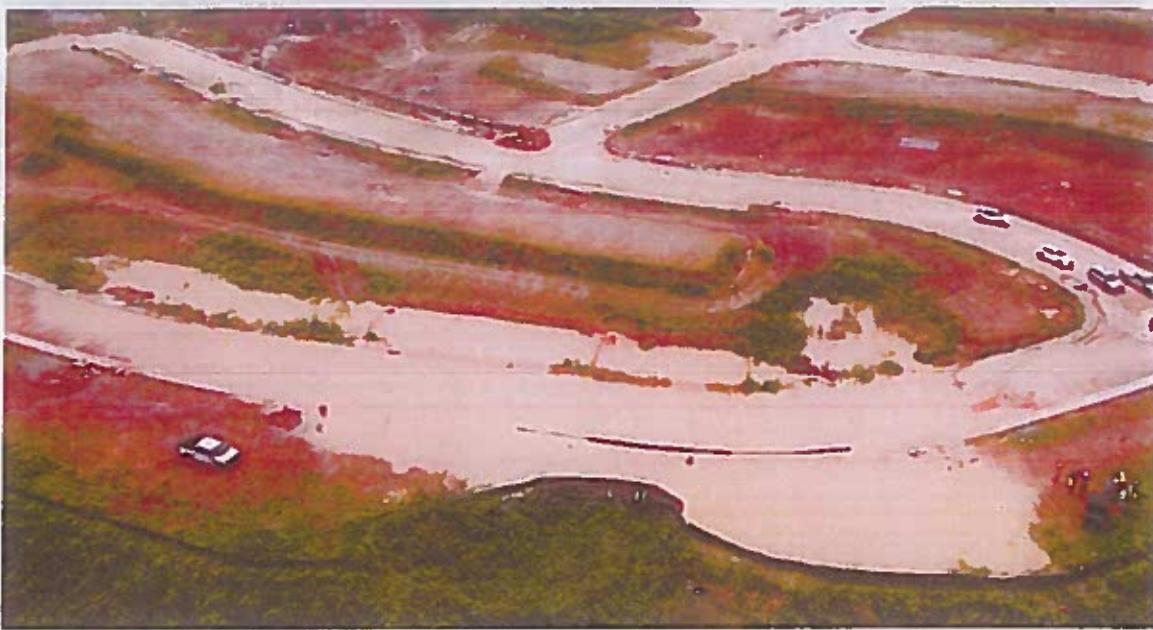
**Photo 3. Subject Site-2**

Vegetation between the subject site and the area of concern appears intact and does not show visible signs of scour (Photo 3 & 4). There has been discussion among government representatives that this is the portion of the cliff area/edge where alleged overtopping occurred from flows escaping from the Palisades project erosion control berm. The suspected overtopping has not been confirmed as no evidence of scour or staining of the berm geotextile is visible and the berm was intact. What can be confirmed however based on photos and interviews with on-site personnel, was the occurrence of limited seepage emanating from beneath the berm (Photo 2). This observed (brown in color) seepage was not free-flowing, even with the contained stormwater and does not appear to be in quantity enough to have caused the landslide.

A meeting on October 16, 2025 with DPW, GEPA, GCLB, the contractor, owner and EOR was called by DPW. At this meeting there was discussion that a contributing factor to this slope failure was seepage flows springing from the side of the cliff face. The basis for this theory was from video taken during the morning of the incident. An excerpt of this video is provided below (Photo 6). Note the water flow is much clearer than what is reflected in Photo 3. One would expect that water from the ponded stormwater contained with the berm would be silty brown in color as shown in Photo 3.

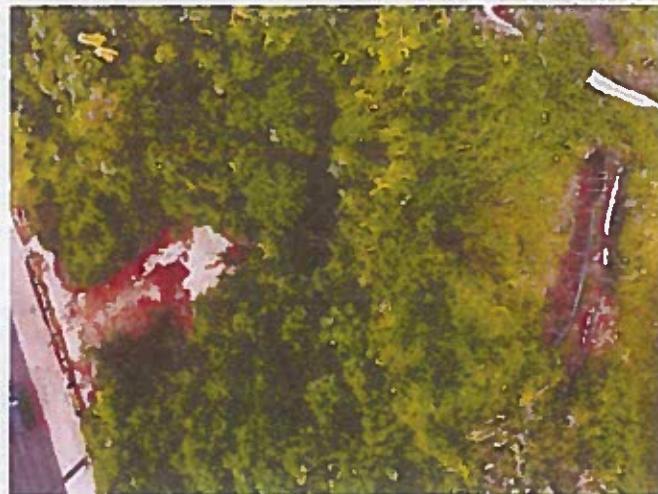
**Photo 4. Subject site on the right, MCD on the left and the area of concern in the center.**

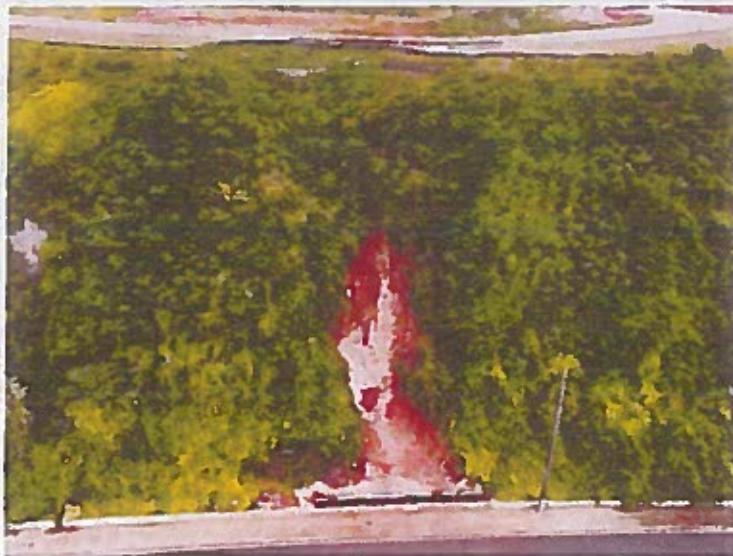
**Photo 5. Alternate view of image above.**

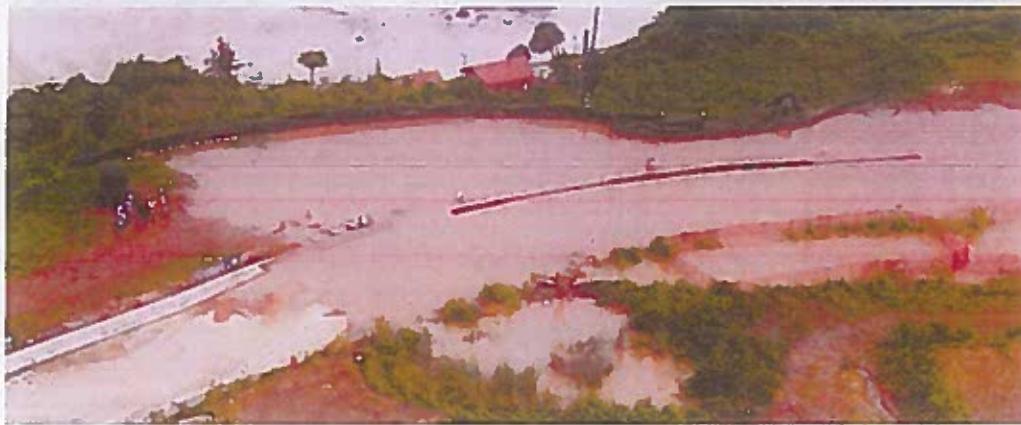
Photo 9. Westerly aerial photo on day of occurrence.

A review of photo 9 indicates the northern location of perimeter ESC berm/silt fence is the lowest top elevation of this ESC system and would be a point of overflow if such an incident were to occur. This was determined by reviewing the water surface and the visual distance to the top of the ESC berm and silt fence. These ESC measures were in place during the time of the occurrence. A second silt fence was under installation by the construction contractor immediately following the incident. The initial ESC system of sandbags and silt fencing was in place this time.

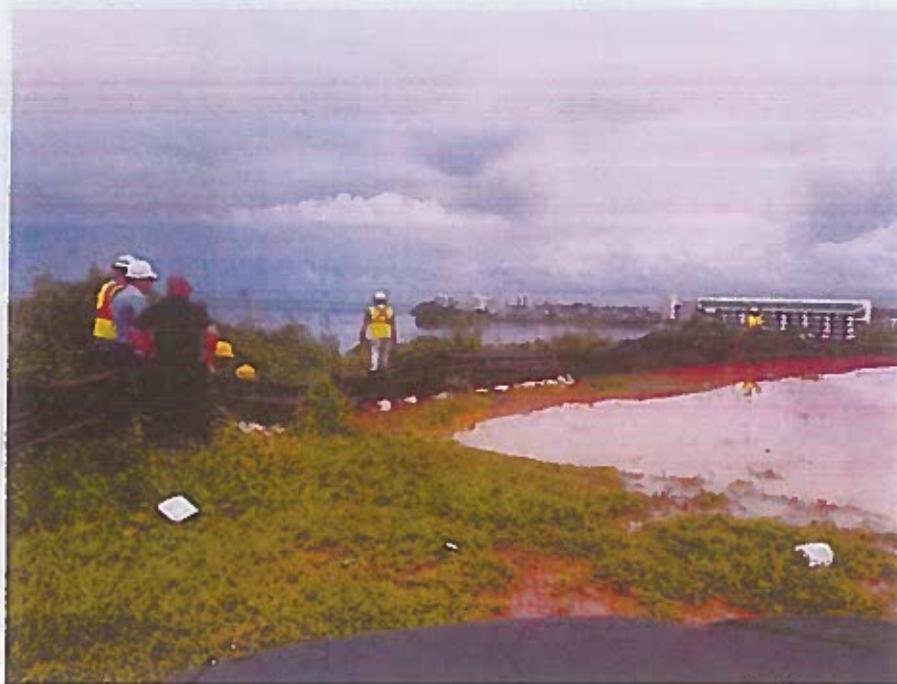
**Photo 10. Intact silt fence and sandbag system with second silt fence installation on day of occurrence.**

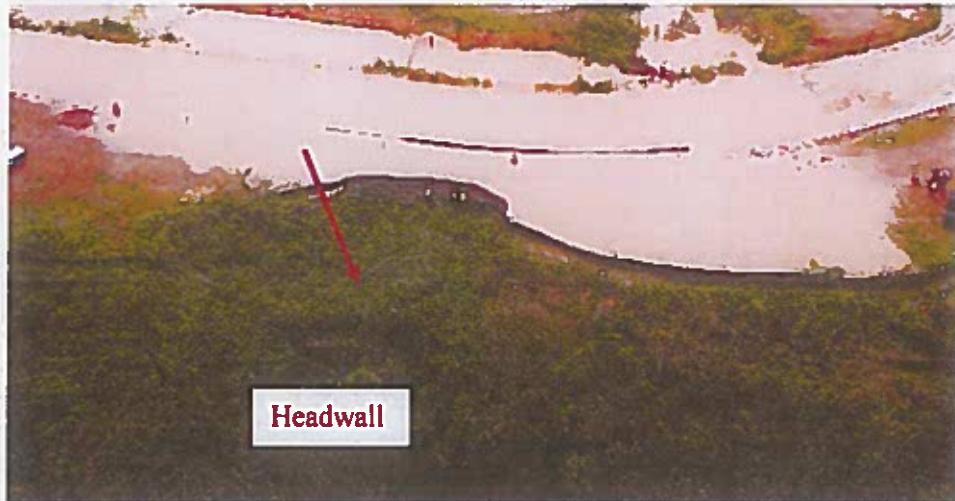
**Photo 11. Easterly aerial photo on day of occurrence.**

Photo 11 has been annotated to reflect flow direction from the low point in the ESC system to an existing head wall. This head wall is connected to the existing storm water drainage system. Open slots in this headwall would allow overtopped flow to drain into this pipe. See photo 11 reflecting this headwall.

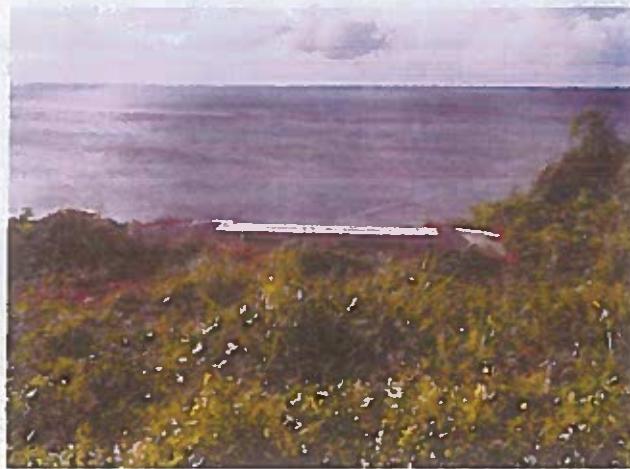
**Photo 12. Headwall Photo reflecting openings taken Oct 24**

If overtopping of the ESC were to occur it would have been directed to this headwall and out the existing discharged pipe rather than toward the area of concern.

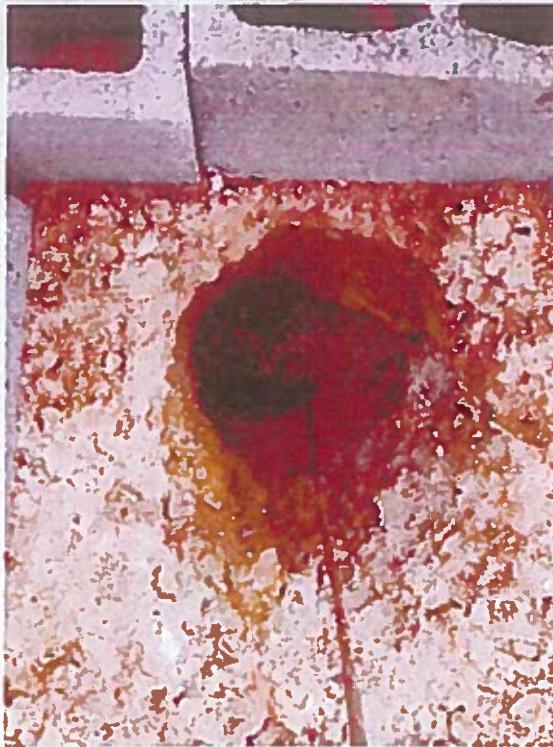
- Of note is a damaged stormwater collection line along this existing stormwater collection system immediately outside of the project site. This damaged line was found as part of the contractor's due diligence investigating possible sources of stormwater flow. The contractor was not previously aware of the damage, which appears to be caused by the removal of an old power pole within the Subdivision on October 10, 2025 by GPA. Photo 13 below reflects a depression where washout occurred.

Photo 13. Damage offsite stormwater collection line
