Ocotillo Express, LLC

Compliance Memorandum in Response to the
November 27, 2013
Summary of Violations Issued by DTSC

Re: Compliance Memorandum in Response to the November 27, 2013,
Summary of Violations Issued by DTSC

Ocotillo Hydraulic Oil Releases

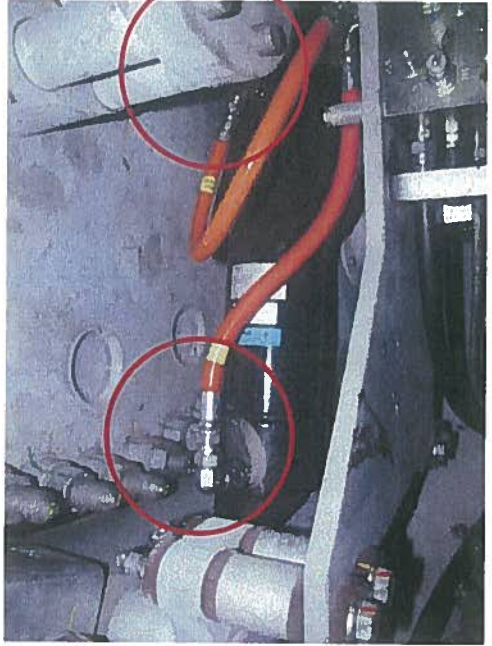
Siemens 2.3 Pitch Cylinder
(similar to a car's shocks)

- The Siemens 2.3 Wind Turbine Generator uses a hydraulic system with approximately 59 gallons of oil to move the blades with pressurize cylinders through a pump station consisting of numerous valves and hoses
- A variety of leak source possibilities exist and are being analyzed in each unit including oil pressure, hose failures, fitting failures and system parameters. To validate the cause, Siemens has to revisit and test each potential theory.

- 22 releases have reached the ground and have been properly and promptly addressed
- Potential Solution: Torque check hydraulic hose fittings
 - A part by part condition assessment checklist was created for technicians to follow and to use to check torque settings and o-rings for proper specifications.
- Comprehensive systems in place to address releases
 - Crews and system diagnostics regularly monitor the turbines for these conditions locally and remotely
 - Upon discovery and notification, crews initiate ground inspections and coordinate clean-up based on the nature of the leak
 - Re-inspections are also used to ensure seepage is evaluated after initial clean-up
