# Aviation Investigation Preliminary Report

| <b>Location:</b> | Lafayette, LA | <b>Accident Number:</b> | CEN24FA353 |
| <b>Date &amp; Time:</b> | September 12, 2024, 11:37 Local | <b>Registration:</b> | N643RS |
| <b>Aircraft:</b> | HAWKER BEECHCRAFT CORP G36 | <b>Injuries:</b> | 1 Fatal |

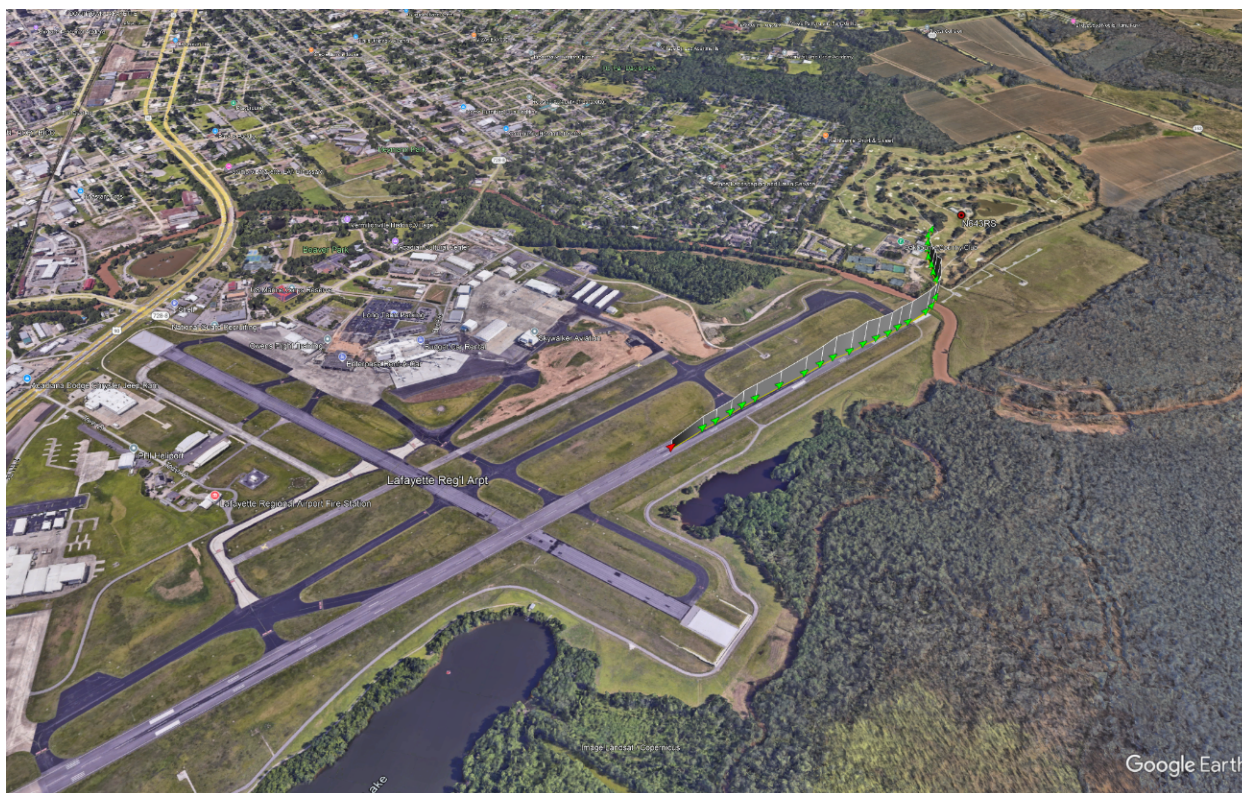
The airplane had just departed from runway 4R at the Lafayette Regional Airport (LFT), Lafayette, Louisiana. Automatic Dependent Surveillance-Broadcast (ADS-B) data showed that the airplane lifted off the runway and achieved an altitude of about 200 ft above ground level (agl) by the time it reached the departure end of the runway. The airplane then made a slight left turn followed by a right turn before the data ended. The final recorded altitude was 25 ft agl and the last recorded location was about 450 ft from the accident location. The airplane impacted a golf course about 2,000 ft and 15 degrees from the departure end of runway 4R.

Figure 1. A 3-dimensional representation of the airplane's flight path.

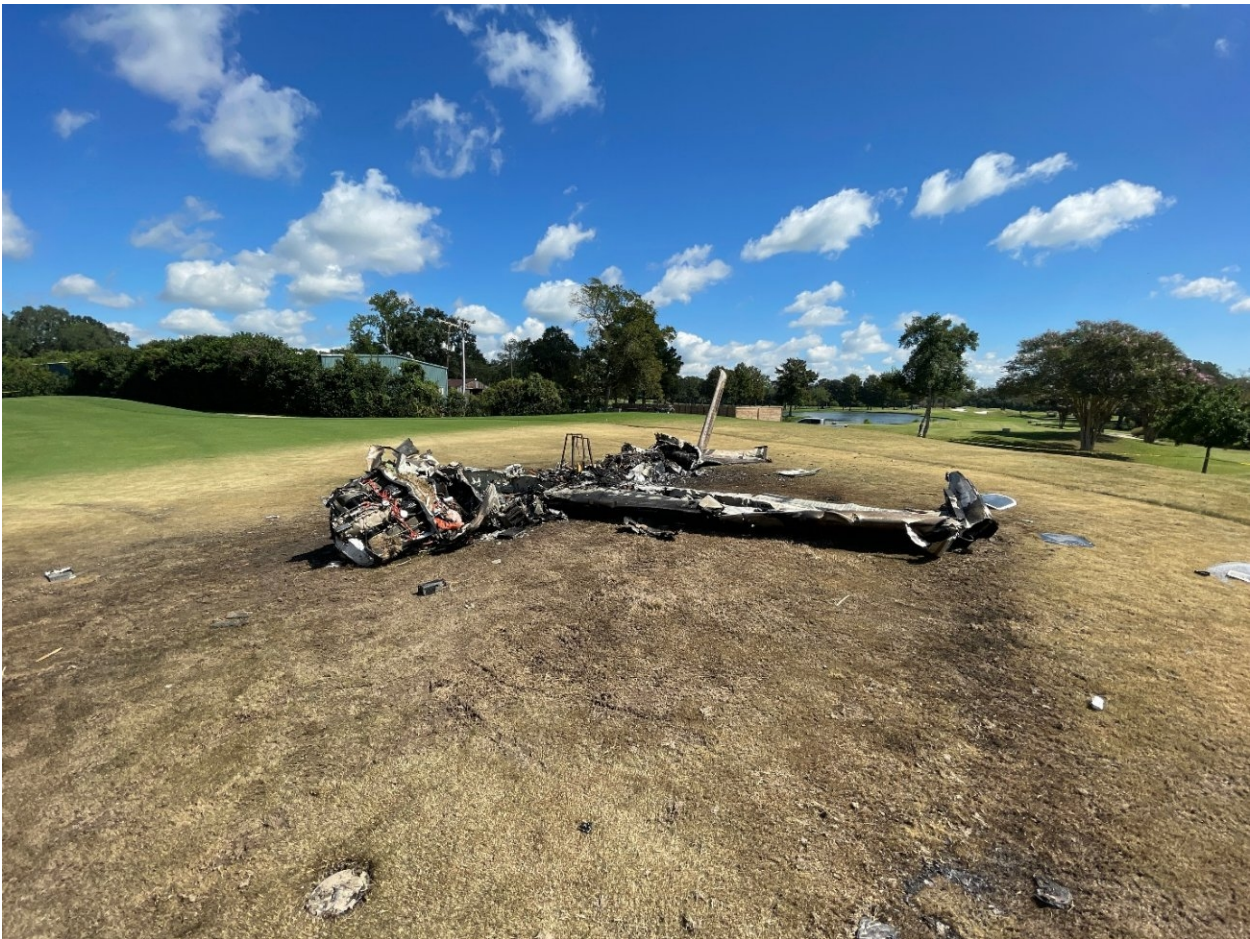
The airplane came to rest on a golf course fairway. There were broken tree limbs near the initial impact location. The wreckage debris path was oriented about 60 degree magnetic heading. The wreckage damage was consistent with a right-wing, nose-low impact. The wreckage debris path was about 150 ft from the initial ground scar to the resting place of the main wreckage. Fire consumed the majority of the fuselage cabin and inboard portions of both wings. The aft fuselage cone and tail surfaces were rotated about 90 degrees to the left. The vertical tail and right horizontal stabilizer remained attached to the aft fuselage. The left horizontal stabilizer was partially separated and folded beneath the aft fuselage. The elevators and rudder were still attached to their respective fixed surfaces.

Remains of both wings were located in their appropriate position relative to the fuselage remains. No evidence of an in-flight failure was noted. Both ailerons remained attached to the wings. The left flap was still attached to the wing. The right flap was almost completely consumed by the fire but the inboard portion remained attached to the wing. The airplane's flight control system was examined and no evidence of a flight control malfunction was found. The cabin section of the airplane was consumed by fire. Evidence of fire was found on the forward side of the firewall with burning and melting of components adjacent to the firewall.

Figure 2. An image of the airplane wreckage at the accident site.
