National Transportation Safety Board Aviation Accident Preliminary Report

Location:	Medford, OR	Accident Number:	WPR22FA055
Date & Time:	December 5, 2021, 16:52 Local	Registration:	N64BR
Aircraft:	Piper PA-31-350	Injuries:	2 Fatal
Flight Conducted Under:	Part 91: General aviation - Personal

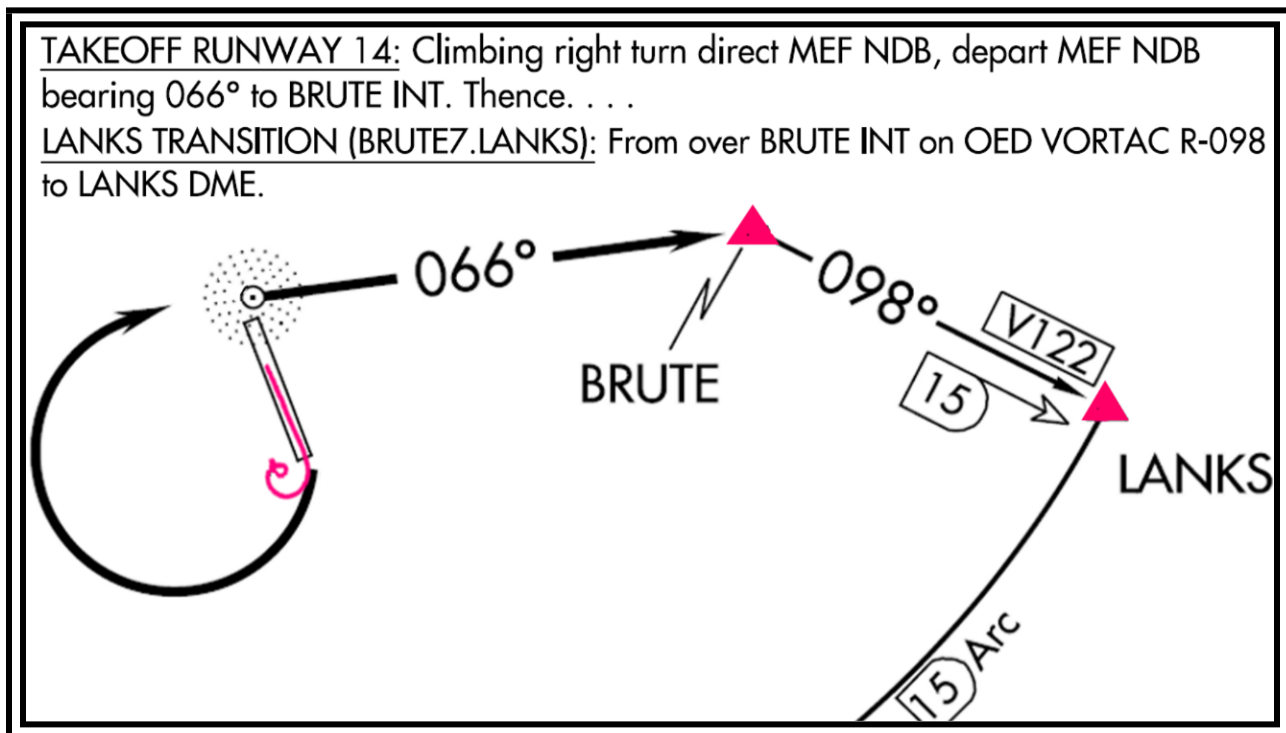
After receiving the clearance, the controller informed the pilot the overcast layer base was at 200 ft above ground level (agl) the tops of the layer was at 2,500 ft. After the airplane departed the pilot made a radio communication to the controller asking "will you be calling my turn for the BRUTE7?" The controller replied that he would not be calling his turn and that the pilot should fly the departure as published making a climbing right turn to overfly the approach end of runway 14 before proceeding to the BRUTE intersection (see Figure 1 below). The pilot acknowledged the communication, which was his last transmission. Several seconds later, the controller stated that he was receiving a low-altitude

alert that the airplane's altitude was showing 1,700 ft. He made several attempts to reach the pilot with no response.

Figure 1: The airplane's flight track overlaid on a visual depiction of the BRUTE7 Departure.

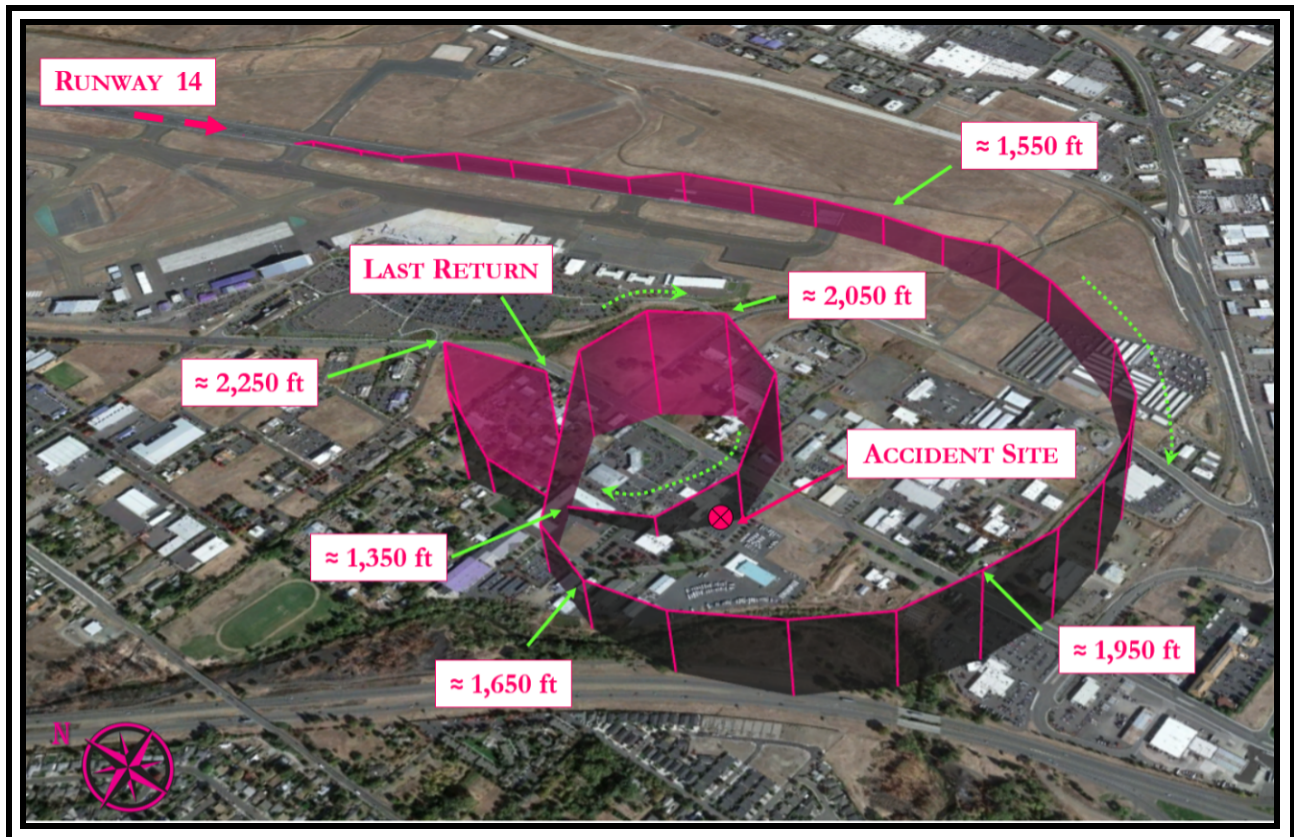
The radar and automatic dependent surveillance-broadcast (ADS-B) information disclosed that the airplane arrived in the run-up area for runway 14 about 1643 and then continued onto the runway about 6 minutes thereafter. The airplane departed about 1649:30 and after crossing over the south end of the runway, it climbed to about 1,550 ft mean sea level, equivalent to 200 ft agl (see Figure 2 below). The airplane then began a gradual right turn and climbed to 1,950 ft maintaining an airspeed between 120-130 kts. As the airplane turn continued to the north the altitude momentarily decreased to 1,650 ft (about 350 ft agl) with the airspeed increasing to 160 kts. Thereafter, the airplane then increased the bank angle and made a 360-degree turn initially climbing to 2,050 ft. At the completion of the turn, the airplane descended to 1,350 ft, consistent with it maneuvering below the cloud layer. The airspeed increased to about 160 kts and several seconds later, the airplane climbed to 2,250 ft with the derived airspeed showing below 15 kts. Six seconds later was the last radar return, located about 990 ft north-northwest of the accident site.

Figure 2: The airplane's ADS-B flight track.

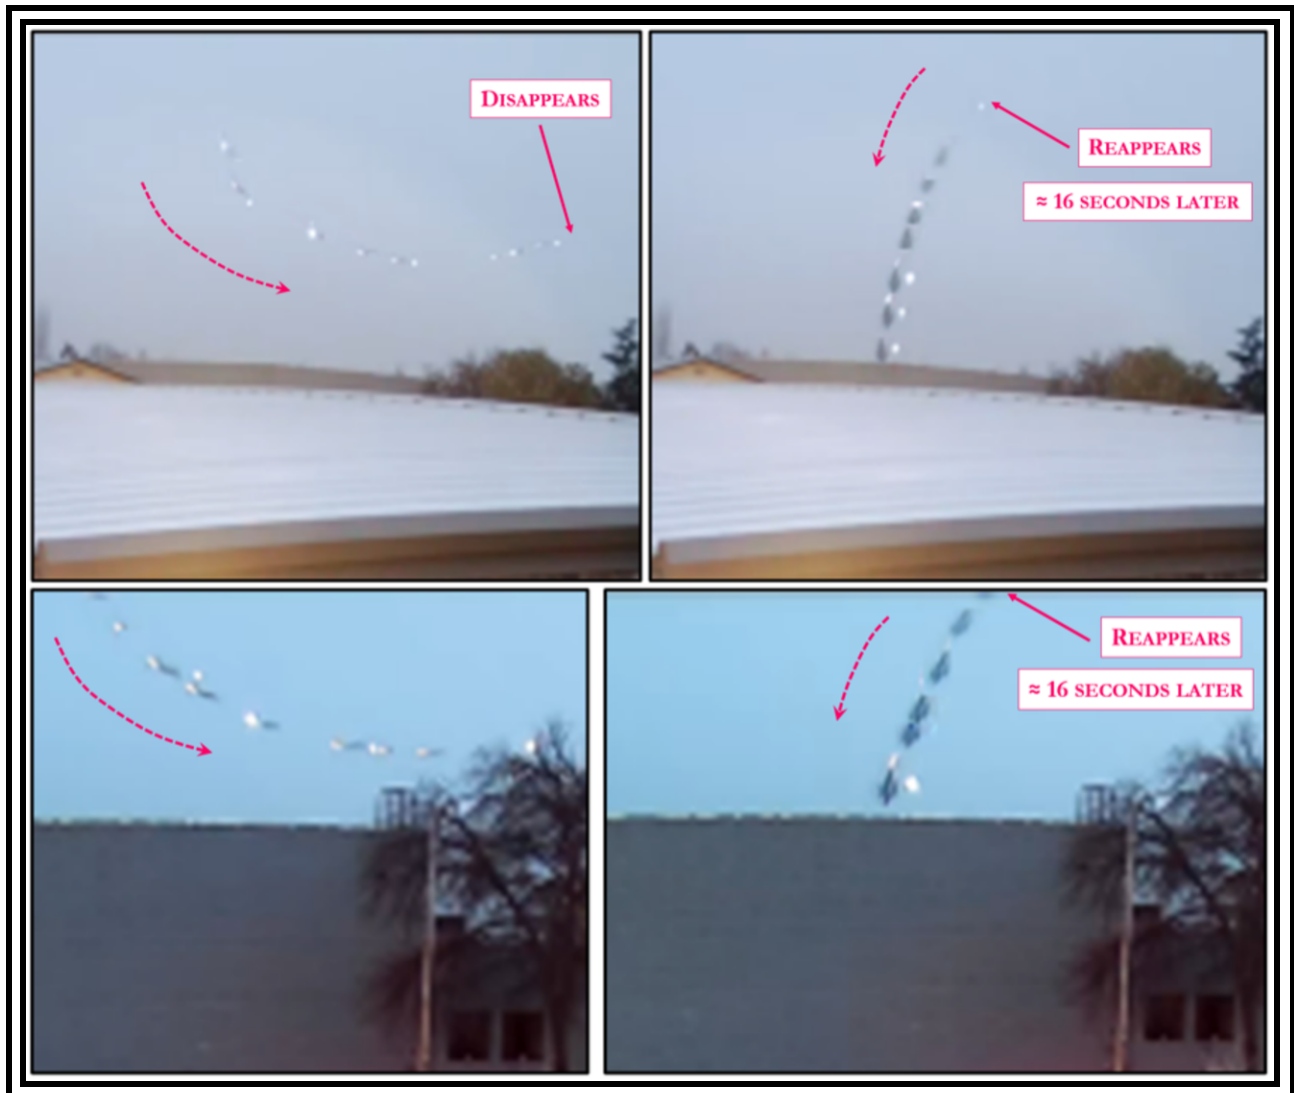
Video footage was obtained from several fixed security cameras on buildings around the accident site. A review of the footage revealed that the airplane descended below the cloud layer and then climbed back up. About 16 seconds thereafter, the airplane is seen descending in a near vertical attitude (see Figure 3 below). The airplane's position and strobe light appeared to be illuminated throughout the video. The preliminary review of the recorded audio from the camera footage revealed that there were sound components at frequencies that correspond to the normal operating speed range of the airplane engines.

Figure 3: Excerpts of security camera footage

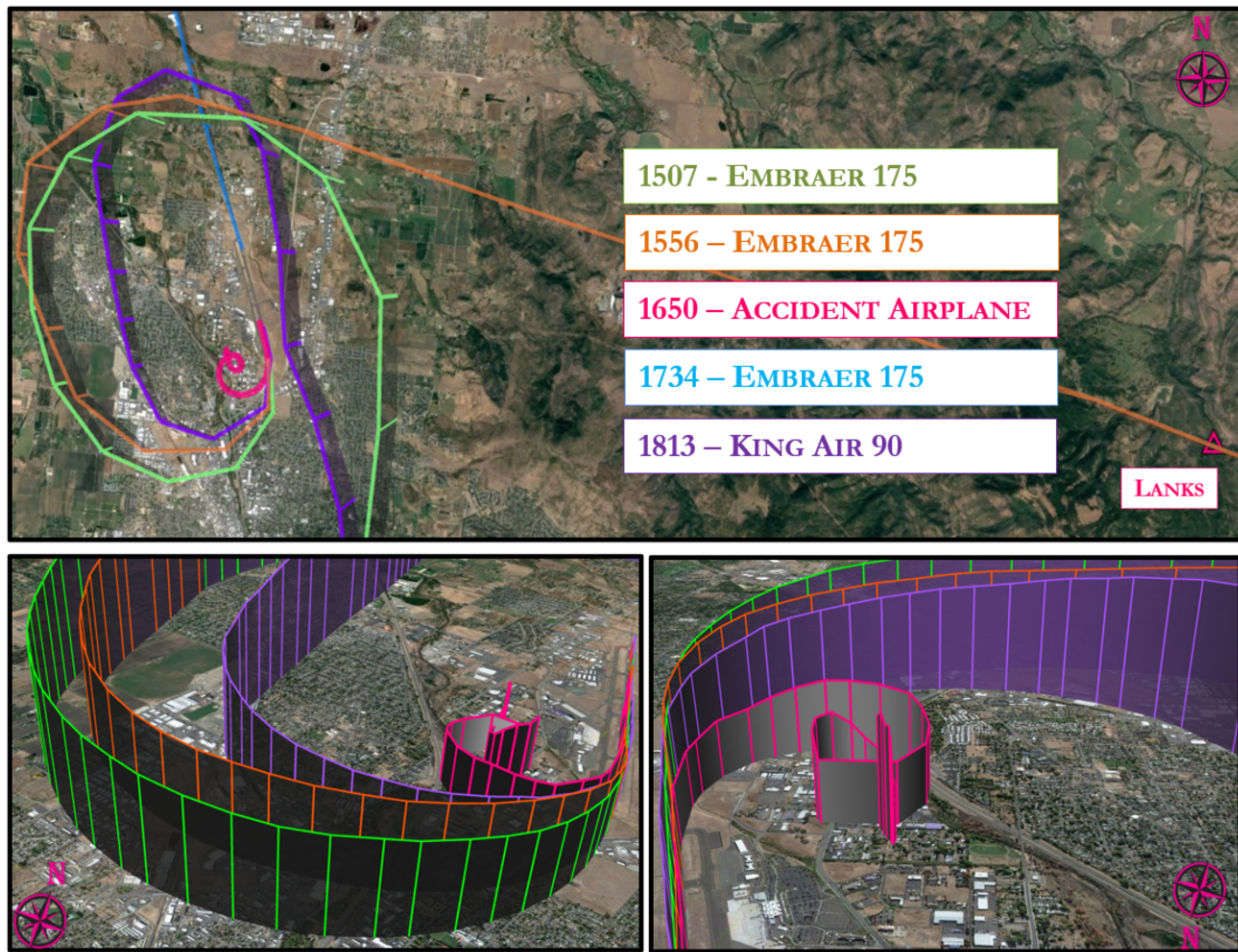
Investigators compiled a comparison of ADS-B data from two airplanes that departed before the accident airplane (at 1507 and 1556) and two that departed after (1734 and 1813). A comparison of flight tracks from the three airplanes that departed runway 14 revealed that all began the right turn after the accident flight (see Figure 4 below).

Figure 4: Comparison of flight tracks from other airplanes' departures before and after the accident flight.
