**NORTH MEDFORD GYM COLLAPSE
MEDFORD, OR
STRUCTURAL EVALUATION**

KPFF PROJECT No. 10022500117

DATE
MAY 5, 2025

NORTH MEDFORD GYM COLLAPSE STRUCTURAL EVALUATION

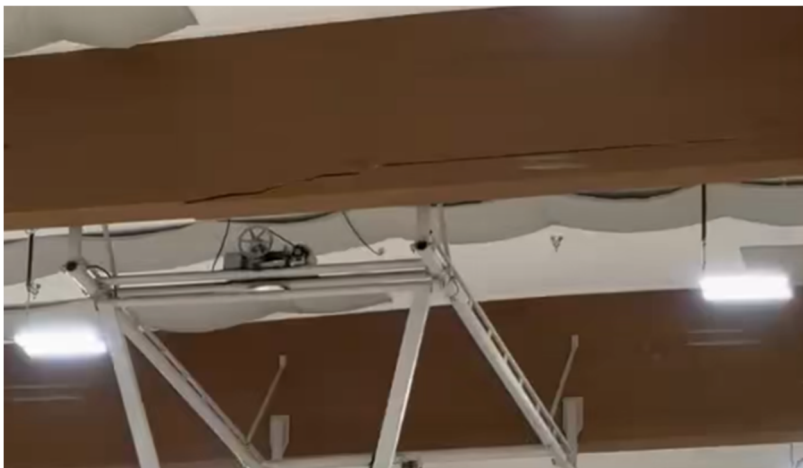
Figure 1 – Beam A Initial Failure

It was first reported that Beam A cracked near mid-span on February 7, 2025. Review of photo and video documentation show the failure initiated near a scarf joint near mid-span at the bottom lamination. The crack propagated upward and north in a flat "V" pattern which is typical of a bending failure in wood beams. The first crack also extended north through one of the connections supporting the basketball hoop below.

A video of the initial crack in Beam A appears to indicate that it originated at a location of a scarf joint in the bottom lamination. Photos of the initial crack in Beam B also exhibit similar signs. Review of the 3D scan of the pre-collapse gym appears to indicate a delaminated scarf joint in Beam B where the crack seen on February 8, 2025, appears to have originated.

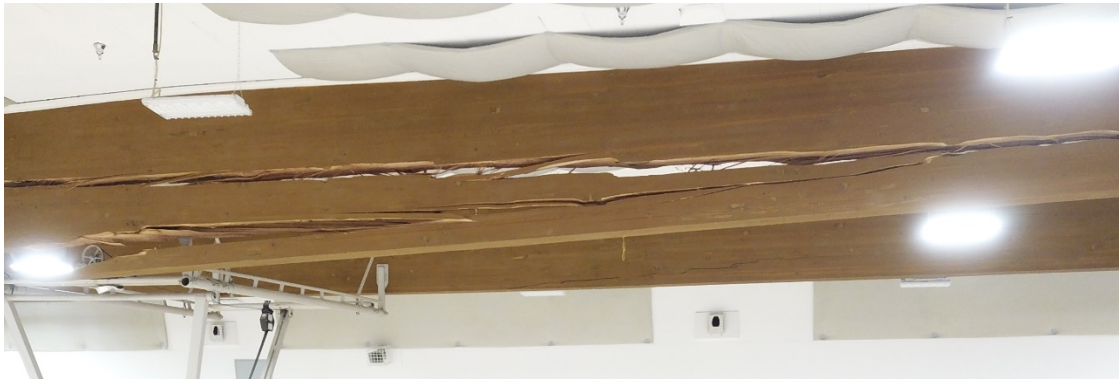
Figure 2 – Beam B Crack

Photos of Beam A's initial crack also show a hairline crack forming in Beam B. Beam B's crack also initiated at the bottom lamination at a scarf joint near mid-span.

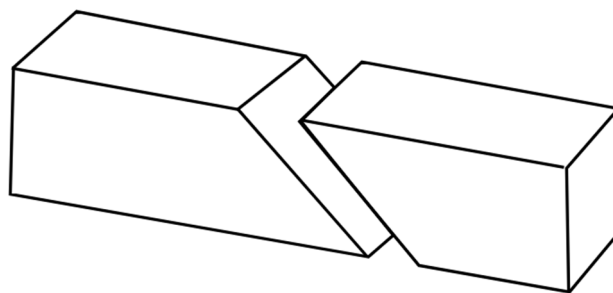
Figure 3 – Scarf Joint

Based on visual observation of the failed beams, the beams were manufactured using Douglas-Fir lumber with 1.5-inch net laminations and sloped scarf joints for individual lumber end joints. A scarf joint is a long-tapered cut on each timber piece which is then overlapped and glue laminated together to transfer tension and compression forces. See Figure 3.

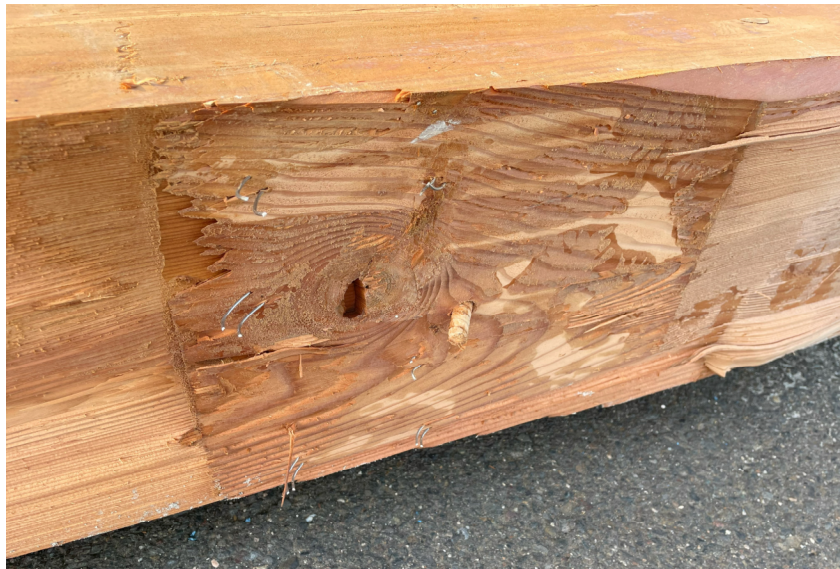
Figure 5 – Failed Scarf Joint

Review of the collapsed beams on site after demolition and removal consistently showed relatively clean scarf joints that indicate poor glue lamination and bonding at scarf joints.

We reached out to experts in the field of glulam construction, and it is our understanding that laminating scarf joints is challenging and therefore it is not uncommon to find pre-maturely failed scarf joints in glulam beams from this time period.

It is our opinion that the manufacturing and delamination of the scarf joints for the glulam beams was a contributing factor in the beam's failure.

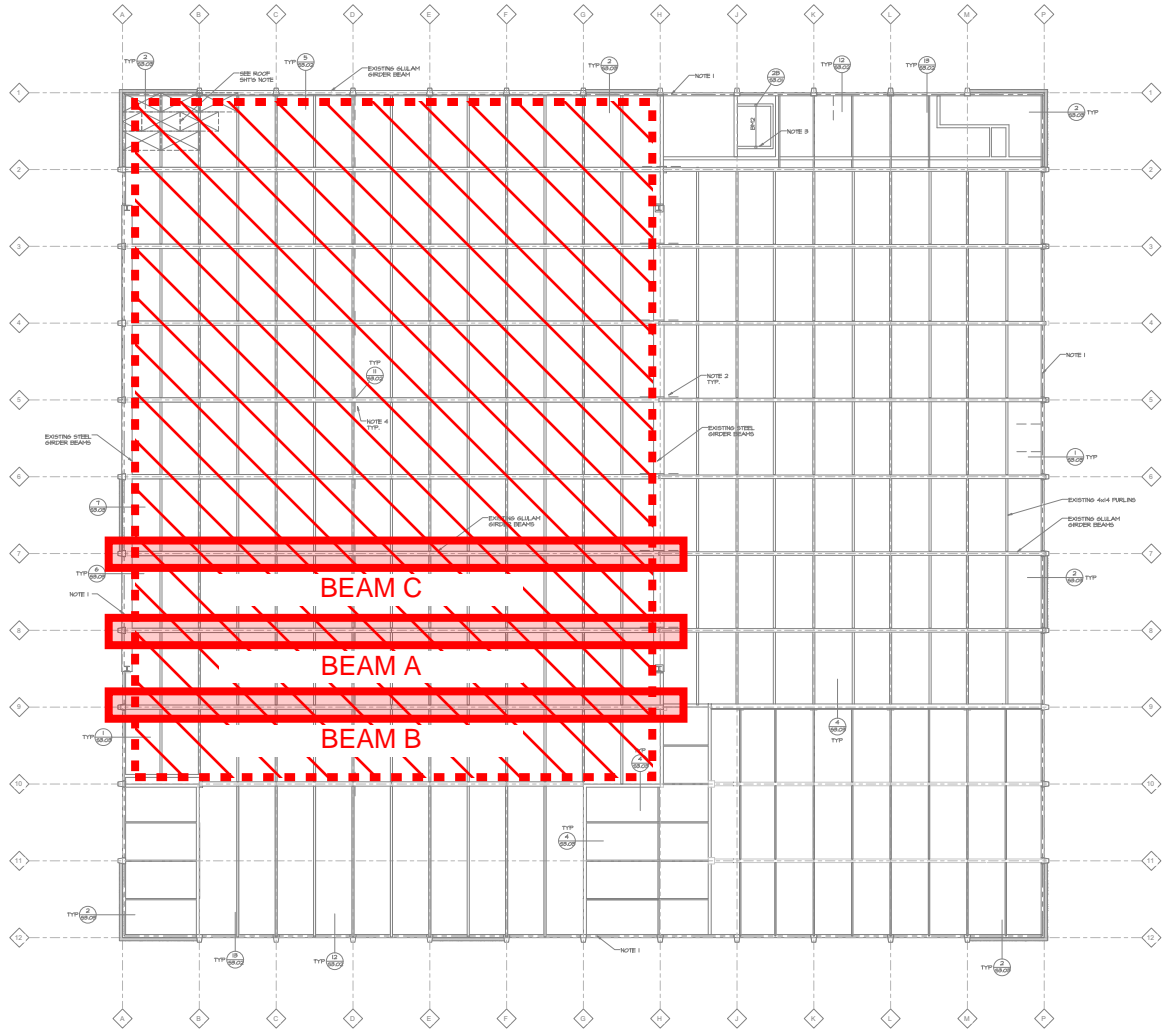
Project	North Medford Gym Collapse	By	KMR	Sheet No. A.1
Location	Medford, OR	Date	4/23/25	
Client	Medford School District	Revised		Job No.
Appendix A - Roof Plan			Date

ROOF BEAM THAT EXHIBITED INITIAL SIGNS OF FAILURE

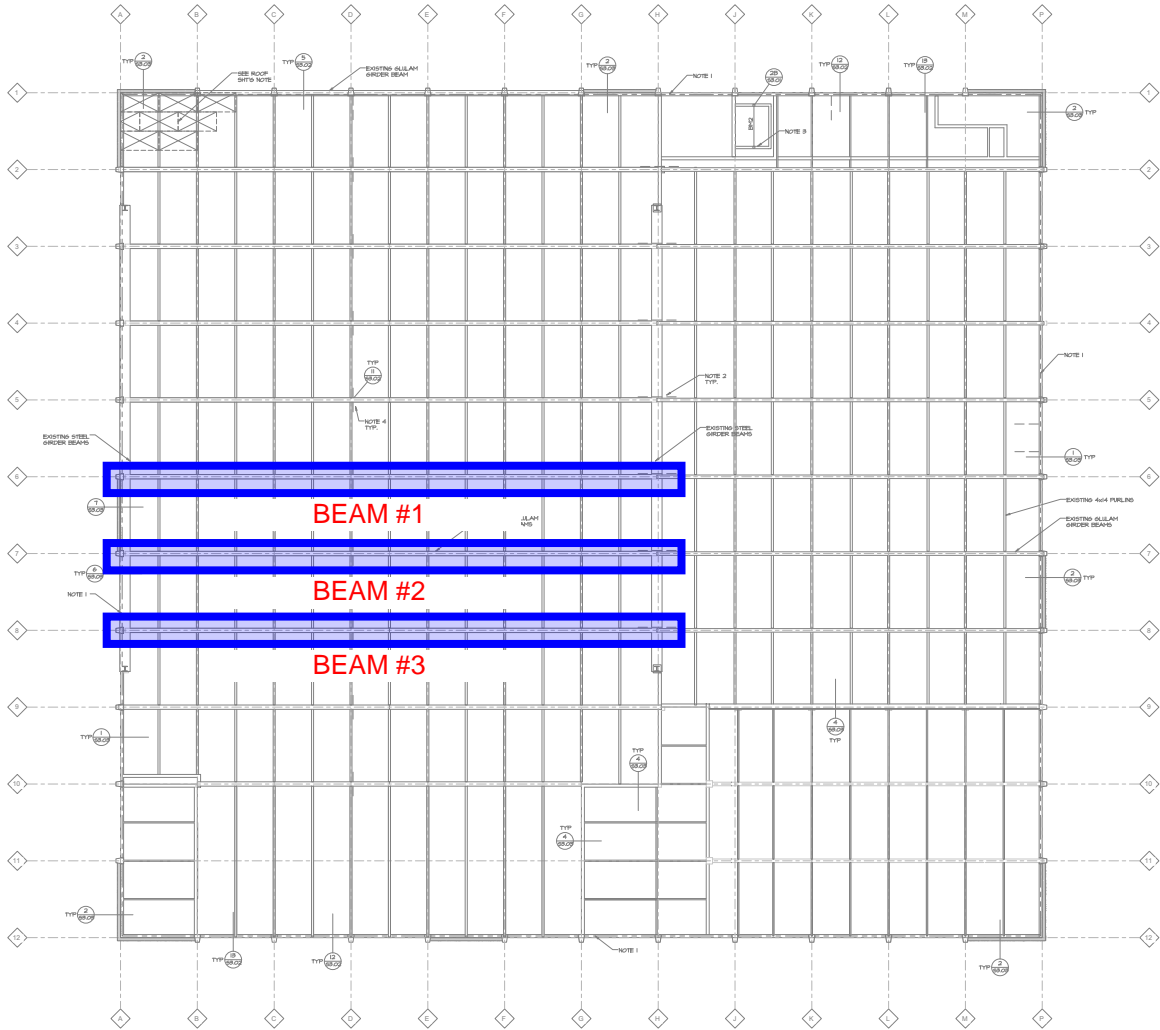
Project	North Medford Gym Collapse	By	KMR	Sheet No. B.1
Location	Medford, OR	Date	4/23/25	
Client	Medford School District	Revised		Job No.
Appendix B - Beam Locations			Date

Three of the gym roof glulam beams which had initially failed were observed after they had been removed from the structure. Appendix B provides a plan identifying these beams in the gym in the pre-collapse. These elements were visually inspected, probed with an awl, and evaluated with a resistograph to determine the presence of decay. Images of the beams after removal were also taken.

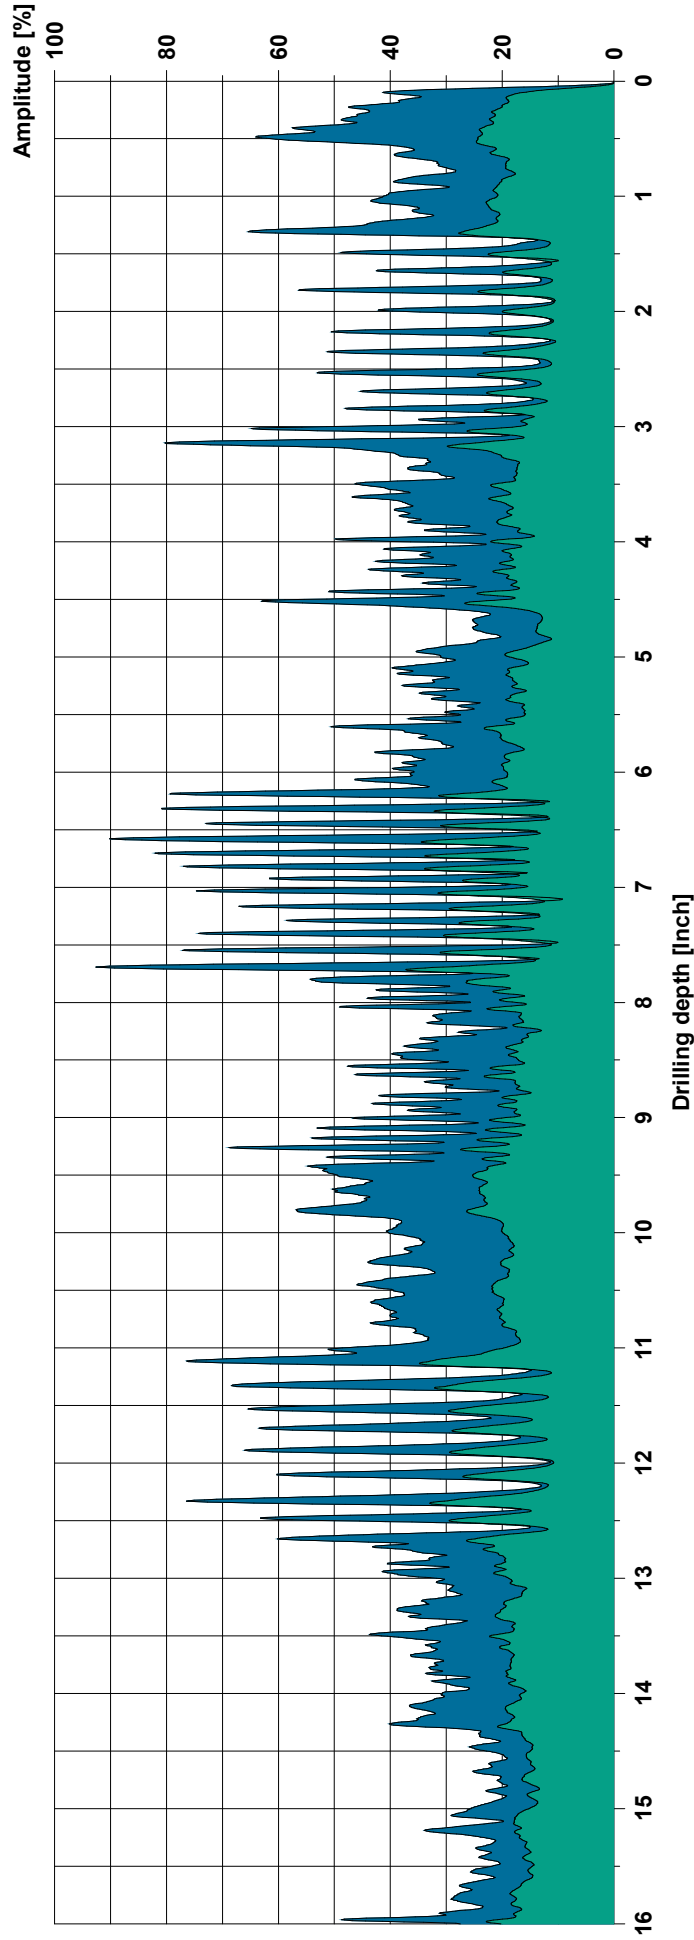
Sound wood throughout measurement

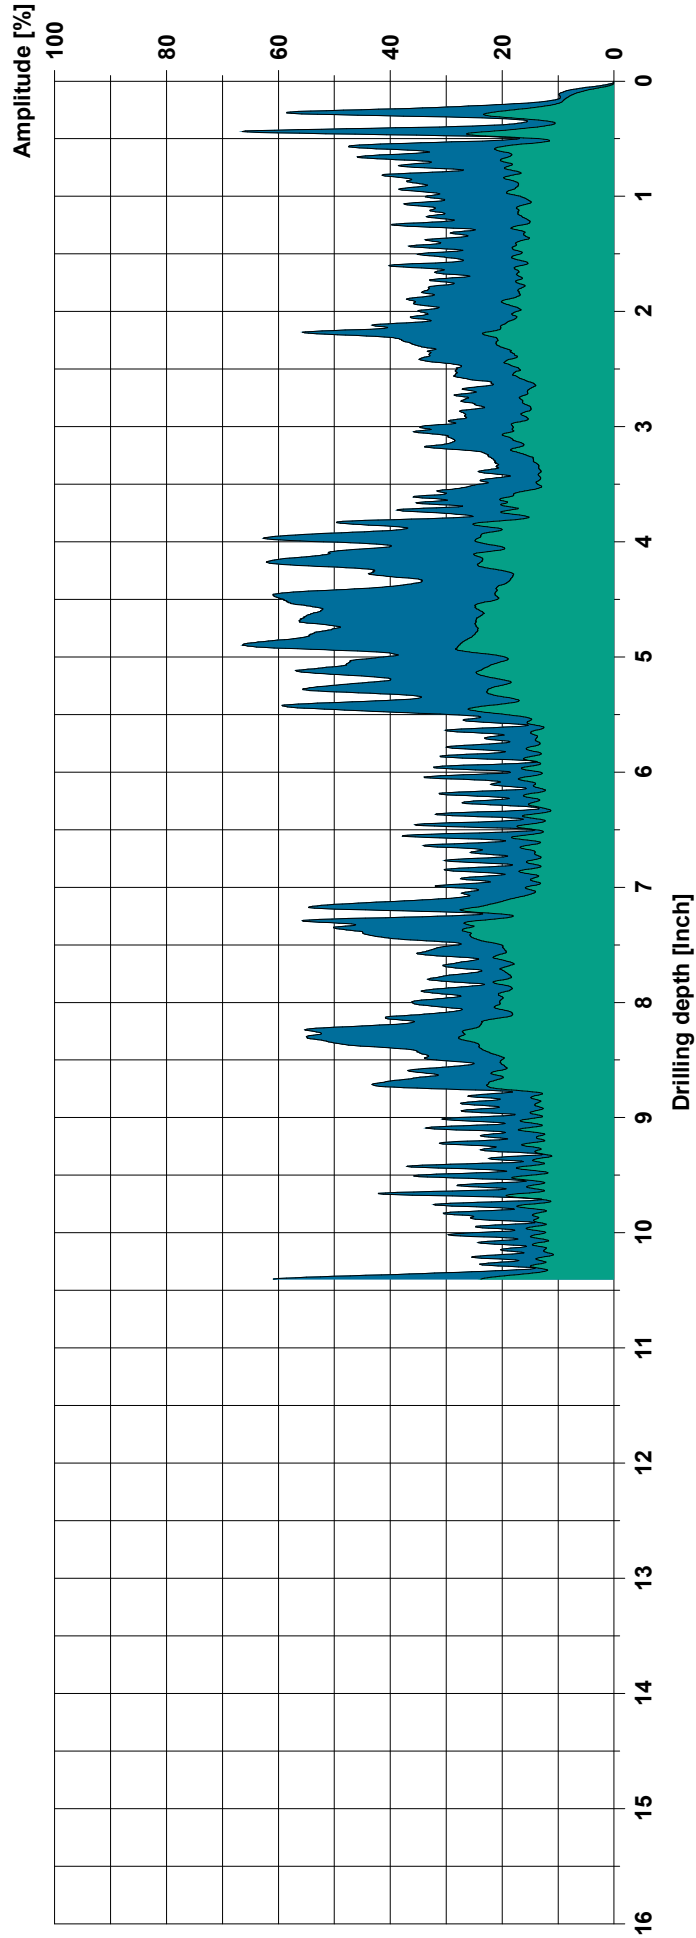
Sound wood throughout measurement

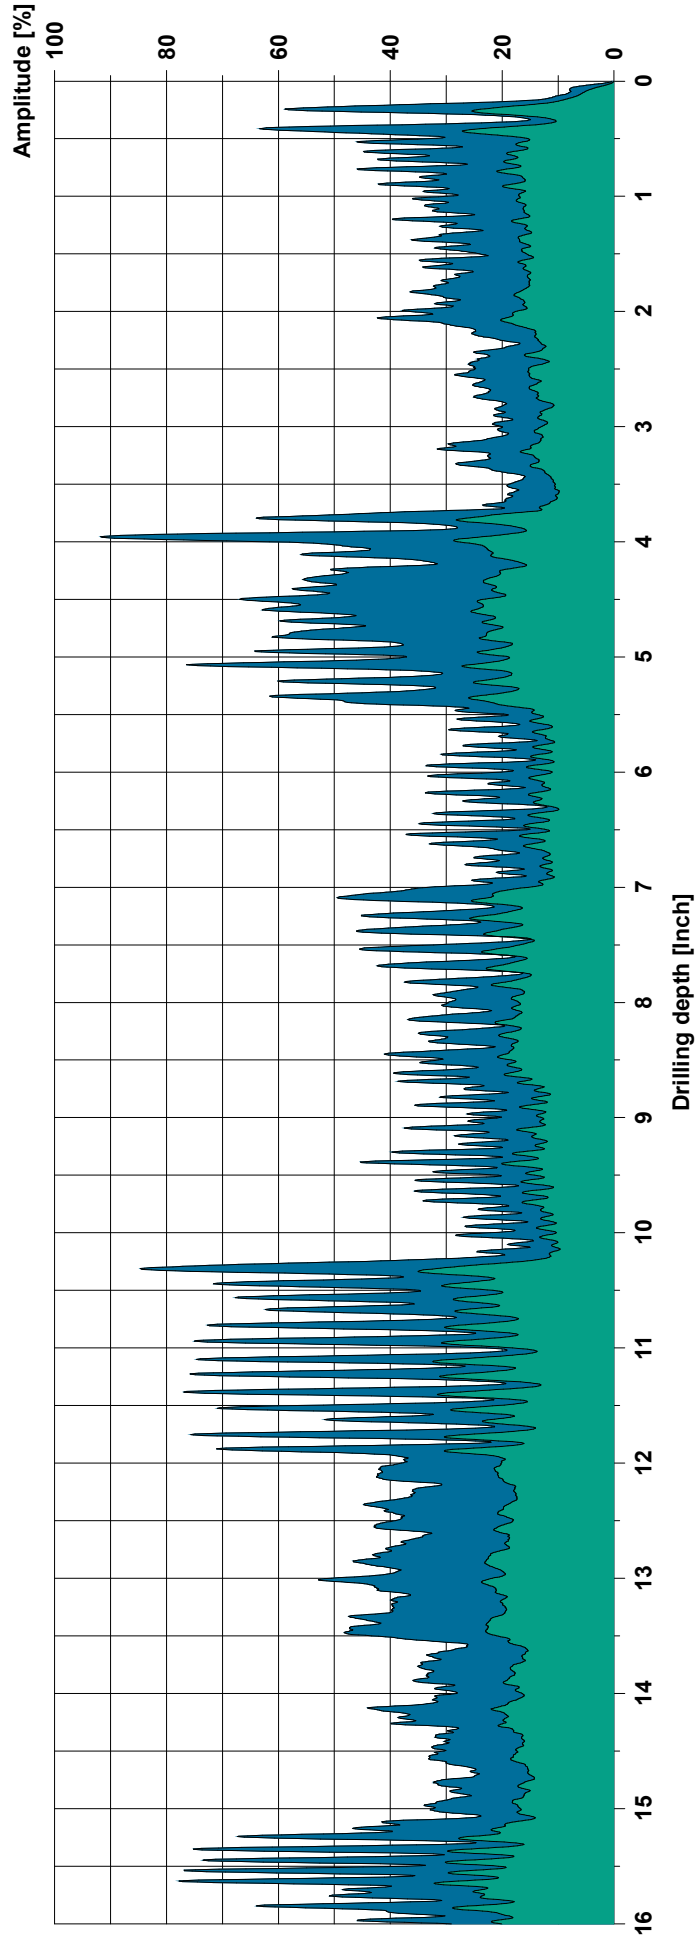
Sound wood throughout measurement

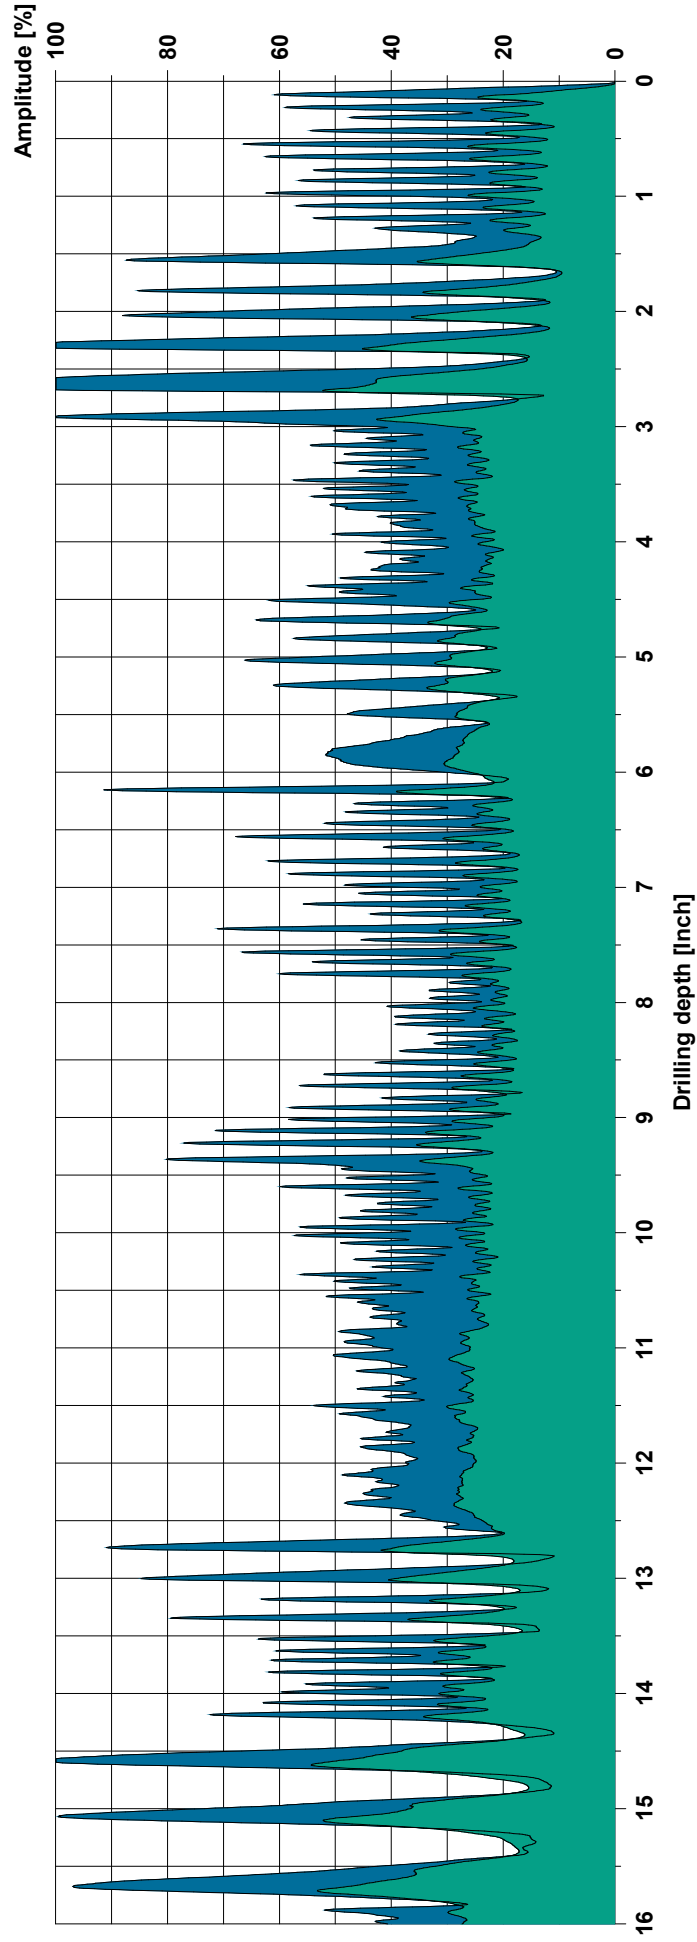
Sound wood throughout measurement

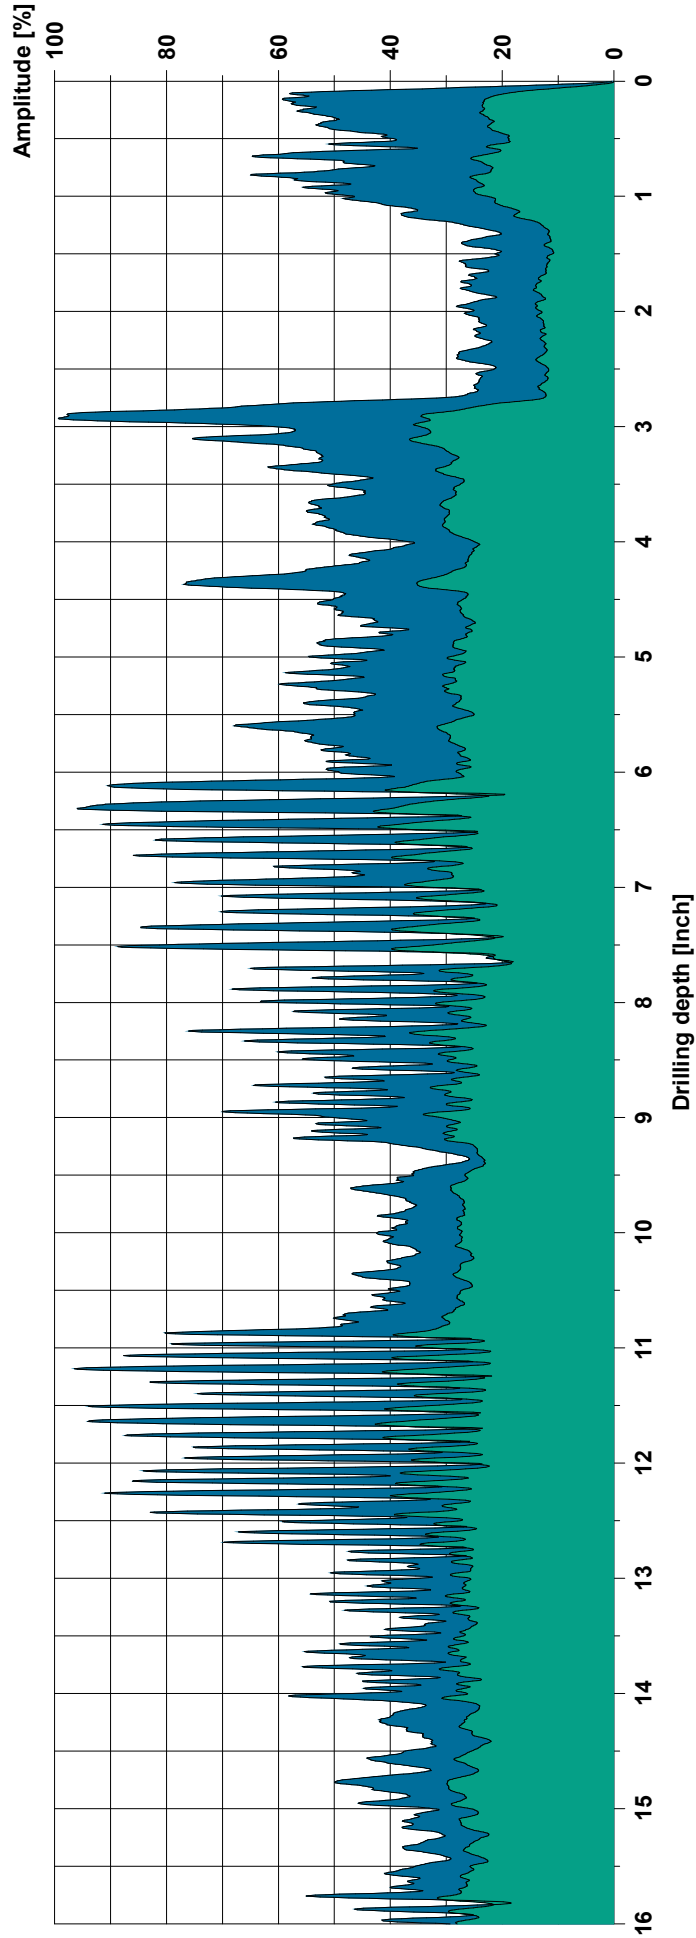
Sound wood throughout measurement

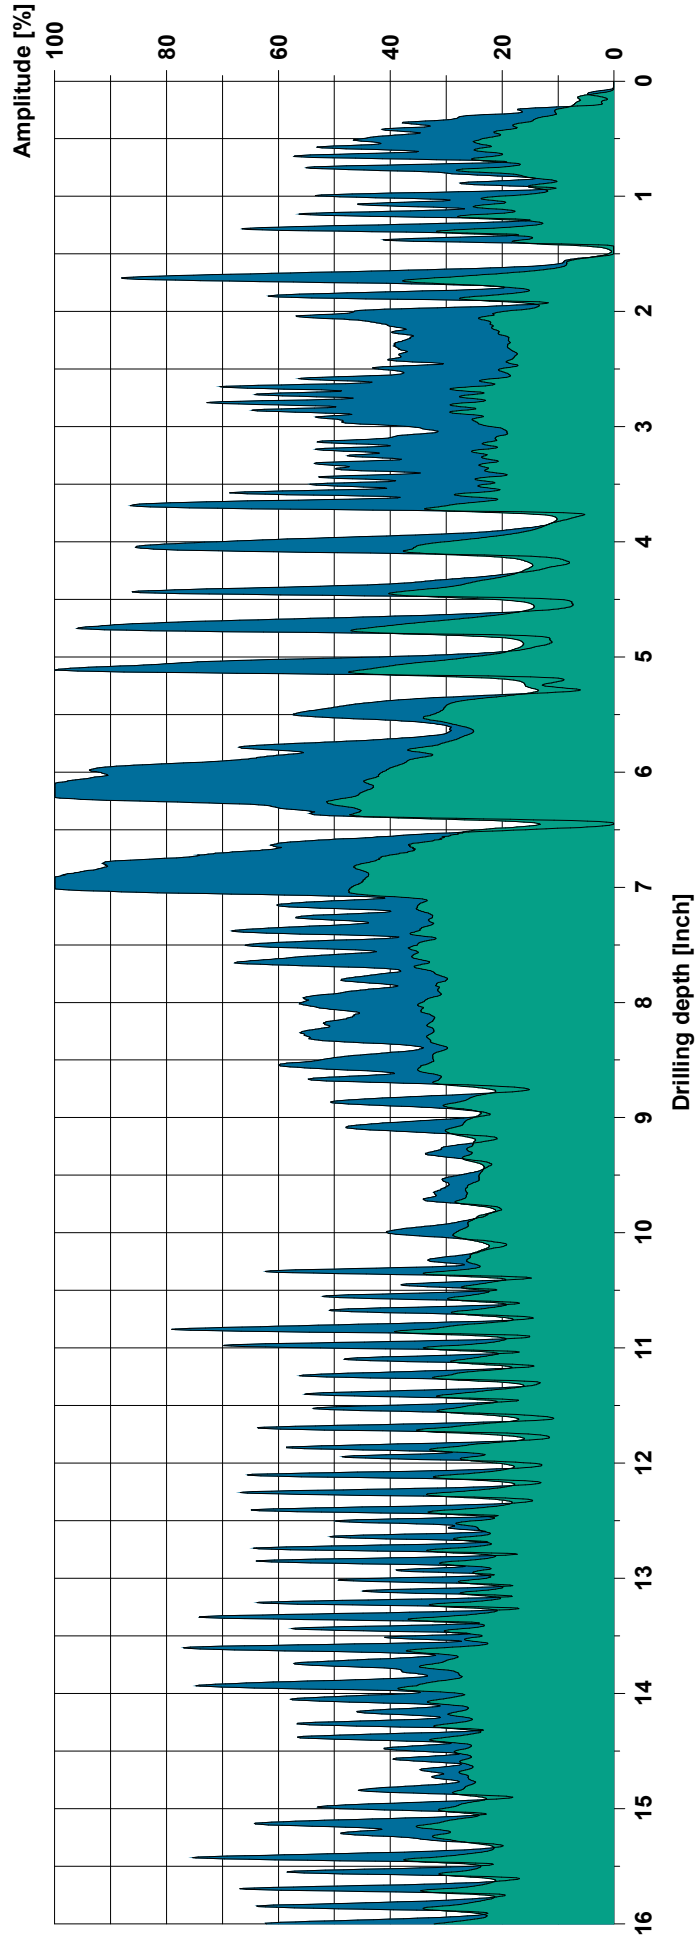
Crack encountered at 1.5" and 6.5".

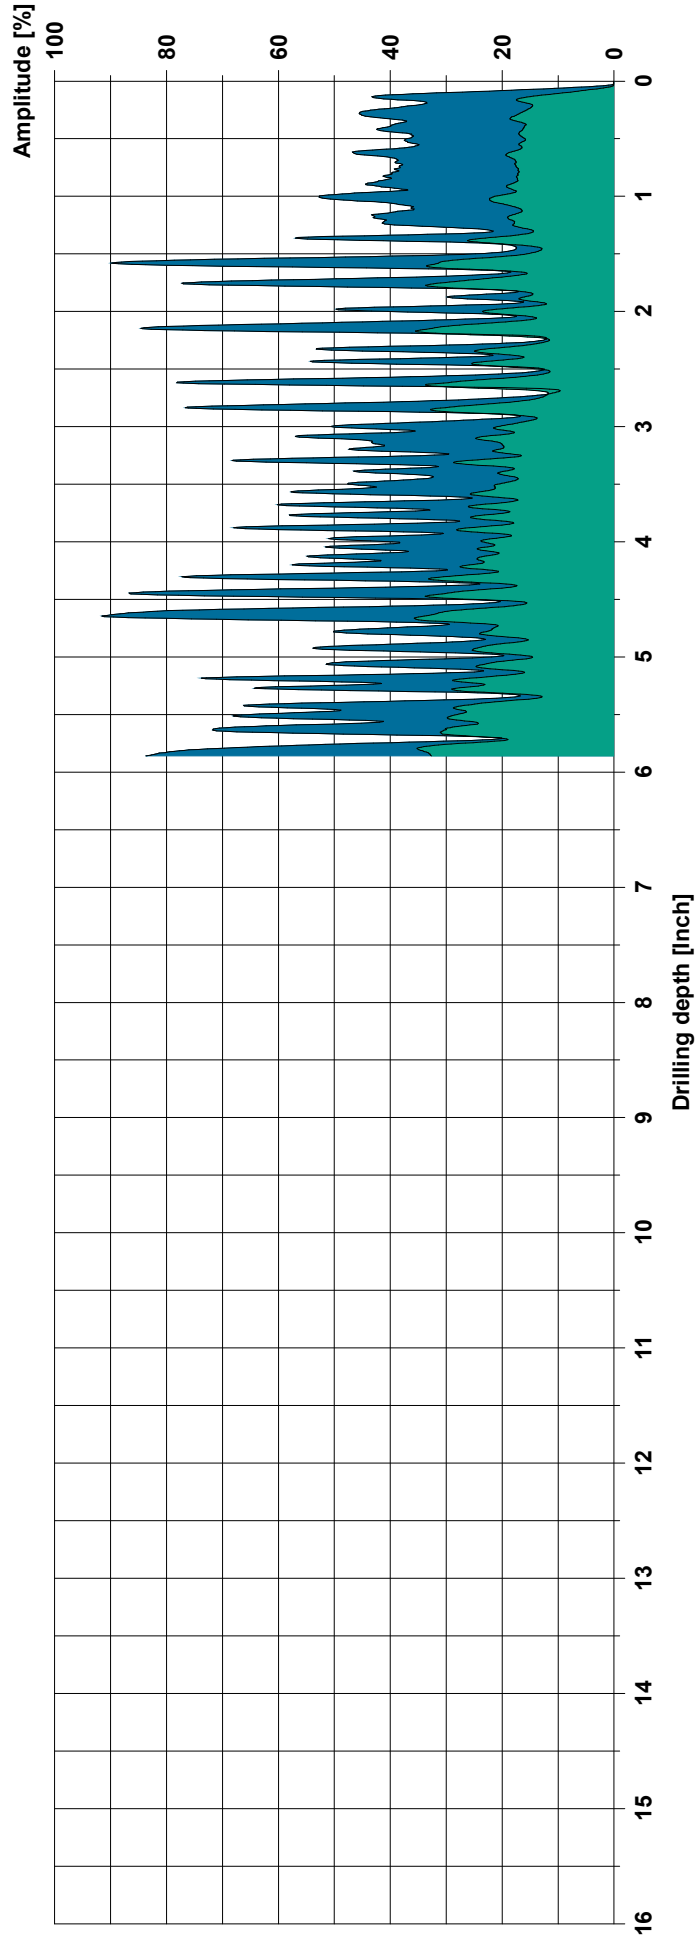
Sound wood throughout measurement

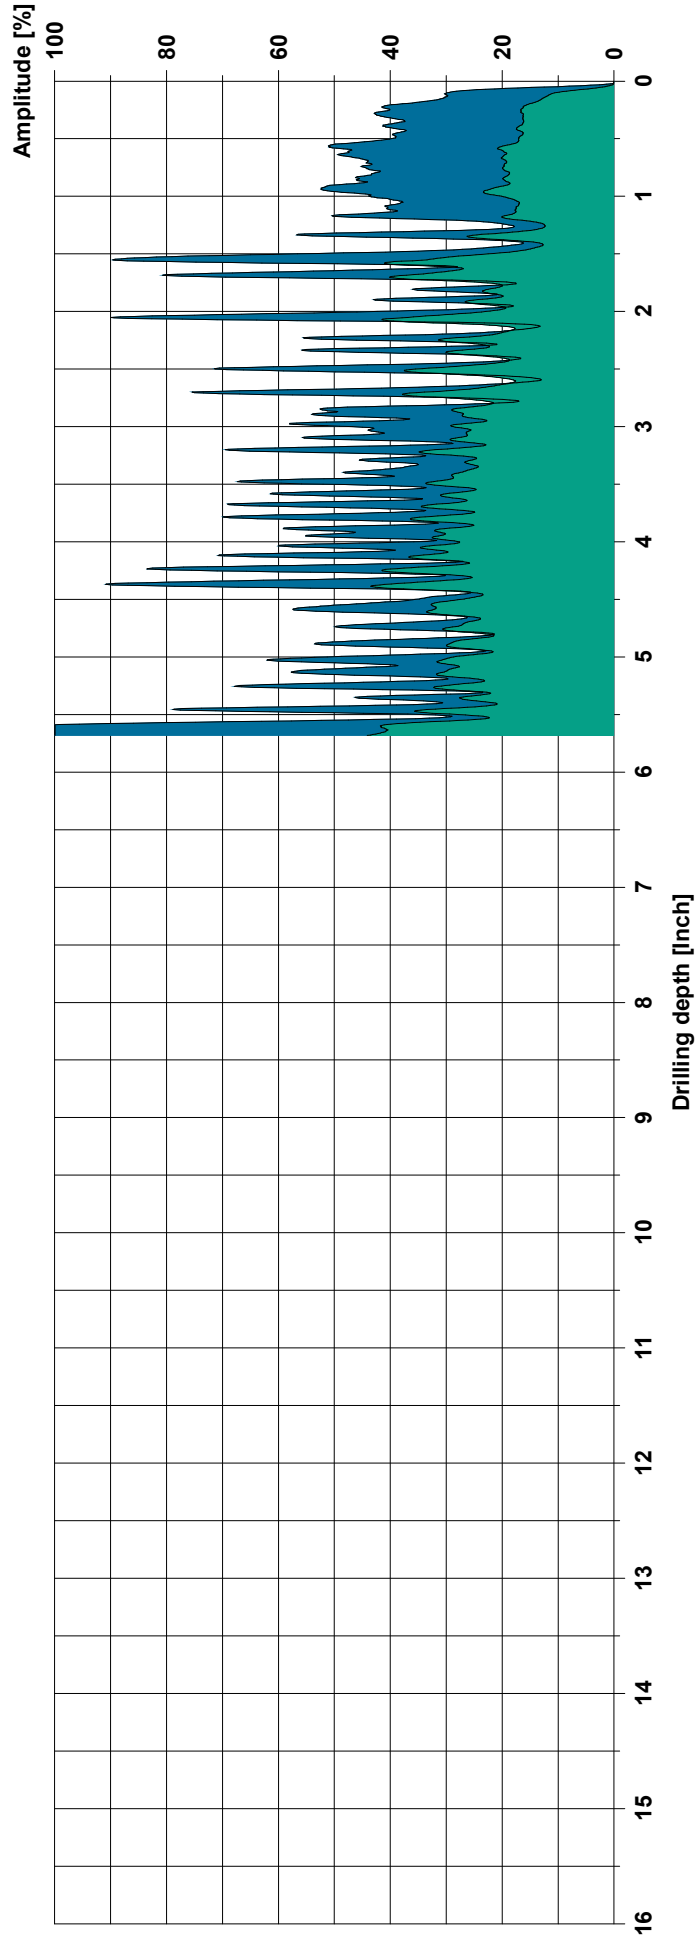
Sound wood throughout measurement

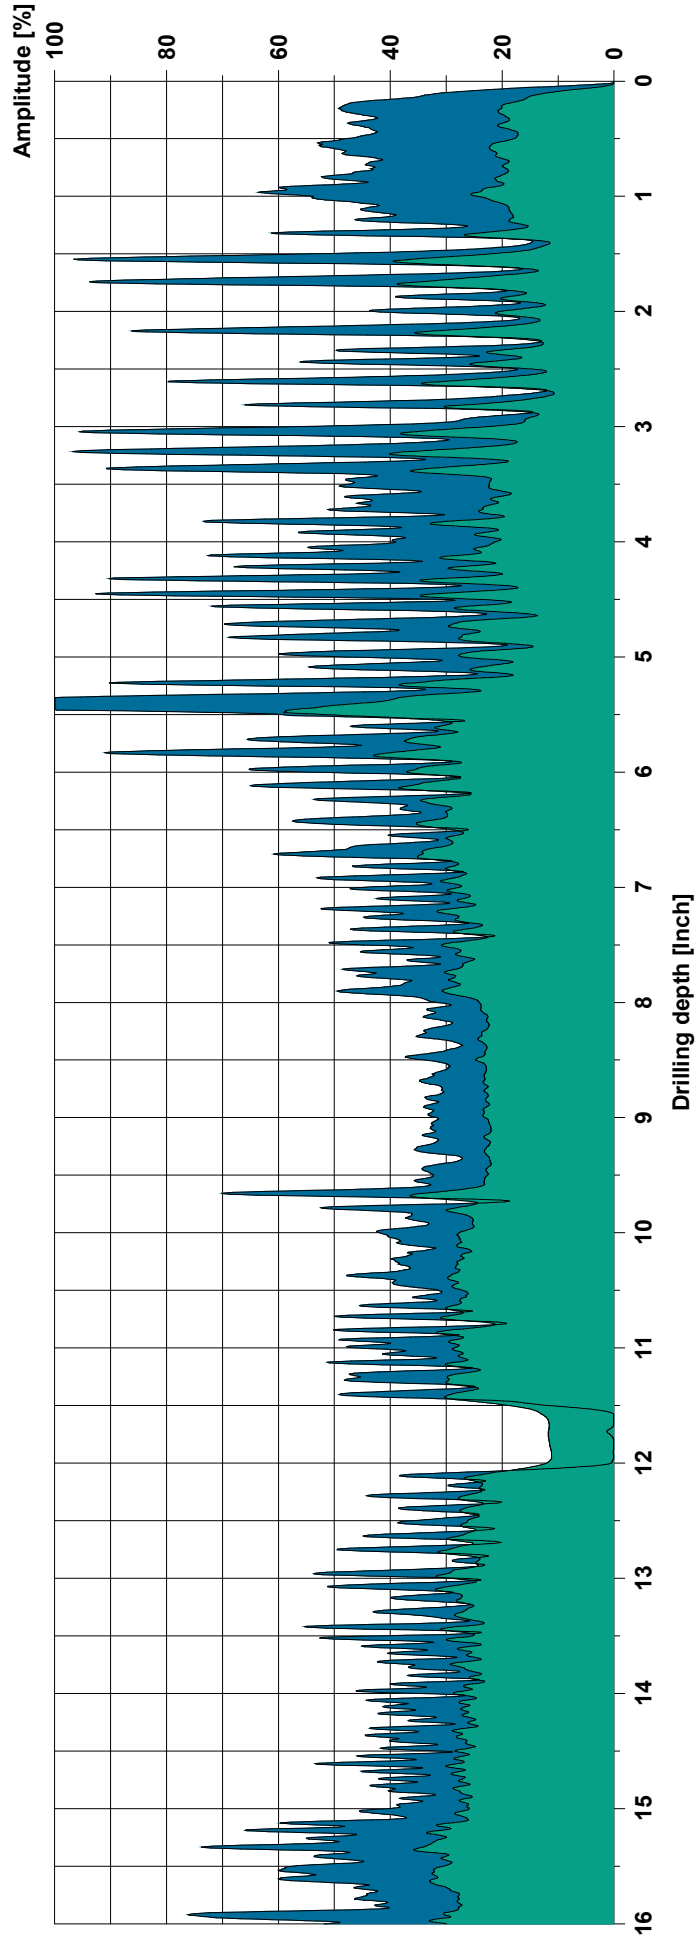
Low reading at 12" consistent with large crack due to mechanical damage of the member

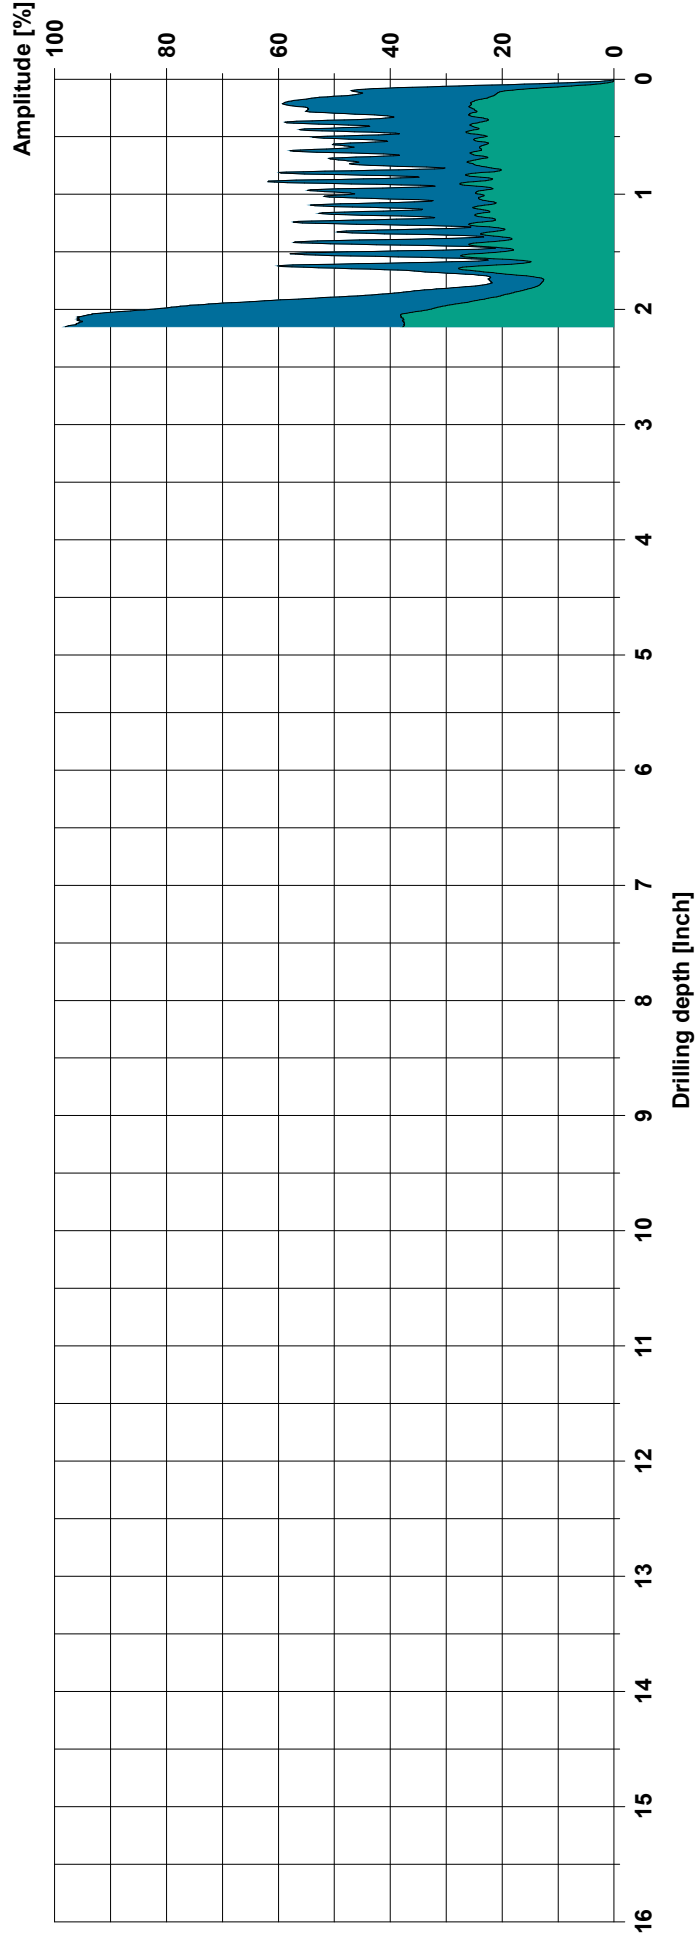
Sound wood throughout measurement

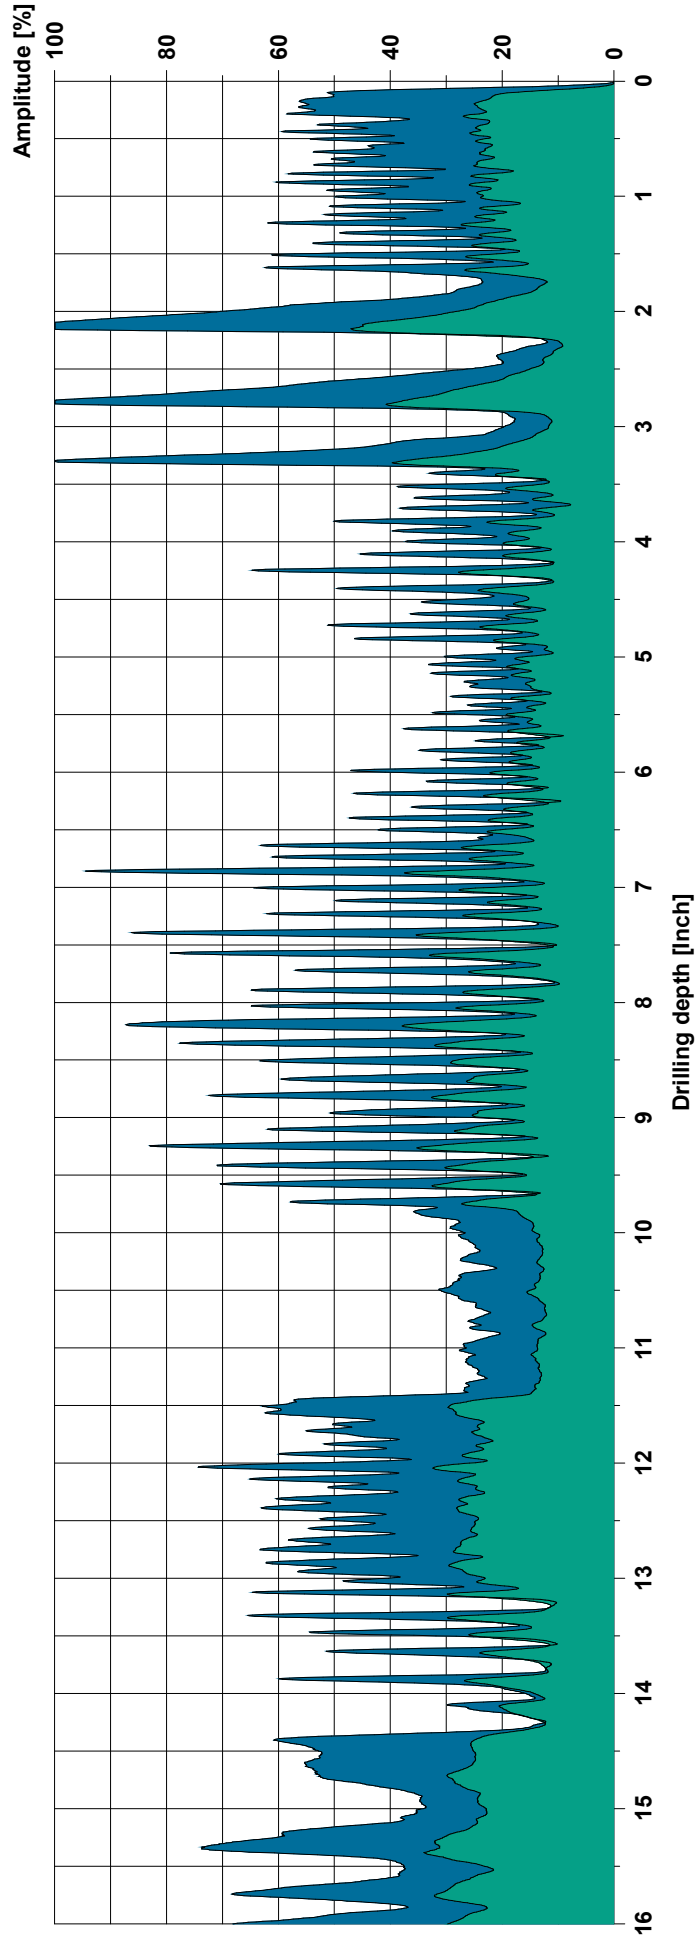
Sound wood throughout measurement

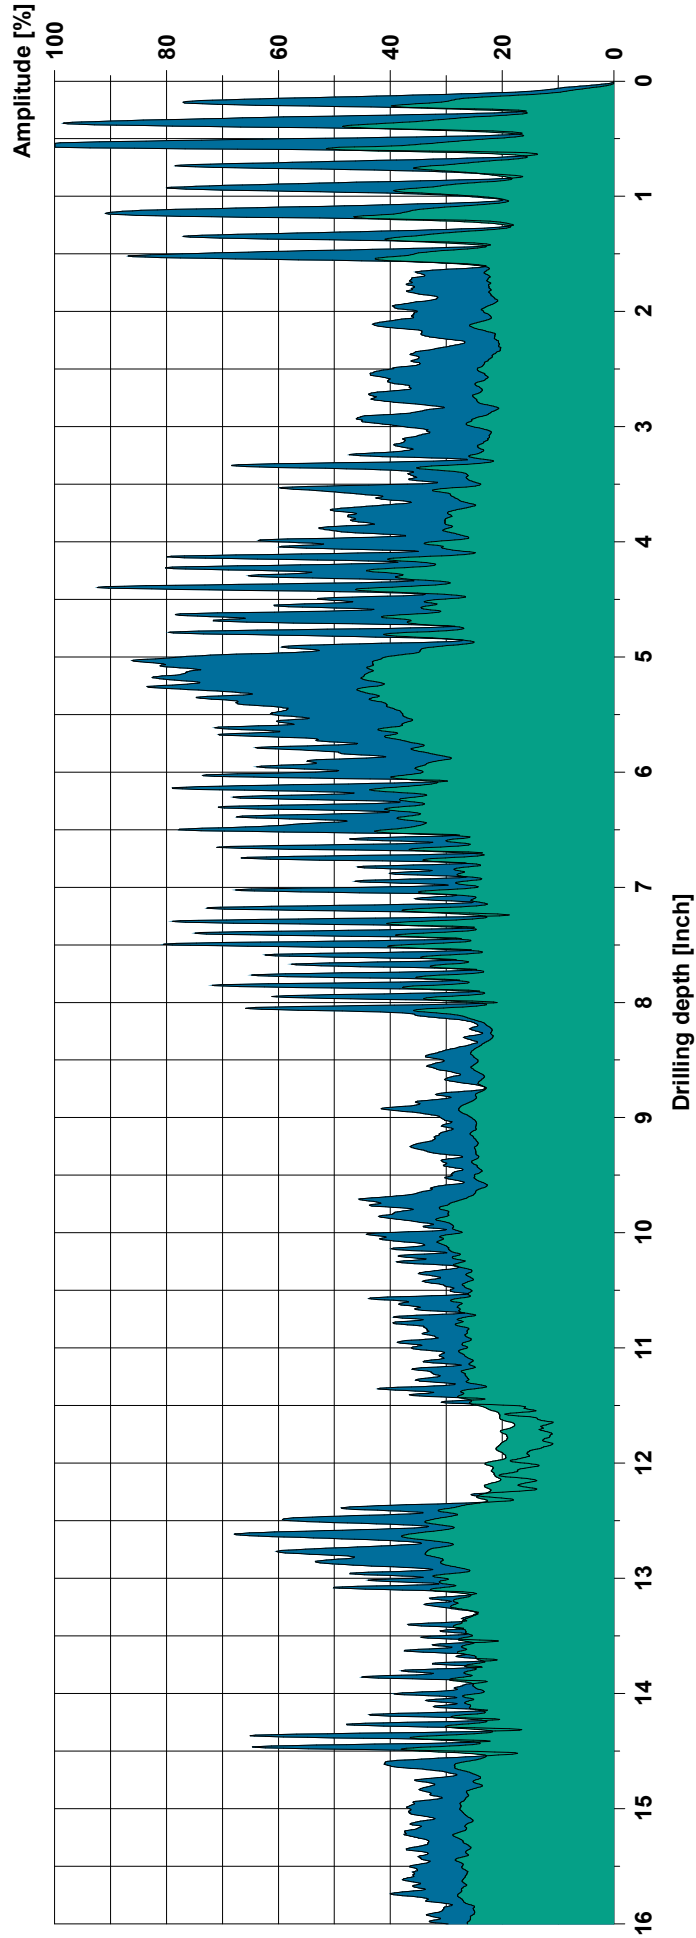
Sound wood throughout measurement

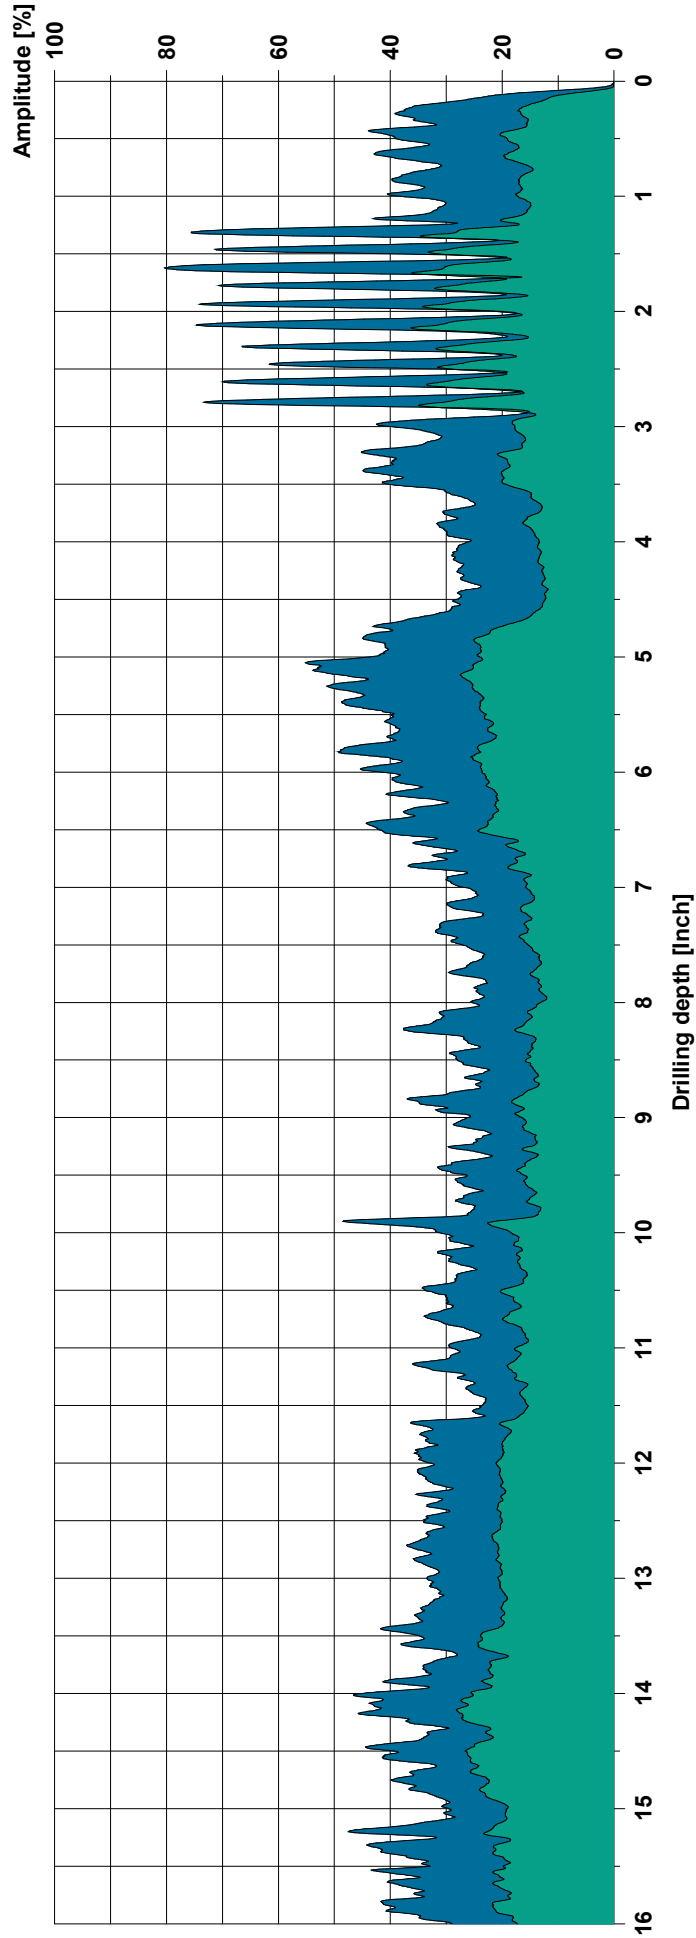
Sound wood throughout measurement
