**NORTH MEDFORD GYM COLLAPSE
MEDFORD, OR
STRUCTURAL EVALUATION**

KPFF PROJECT No. 10022500117

DATE
MAY 5, 2025

NORTH MEDFORD GYM COLLAPSE STRUCTURAL EVALUATION

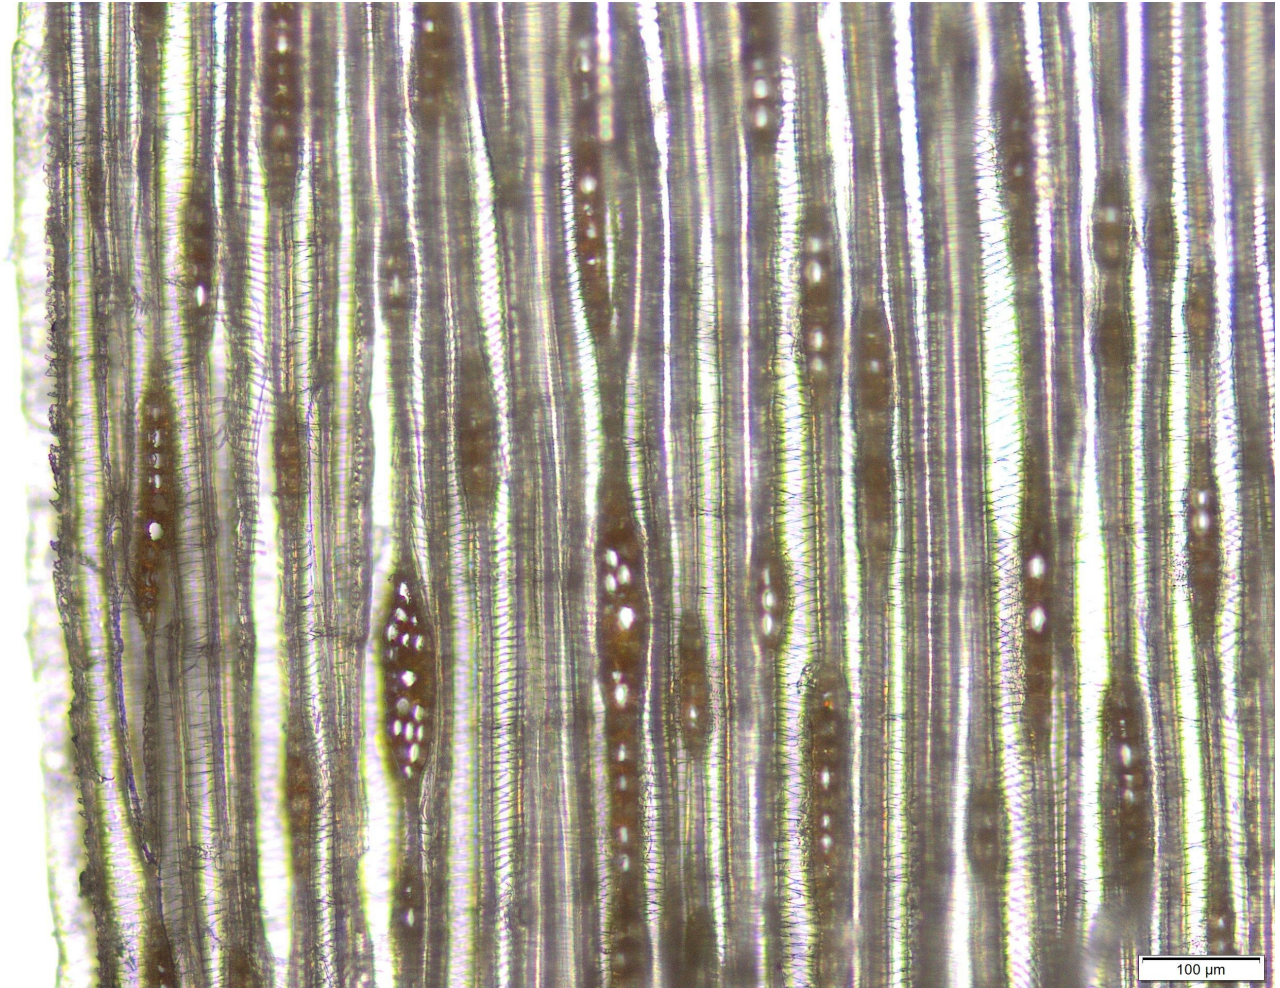
Project	North Medford Gym Collapse	By	KMR	Sheet No.	D.2
Location	Medford, OR	Date	4/23/25		
Client	Medford School District	Revised		Job No.	
Appendix D - Wood Identification		Date

Tangential view of sample recovered from Beam #2. Ubiquitous presence of spiral thickenings in longitudinal tracheids in conjunction with fusiform rays cells positively identify Douglas fir (*pseudotsuga menziesii*).
