# Aviation Investigation Preliminary Report

| <b>Location:</b> | Moab, UT | <b>Accident Number:</b> | DCA26LA012 |
| <b>Date &amp; Time:</b> | October 16, 2025, 06:43 Local | <b>Registration:</b> | N17327 |
| <b>Aircraft:</b> | Boeing 737 | <b>Injuries:</b> | 1 Minor, 111 None |

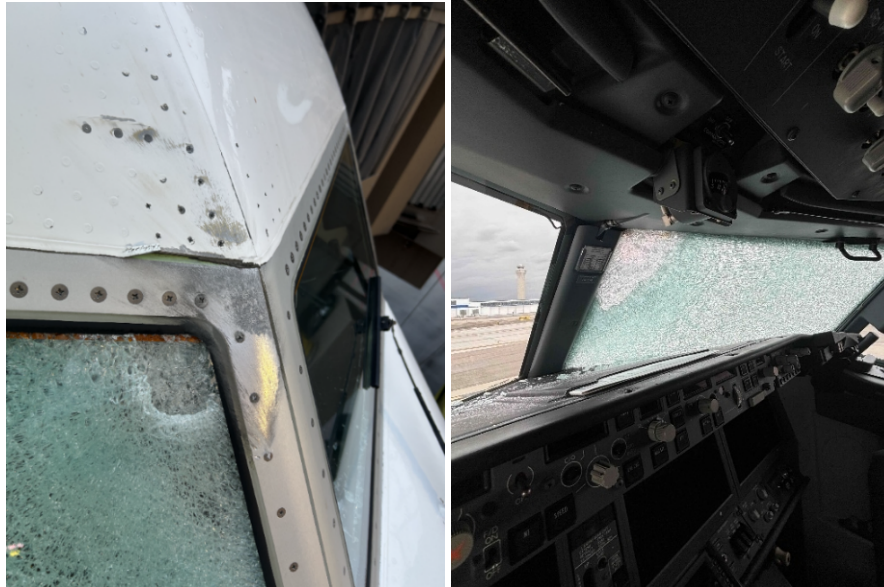
According to the captain, while established in cruise flight at flight level 360 (36,000 ft pressure altitude), he noticed an object distant on the horizon. Before he could mention the object to the first officer (FO), there was a significant impact to the FO's forward windshield along with a loud bang. The impact resulted in both pilots being showered with pieces of glass. The captain sustained multiple superficial lacerations to his right arm; the FO was uninjured.

**Figure 1.** Photos of the first officer's forward windshield. (Source: United Airlines)

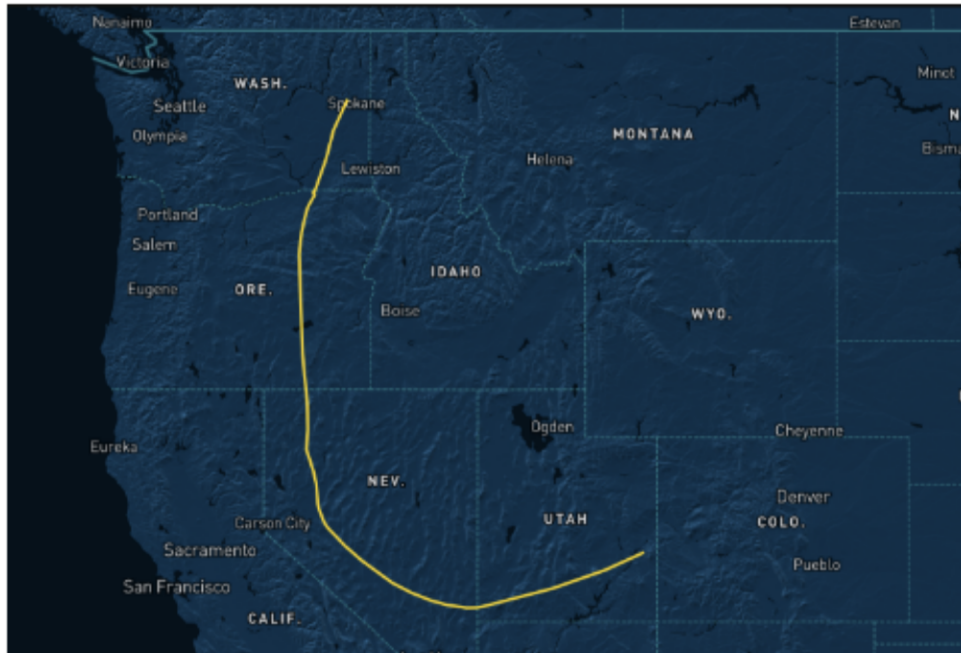
After the event was reported, data was requested for the position of weather balloons, any other aircraft, and for any known reentry objects that were large enough to have significant portions survive that might have been in the area of the collision. WindBorne Systems Inc. reported that they lost contact with one of their global sounding balloons (GSBs) that was in the vicinity of the airplane at the time of the accident. The GSB was launched from Spokane, Washington at 1129 MDT on October 15, 2025. The balloon traveled south from Washington, down through Oregon and Nevada before turning northeast, and was crossing through Utah at the time of the accident.

**Figure 2.** Flight path of the GSB. (Source: WindBorne)

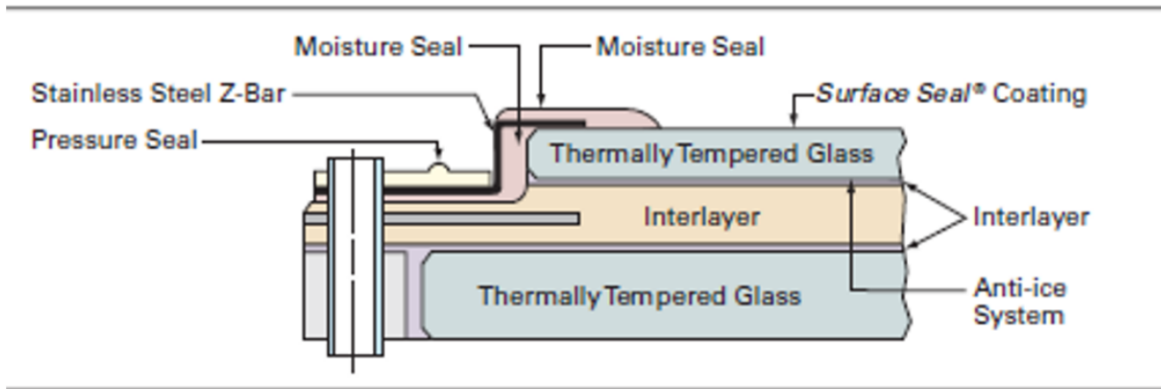
The windshield installed in N17327 was manufactured by PPG Aerospace and was designed to withstand the flight and pressurization loads encountered during flight while providing visibility for the pilots. From outboard to inboard, the windshield consists of a thermally tempered glass pane, a conductive heating film for deice capabilities, a urethane interlayer, a vinyl interlayer, a urethane interlayer, and a thermally tempered glass pane. The windshield is surrounded by a stainless-steel z-bar encased in a moisture seal to attach it to the fuselage. A coating is applied to the outer surface of the outboard pane to improve the ability to shed water in rainy conditions.

Windshields are certified to withstand the impact of a four-pound bird without penetration, to be capable of withstanding the maximum cabin pressurization loads with the failure of a single pane, and the internal pane must be non-splintering. The inboard pane of glass is considered a structural pane, the vinyl interlayer is considered a structural fail-safe pane, and the outboard pane of glass is considered a non-structural pane for this design. The damaged right windshield from the accident airplane, P/N 29-5612-9-9008, S/N 23089H0823, was manufactured on March 30, 2023. The damaged windshield was removed from the airplane and sent to the NTSB Materials Lab in Washington, DC for examination.

**Figure 4.** Windshield construct. (Source: PPG Aerospace website)

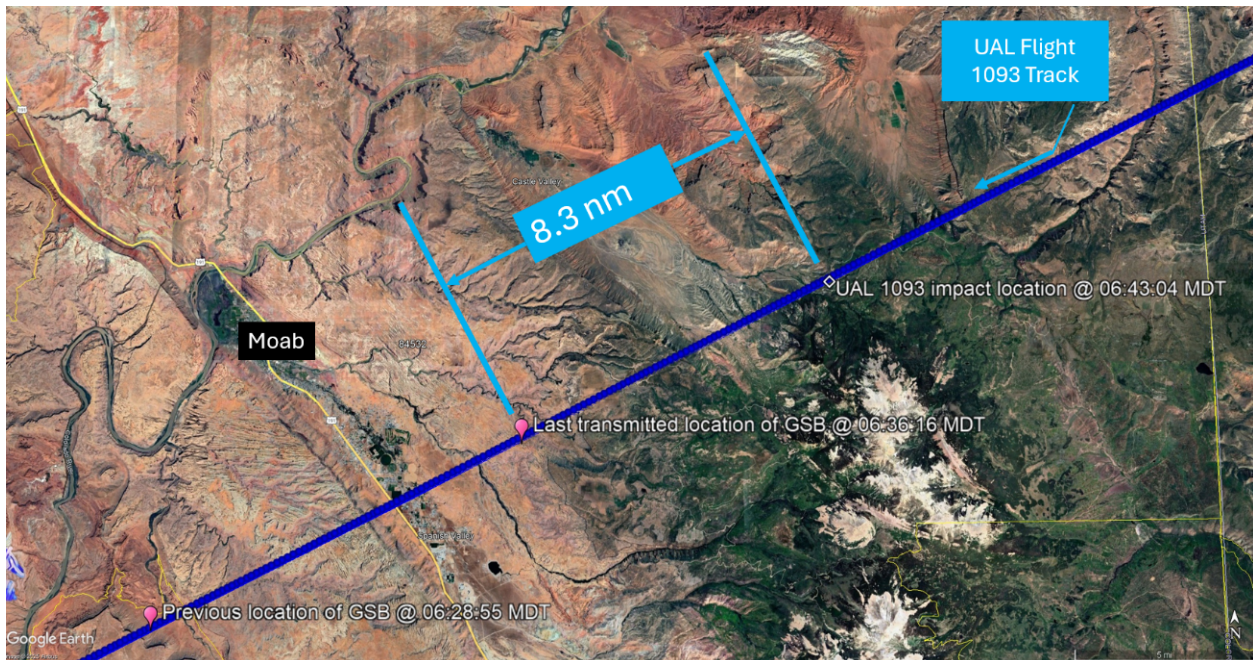
In addition, the flight data and the cockpit voice recorder were sent to the NTSB Vehicle Recorder Laboratory in Washington, DC. A preliminary review of the data from the cockpit voice and flight data recorders revealed that at the time of the collision, the airplane's track was to the southwest at 233° magnetic (nearly the reciprocal of the balloon track), at a pressure altitude of 36,002 ft, and a groundspeed of 395 knots.

**Figure 5.** UAL flight 1093 ground track and GSB locations.
