Babb Fire

AKV-221- Incident #NES-2151

Wildland Fire Investigation Report

September 7, 2020

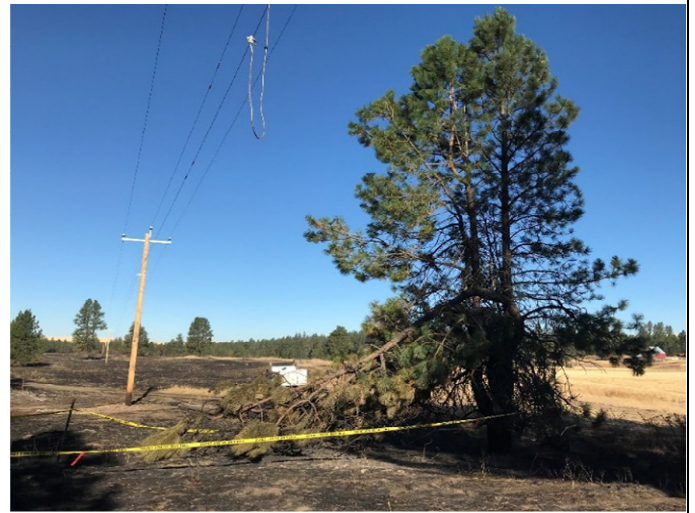
Upon further observation, on the south side of the access road there was a flagged off area with yellow fire line barrier tape. Inside the flagged off area was a multi-topped Ponderosa Pine tree with a portion of the tree bent to the south in the direction of the power lines with the top resting on the ground under the power distribution lines. There was also a second Ponderosa Pine adjacent to the first noted tree to the north northwest with very little separation. The power distribution lines adjacent to the tree were still intact and attached to the east and west power poles. Photo Log #8 Photograph Cropped (right). Just east of the flagged area was, what appeared to be, a recently created access point I believe was created by suppression crews accessing the power line right-of-way to the east.

The power pole to the west of this section of power lines was resting on the ground partially suspended by the power lines and the lower portion of the wood pole was missing. I noticed the mild predominate wind was out of the northeast at the time of our arrival, which is consistent with the previous day's expected high winds.

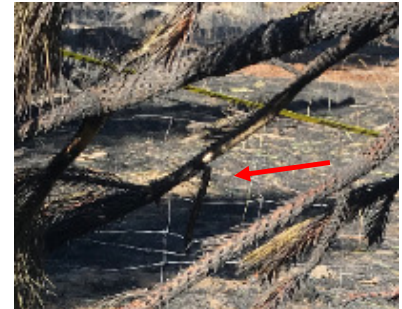
While SWFI DuPrey worked the Specific Origin Area (SOA), I began looking at the Ponderosa Pine tree. I did not observe any marks consistent with a lightning strike. I did note on the upper portion of the failed branch was a strip of peeled bark hanging down from a branch. The bark appeared to be stripped from the bottom up as though it had contacted something as it was pulled across an object. The picture to the right (photo log picture #14) shows hanging bark and its location to the bare branch above it. Photo log picture #19 (IMG0074) also shows the hanging bark after the top had been removed.

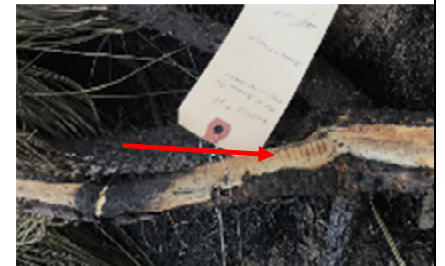
Upon further inspection of the top portion of the branch, we observed marks or striations perpendicular on the branch that did not appear to be natural. These marks appeared to similar in size to the conductors we obtained by the Avista Utility crew. The photo to the right shows the striations on the branch. Photo log #18 (IMG0073) cropped and rotated.

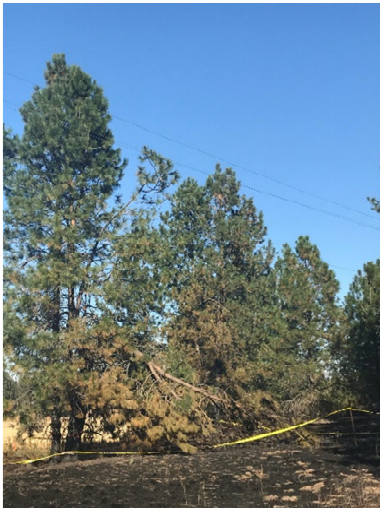
1

IMG0051 looking east/northeast at Ponderosa Pine tree that had a branch fail.

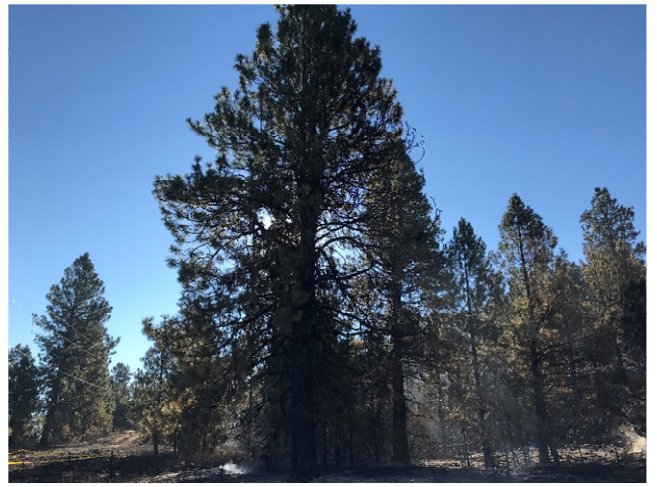
6

IMG0058 depicts for moving from left to right through the pine tree with angle of char indicator

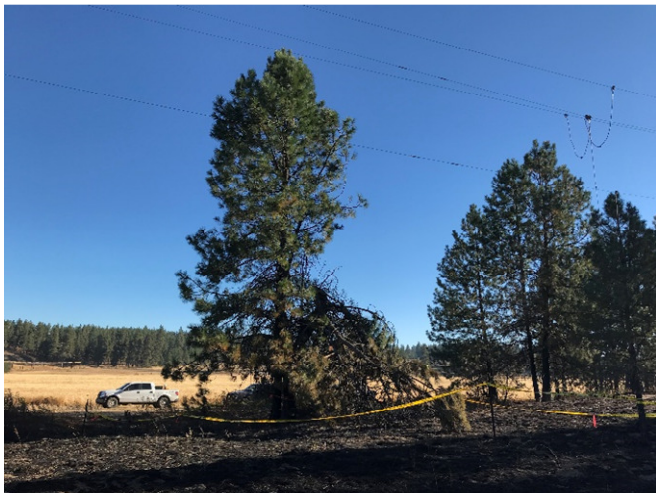
7

IMG0059 view of tree and power lines with new splices looking north/northeast

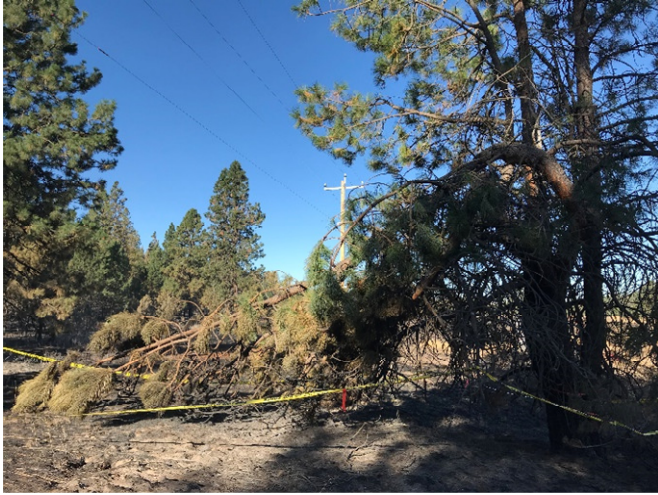
9

IMG0061 closer view of failed branch

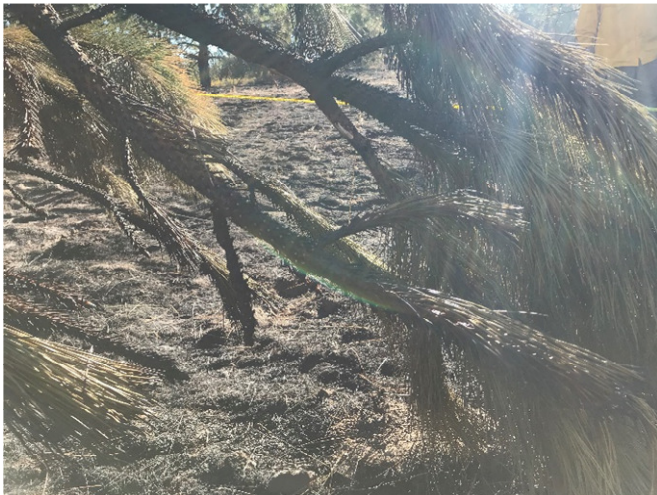
15

IMG0067 different side of IMG0066 also showing second scrape mark on different branch

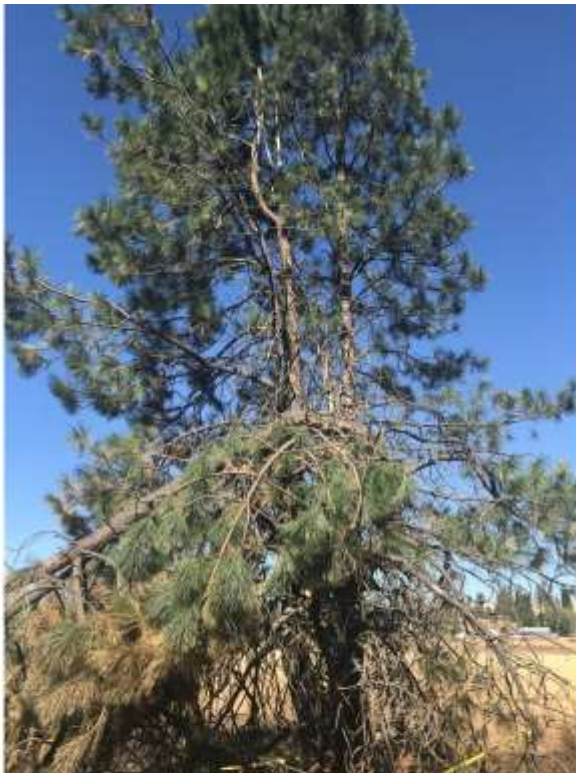
Image 1: NW view of ponderosa pine tree whose branch failed, hitting the powerline that ignited the Babb Road Fire. Babb Road is behind the tree. Note there is a second tree present on the left.

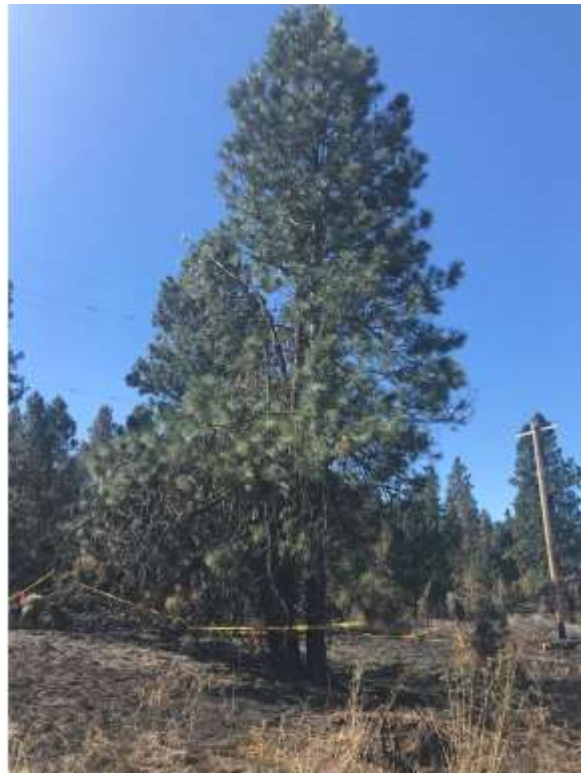
Image 2: SW view of ponderosa pine tree whose branch failed, hitting the powerline that ignited the Babb Road Fire. The powerline is behind the tree. Note the second tree present on the right.

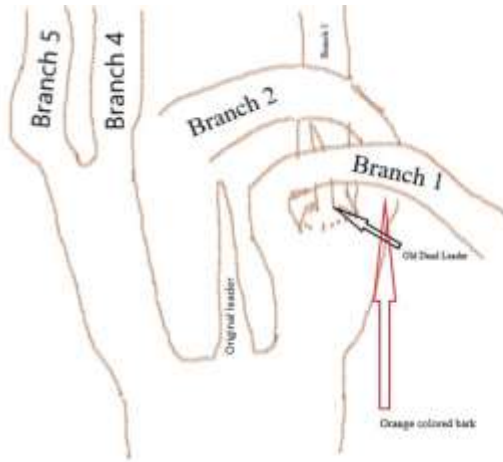
Drawing (not to scale) of the main branches of the ponderosa pine whose branch failed and struck the powerline that ignited the Babb Road Fire, facing NW. Branch 2 is the branch that failed and hit the powerline. Branch 2 fell on Branch 1, breaking that branch. Branch 1 was dead at the tip.

Branch 2 was the branch that initially failed, striking the powerline. This branch was 54 feet 10 inches in length, from the tip to the base of the tree. Branch 2 hit branch 1 when it failed, breaking that branch as well. There is no evidence that branch 1 hit the powerline.

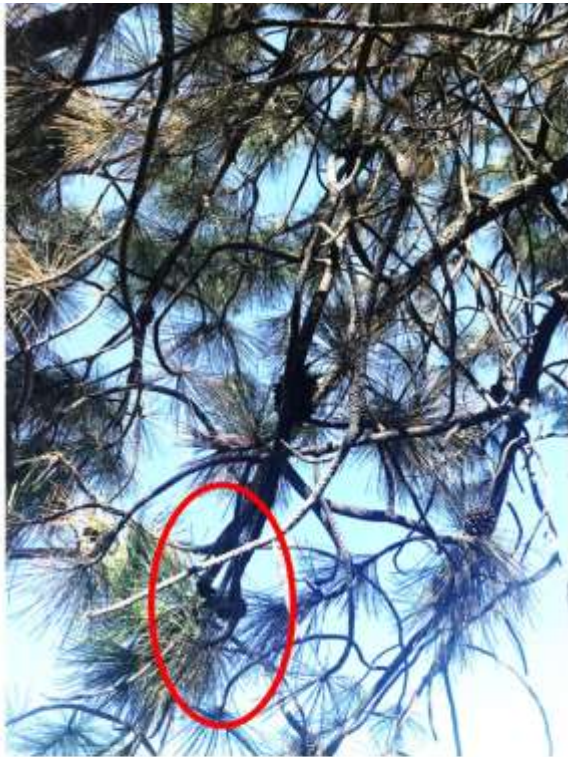
Evidence of western gall rust included galls on the branches (Image 4), potential cankers (compressed/ flattened areas) located on branches 2 and 4 (Image 5), and elongated/ malformed tertiary branches at the base of the crown.

Image 4. Western gall rust gall

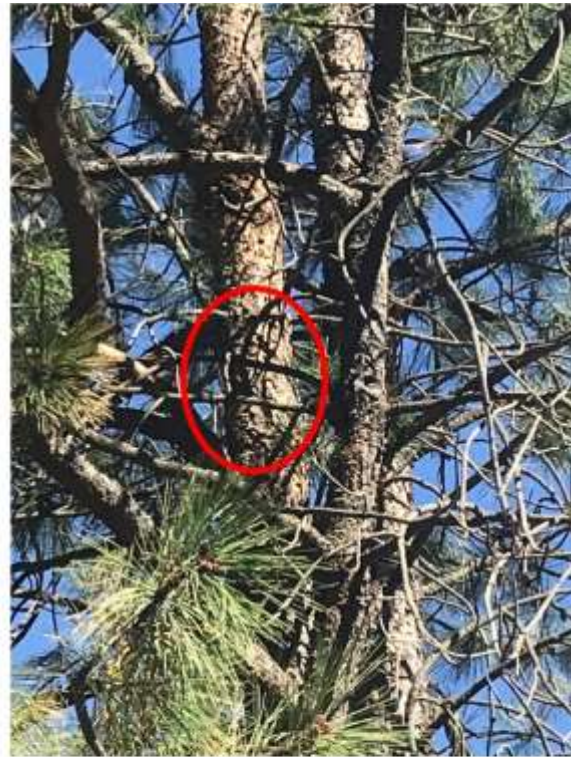
Image 5. Pinched area denoting a potential gall rust canker on branch 4

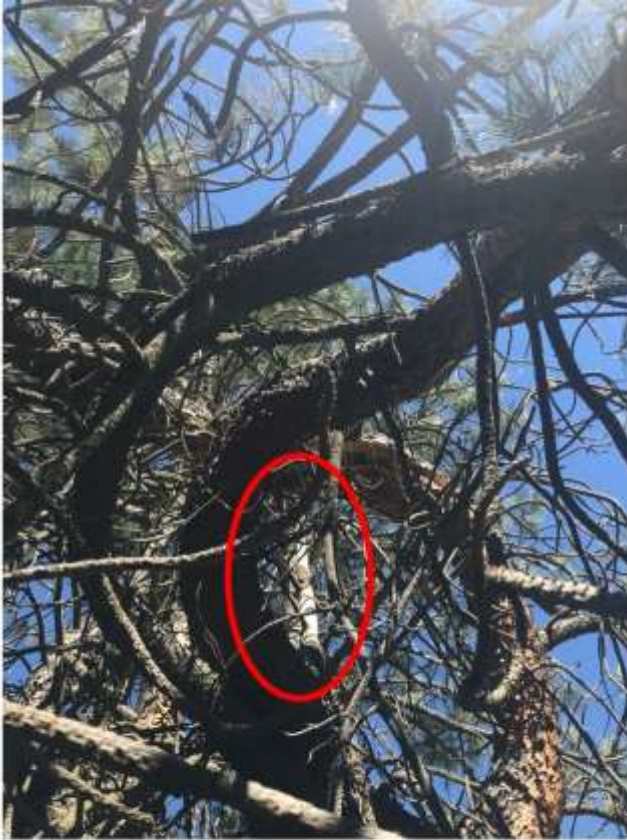
Evidence of porcupine damage included old, dead leaders (Image 6), recent bark that had been stripped away in areas throughout the crown, and multiple tops/ leaders. Evidence of tension/ compression included orange coloration on one side of branch 2 (Image 7). Orange coloration can also denote an older ponderosa pine (> 100 years of age), but given the fact that this tree was approximately 44 years old, this orange coloration can confidently be attributed to tension/ compression.

Image 6. Old, dead leader resulting from porcupine damage

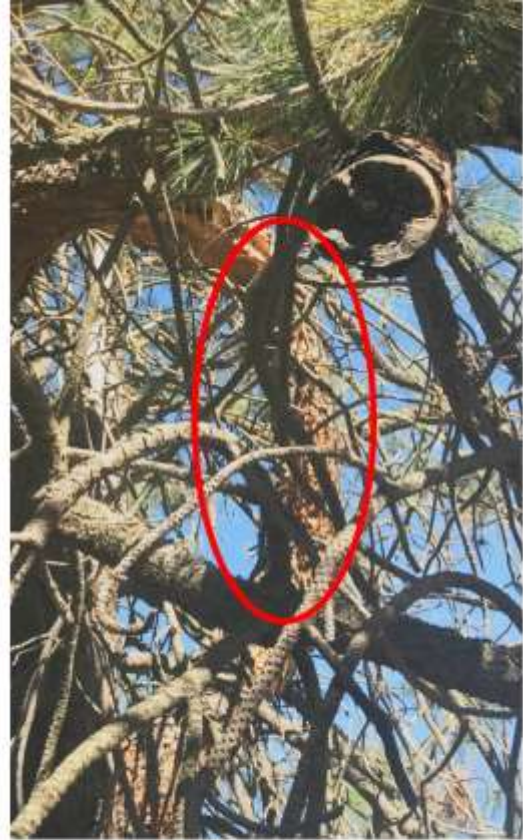
Image 7. Orange coloration of bark on one side of branch 2 denoting an area of tension/ compression

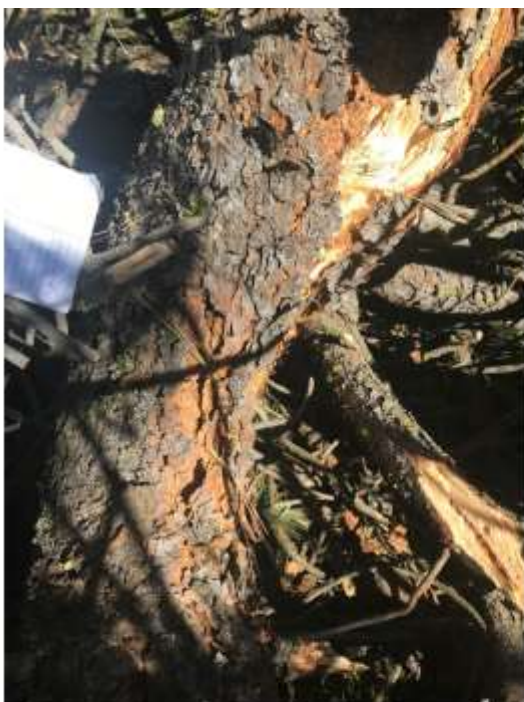
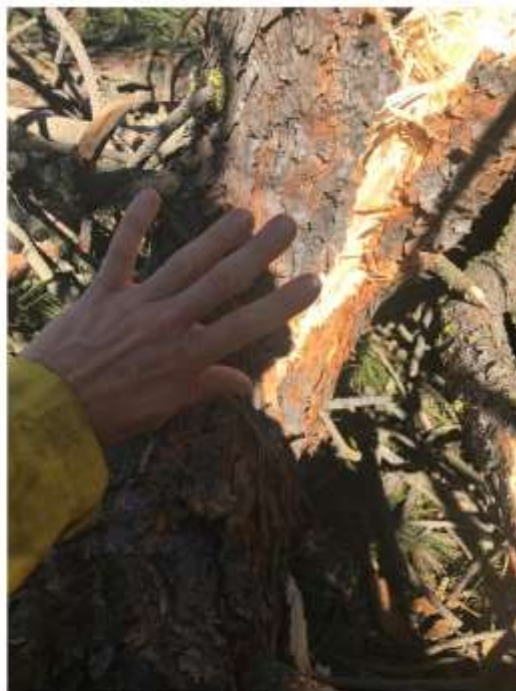
1. A compressed/ flattened area below the failure denoting a potential western gall rust canker within the branch (Images 8 and 9),
2. Orange coloration of the bark on the NW facing side (opposite side) of the failure/ split denoting an area of tension/ compression (Image 10),
3. A potential canker or old wound on the NW facing side (opposite side) of the failure/ split with resin running from the crack (Image 10),
4. Tightly compressed growth rings opposite wide rings inside the branch denoting tension/ compression (Image 11),
5. White mycelium inside of the failure point/ split on branch (Image 12) and
6. A pitch moth globule (Image 13).

Images 8 and 9. A compressed/ flattened area below the failure point on branch 2 denoting a potential western gall rust canker.

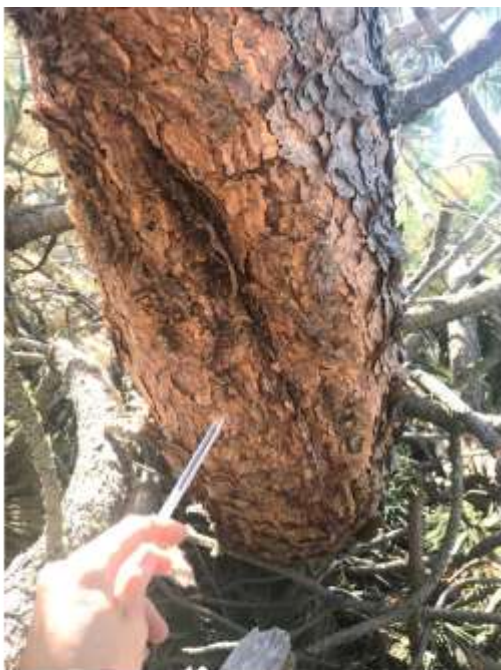
Image 10. The NW facing side of the failure/ split on branch 2 showing a potential canker or old wound. Note also the orange coloration of the bark on this side, denoting an area of tension/ compression. Resin was running from the crack.

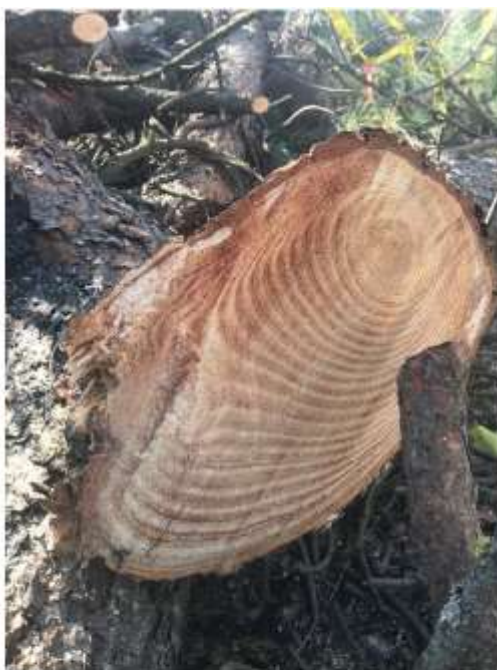
Image 11. Tightly compressed growth rings opposite wide growth rings inside branch 2 denoting tension/ compression.

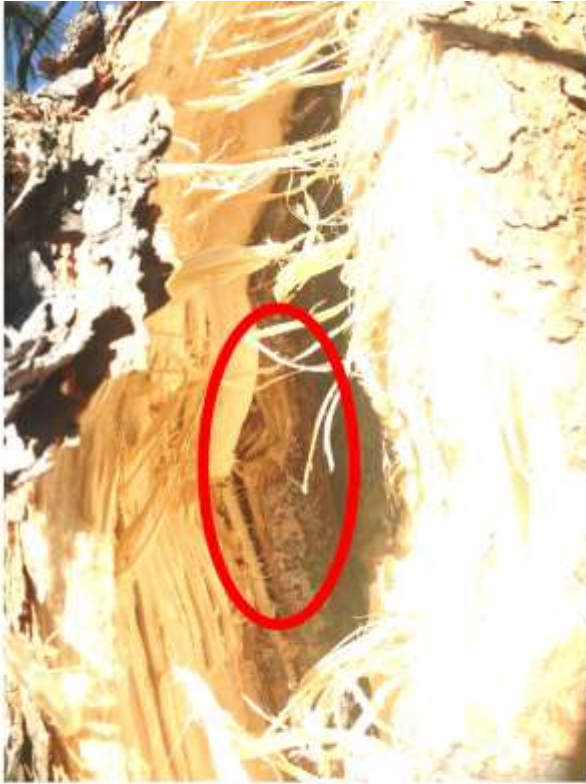
Image 12. White mycelium inside of the failure point/ split on branch 2 denoting rot.

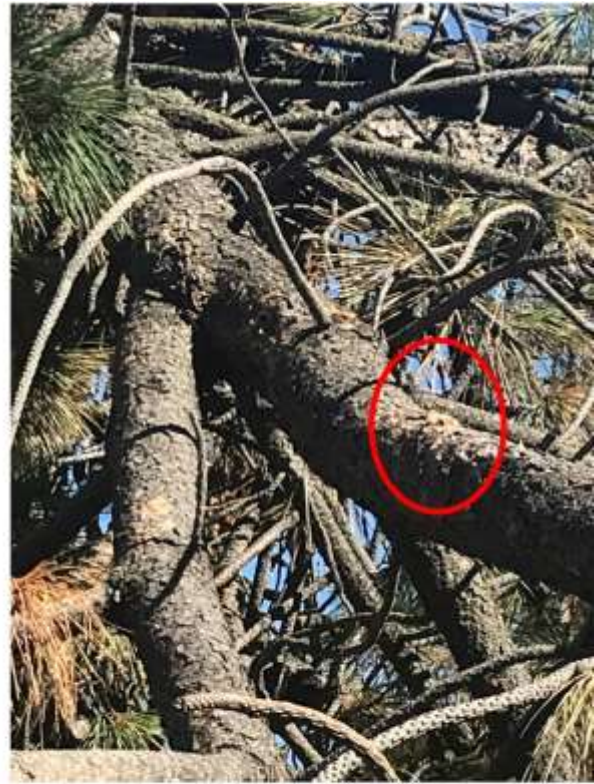
Image 13. Pitch moth globule.

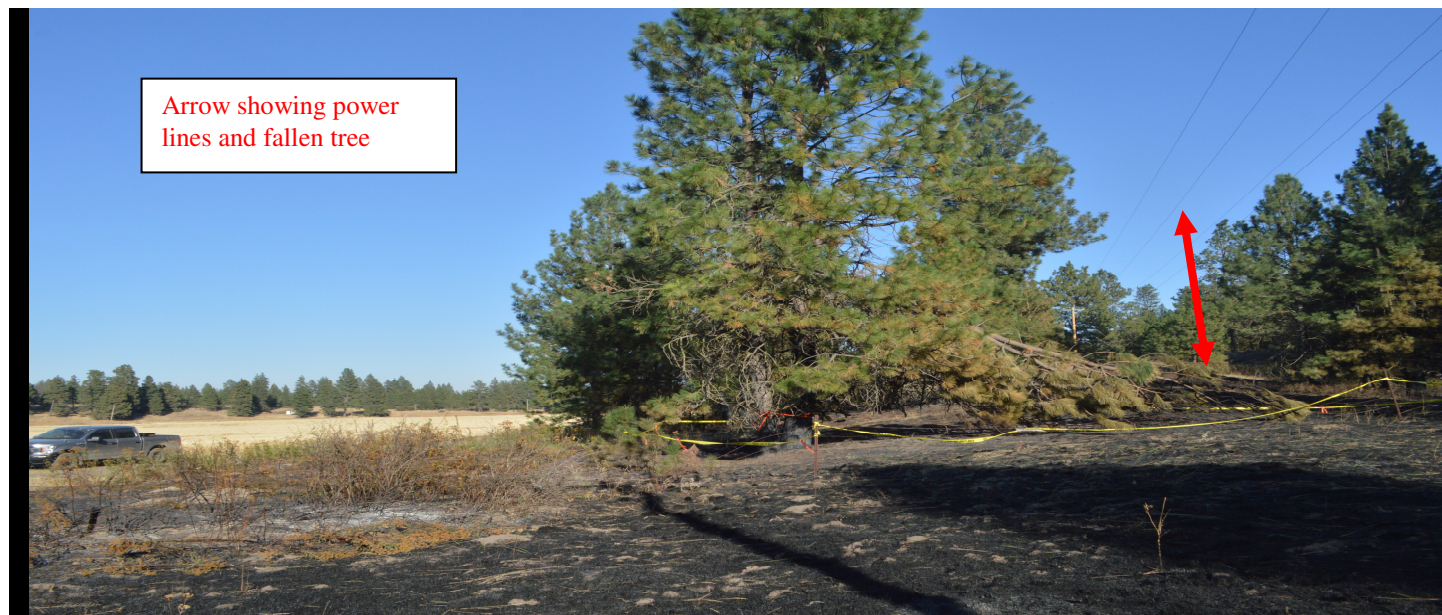
Sgt. Margheim and I observed a power pole to the west of our location that was resting on the ground and the lower portion of the wood pole was missing.

(Photo taken westside of the fire scene of showing fallen tree and power lines)

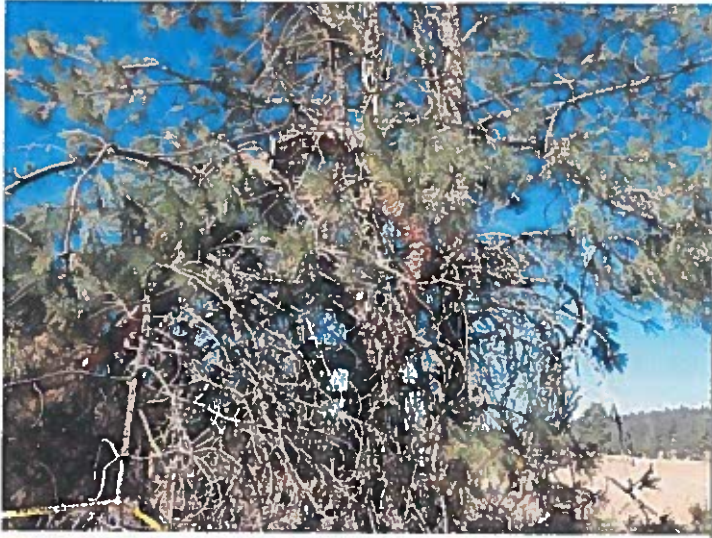
9-014

Photo taken looking at the east side of the tree and is showing the defect in the limb that failed.

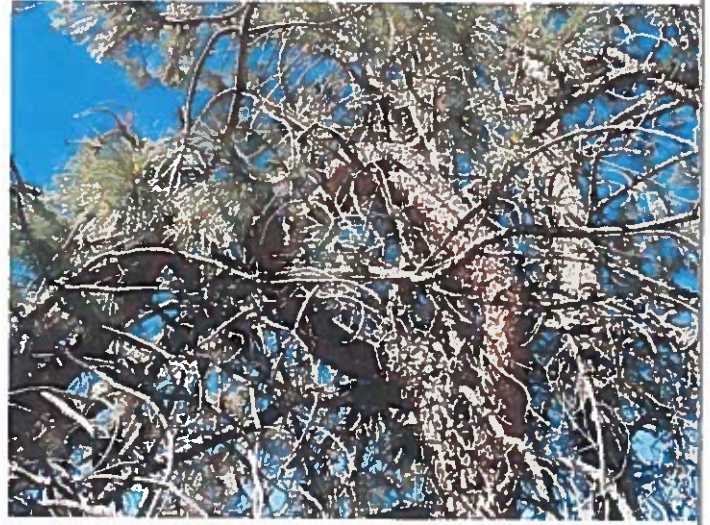
10-015

Photo taken looking at the east side of the tree and is showing the defect in the limb that failed.

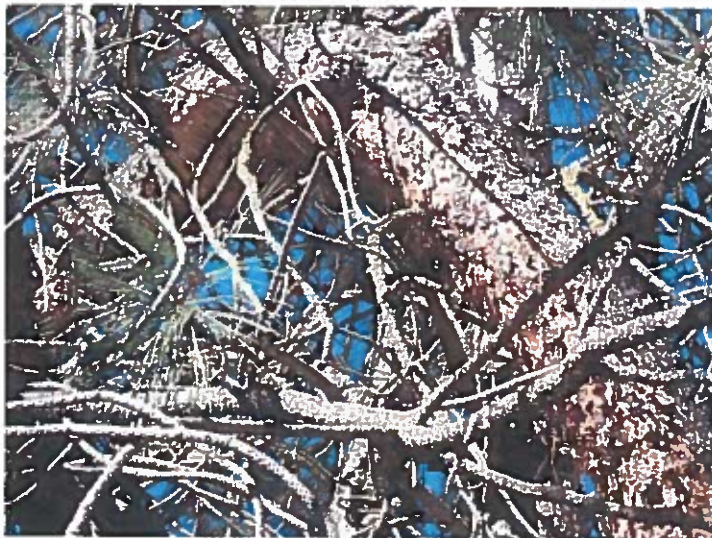
11-016

Photo taken looking at the east side of the tree and is showing the defect in the limb that failed.

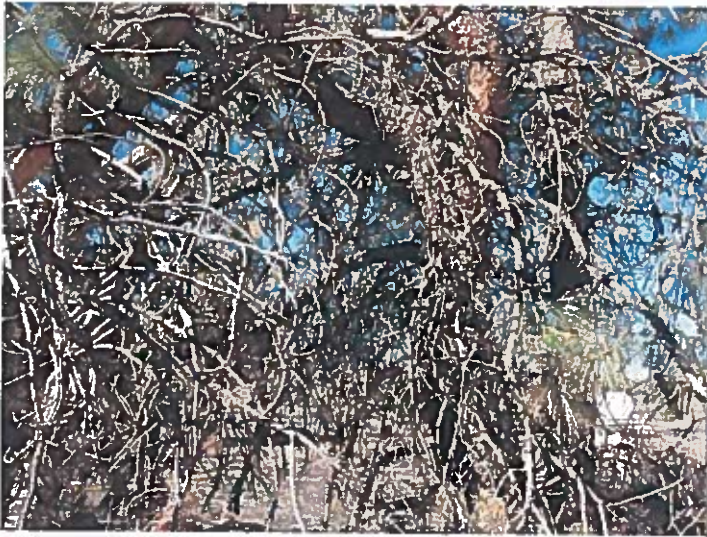
13-018

Photo taken looking at the east side of the tree and is showing the defect in the limb that failed.

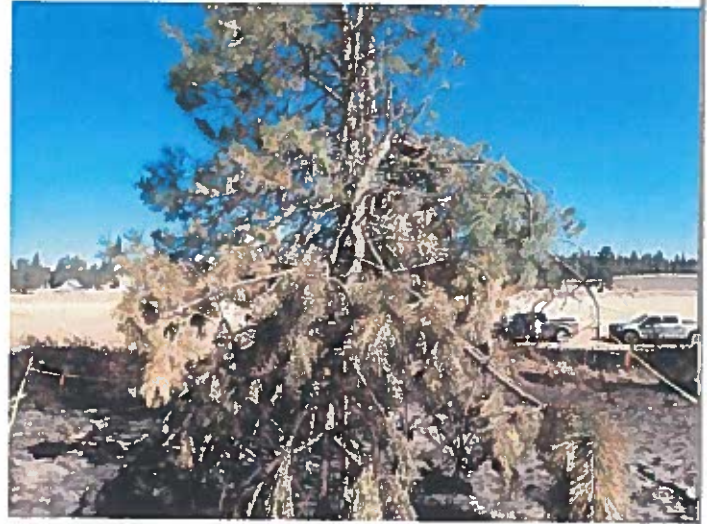
14-019

Photo taken looking north from the power lines and is showing the limb that failed

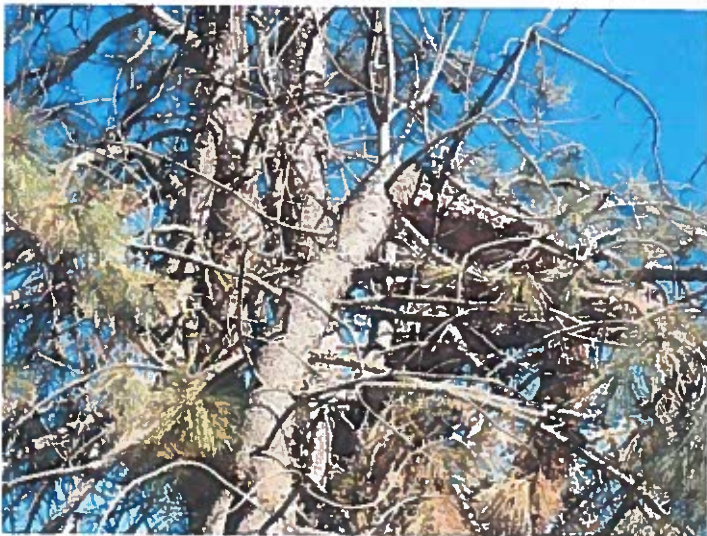
15-020

Photo taken looking northeast and is showing the opposite side of the failure in the limb.

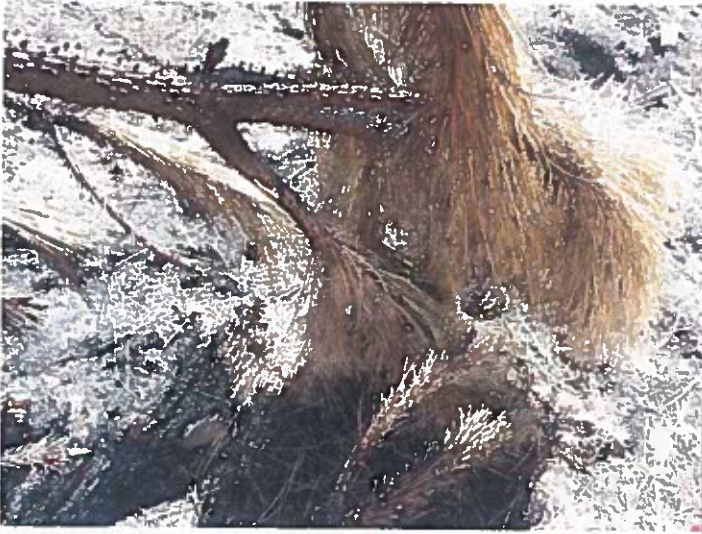
17-022

Photo is a close view of the fire pattern indicators on the pine needles. It is showing the fire was backing at this point.

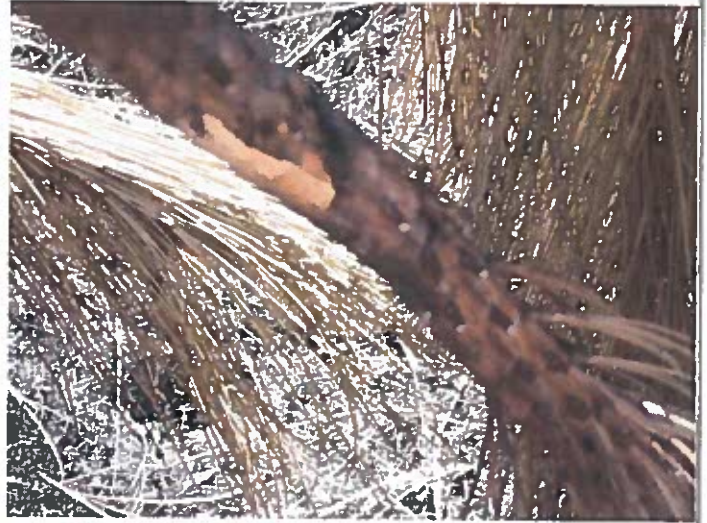
18-023

Photo is a close up of the scar from the power line.

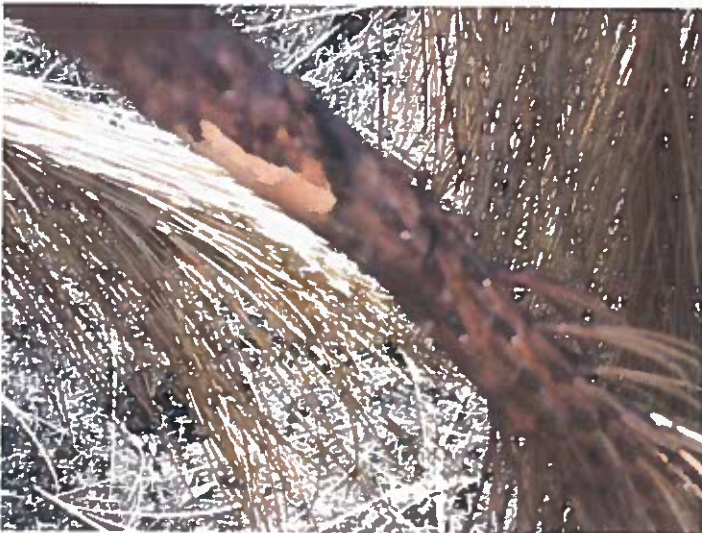
19-024

Photo is a close up view of the scar from the power line.

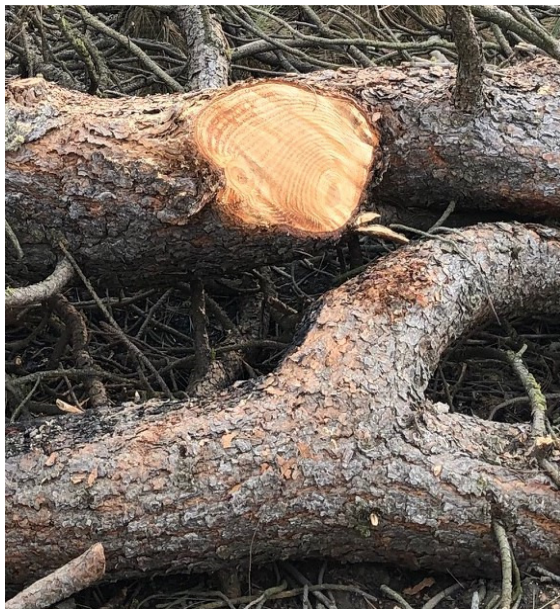
The use of compression wood means that these leaders are stouter and more rigid than they would otherwise be, and more likely to snap at their midpoint due to wind or ice loading. Similarly, as the lateral branch/leader gets larger, additional compression tissue must be added, not just at the trunk juncture but along the branch/leader, which further increases its weight and clearly places a limit on its length.

Figure 1. Cross section of the lateral branch/leader at juncture with stem revealing reaction wood.

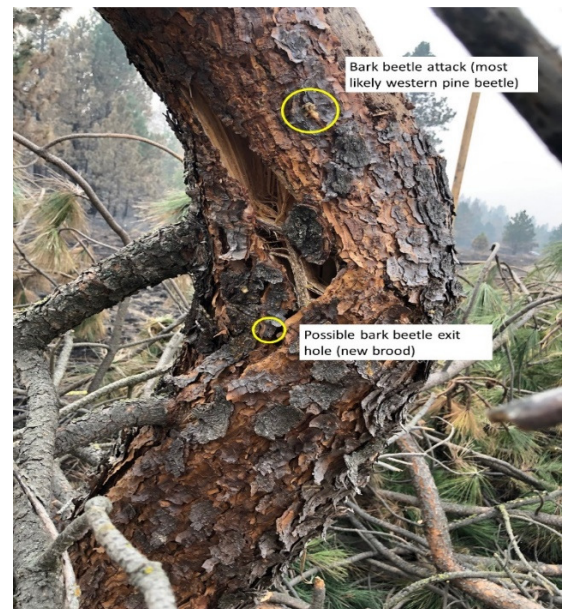
Figure 2. Failed lateral branch/leader with indicators of bark beetle activity.

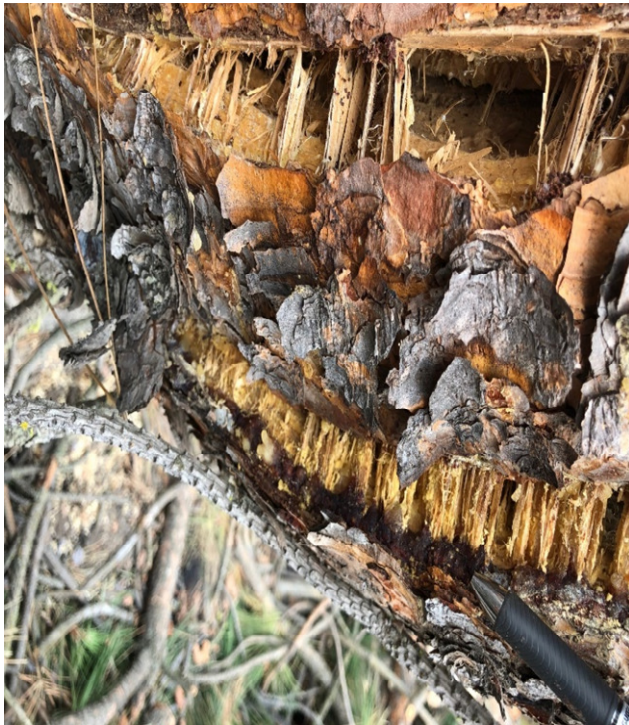
Regarding these two, the LBL that originated on the side of the suspect pine nearer the power lines, appears to have broken/split two to three years ago. Evidence to support this date includes the presence of callous tissue at the wound margins where the LBL split (Fig. 3), and larval galleries with boring material and oval exit holes left by emerging adult wood boring beetles (Fig. 4). Wood borers commonly occur in dead and dying trees and are generally considered secondary agents of mortality. Most species are non-aggressive, attacking only dead and dying trees, or their parts, and are frequently found in trees infested or killed by other agents, such as bark beetles or root disease. Figure 2 shows an egg laying bark beetle attack (pitch tube) most likely western pine beetle, and a possible bark beetle exit hole made by brood emerging from the tree. While symptoms of bark beetles and wood borers are abundant on this LBL, the absence of physical signs of the insects suggest that they have since abandoned this portion of the tree.

Figure 3. Callous tissue formation along margin of wound on failed lateral branch/leader.

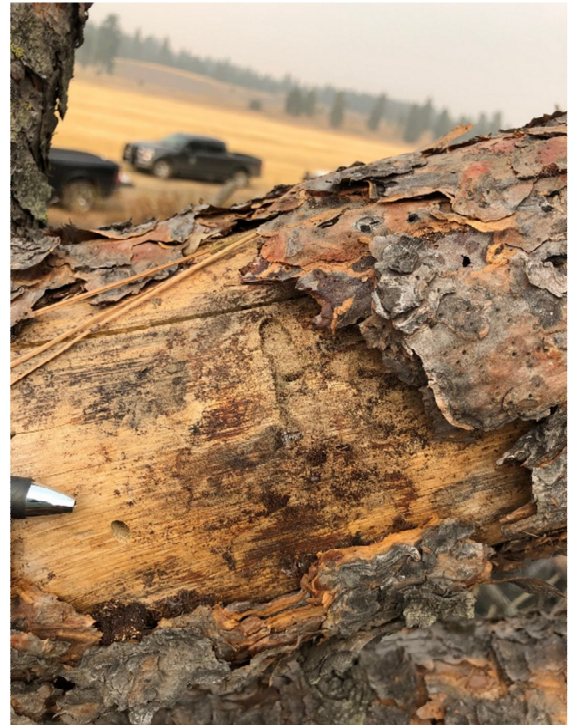
Figure 4. Wood borer gallery and exit hole on failed lateral branch/leader.

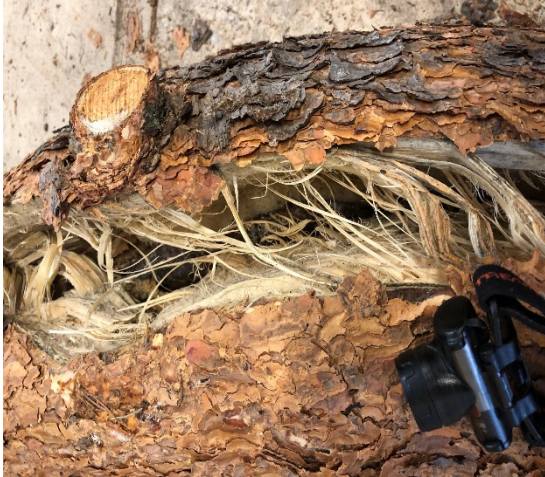
Figure 5. “Fresh” wound, lacking callous at the margins and still “sticky” to the touch.

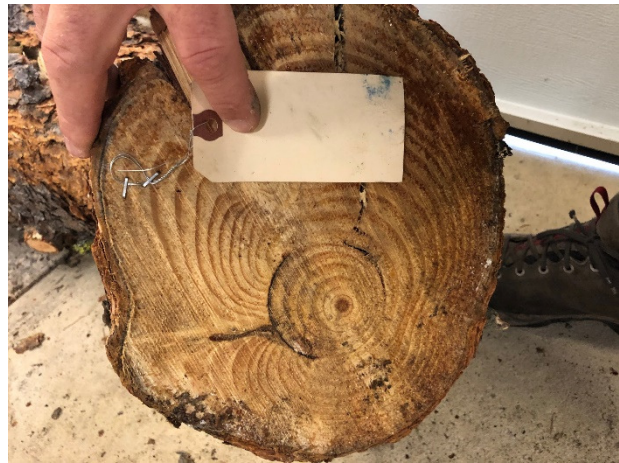
Other defects noted on the suspect pine include galls caused by *Endocronartium harknessii*, causal agent of western gall rust, and old wounds. Neither of these directly contributed to the LBL failure, although there is evidence of earlier wounding, potentially caused by porcupine feeding several years prior, that may have indirectly contributed to its failure (Fig. 6).

Figure 6. Previous damage being “sealed” over after ca. 14 years of growth.

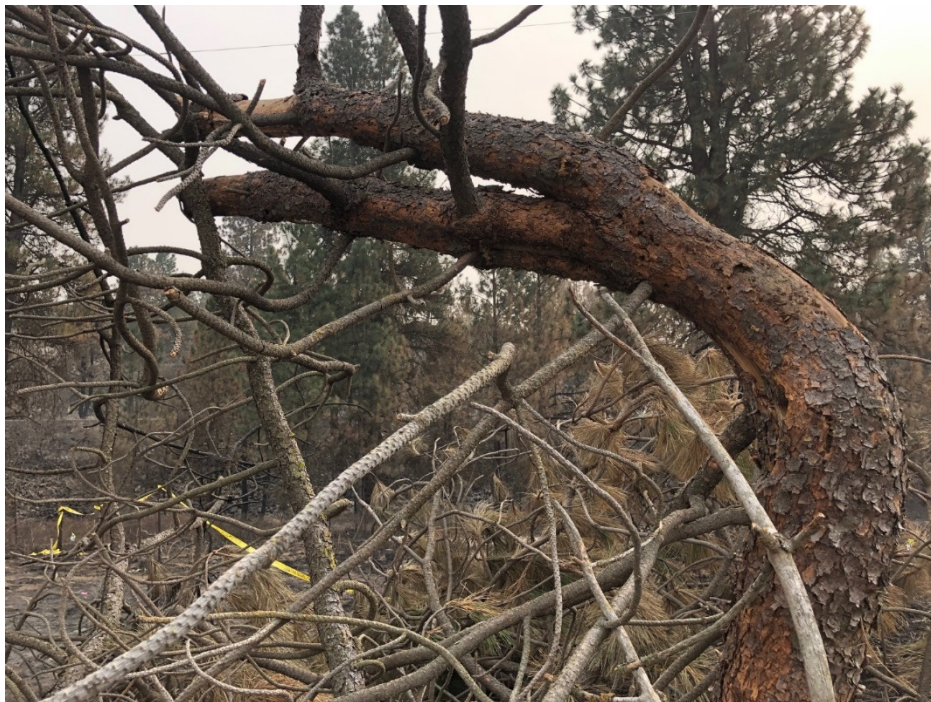
Figure 7. Portion of LBL, revealing split and cut ends, which failed prior to LBL implicated in Babb Road Fire.
