# Aviation Investigation Final Report

<b>Location:</b>	Bay City, Wisconsin	<b>Accident Number:</b>	ERA22FA399
<b>Date &amp; Time:</b>	September 6, 2022, 13:25 Local	<b>Registration:</b>	N11HC
<b>Aircraft:</b>	CONWAY PHILIP J Glasair Super II SFT	<b>Aircraft Damage:</b>	Substantial
<b>Defining Event:</b>	Collision with terr/obj (non-CFIT)	<b>Injuries:</b>	2 Fatal
<b>Flight Conducted Under:</b>	Part 91: General aviation - Instructional

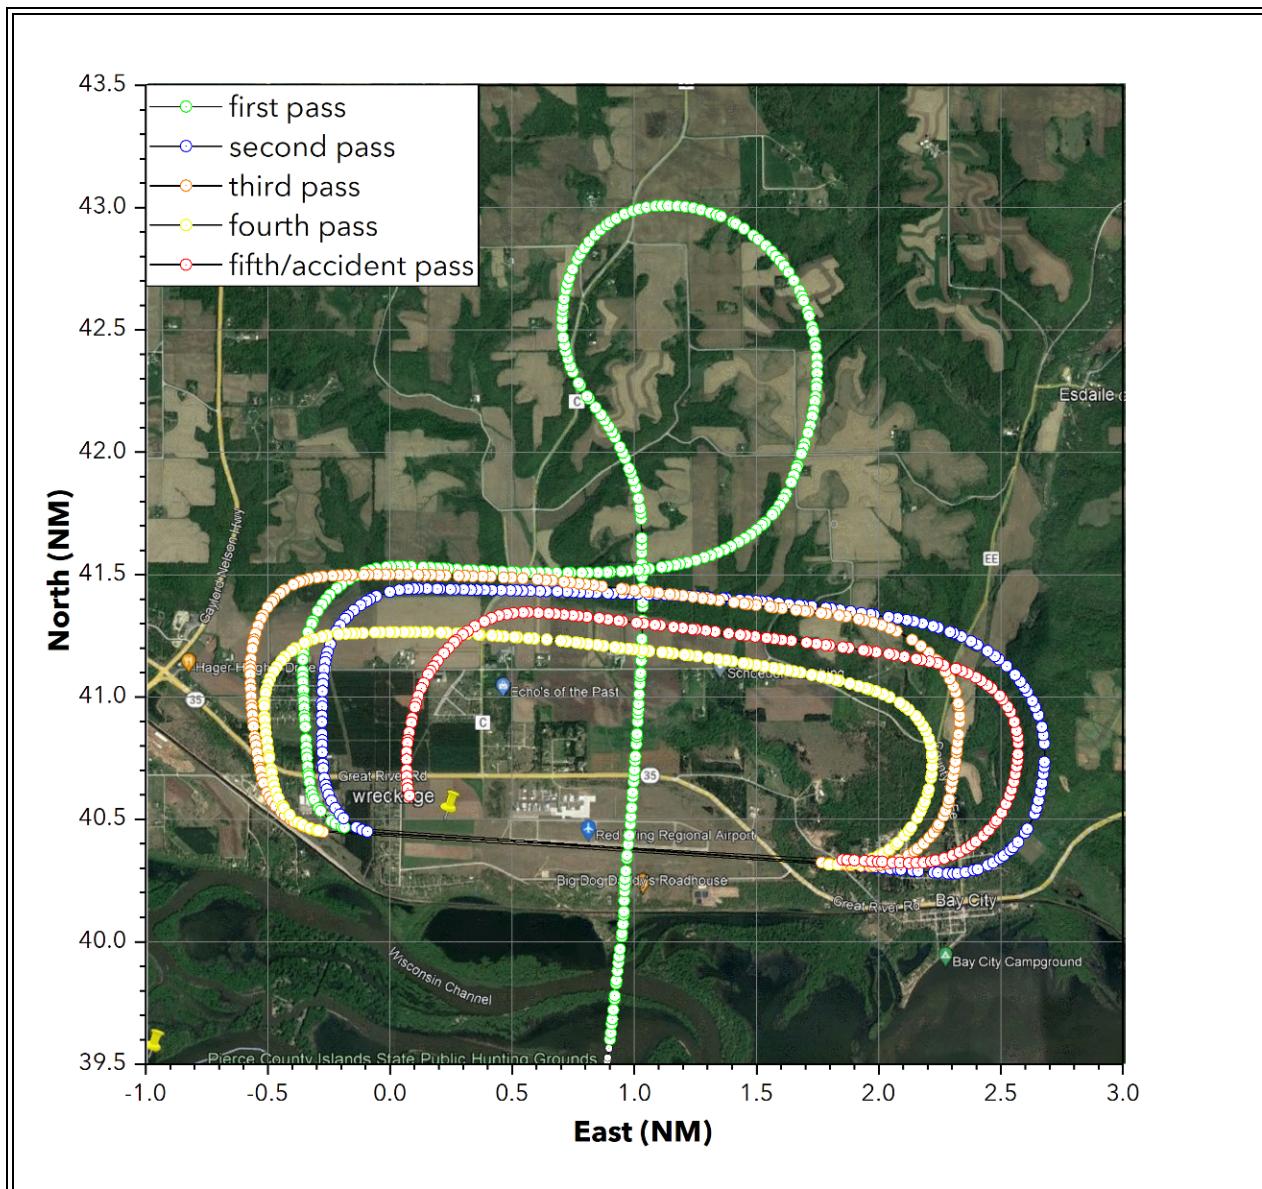
Figure 1: Pattern Work at Red Wing Regional Airport and Wreckage Location

The flight departed from Rochester Regional Airport (RST), Rochester, Minnesota about 1218. Following some air work, the flight proceeded to Red Wing Airport (RGK), Bay City, Wisconsin and entered left traffic for the visual airport traffic pattern to runway 9. According to automatic dependent surveillance-broadcast (ADS-B) and GPS data, four circuits of the traffic pattern were flown without touching down and a fifth traffic pattern was initiated. The data indicated that the airplane turned onto the base leg of the airport traffic pattern about 0.5 to 1 mile sooner (tighter) than on the previous approaches (figure 1). The airplane impacted the ground about 1/3 nautical mile west-northwest of the approach end of runway 9.

An examination of the accident site revealed that the airplane impacted terrain on a heading of about 045° and the main wreckage came to rest, upright, about 80 ft from the point of initial impact. There was no fire. All structural components of the airplane were located within the confines of the wreckage path.
