National Transportation Safety Board Aviation Accident Preliminary Report

Location:	Kalea, HI	Accident Number:	ANC22FA041
Date & Time:	June 8, 2022, 17:26 Local	Registration:	N402SH
Aircraft:	Bell 407	Injuries:	3 Serious, 3 Minor
Flight Conducted Under:	Part 135: Air taxi & commuter - Non-scheduled - Sightseeing

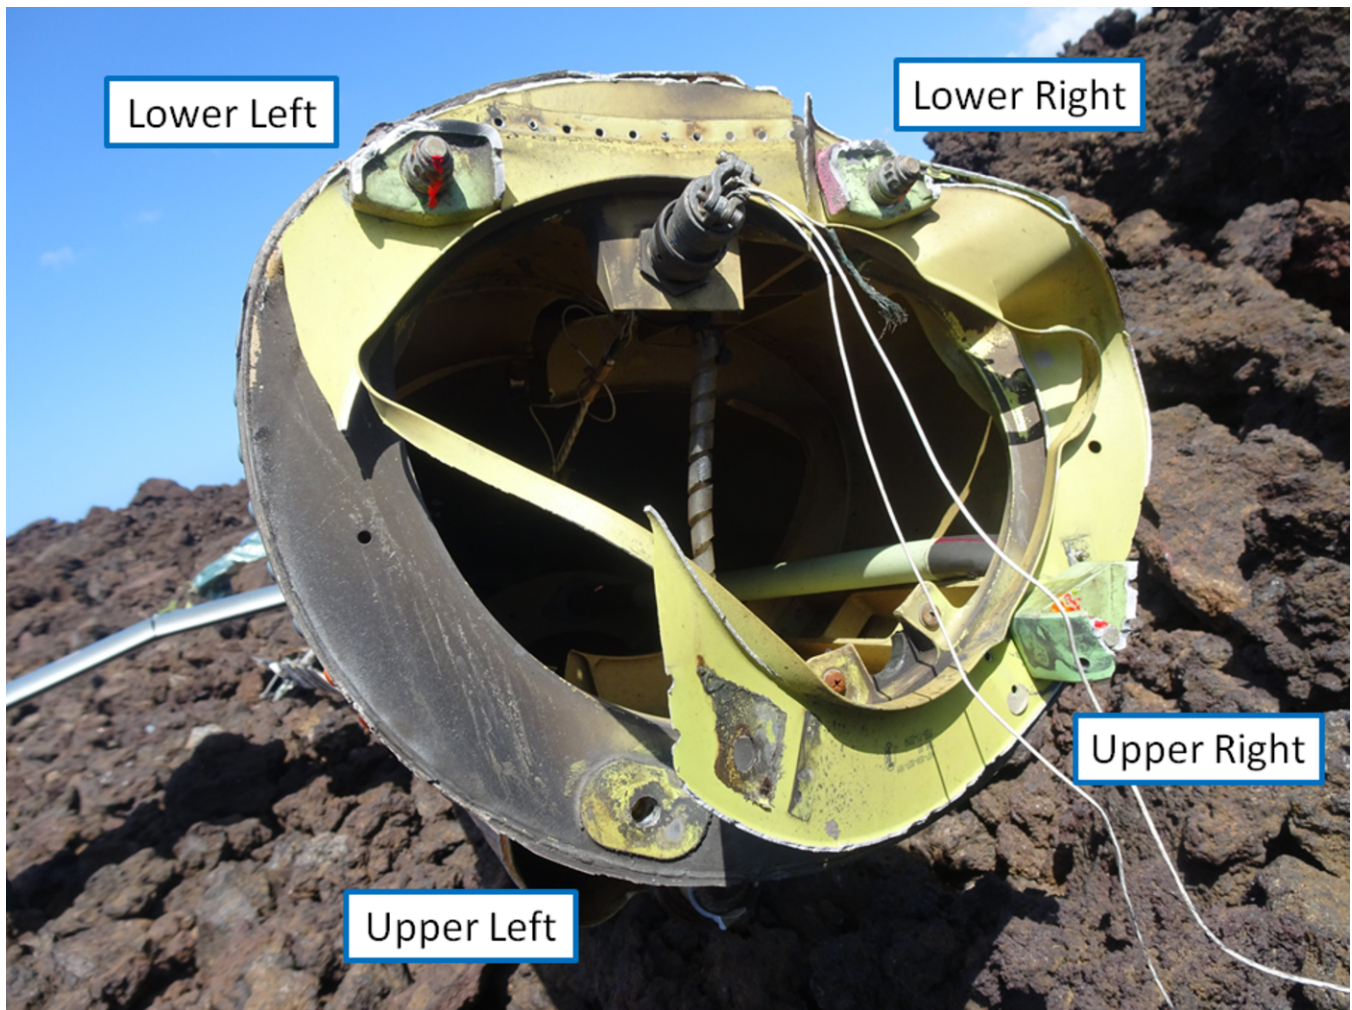
An NTSB on site examination of the accident site revealed the tail boom came to rest about 762 ft northeast from the main wreckage, which consisted of the fuselage, engine, and main rotor system. The tail boom separated from the fuselage at the tail boom attach point. (See Figure 2.) The upper left attachment fitting fastener was not present, and the lower left attachment fitting was fractured and displayed fatigue signatures. The fasteners for the lower left, lower right, and upper right attachment fittings were present.

Figure 2. Tail boom at accident site
