# ECRI

November 16, 2022

Re: Investigation of a Fire within an Ambulance

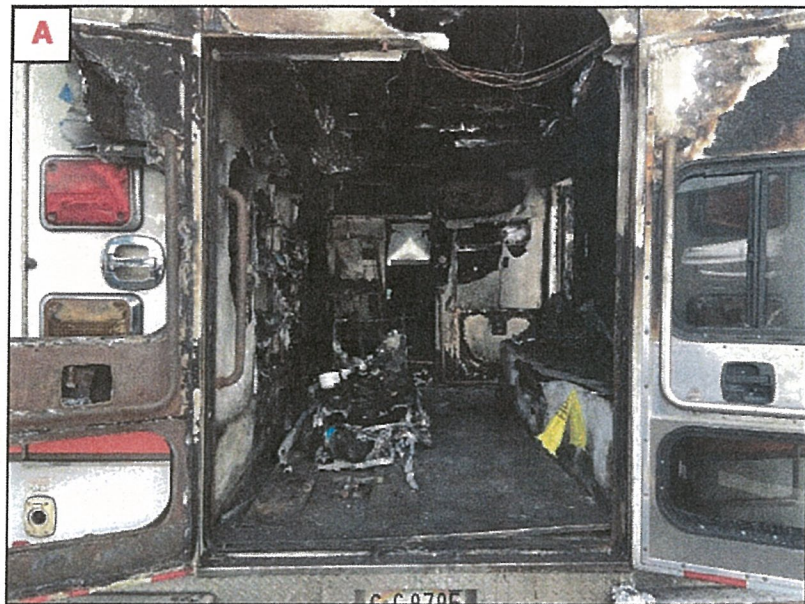
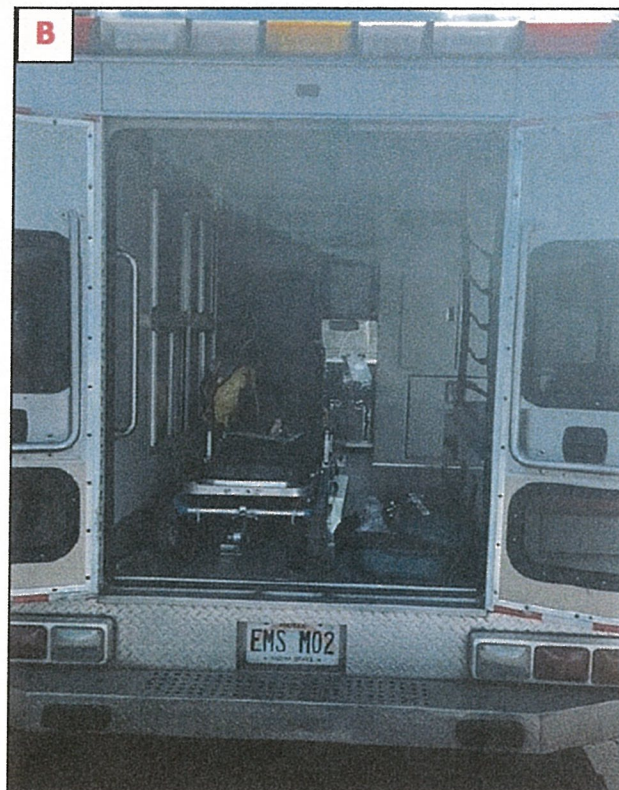
The investigation scene was set up so that the incident ambulance and an exemplar ambulance of the same make and model (Braun Northwest Ford 350 2192/3/4/5-1) were parked parallel to each other. Before my arrival, the Honolulu Fire Department had already spent seven days recreating the incident ambulance while salvaging damaged equipment and organizing them along the side of the ambulance from the back of the box to the driver's cabin. The amount of damage to the incident ambulance was extensive compared to the exemplar model (see Figures 4, 5, and 6).

**Figure 4A)** Incident ambulance damage perspective behind the ambulance **4B)** Exemplar ambulance from the same perspective

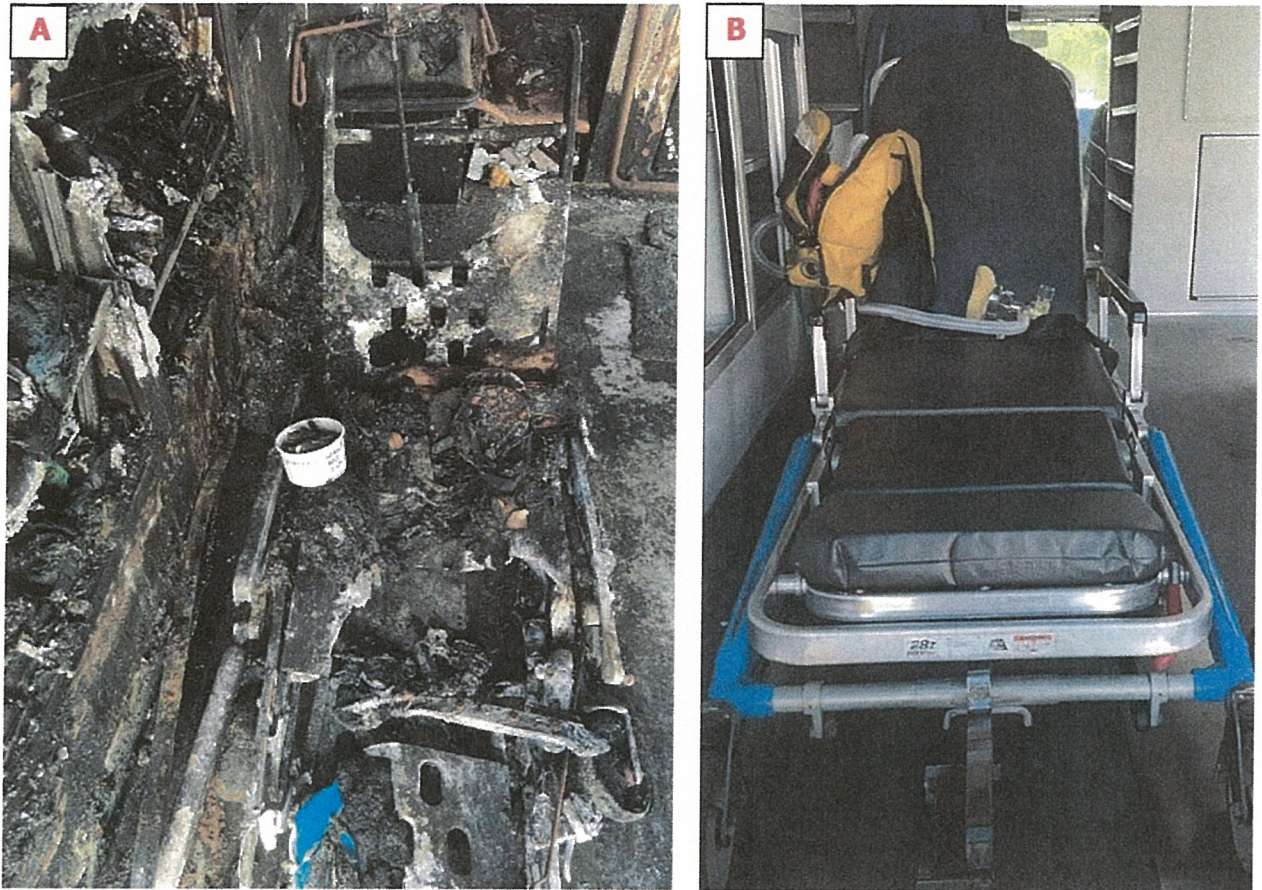
**Figure 5A)** Gurney inside the incident ambulance **5B)** Gurney inside the exemplar ambulance

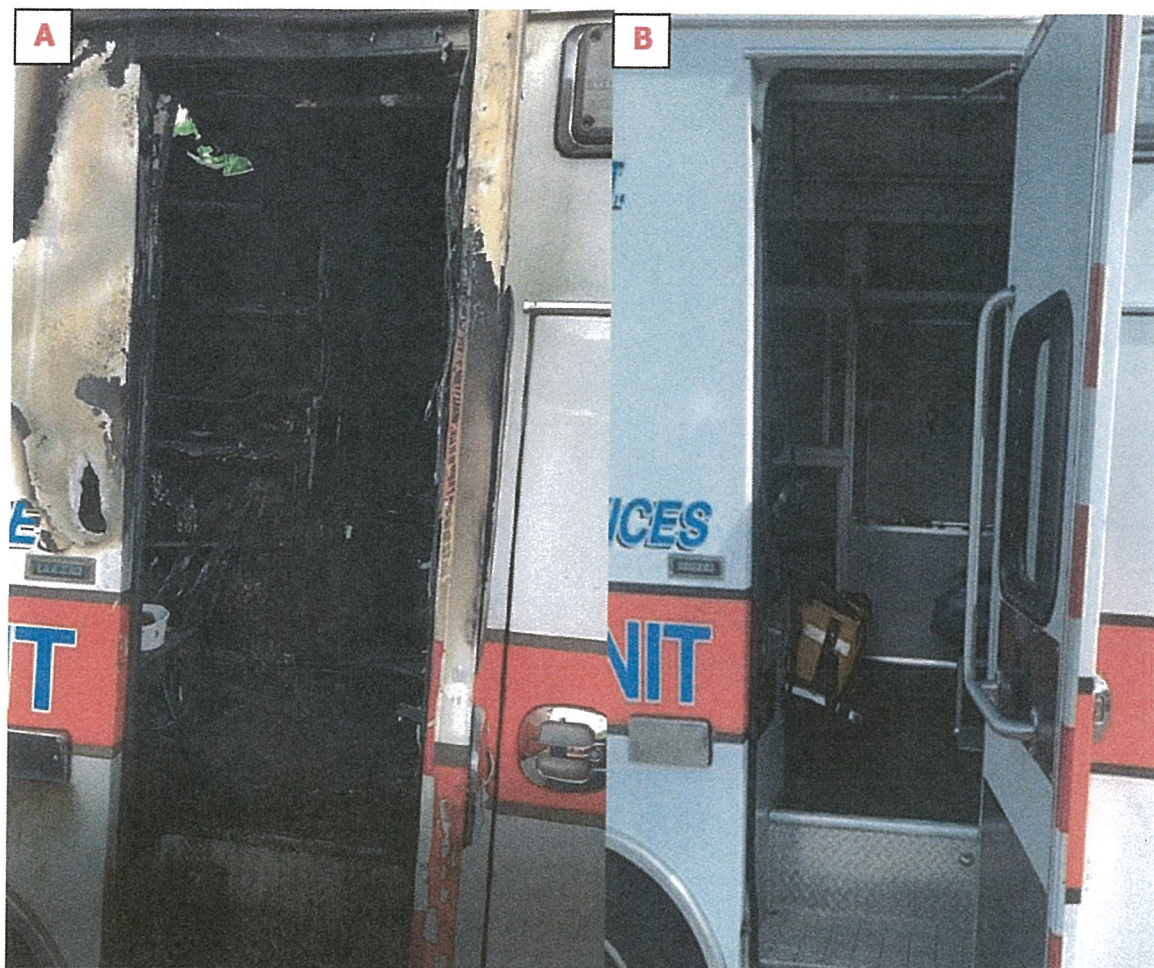
**Figure 6A)** Incident ambulance damage side perspective **6B)** Exemplar ambulance from the same perspective.

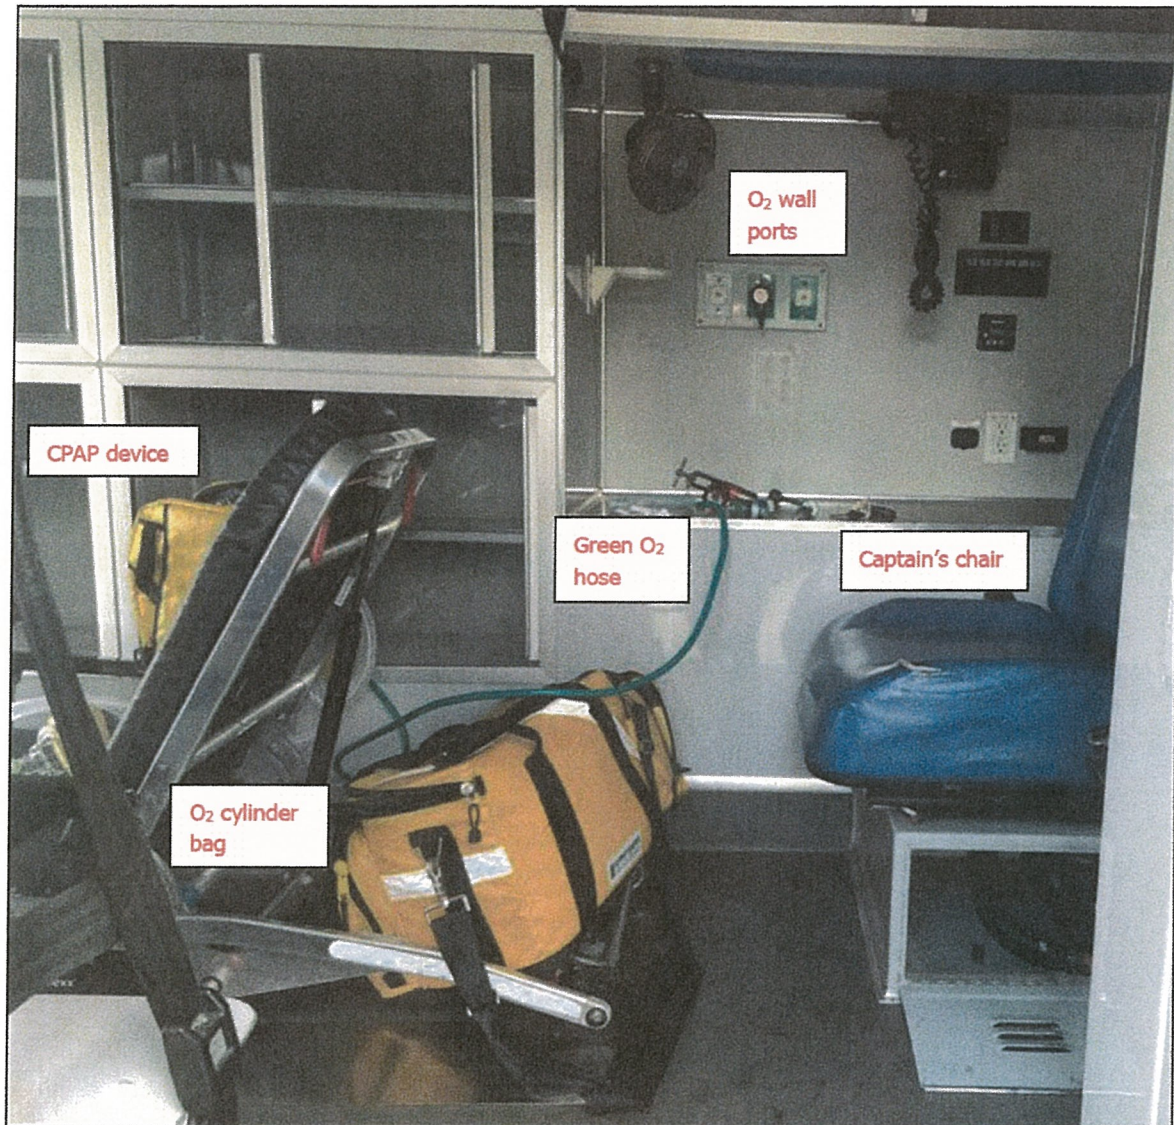
When the paramedic connected the quick connects of two O<sub>2</sub> hoses, he was seated at the captain's chair and the yellow bag containing the portable O<sub>2</sub> cylinder was likely positioned behind the head of the gurney with the regulator facing either the ceiling or the closest wall to the paramedic's right. The CPAP device was likely positioned near the patient's side or hooked around the head of the gurney (see Figure 7, 8, and 9).

**Figure 7)** Photograph taken from exemplar ambulance's side door showcasing the most likely locations of the CPAP device, portable O<sub>2</sub> cylinder bag, the captain's chair, and the O<sub>2</sub> wall ports.

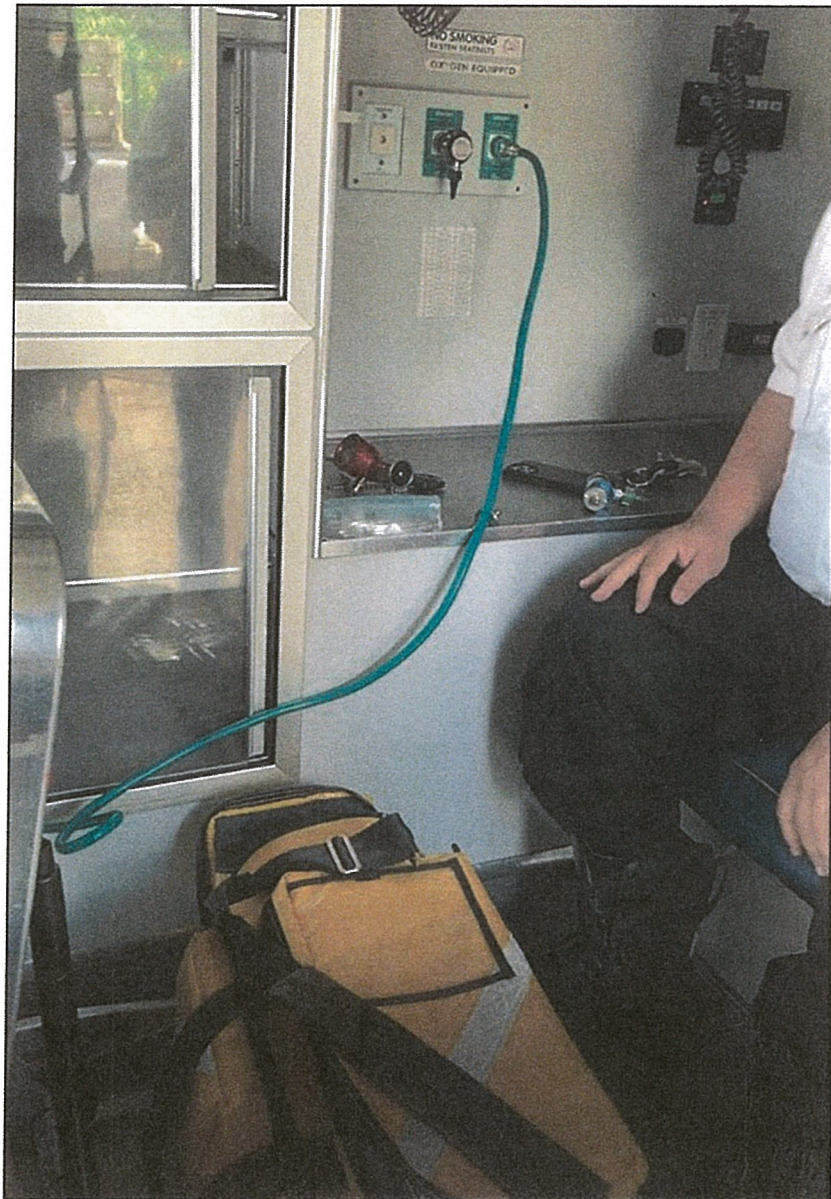
**Figure 8)** Seat location of the paramedic relative to the wall O<sub>2</sub> port and portable O<sub>2</sub> cylinder bag. Note the regulator is facing toward the wall beside the paramedic.

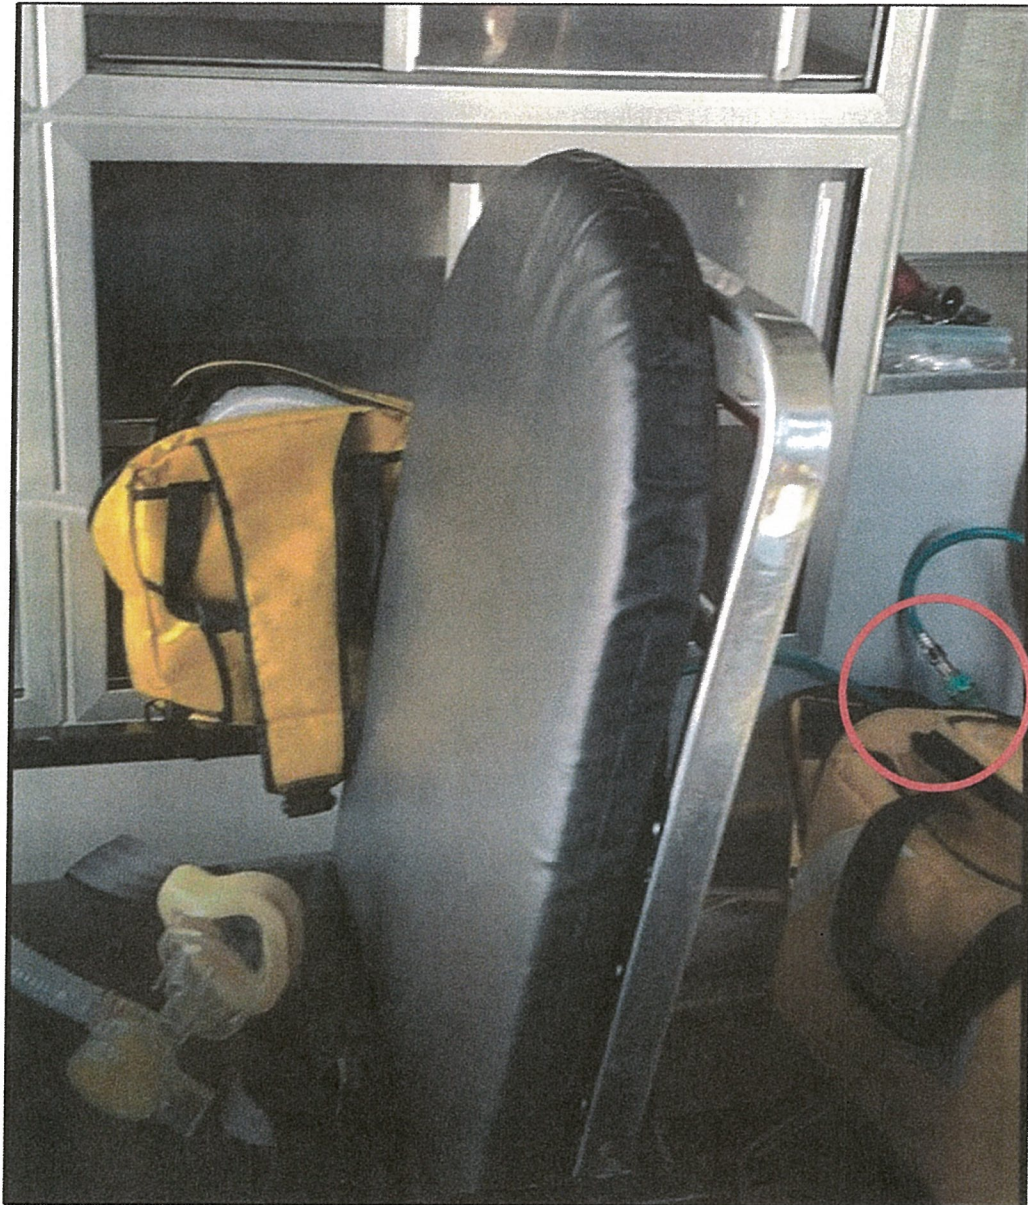
**Figure 9)** Possible position of the CPAP device and the position of the O<sub>2</sub> cylinder bag with the green O<sub>2</sub> hose connected to the pigtail linking the two pieces of equipment together (within the red circle) to enable O<sub>2</sub> flow to the patient via the CPAP device.

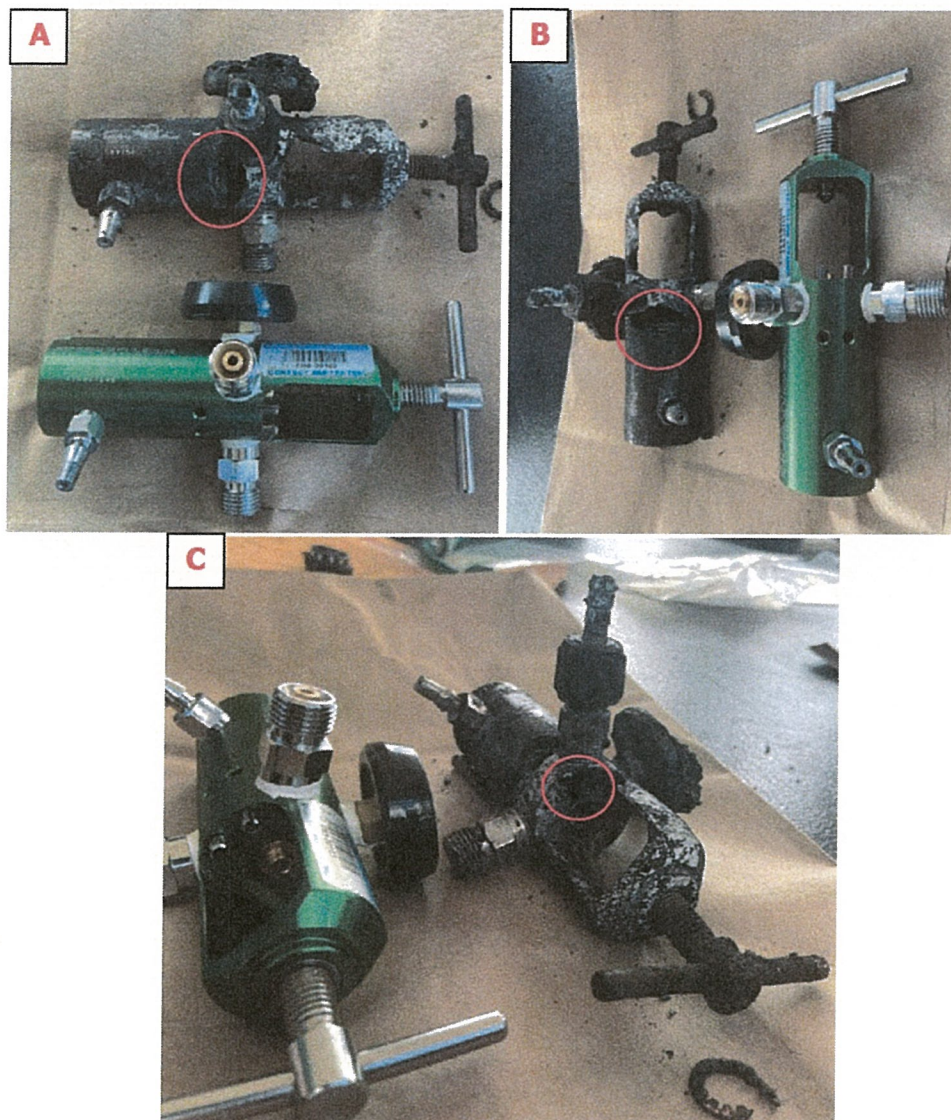
The incident regulator displayed signs of significant physical damage. The area surrounding the two vent holes was completely blown out. The "pigtail" female DISS connector was fused to the regulator's male connector and the hose component was entirely gone. Additionally, there is another small hole at the location of one alignment pins. Figures 10A, 10B, and 10C illustrate the damaged regulator compared to an exemplar regulator of the same model.

Determining that no other external ignition source was close to the regulator and assessing the significant structural damage to it, it is most likely that the fire initiated within the regulator as the two Ohmeda connectors were pushed together. Given that these connectors were not recovered, it is unknown if the connectors latched. Nevertheless, initiation of O<sub>2</sub> flow begins prior to the spring-loaded latching of the connection. At this time, the O<sub>2</sub> cylinder valve was open, and the gas regulator was pressurized. This is supported by the paramedic's recollection of hearing an audible "pop" right before the fire occurred. Fires within an oxygen enriched atmosphere commonly make an audible noise because of rapid gas expansion.

Due to high internal pressure and pure O<sub>2</sub> within the regulator, the fire burned very quickly (i.e., milliseconds) leading to an explosion that created the holes in the aluminum body. This action is probably the moment the paramedic was forced to close his eyes because of the bright flash and intense heat. Afterwards, the holes in the regulator allowed the fire to escape. Now amplified by 100% O<sub>2</sub> under high pressure acting as the oxidizer, the O<sub>2</sub> cylinder and regulator assembly acted like large flamethrower igniting surrounding materials easily and quickly. Materials that do not burn in ambient air would begin to burn under these circumstances, particularly aluminum, which comprised the regulator body and was present among most of the equipment in the ambulance. The continuous flow of O<sub>2</sub> out of the regulator most likely created the loud hissing noise recounted by both the paramedic and EMT. This was confirmed during the investigation by opening an exemplar jumbo-D size O<sub>2</sub> cylinder inside the ambulance box that could be easily heard in the driver's cabin.

**Figure 10A)** Incident regulator (top) with large hole at the location of the two vent holes (within red circle) **10B)** alternative perspective of the regulators more clearly showing the fused DISS connectors (within red circle), **10C)** longitudinal view showing a small hole at the location of one alignment pin (within red circle)

At the time of this report, the precise mechanism that caused the fire within the regulator is not known. Additional testing may provide more evidence to definitively determine the cause of the fire, but there is also a chance that it will not deliver enough information to offer more clarity. However, there are two mechanisms known to cause regulator fires both of which involve contaminants, such as small amounts hydrocarbons (e.g., oil and grease), organic, and metallic substances, within the O<sub>2</sub> cylinder and regulator assembly that burn when exposed to high pressure and heat in an oxygen enriched atmosphere. These ignition mechanisms are known as adiabatic compression (colloquially known as a gas hammer effect) and particle impact. If these two mechanisms are coupled with promoted ignition (fire propagation along the flow of O<sub>2</sub> burning other material downstream), they can cause a catastrophic failure of the gas regulator.

Based on the evidence described above, it is likely that the regulator fire was the result of one of these phenomena.

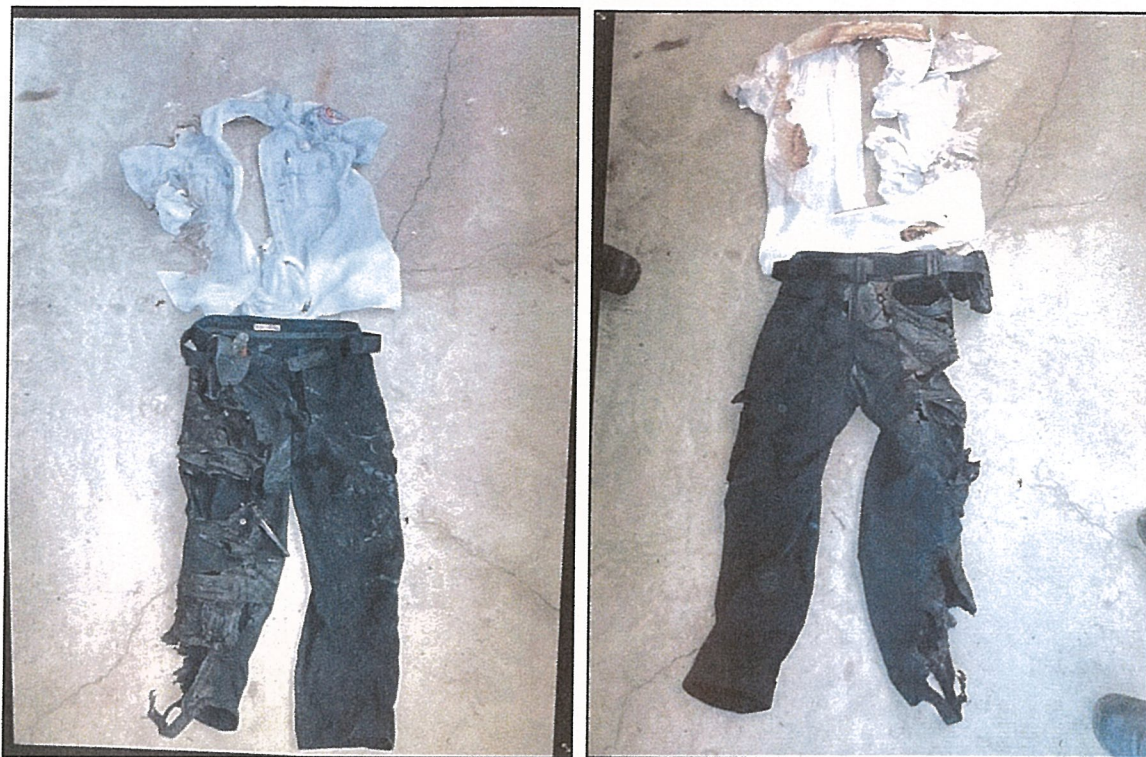
These findings are further supported by the damage to the paramedic's clothing [REDACTED]

**Figure 11A)** The frontside of the paramedic's clothes worn during the fire with significant burns on the right side and noticeable less damage on the left side. **11B)** The backside of the paramedic's clothes showing a distinct difference in damage between the right and left side as well as extensive thermal damage to the back of the shirt.
