# Aviation Investigation Preliminary Report

| <b>Location:</b> | Honolulu, HI | <b>Accident Number:</b> | ANC25FA010 |
| <b>Date &amp; Time:</b> | December 17, 2024, 15:15 Local | <b>Registration:</b> | N689KA |
| <b>Aircraft:</b> | Cessna 208B | <b>Injuries:</b> | 2 Fatal |

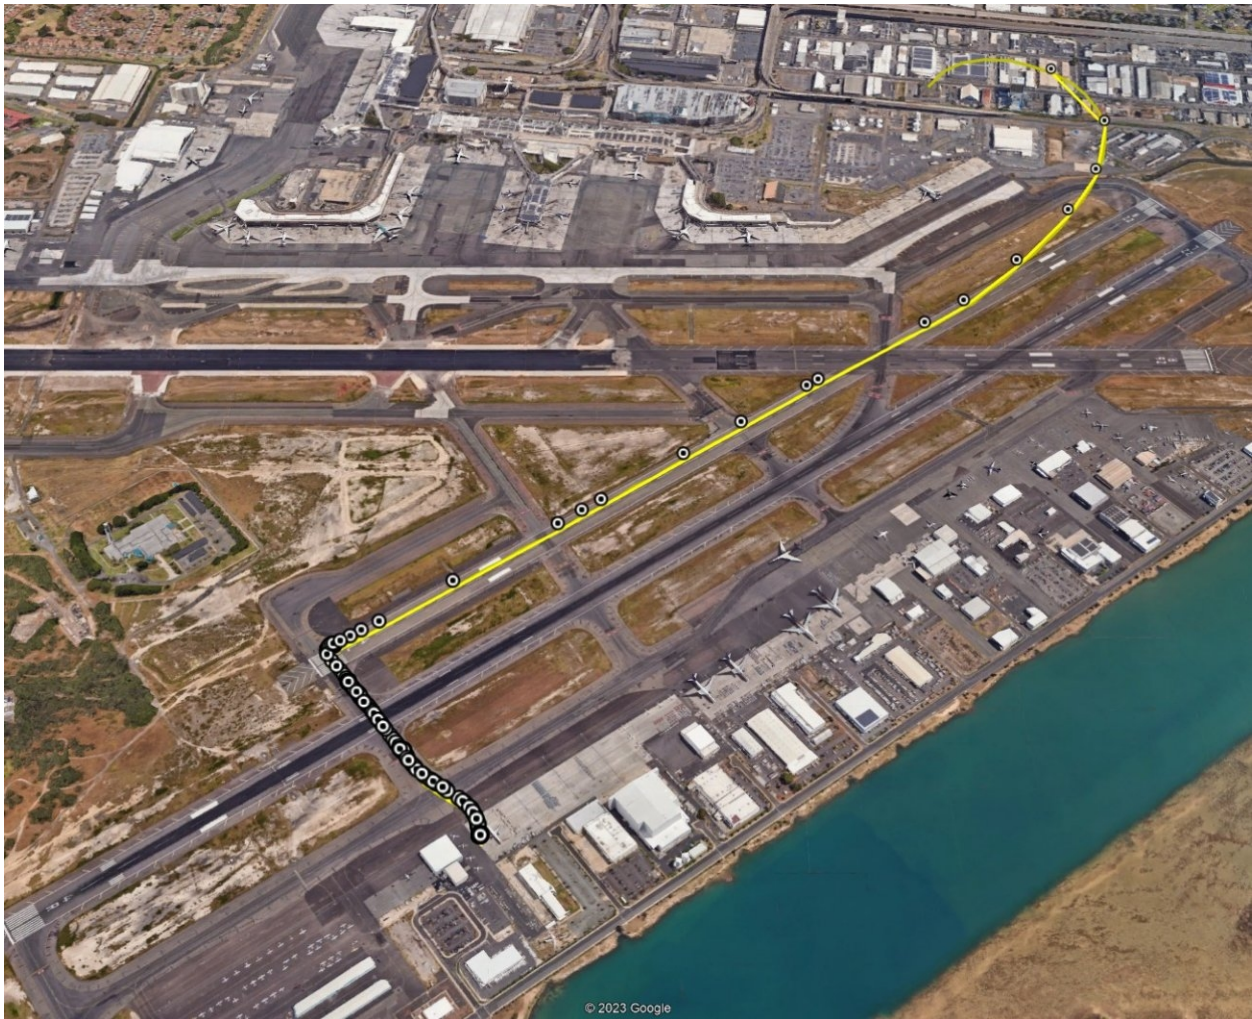
As the airplane continued a shallow climbing left turn, it eventually passed over an industrial area to the northeast of PHNL. As the flight progressed on a north-northeasterly heading, the left turn continued, and the airplane turned to a south westerly heading. The airplane's left turn continued to steepen, and it eventually descended nose down into the industrial area just north of PHNL. See figure. 1

Figure 1. Automatic Dependent Surveillance–Broadcast (ADS– B) overlay, which depicts N689KA's departure from Runway 4L.
