Aviation Investigation Preliminary Report

Location:	Kaupo, HI	Accident Number:	ANC23FA008
Date & Time:	December 15, 2022, Local	Registration:	N13GZ
Aircraft:	RAYTHEON AIRCRAFT COMPANY C90A	Injuries:	3 Fatal
Flight Conducted Under:	Part 91: General aviation - Positioning

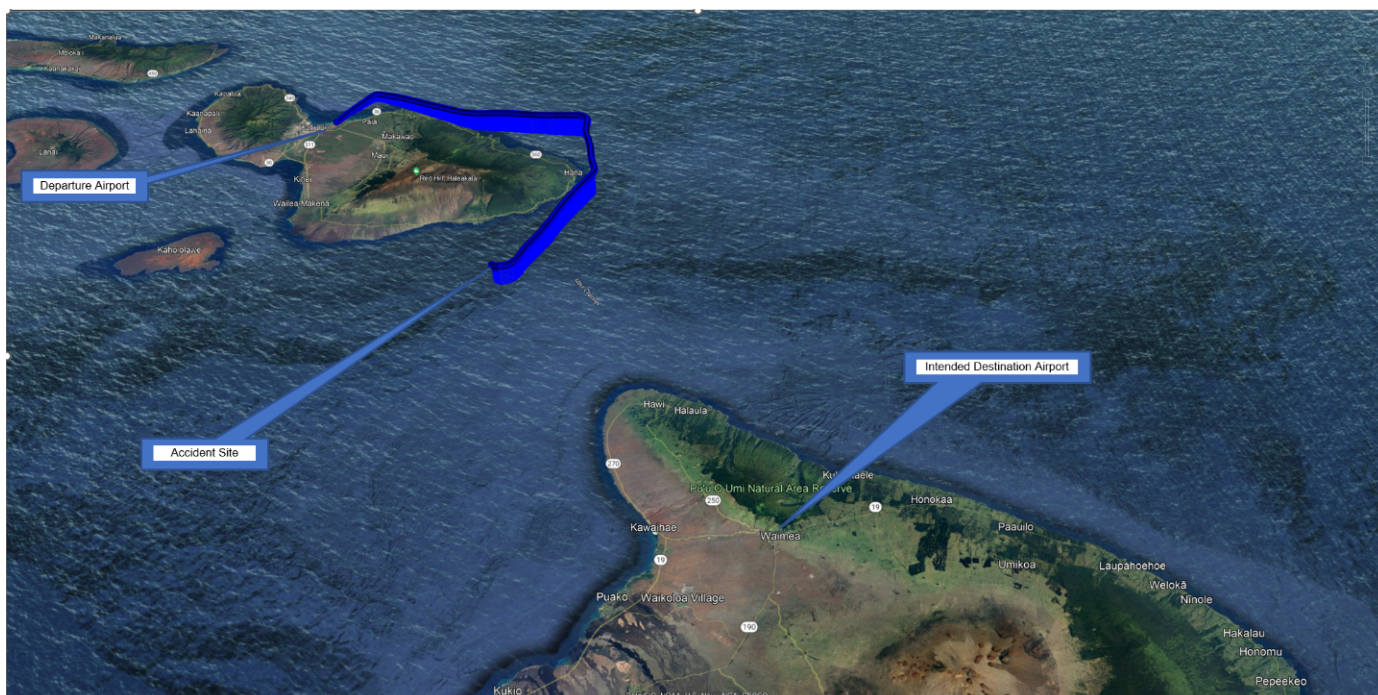
According to archived FAA ADS-B data, after the airplane departed OGG, it initially proceeded north, then it turned eastbound, which is consistent with the Onohi Two standard instrument departure procedure. As the airplane neared the northeastern shores of Maui, while climbing to 11,000 ft msl, it eventually turned southbound along the Victor 11 airway. The ADS-B data eventually stopped near where the witness observed the accident airplane impact the water. (See figure 1.)

Figure 1: ADS-B track data for N13GZ
