# Aviation Investigation Preliminary Report

| <b>Location:</b> | Neosho, MO | <b>Accident Number:</b> | CEN26FA311 |
| <b>Date &amp; Time:</b> | September 7, 2026, 13:37 Local | <b>Registration:</b> | N101XV |
| <b>Aircraft:</b> | EXP STOL CH701 | <b>Injuries:</b> | 2 Fatal |

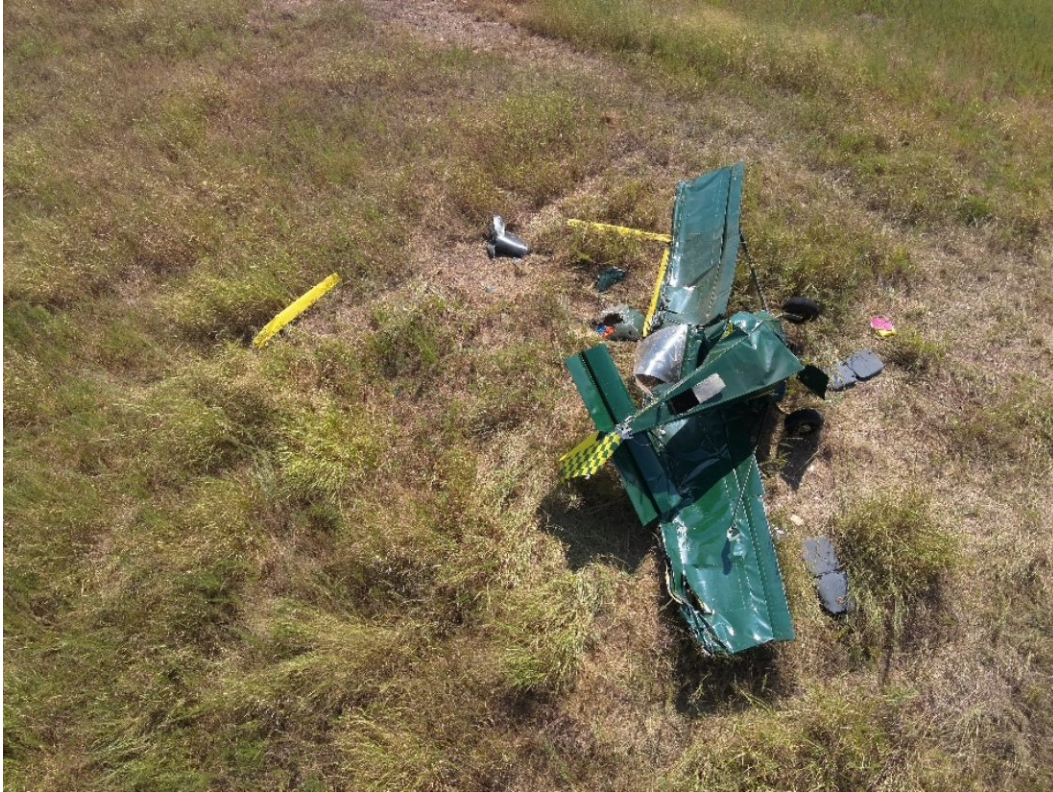
The accident site was located in an open field about 0.48 nautical miles east of the departure end of runway 19. Impact ground scars and debris were consistent with the airplane impacting terrain in a nearly vertical nose down attitude (see figure 1).

Figure 1. Accident site overview

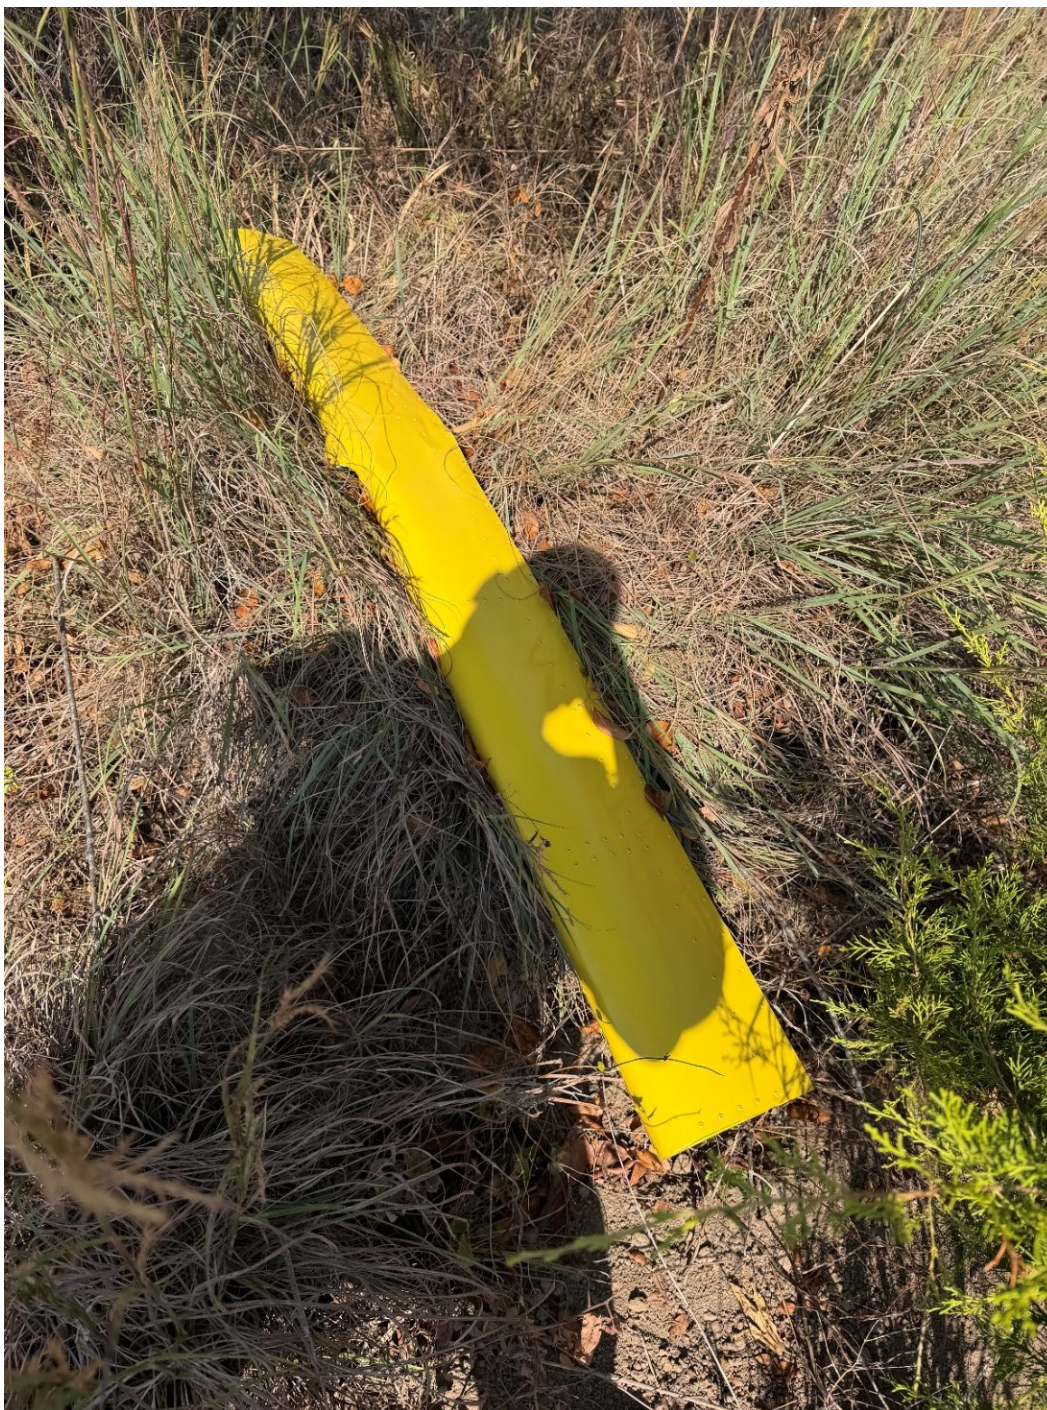
Postaccident examination revealed that the left inboard leading-edge PegaSTOL slat was separated and not found within the vicinity of the main wreckage. The PegaSTOL wing slat system is manufactured by Dédalius Aviation Inc. A couple of days after the accident, the leading-edge slat was found by law enforcement about 0.14 nautical miles southwest of the accident site (see figure 2).

Figure 2. Left inboard leading-edge slat.
