**RE: STRUCTURAL REVIEW  
1215 W CHESTNUT ST  
SAVANNAH, MO 64485**

**JOB #2025-0858**

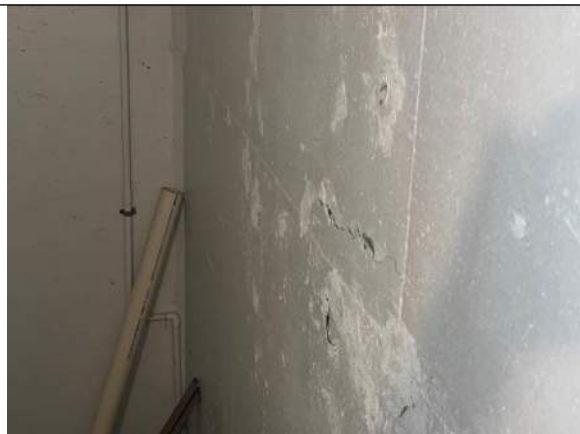
Horizontal cracks were noted on the west side of the center concrete wall. It appears that this section has been previously repaired, as indicated by noticeable patchwork. In my opinion, the cracks may be due to rust in the reinforced steel, which has caused the steel to expand and crack the face of the concrete. Therefore, it is recommended to remove the loose material, clean the exposed portion of the steel from the rust, then apply grout (such as hydraulic grout or similar methods) and seal the area. If it is found that the reinforcement is not rusted, please feel free to reach out to our office for further consultation.

Horizontal cracks in pump house concrete wall

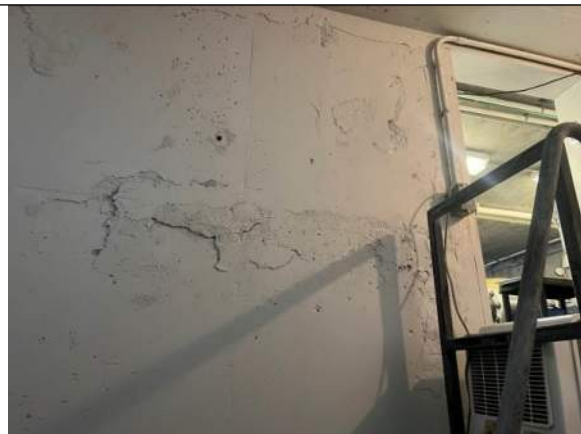
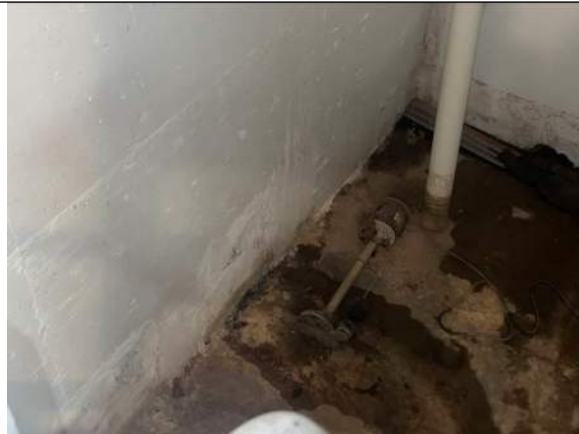
Water leak near west side of east pump house wall

Water leak near west side of  
east pump house wall

During the pump house inspection, water leaks were noted near the bottom of the east concrete wall. At this point, it remains uncertain whether the leaks originate from underground water or from a failure in the water lines serving the pool. At this time, it is recommended to remove a portion of the exterior concrete slab that is located between the pump house and the pool, and excavate the soil located under the slab to determine the source of water behind the wall.

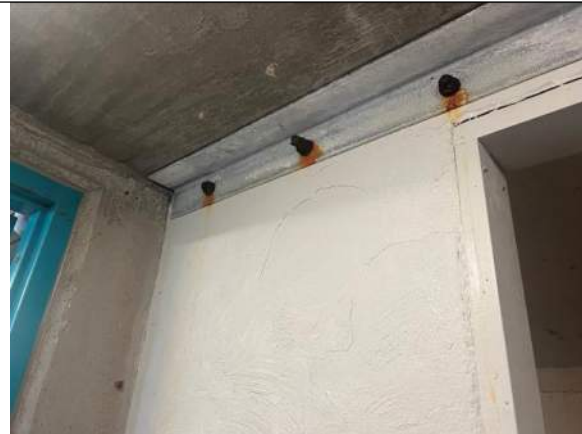
Rusted bolts at angle on the  
Wall inside the pump house

Further investigation of the pump house also revealed that some of the anchor bolts supporting the steel angles at the top of the wall are rusted and should be replaced with new bolts of the same size. As an alternative, new bolts of similar dimensions and diameter can be installed 3 inches away from each of the rusted bolts.

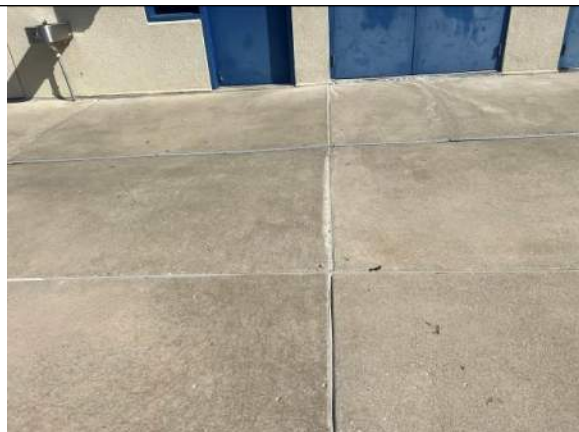
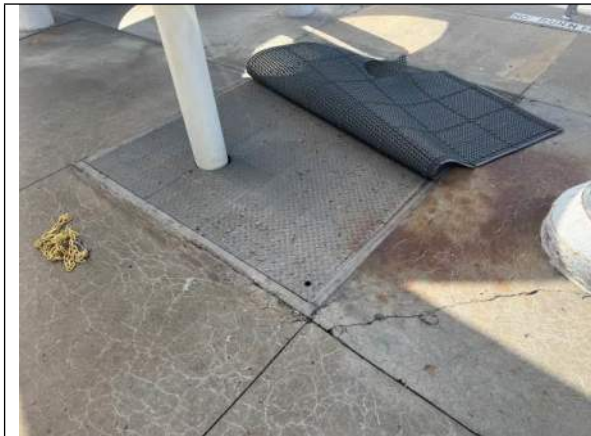
During the site visit, several area of the pool floor and pool deck appeared to have shifted. Differential movement of the various portions of the slab caused by swelling and shrinkage of the clay subsoil occurs with changes in the soil's moisture content. When the subsoil absorbs water, it expands and heaves the basement floor slab and foundation walls upward distorting the framing above. As it dries, the soil shrinks resulting in some rebound or settlement. This uneven movement and distortion can appear as cracks in the concrete floor slabs. Additionally, using a steel chain to assess certain areas beneath the concrete slab reveals that some spots may be hollow. The sound produced by the chain as it traverses the surface provides a clear indication of whether the underlying area is solid or hollow.

Shifting of the concrete pool deck

In some areas, the vertical shifting of the slab may have affected some of the steel plates near the waterslide. It was reported that the openings around these steel plates fluctuate in size due to the slab's movement. In my opinion, it is essential to conduct a more thorough investigation regarding the hollow area and voids beneath the concrete slab pool deck. This process should involve removing the slabs to assess the underlying issues and identify the necessary repairs based on the findings. Additionally, as mentioned previously, portions of the concrete slab located on the east side of the pump house need to be removed, and the area should be examined to uncover the cause of the water leaks occurring within the pump house.

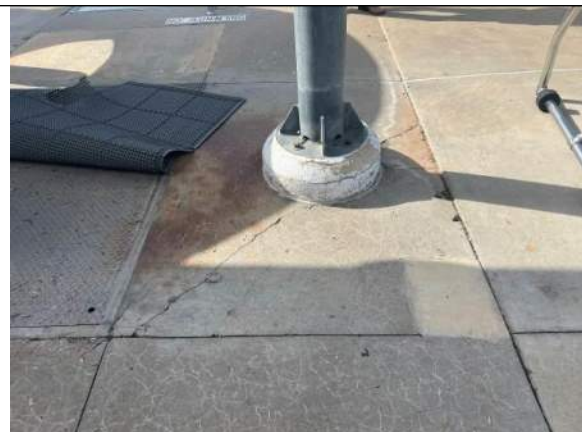
Shifting and cracks of the  
concrete pool deck

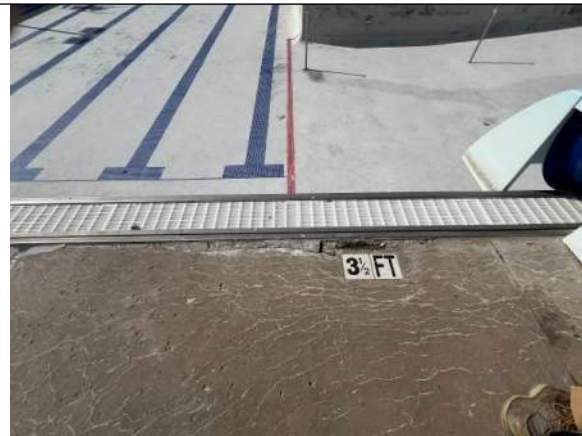
Concrete deterioration at the  
northeast corner of the pool deck

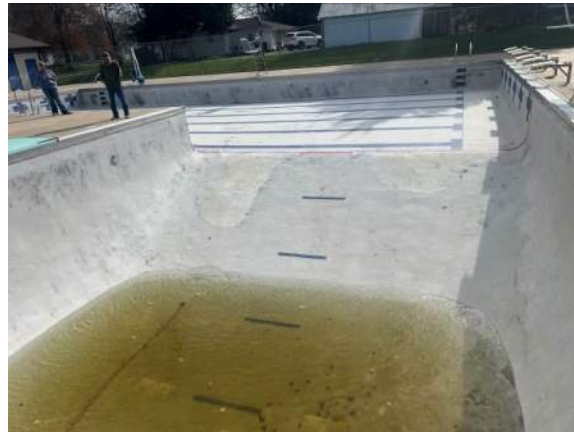
An examination of the pool floor revealed that the concrete slab is topped with a layer of plaster. Previous repair work was observed near the deep end; however, it remains uncertain whether these patches are holding up well or if they are contributing to water leaks. Consequently, it is advisable to assess this area thoroughly to ensure that the seams between the old and new plaster are watertight.

Patches of past plaster repairs near  
The deep end of the pool

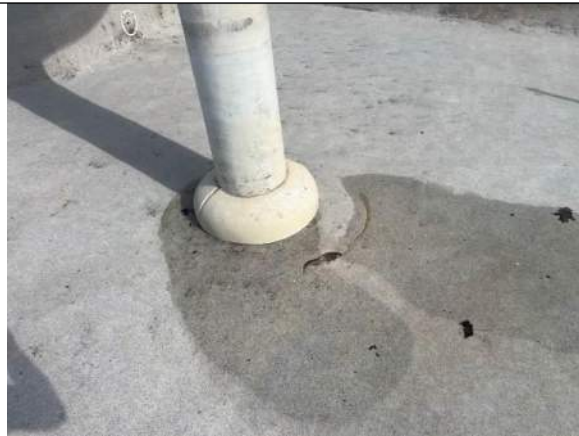
Water leak appears to be occurring at the mushroom column. It was reported that there are water leaks even after the water supply line to the mushroom has been shut off. Due to finish material, the source of the water leak could not be confirmed. This areas should be further reviewed and the water leaks repaired.

Water leak around  
the mushroom column.

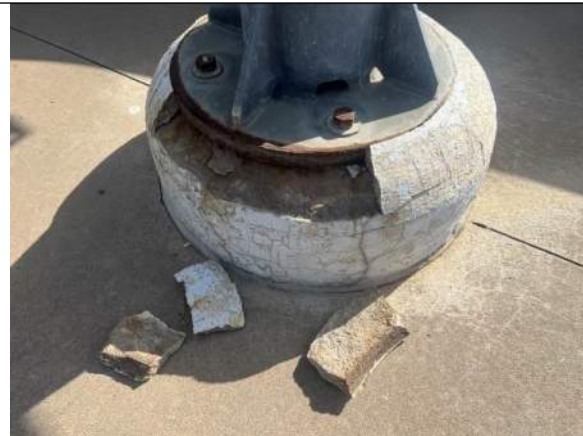
Cracks in concrete pilaster.

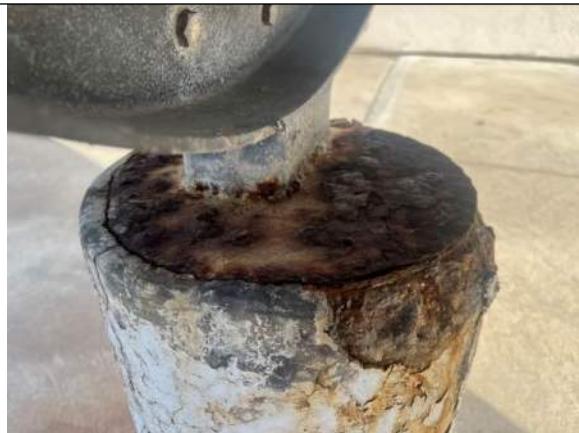
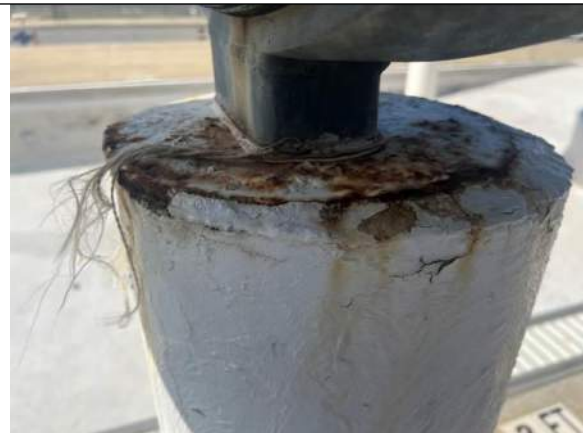
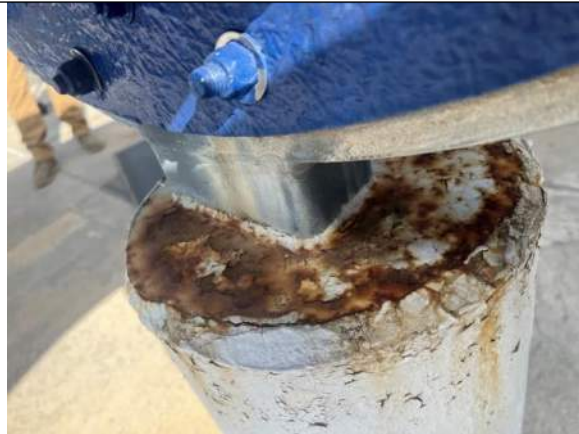
Upon inspecting the steel supports of the water slide, it became evident that several of them exhibit rusted baseplates and anchor bolts. Additionally, there are multiple cracks present in the concrete pilasters. In my assessment, the level of rust on the baseplates and steel anchor bolts of most supports exceeds acceptable limits. Merely removing the rust and applying a primer will not adequately address the issues with the majority of the supports. Some cracks in the concrete are attributable to the expansion caused by rust, while others have resulted from the shifting and movement of the pilasters. Moreover, some of the cracks can be attributed to the natural aging and deterioration of the materials used.

Rusted steel and anchor bolts  
at the waterslide supports.

In my opinion, the level of rust present on the waterslide support exceeds acceptable limits and warrants immediate replacement.

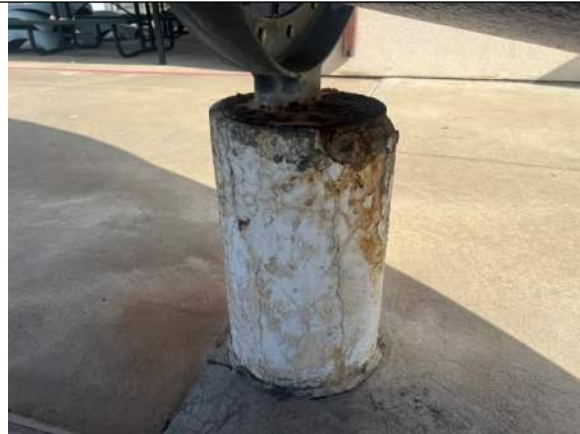
Rusted steel and anchor bolts  
at the waterslide supports.  
Cracks in concrete pilaster.

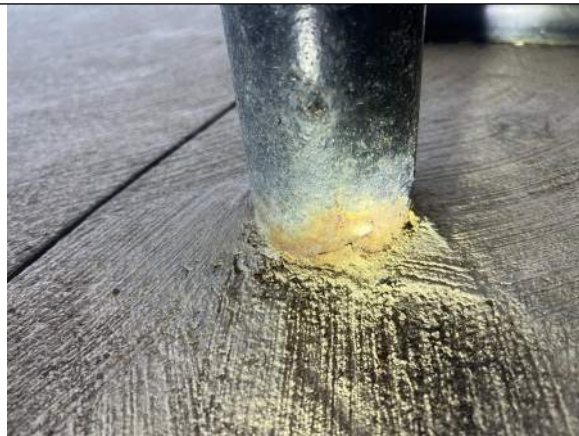
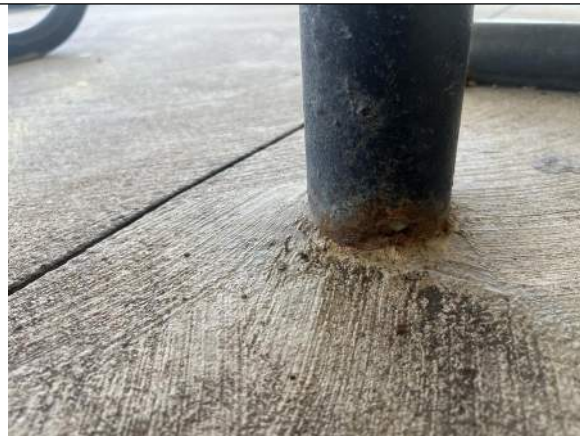
Signs of rust at bottom  
of steel column

An examination of the steel frame at the patio located on the west side of the existing building revealed several columns showing signs of rust at the bottom. Therefore, the rust should be wire brushed and removed down to bare steel and the area primed and painted. For removal of rust, follow SSPC-SP11 recommendations. Please note that this inspection did not attempt to determine the extent of the rust nor the steel capacity of the members.

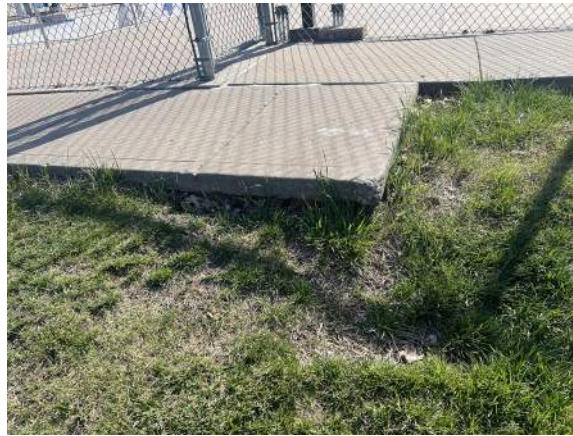
Voids below concrete sidewalk

An examination of exterior concrete sidewalk revealed several area of soil erosion below the slab. All void should be filled with compacted soil, compacted gravel or concrete.

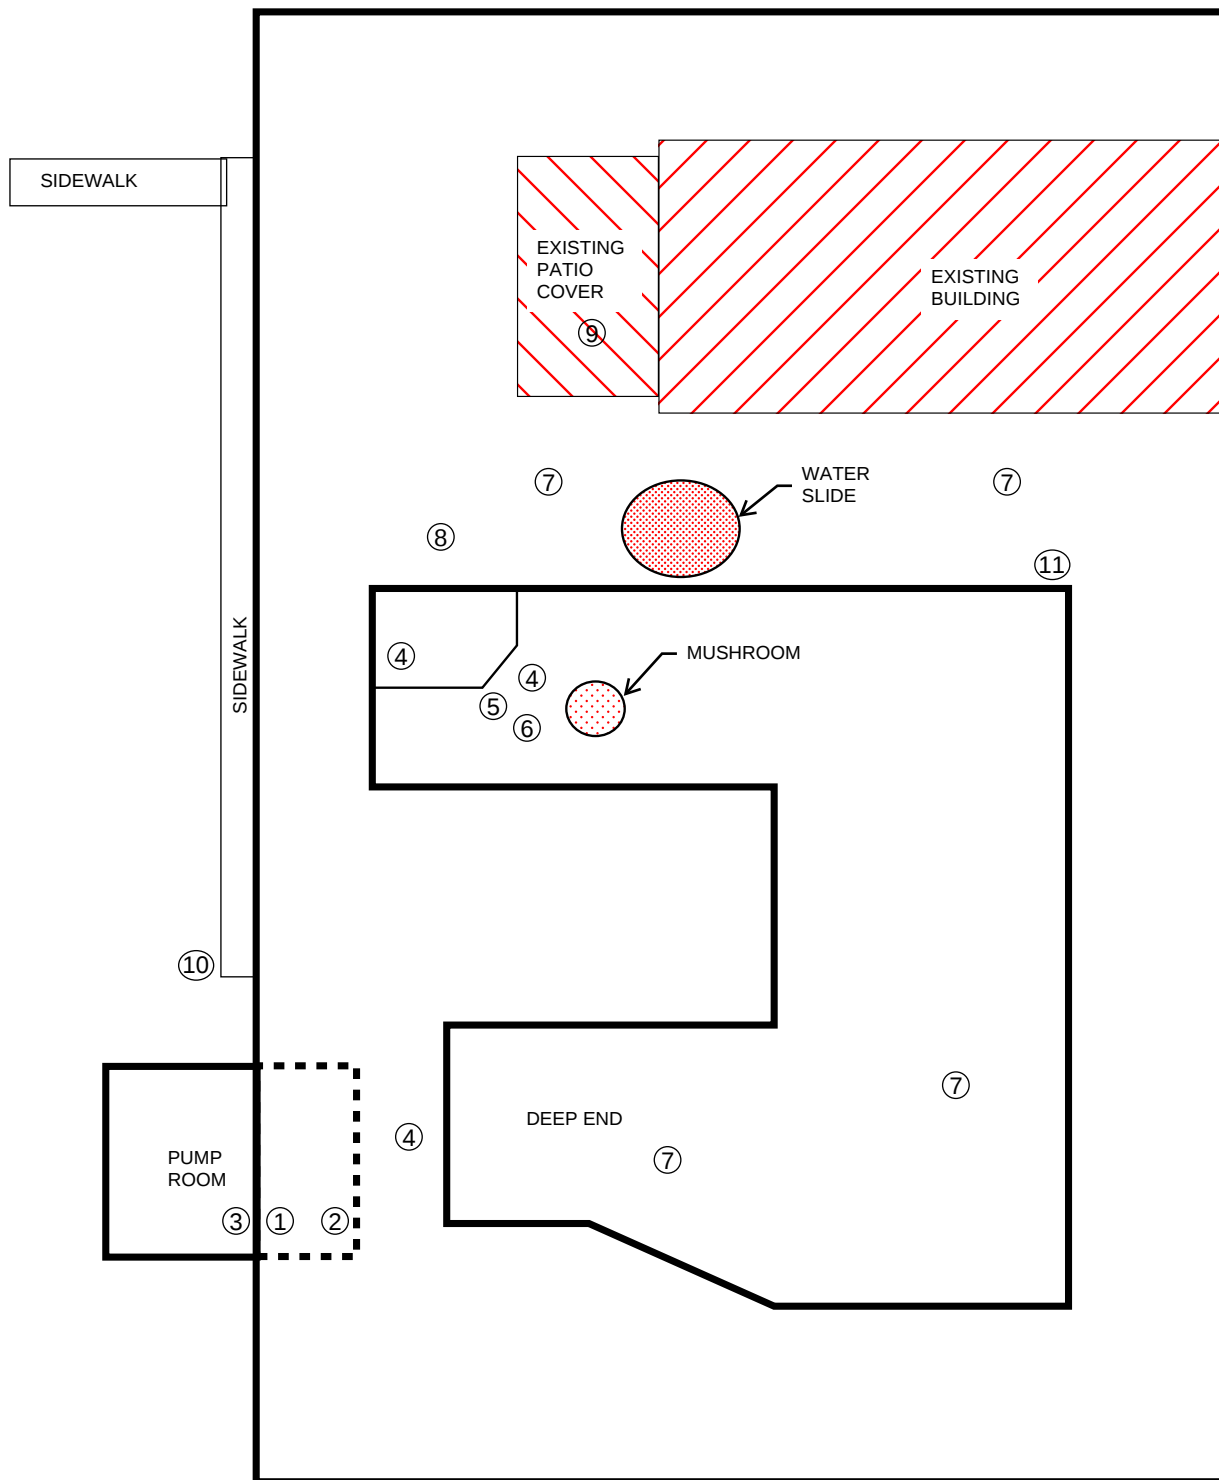
- ① Past patch in concrete. Remove and expose rebar for further review
- ② Water leaks
- ③ Rusty bolts at steel angle
- ④ Hollow sound. Voids appear below slab.
- ⑤ Cracks in concrete slab for further review
- ⑥ Water leaks at mushroom post.
- ⑦ Heaving of concrete slab.
- ⑧ Settlement of concrete slab
- ⑨ Minor rust at steel columns
- ⑩ Voids below concrete slab
- ⑪ Concrete deterioration at the pool deck
