# Aviation Investigation Final Report

<b>Location:</b>	Anaconda, Montana	<b>Accident Number:</b>	WPR24FA132
<b>Date &amp; Time:</b>	April 26, 2024, 06:59 Local	<b>Registration:</b>	N988B
<b>Aircraft:</b>	Bell 206-L4	<b>Aircraft Damage:</b>	Destroyed
<b>Defining Event:</b>	Loss of engine power (total)	<b>Injuries:</b>	1 Fatal
<b>Flight Conducted Under:</b>	Part 133: Rotorcraft ext. load

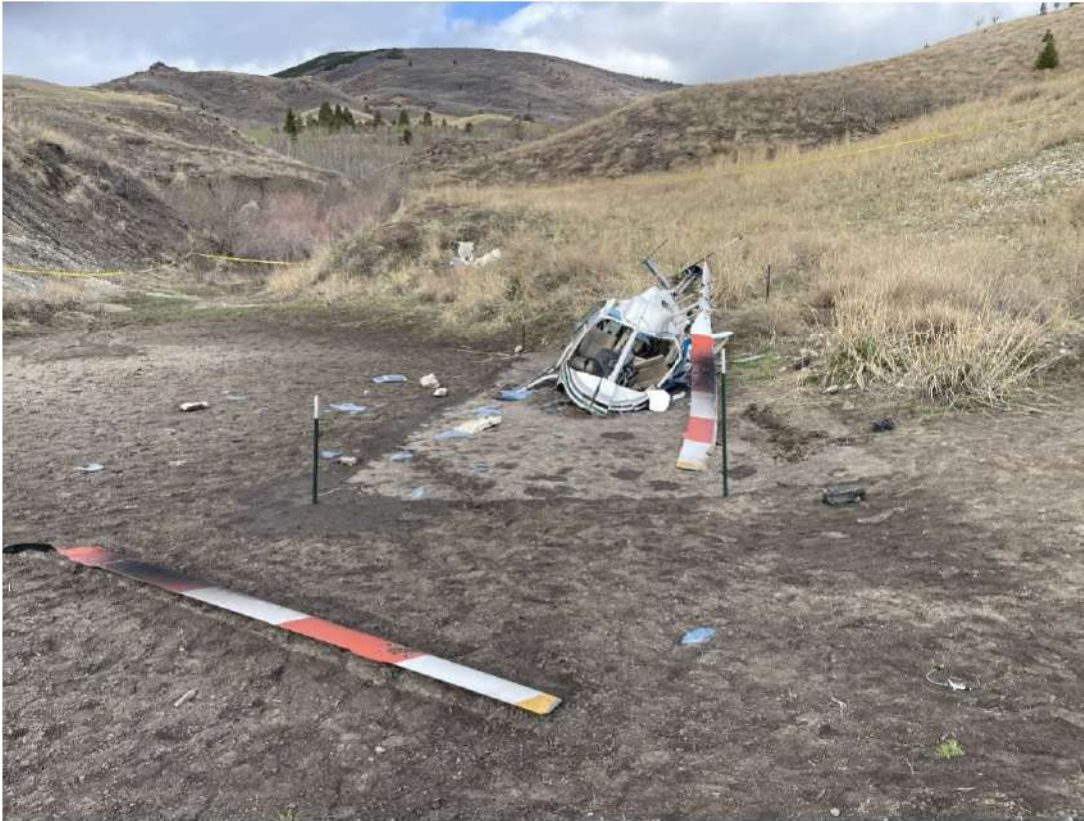
Figure 1. Helicopter Wreckage

Examination of the accident site revealed that the helicopter came to rest in a mostly upright position immediately adjacent to a flat and dry pond area in a gully about 855 ft southwest of the load truck (see figure 1). The fuselage came to rest oriented on a heading of about 060°. The bottom of the fuselage exhibited crushing deformation and the left skid was splayed outward. One main rotor blade was fracture-separated about 3 ft from the rotor attachment point just outboard of the blade doubler and the fracture surfaces exhibited downward deformation. The remainder of the blade was located about 15 ft forward of the helicopter. The second rotor blade remained attached to the rotor mast and exhibited some bending opposite of rotation. The spreader and 25-ft long line were located about 30 ft aft of the helicopter and were not attached to the helicopter, consistent with separation prior to impact. The long-line attachment shackle was unmarred and showed no visible damage. Fuel was observed leaking from the wreckage following the accident.

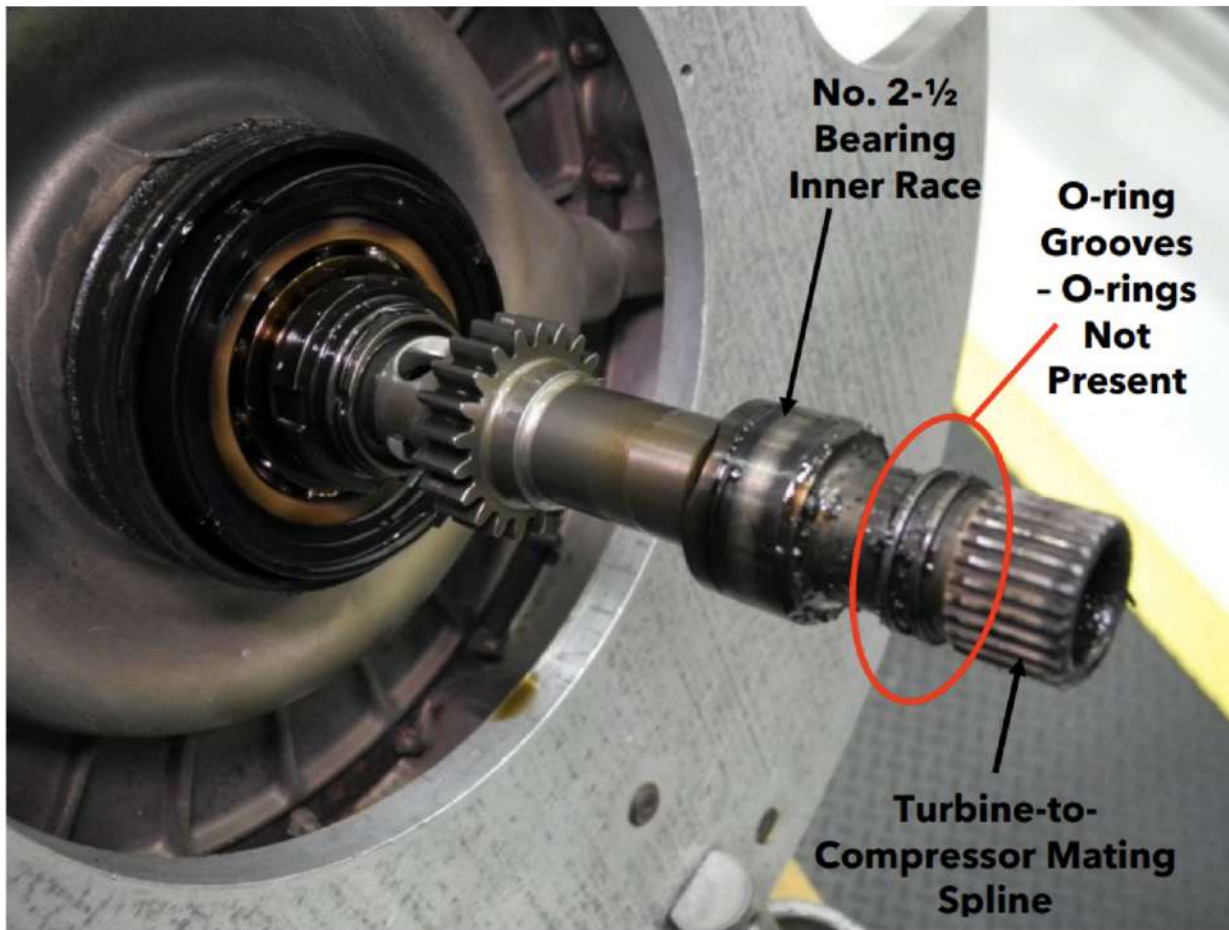
Figure 2. Spur Adapter Gearshaft

Coked material was found that restricted oil flow in one orifice of the piccolo tube and blocked a second orifice of the oil jet to the No. 3 bearing. Analysis of the coked material revealed fluorocarbon rubber signatures consistent with O-ring material. The engine manufacturer stated they were not aware of any previous instances of O-rings disintegrating. The initiating event for the disintegration of the O-rings could not be determined.

Maintenance records indicated that the spur adapter gearshaft, where the O-rings would normally be located, was last accessible when the engine was overhauled about 5 years (1,414.1 flight hours) before the accident. According to the engine manufacturer, a damaged or wrong part number O-ring (or a missing O-ring) may allow cooling oil flow to leak back into the gearbox rather than flow between the concentric shafts. The reduced oil flow between the shafts is not sufficient to cool the shafting below oil carboning temperatures, as evidenced by the finding of coked carbon material in the area of the fractured compressor coupling shaft. Carbon deposits on the outside diameter of the turbine-to-compressor coupling and the inside diameter of the power turbine inner shaft and turbine-to-compressor coupling can build up until rub occurs, causing interference between the shafts, resulting in frictional heating and ultimate failure, which subsequently resulted in a total loss of engine power.

The engine was removed from the wreckage and transported to a manufacturer facility for further examination. The engine was disassembled and the spur adapter gearshaft (SAG) O-rings were not present in either the forward or aft O-ring grooves during engine disassembly (see figure 2).

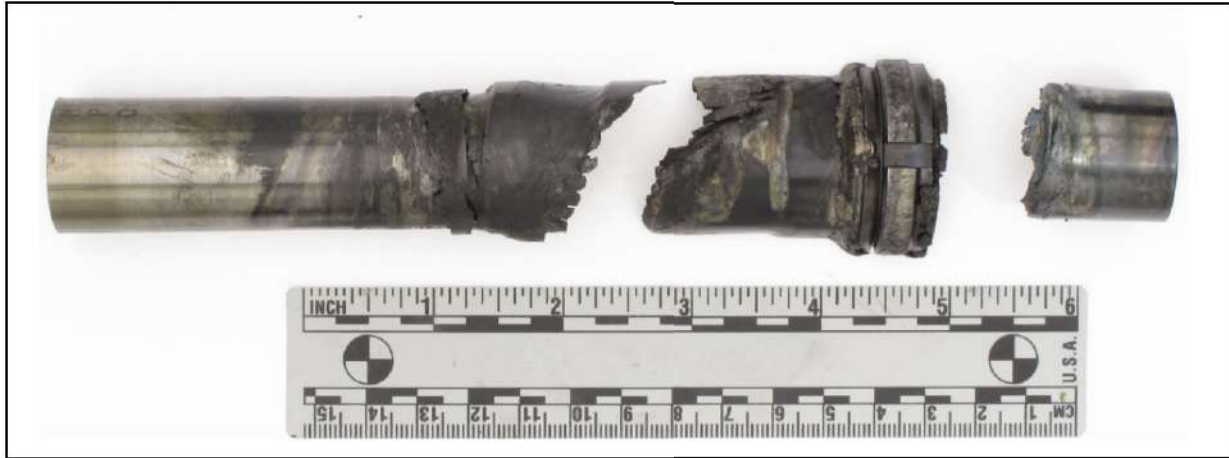
A total loss of engine power due to a loss of cooling oil to the turbine-to-compressor coupling shaft and subsequent fracture of the shaft at an altitude too low for the pilot to complete a

The turbine-to-compressor coupling shaft was found fractured into three pieces as shown in figure 3.

Figure 3. Turbine-to-compressor coupling shaft fractured. Photo courtesy Rolls-Royce.

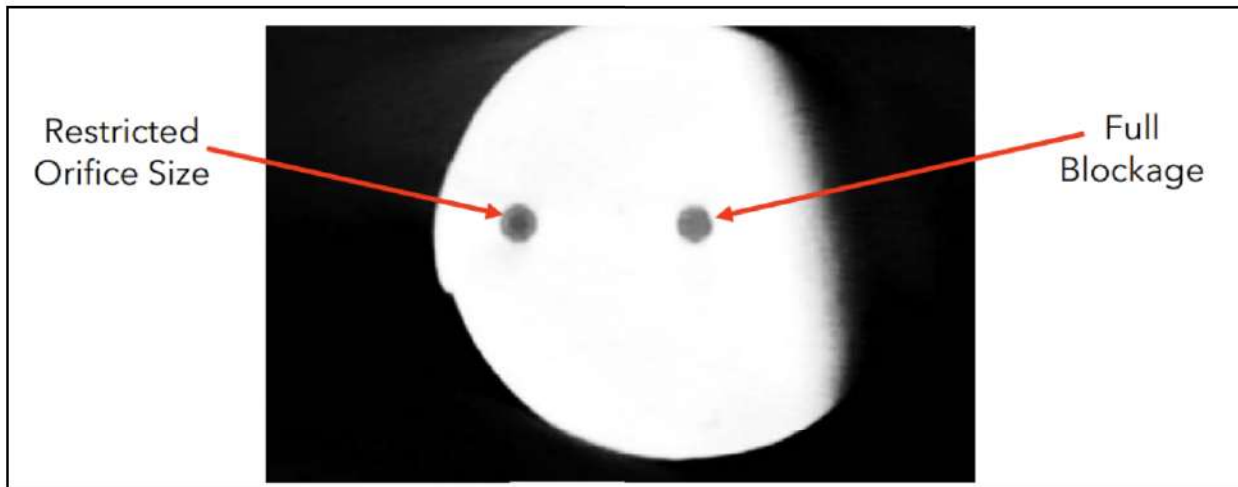
It is likely that the carbon buildup in the piccolo tube screen and nozzles reduced cooling oil flow to the turbine-to-compressor coupling and the turbine inner shaft that caused the shafts to operate at a higher temperature than the carboning limits of the oil, allowing coke to build up between the shafts. The reason for the carbon accumulation in the piccolo tube screen and nozzles was not determined.

Heavy coking was observed in the forward and aft spline locations of the turbine-to-compressor coupling shaft. Coking was noted between the coupling shaft and the power turbine outer shaft. Extensive coking was noted upon removal of the power-turbine-to-pinion-gear coupling shaft. No evidence of coked oil was observed in the aft O-ring groove. Analysis of the coked material revealed fluorocarbon rubber signatures consistent with O-ring material. A computer tomography (CT) scan of the piccolo tube revealed coked material sufficient to restrict oil flow in one orifice and block the other orifice of the oil jet to the No. 3 bearing (see figure 4).

Figure 4. Restricted oil jet orifices in piccolo tube. Photo courtesy Rolls-Royce.
