PROPERTY INSPECTION REPORT

601 Main St
Inspection Prepared For: Kirk Beattie
Agent: Warren Clement - Re / Max Innovative Bayside Laconia

Date of Inspection: 4/24/2024

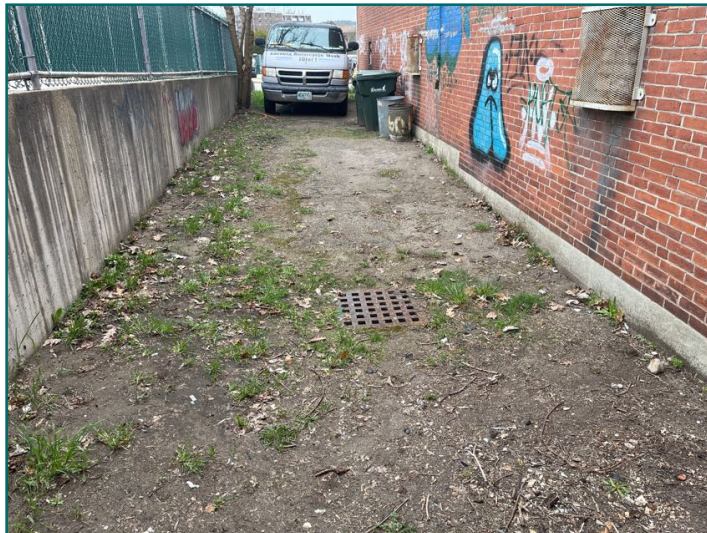
2.2. There is one or more surface drain at exterior of building, recommend monitor for proper drainage, keep clear of snow / ice / debris and have cleaned and serviced as needed.

Surface drain at rear alley

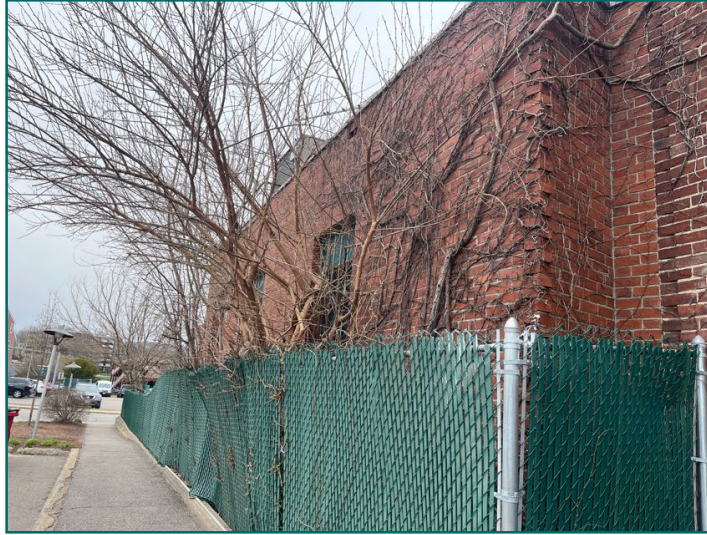
3.2. Vegetation such as trees, shrubs and/or vines are in contact with or less than one foot from the structures exterior. Vegetation can serve as a conduit for wood destroying insects and fungal growth and may retain moisture against the exterior after it rains. Vegetation should be pruned and/or removed as necessary to maintain a one foot clearance between it and the structures exterior.

Vegetation in contact with siding at rear of building

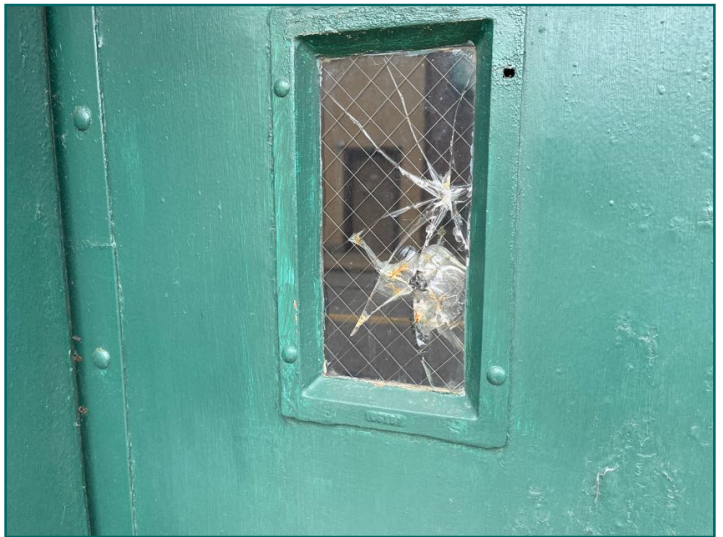
1.3. Front entrance is glass store front style doors are in good condition and operated cleanly with no binding. Rear loading dock door frames are damaged, excessive corrosion on rear metal doors, recommend repairs by a qualified contractor.

Broken glass on cargo elevator door at right side

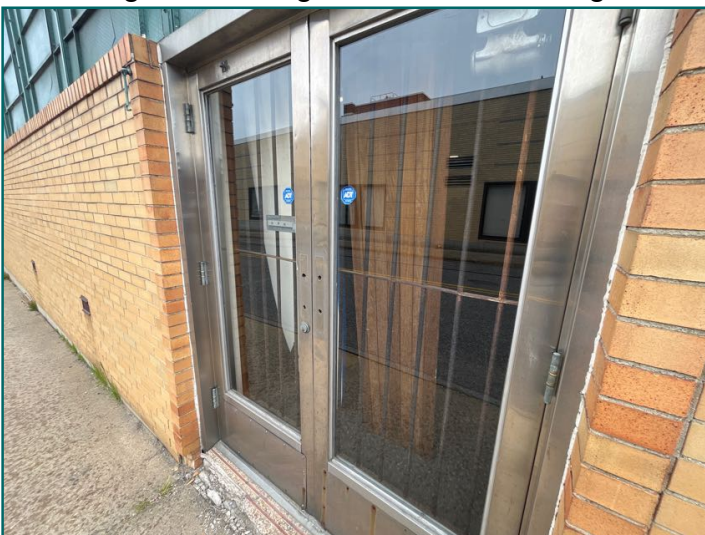
Door at right side is locked, could not assess

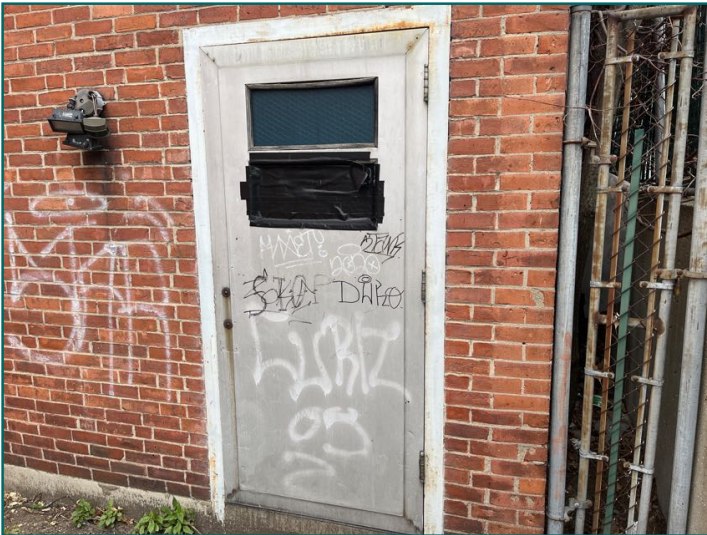
Broken glass at rear / door is sealed could not assess

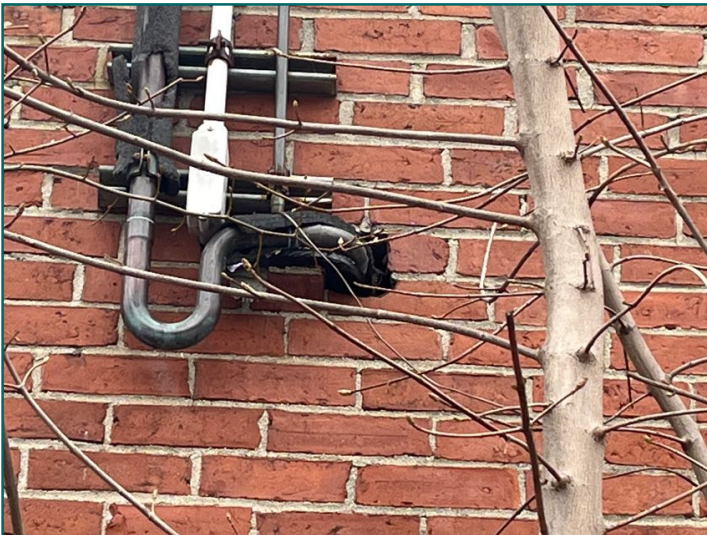
2.3. Gaps exist at one or more openings around the exterior, such as those where outside faucets, utility supply pipes penetrate the exterior or at transitions or flashings. Gaps should be sealed as necessary to prevent moisture intrusion and entry by vermin.

Penetration gaps at rear

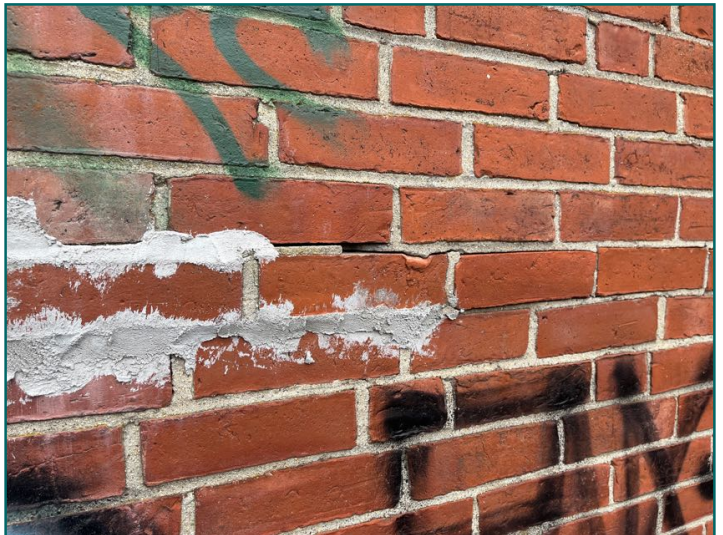
2.2. One or more areas of damage to exterior wall surfaces, recommend full assessment and repairs by a qualified contractor.

Deterioration to brick and grout

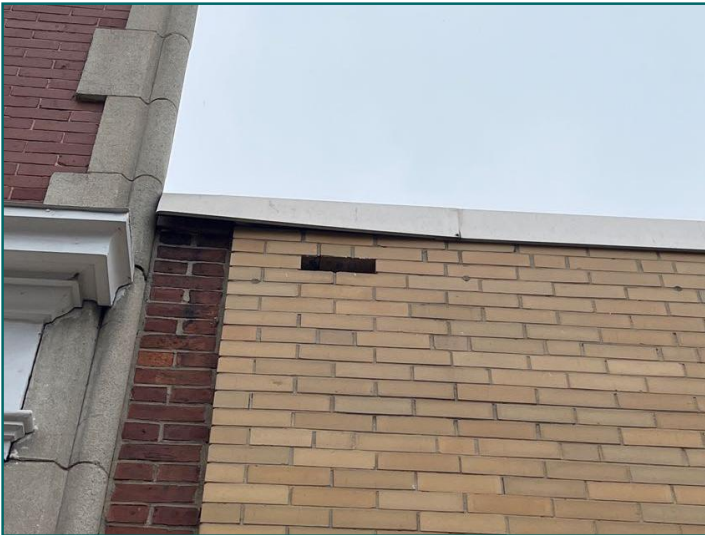
Damaged / missing brick at front

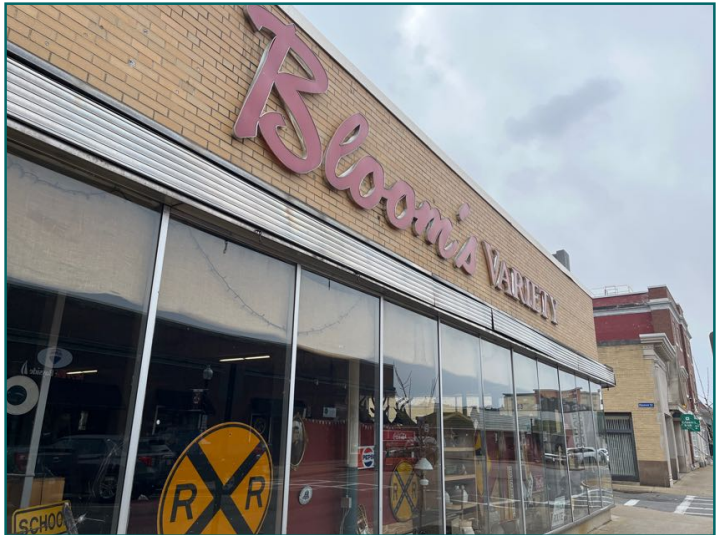
Awning at front reported to bind when closing, not assessed

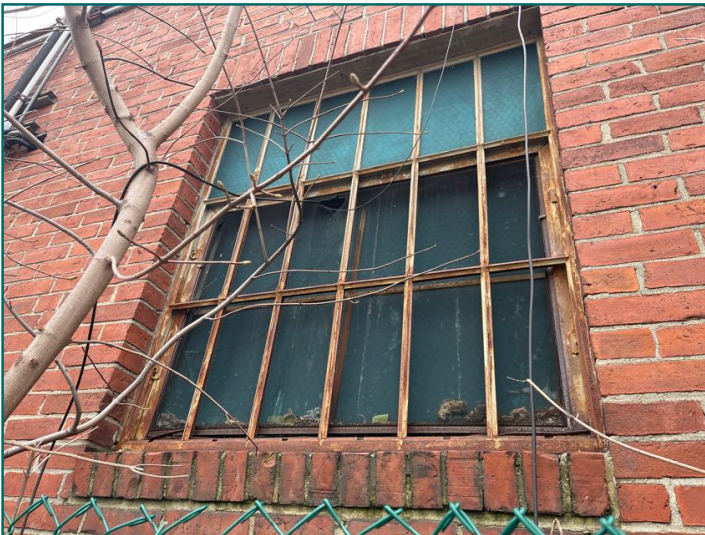
3.3. Deterioration of frames or trim at one or more window. Recommend assessment of all windows and repairs as needed by a qualified contractor.

Corrosion on frame at rear

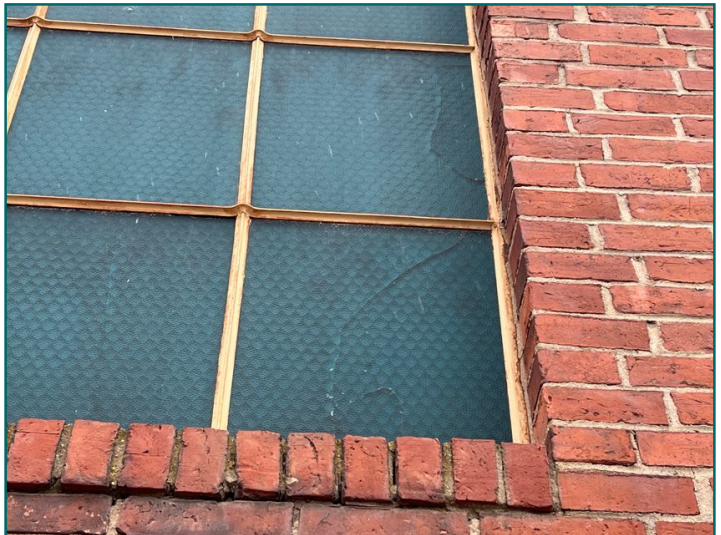
3.2. There is broken glass at one or more window, recommend repairs by a qualified tradesman.

Broken glass at right side, similar areas throughout

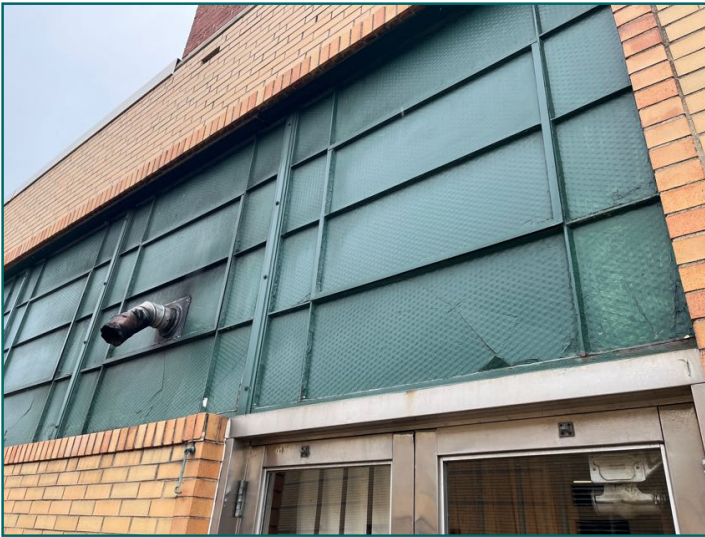
Broken glass at right side

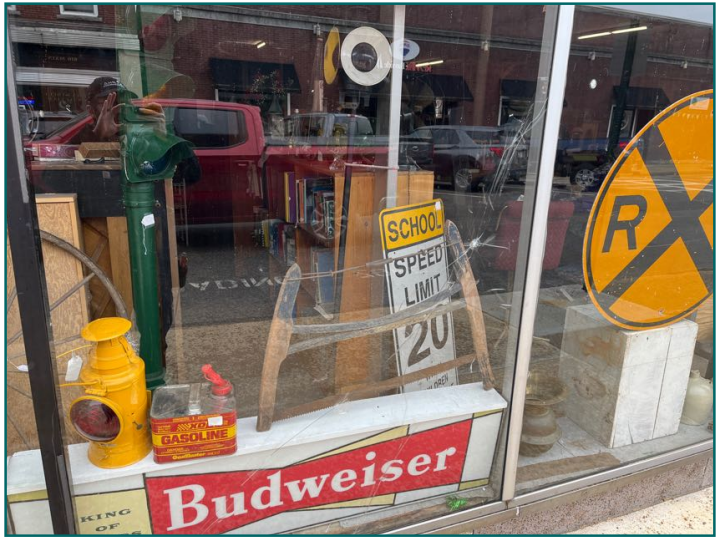
Broken glass at front

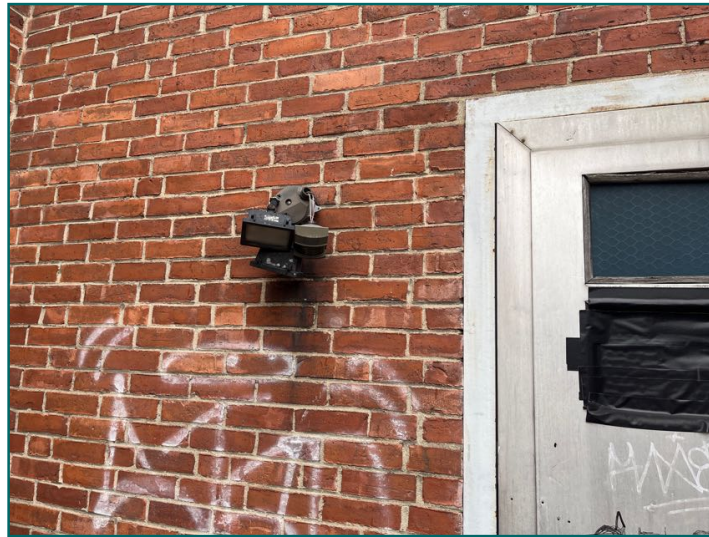
- 4.1. One or more loose or damaged exterior light, recommend repair by a licensed electrician.

Damaged / loose fixture at rear

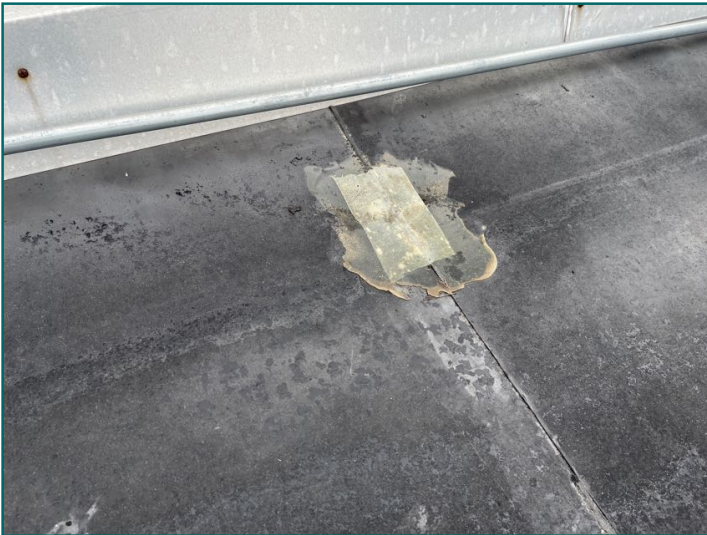
Numerous patches / repairs noted to roof surface

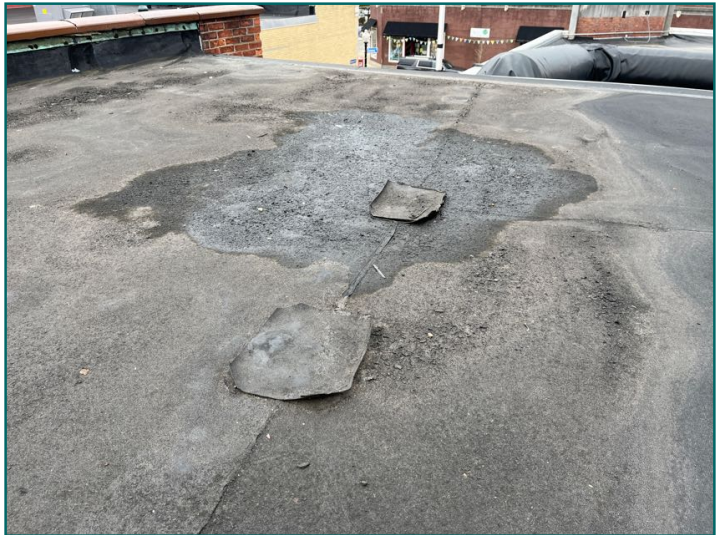
1.2. There are areas of lifting and or damage to roof surfaces, recommend assessment and repairs as needed by a qualified roofing contractor.

Damaged / lifting patches on rear roof surface

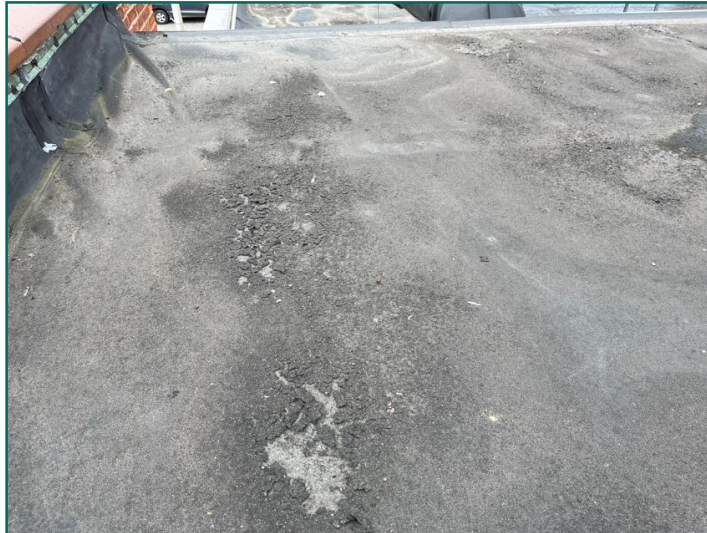
Deterioration to rear roof surface

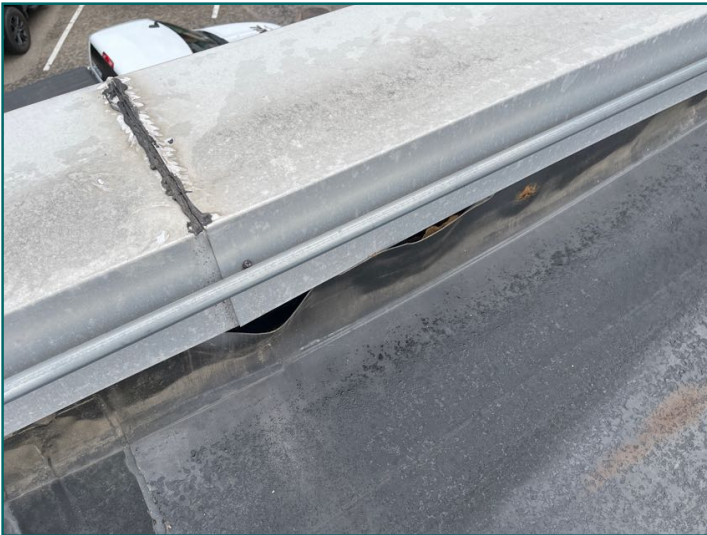
2.2. Damaged flashing at **drip edge** and or transitions at one or more area of building, recommend assessment and repairs by a qualified roofing contractor.

Sections of damaged flashing at front

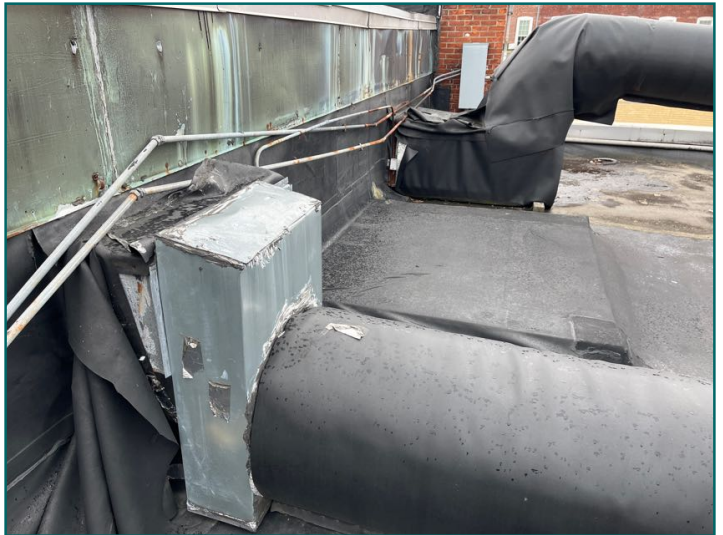
Damaged flashing around HVAC penetrations

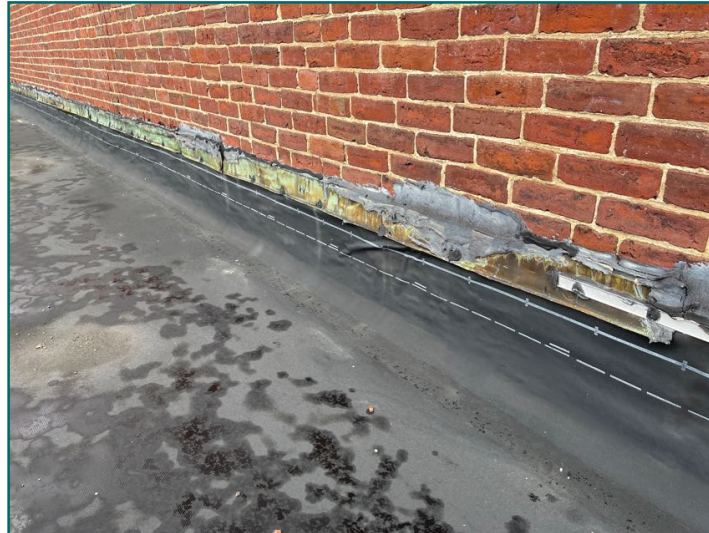
Dried / cracking flashing sealant at shared wall

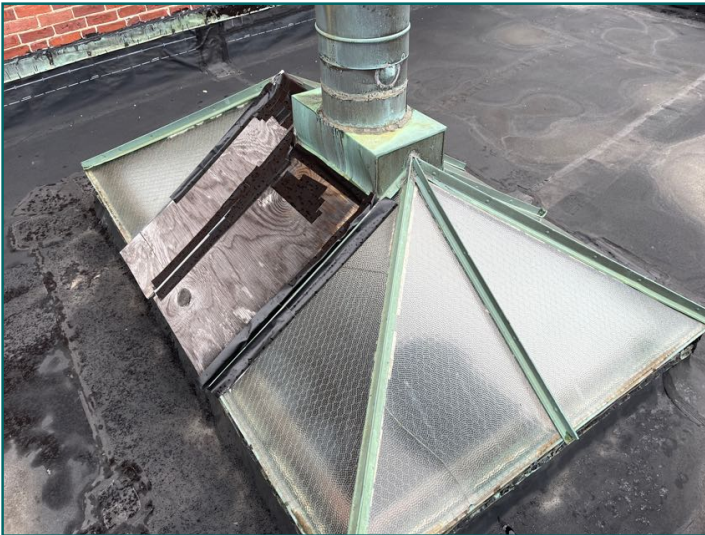
3.2. Sky lights have damage to framing or glass, recommend repair or replacement as needed by a qualified contractor.

Damaged skylight / broken glass at rear

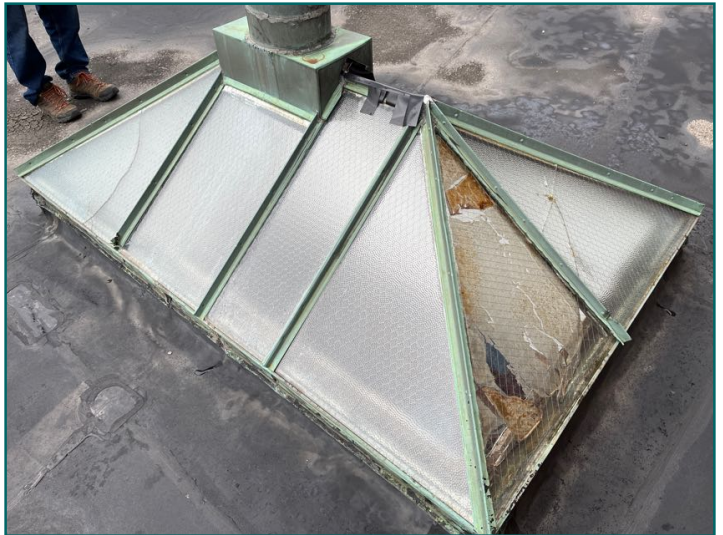
Damaged skylight / broken glass at rear

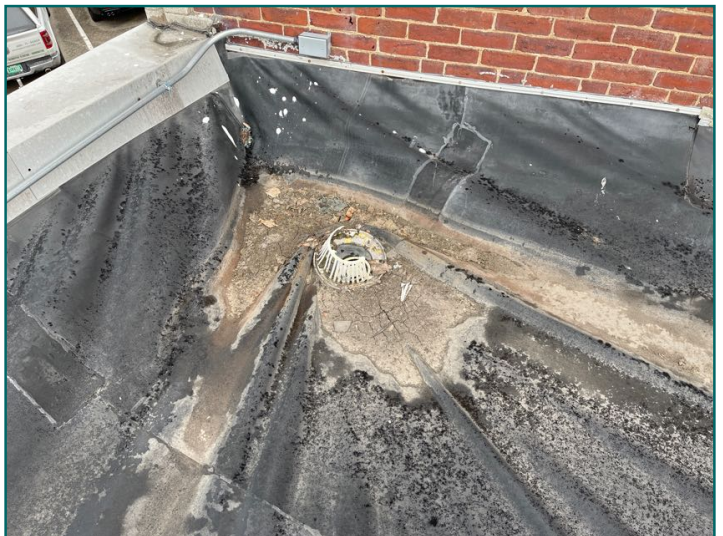
4.2. One or more of the roof top gutter screens are missing or damaged. Recommend installation of drain screens to help prevent clogging and ponding on roof, and regular maintenance of drains and gutter system.

Damage roof drain cover

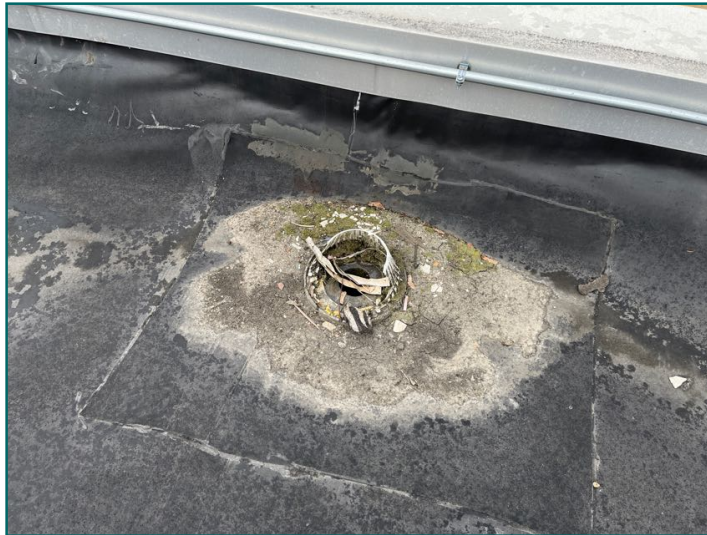
Damage roof drain cover

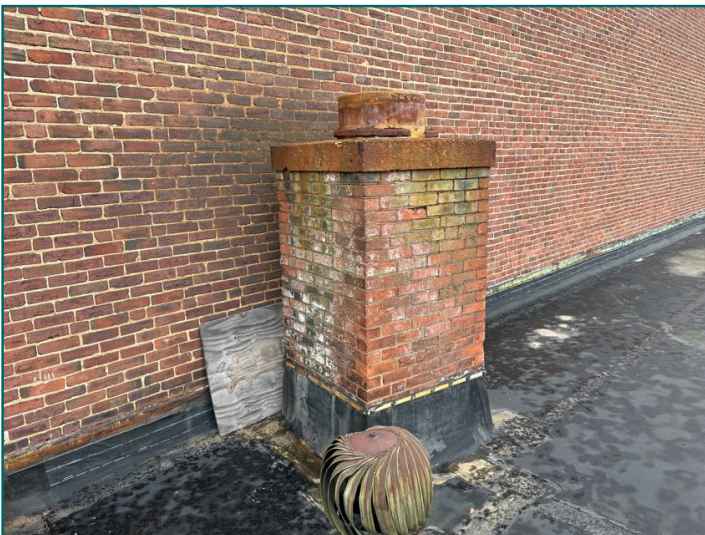
5.5. Chimney mortar and brick have areas of deterioration or cracking. Recommend having assessed and repaired as necessary by a qualified masonry contractor.

Deterioration to brick and grout

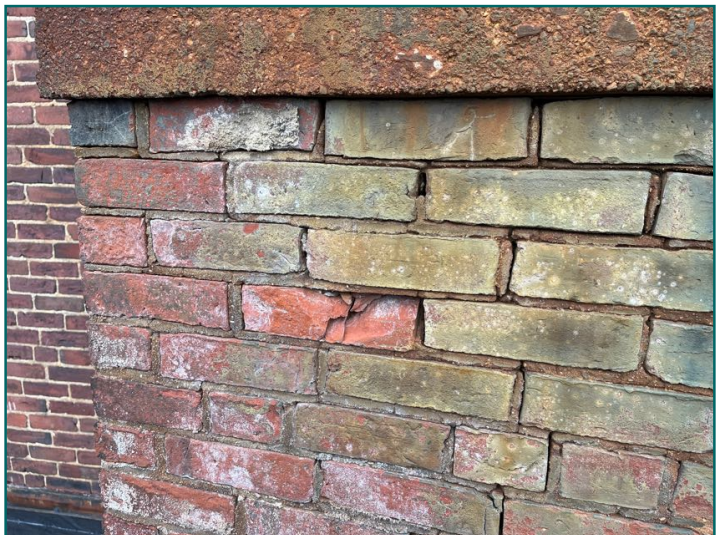
Deterioration to brick and grout

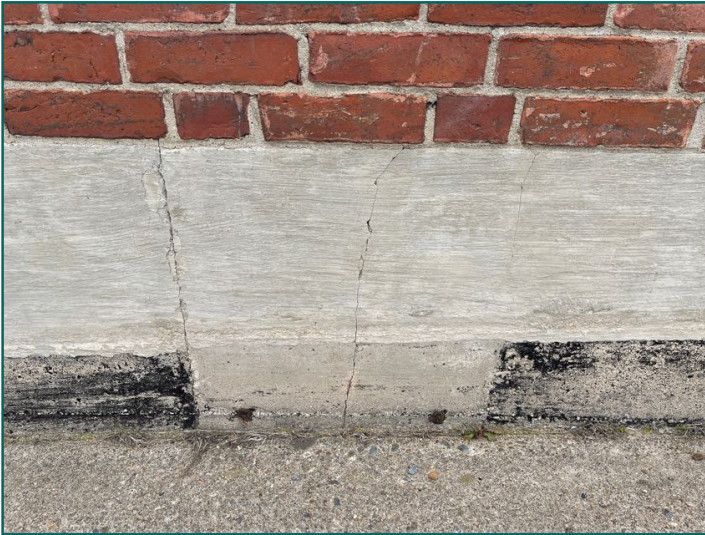
1.4. Vertical cracks noted on foundation wall at one or more location, recommend monitor for further movement and or water intrusion and sealing / repairs as needed.

Vertical crack on side wall.

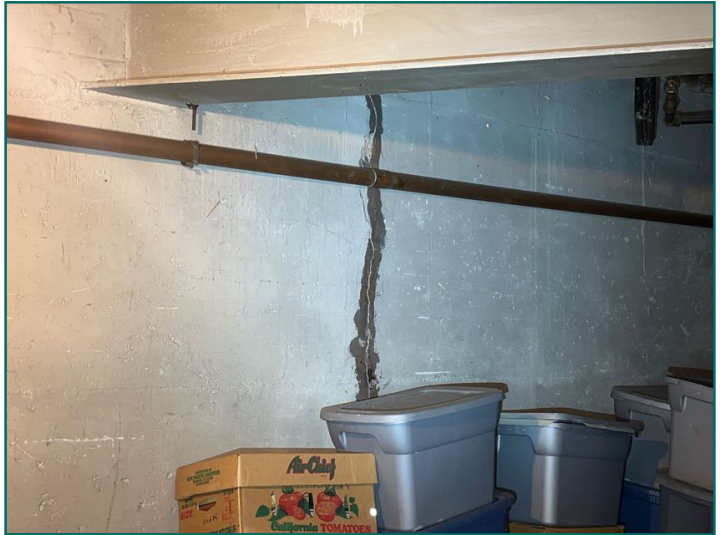
Vertical crack on front wall with repairs

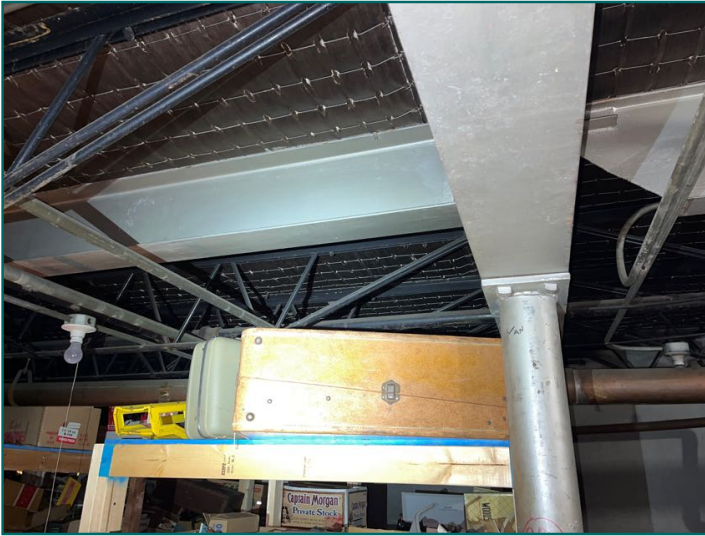
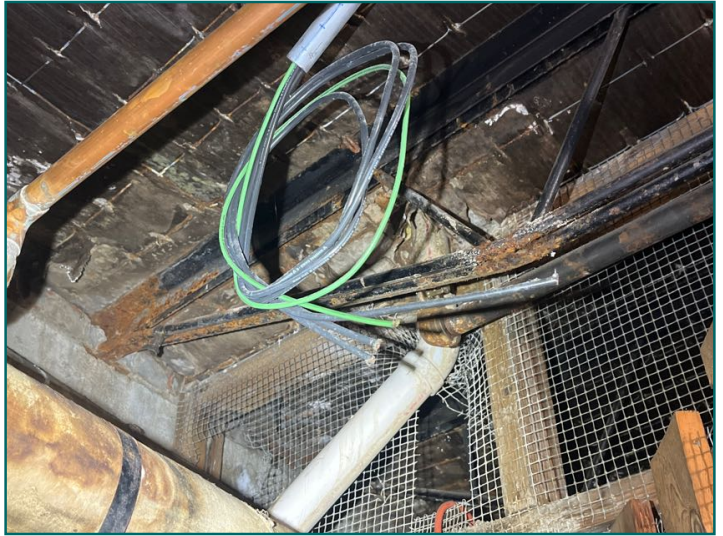
2.5. Corrosion / deterioration was observed on one or more framing members, Recommend monitor condition and have evaluated by a qualified contractor as needed.

Corrosion on framing members at left side

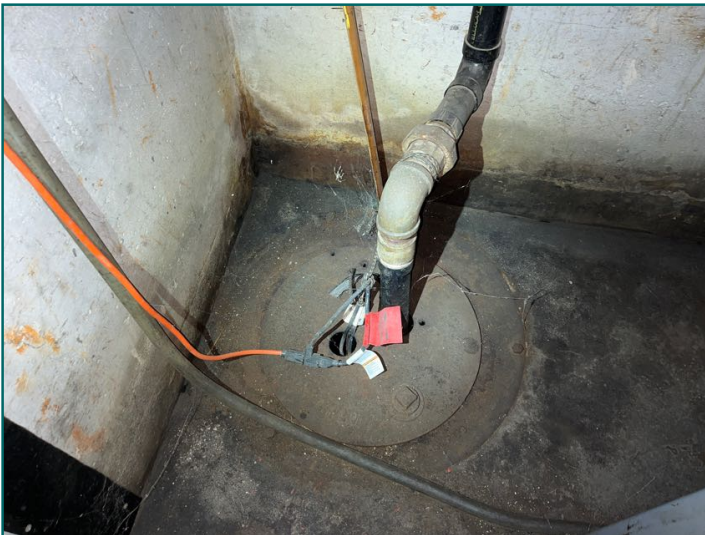
4.3. Sump pump is draining directly into sewer system, this is not allowed by most municipalities, should be drained to the exterior of building, recommend repair by a qualified contractor.

Sump pump at rear of basement, drain termination not located.

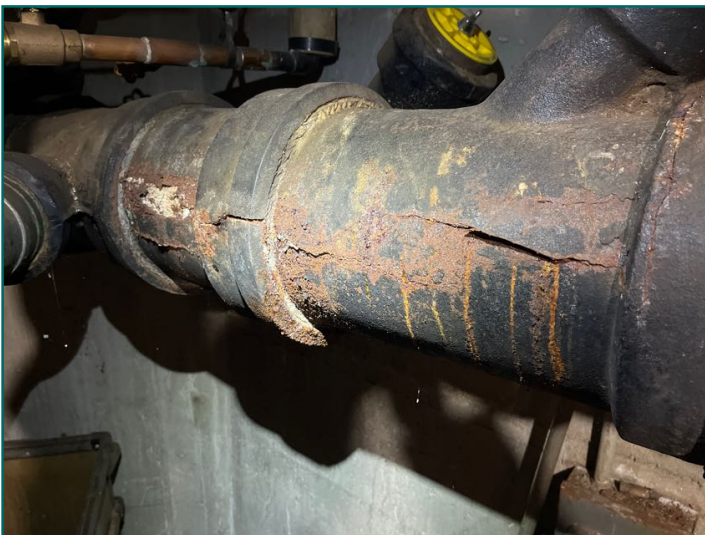
1.4. There area areas of damaged pipes or fittings, recommend assessment and repairs by a licensed plumber.

Cracked / damaged drain pipe at left side

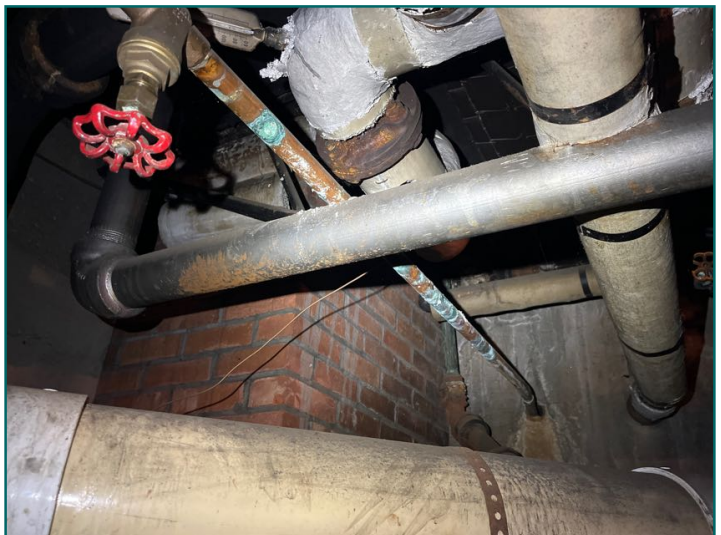
1.3. There is corrosion on one or more plumbing line or fitting, recommend monitor for any further corrosion and leaking and have repairs by a licensed plumber as needed.

Corrosion on fittings at left side

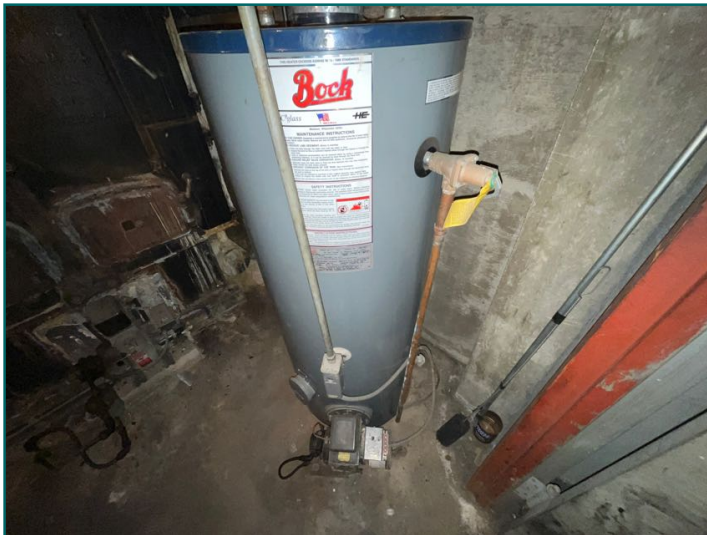
1.4. Basement water heater is shut down, could not assess. Recommend confirming operation with seller prior to closing and further evaluation by a qualified contractor as needed.

Basement water heater

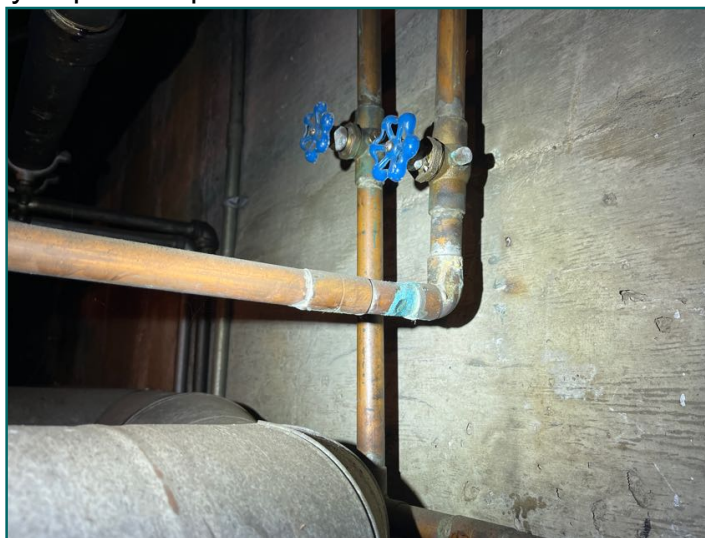
3.1. Corrosion observed on plumbing fittings, recommend monitor for further corrosion and leaks and repairs as needed by a qualified plumber.

Corrosion on fittings

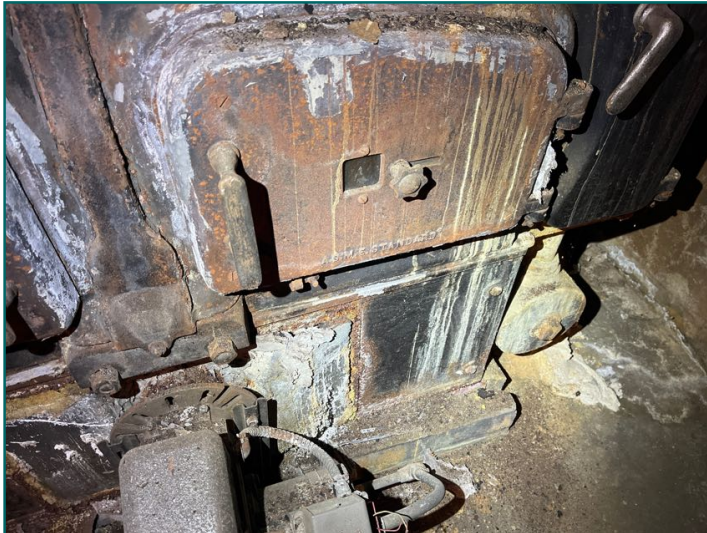
1.7. There is corrosion on plumbing fixtures and or outside cabinet surface, this is an indication of leaks, of age or improper combustion. Recommend full inspection and repairs if needed by a qualified heating contractor.

Corrosion on boiler noted

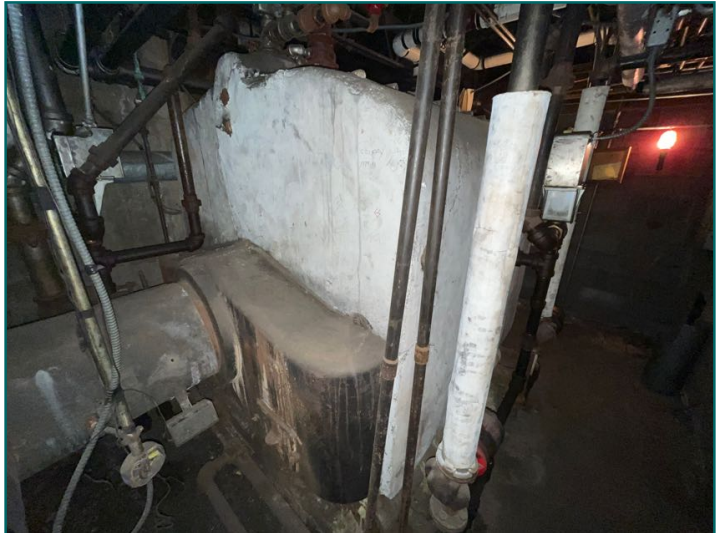
Suspected asbestos insulation on boiler

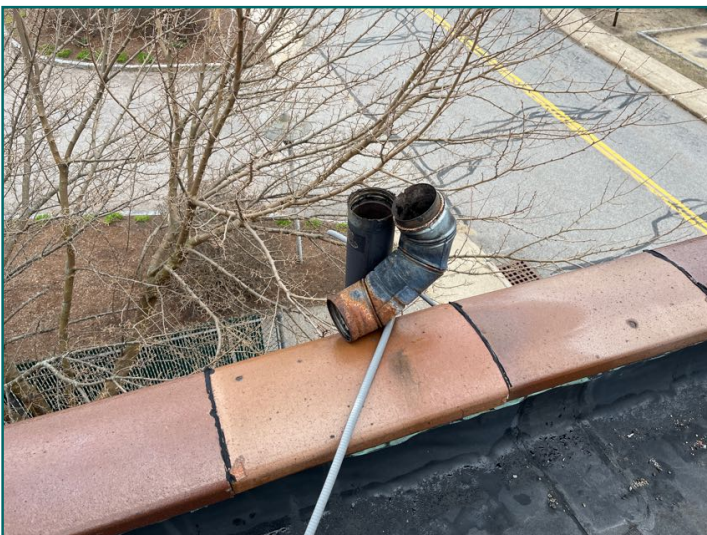
2.3. There is damage to venting components, recommend assessment and repairs by a licensed heating contractor.

Vent termination at rear is damaged

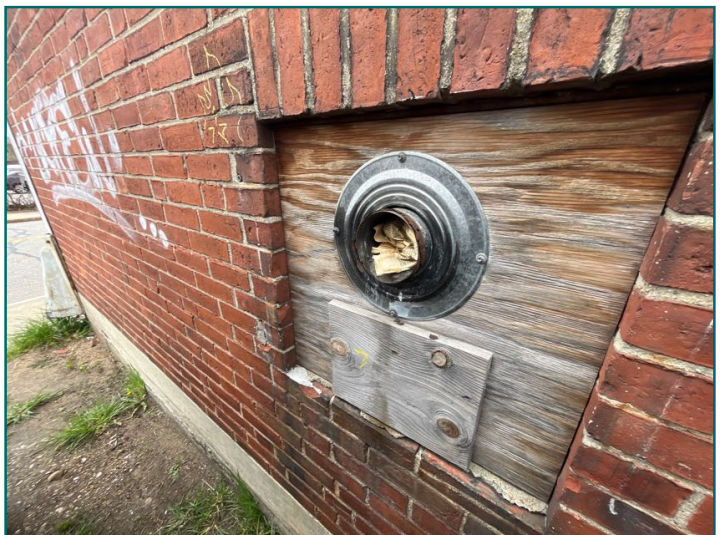
Vent termination at rear is sealed / no longer in use

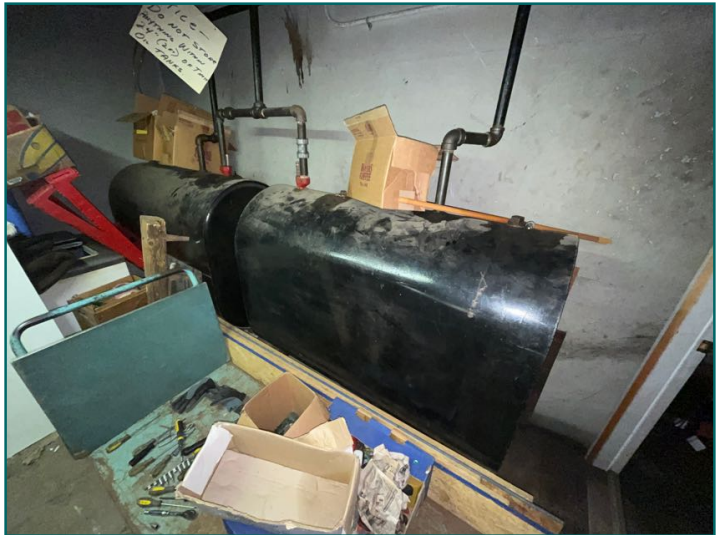
3.4. Corrosion or staining on oil tank, recommend inspection by a qualified oil burner company. A leaking oil tank can create environmental hazardous conditions. Oil tank should be inspected for evidence of leaking by a qualified oil burner company and replaced or repaired as needed.

Dry oil stains / corrosion on tank noted

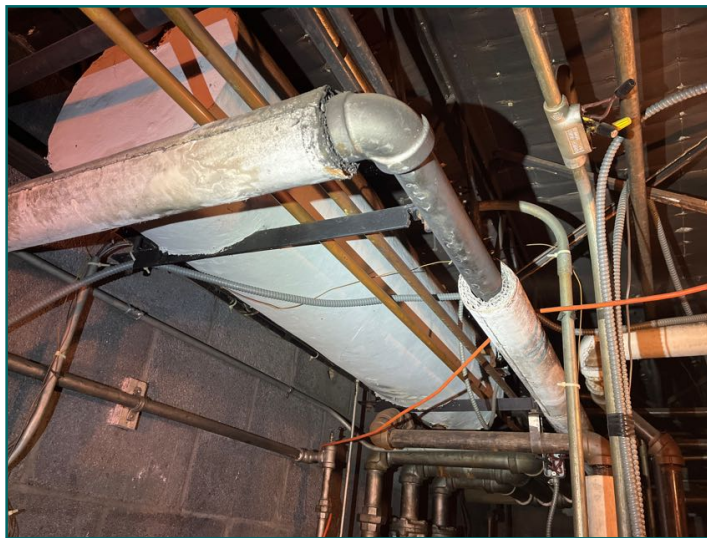
4.5. Insulation on heat pipes in one or more area of building may contain asbestos. Recommend further investigation and encapsulation or proper removal if needed by a qualified asbestos remediation company.

Suspected Asbestos insulation on boiler distribution noted

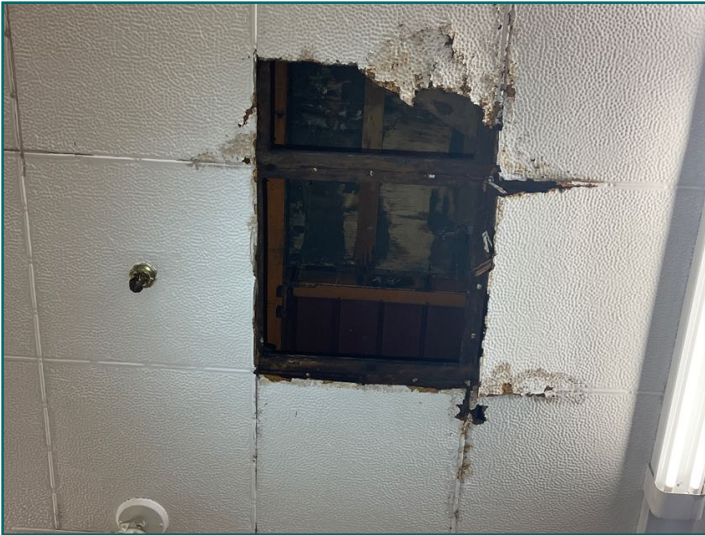
4.3. There is a damage to interior space ceiling at one or more areas, see photos. Recommend assessment and repairs by a qualified contractor.

Damaged ceiling tiles

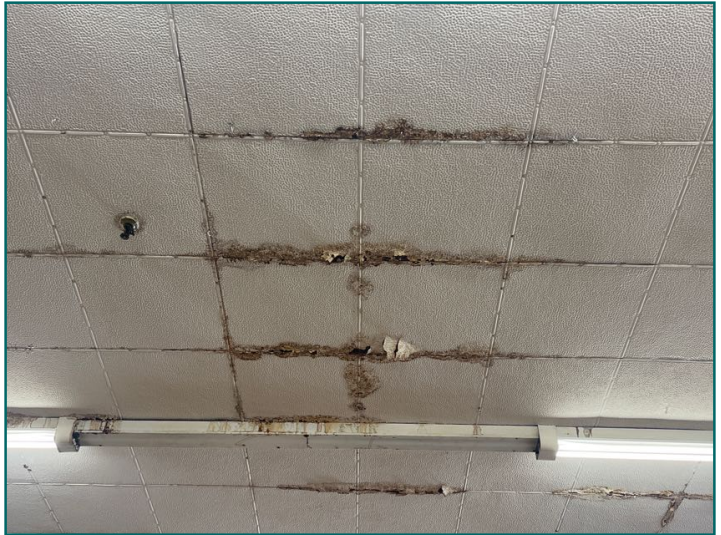
Stains on ceiling, appear to be dry / reported to be old stains

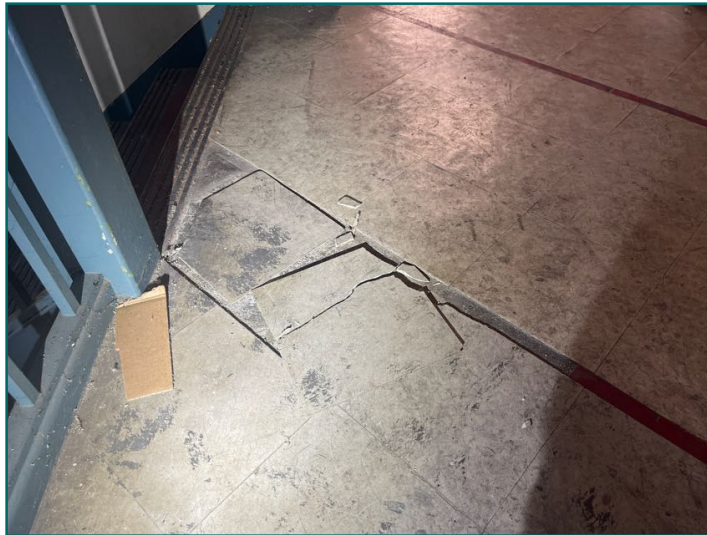
5.2. Cracked or loose tiles noted at one or more area of building, recommend assessment and repairs by a qualified contractor.

Cracked / damaged tiles at rear

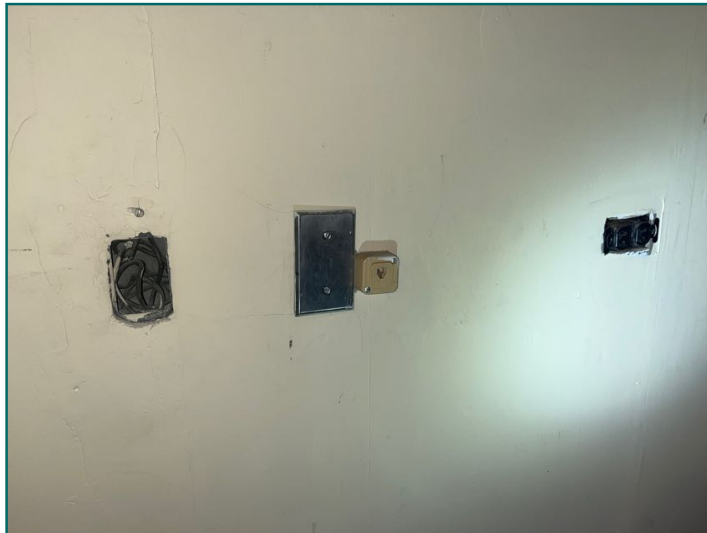
6.2. One or more outlet / switch cover plates missing. Recommend repairs for safety.

Missing plate covers at rear left

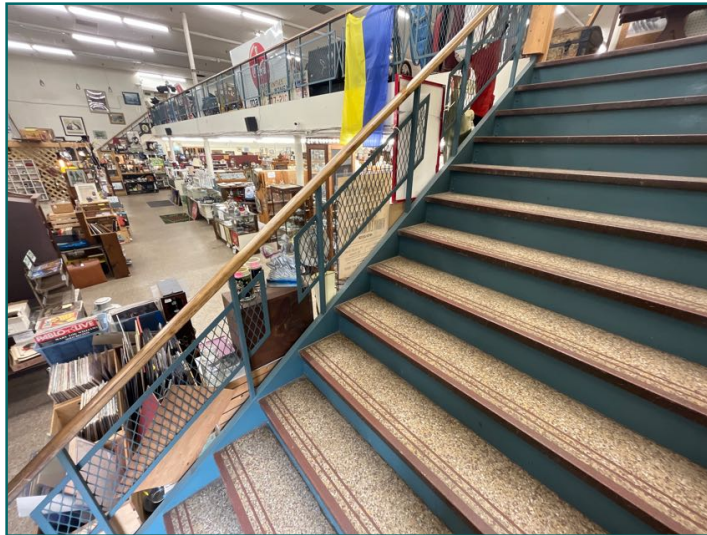
8.2. Rail opening on stairs is greater than 4 inches, this is a safety hazard for young children. By todays construction and safety standards vertical ballusters should be installed no greater than 4" apart.

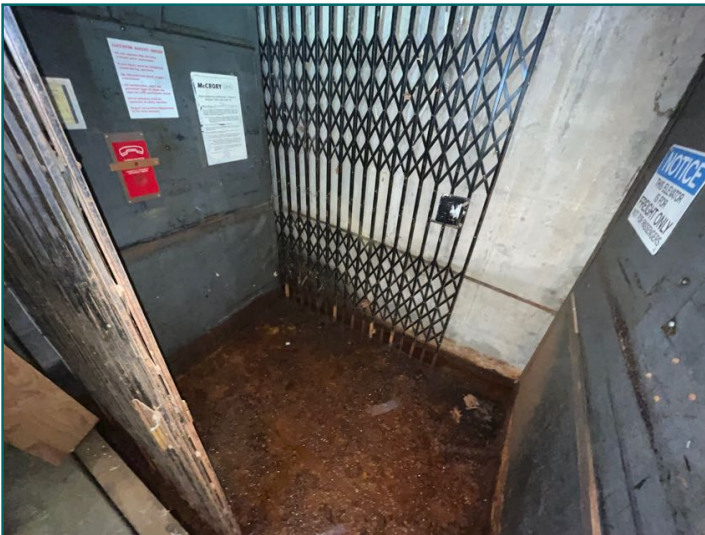
9.2. Elevator shaft is filled with ground water, recommend evaluation and repairs by a qualified contractor.

Elevator / elevator shaft are filled with water

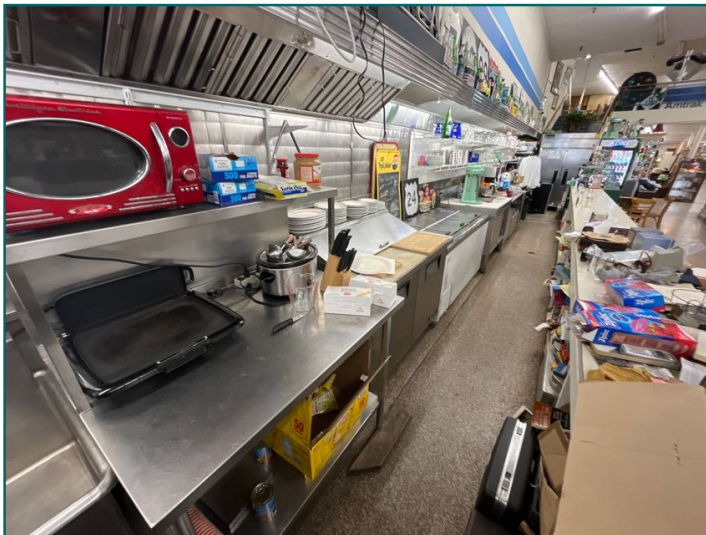
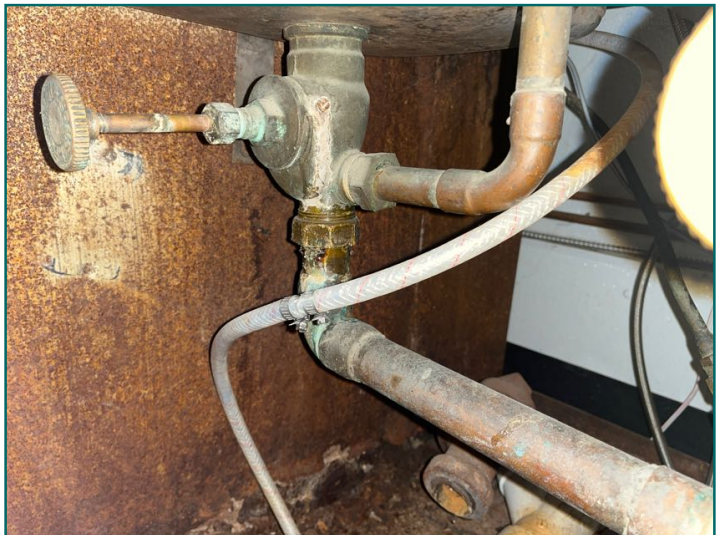
- Kitchen appliances are not operated, visual inspection only.
- One or more drain lines has corrosion / evidence of elevated moisture/leak, recommend assessment and repairs by a qualified plumber as needed.

Corrosion / suspected leak on fittings below sink at left side / kitchen
