National Transportation Safety Board

Pipeline Accident Brief

UGI Utilities Natural Gas-Fueled Explosion

Millersville, Pennsylvania

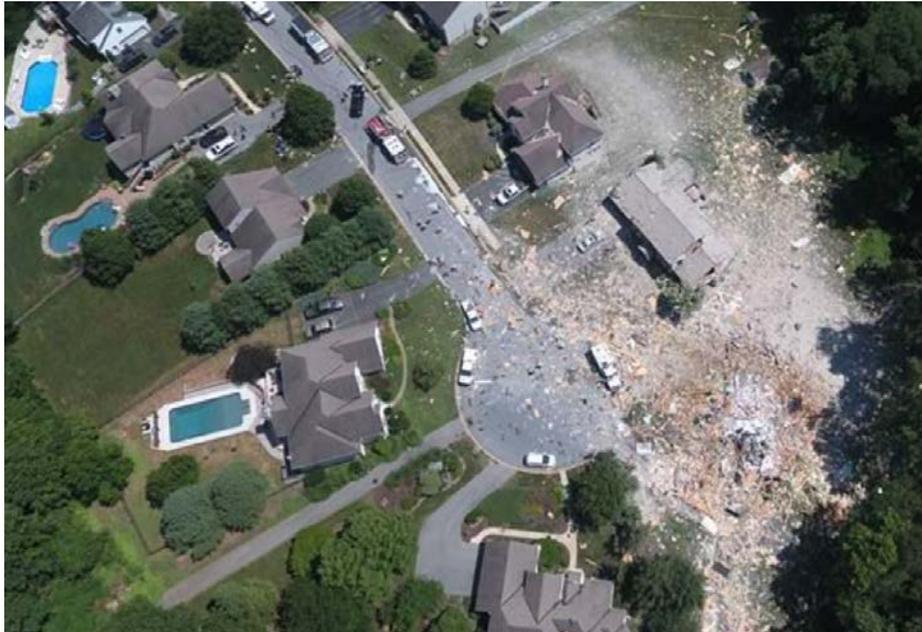
On July 2, 2017, at 12:32 p.m. eastern daylight time, a natural gas-fueled explosion occurred at a single-family residence at 206 Springdale Lane, Millersville, Pennsylvania.¹ The explosion killed one person and injured three others, destroyed the residence and significantly damaged six neighboring homes, one of which was subsequently condemned.² (See figure 1.)

Figure 1. Debris field at cul-de-sac area where explosion occurred.

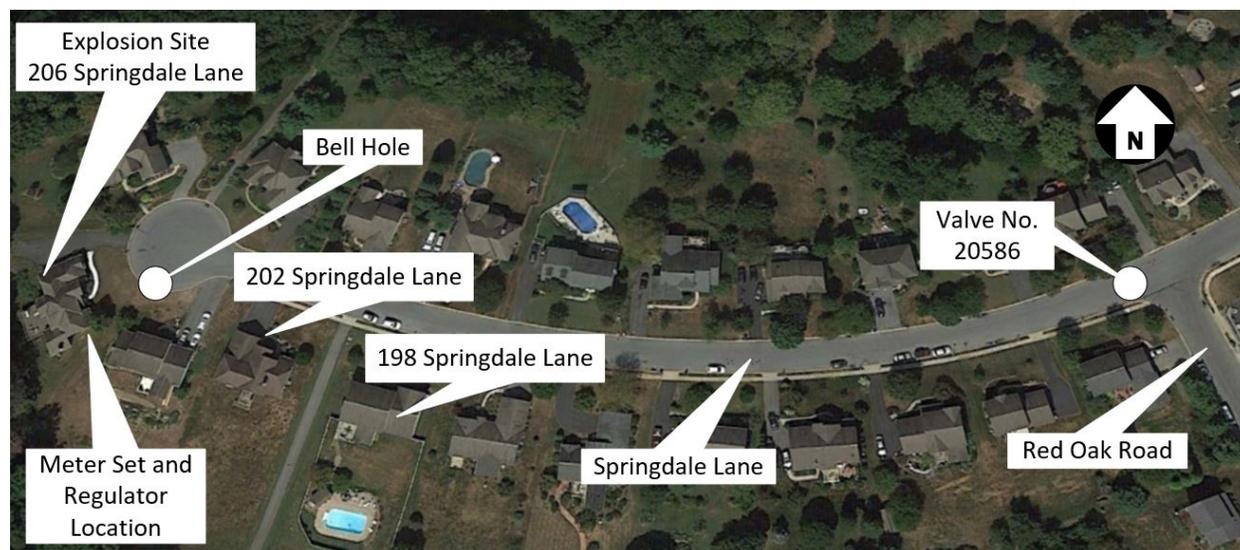
After assembling a response crew, the senior supervisor traveled to the scene. The senior supervisor told National Transportation Safety Board (NTSB) investigators that prior to arriving on-scene he reviewed the location of the closest shutoff valve to the site. On his way to the shutoff valve, he contacted the UGI engineer and informed her that he expected to shut down a main line. As the duty supervisor, the senior supervisor could exercise judgement to determine whether it was appropriate to either squeeze off the line or close a gas valve.⁸ After the discussion with other responding UGI employees, the senior supervisor decided to squeeze off the main line rather than closing the mainline valve, because he thought this action was the fastest way of stopping the flow of gas. Figure 2 shows the location of the valve.

Figure 2. Location of gas shut-off valve in relation to accident site.
