02/22/2019

# ROUTE 66 GASCONADE RIVER BRIDGE | STRUCTURAL EVALUATION

Prepared for the Gasconade River Bridge Guardians

SPARKS ENGINEERING, INC.

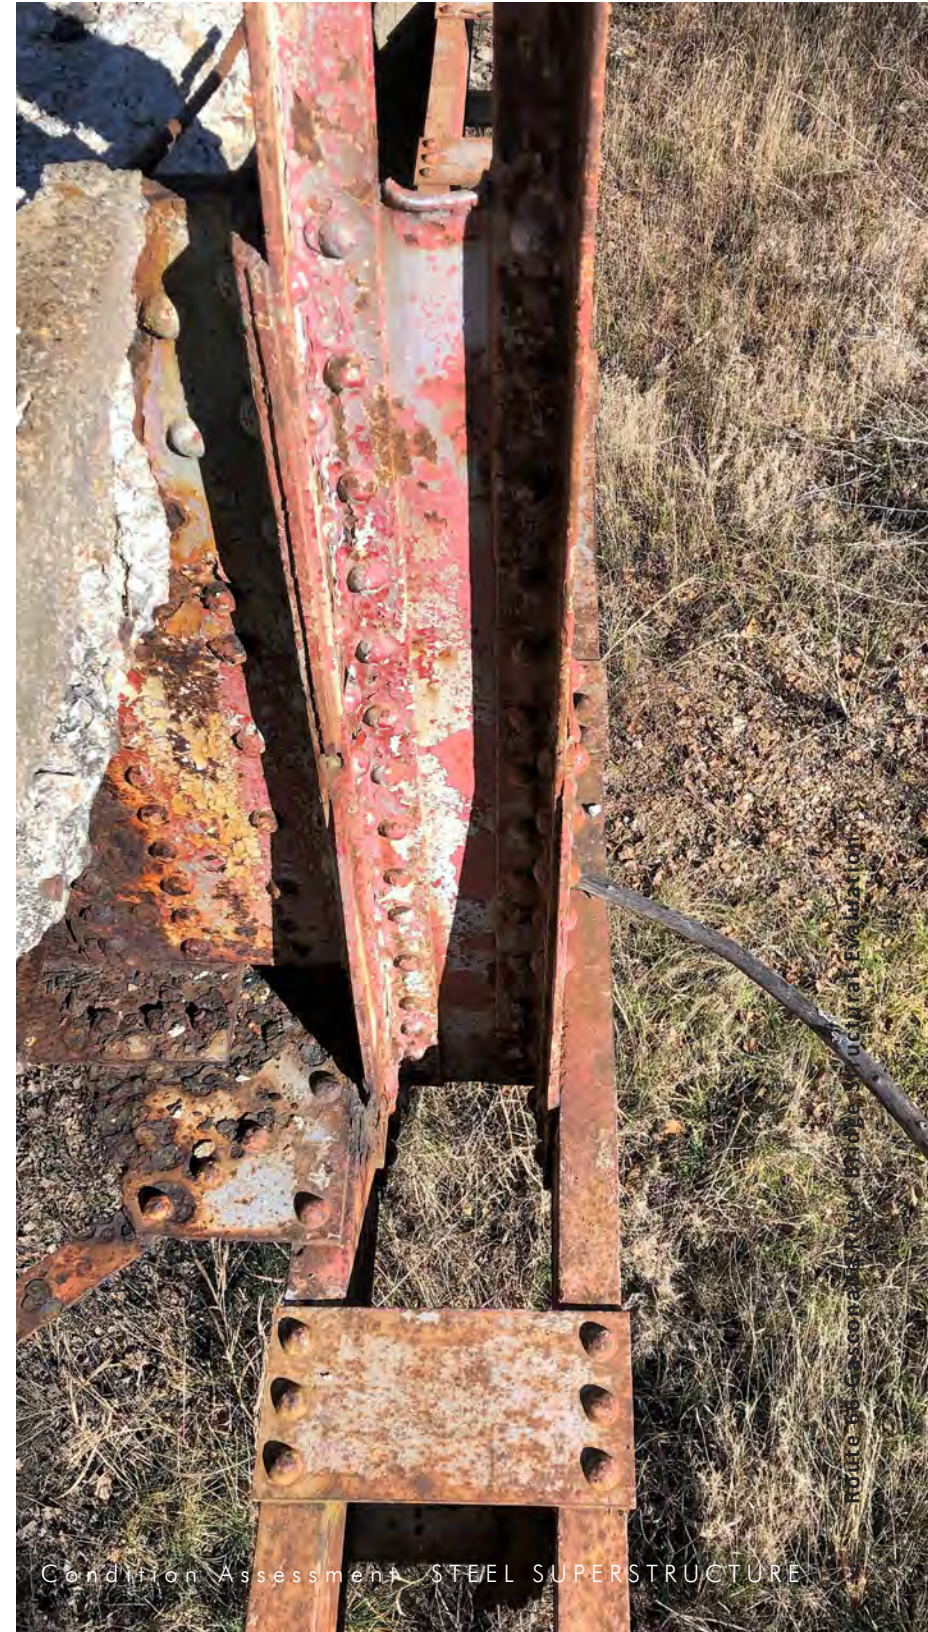
*Localized pitting corrosion from chloride salts is common on the horizontal gusset plates directly below the edge of the concrete slab. However, the truss appears to be in good condition.*

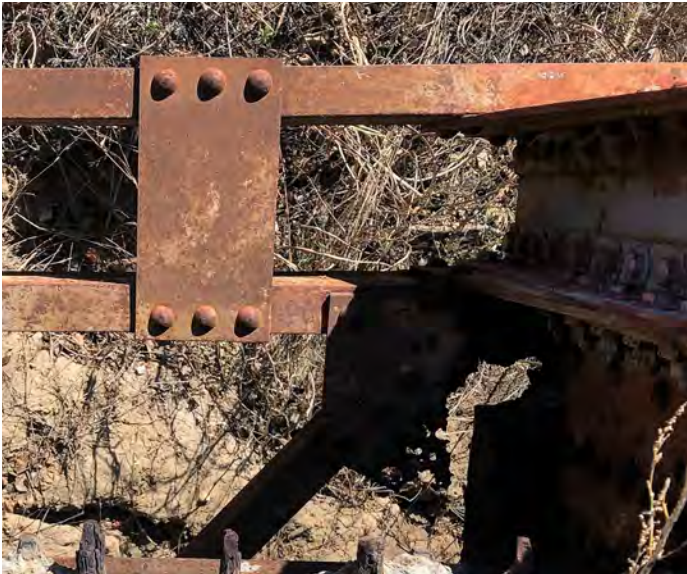
The corrosion is severe, but isolated, in several of the below-deck components such as this gusset plate which has significant section loss.

- Repair corroded steel members (stringers, gusset plates, and floor beams). Gusset plate repairs will likely consist of replacing the existing with a new bolted plate. Stringer repairs will consist of replacing the severely corroded top flanges (>50% section loss) with welded steel angles.
- Replace corroded top chord heel plates with bolted plates.
- Clean and paint the bridge. For economy, we suggest painting the bottom chord and below-deck supports only.

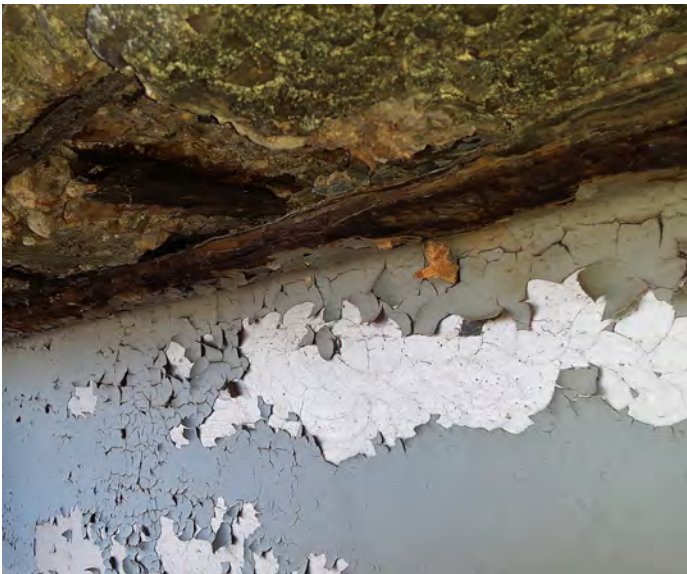
Close-up of severe corrosion.

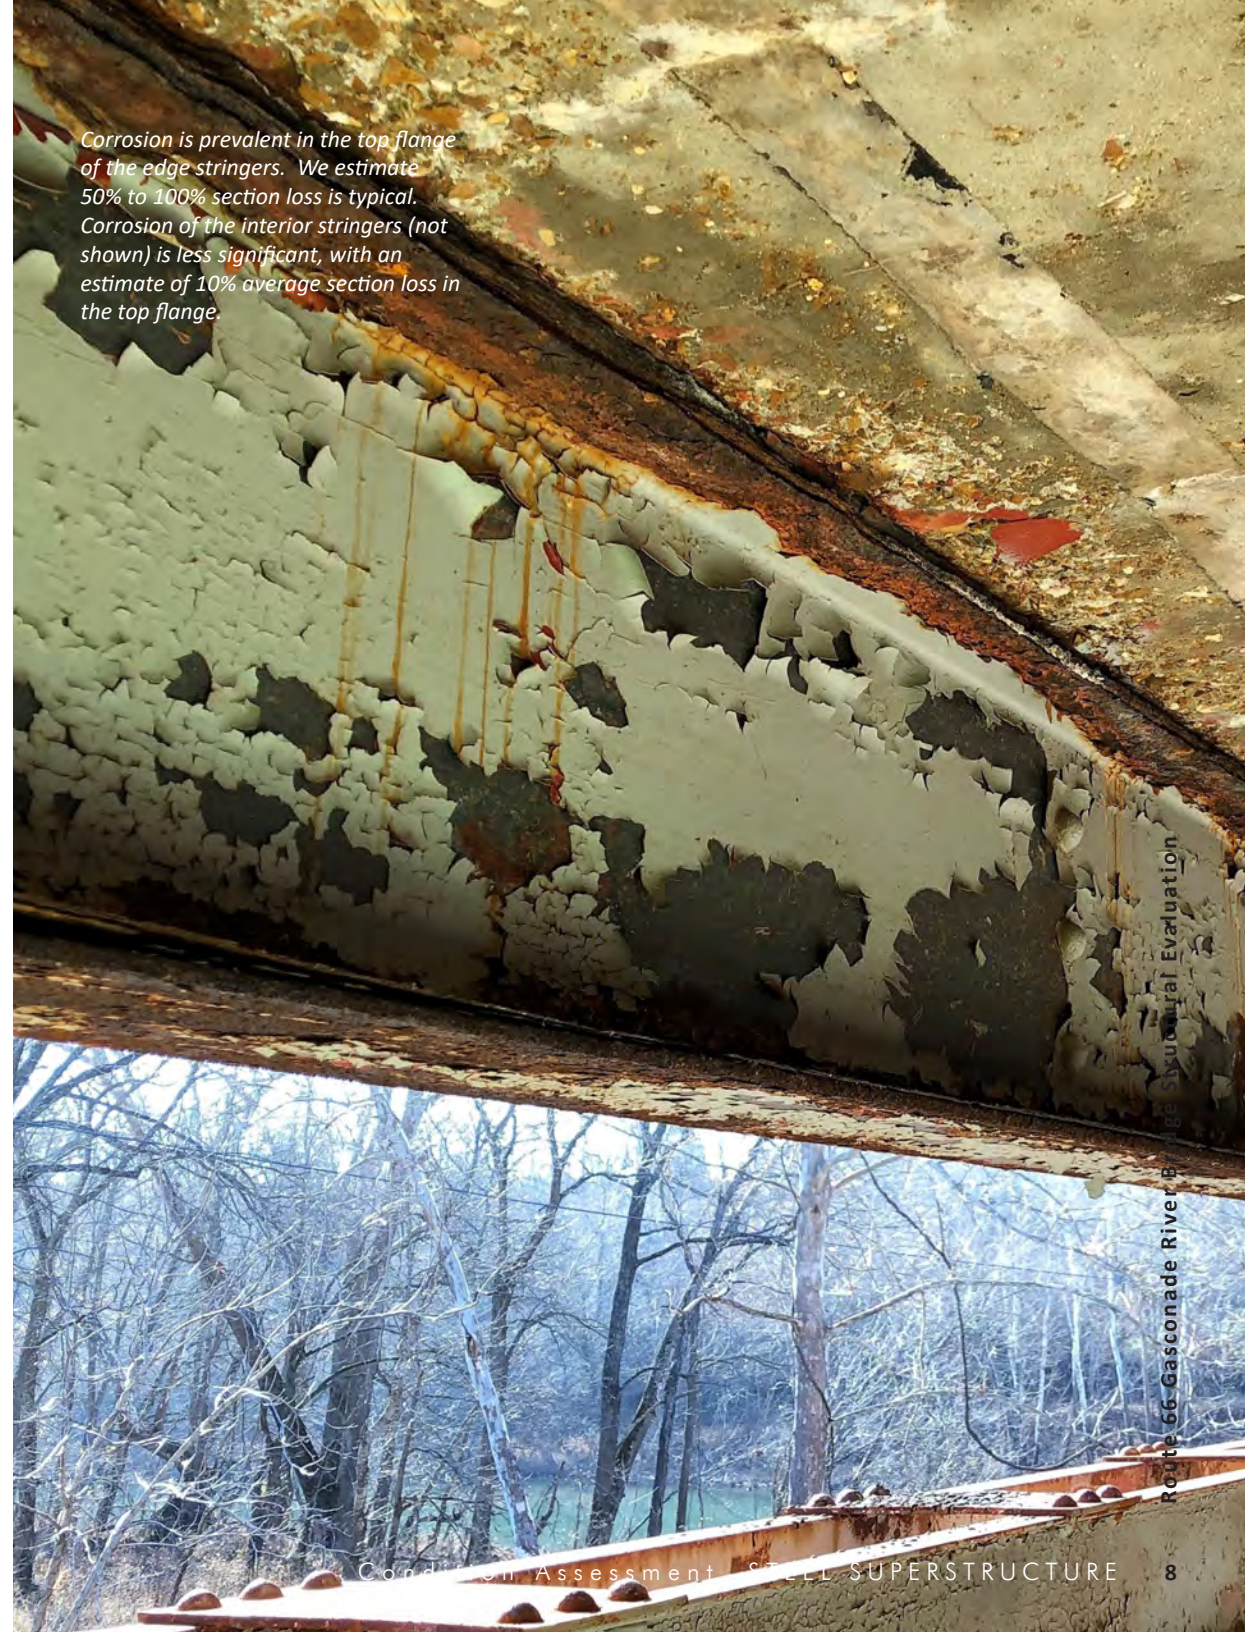
Corrosion is prevalent in the top flange of the edge stringers. We estimate 50% to 100% section loss is typical. Corrosion of the interior stringers (not shown) is less significant, with an estimate of 10% average section loss in the top flange.

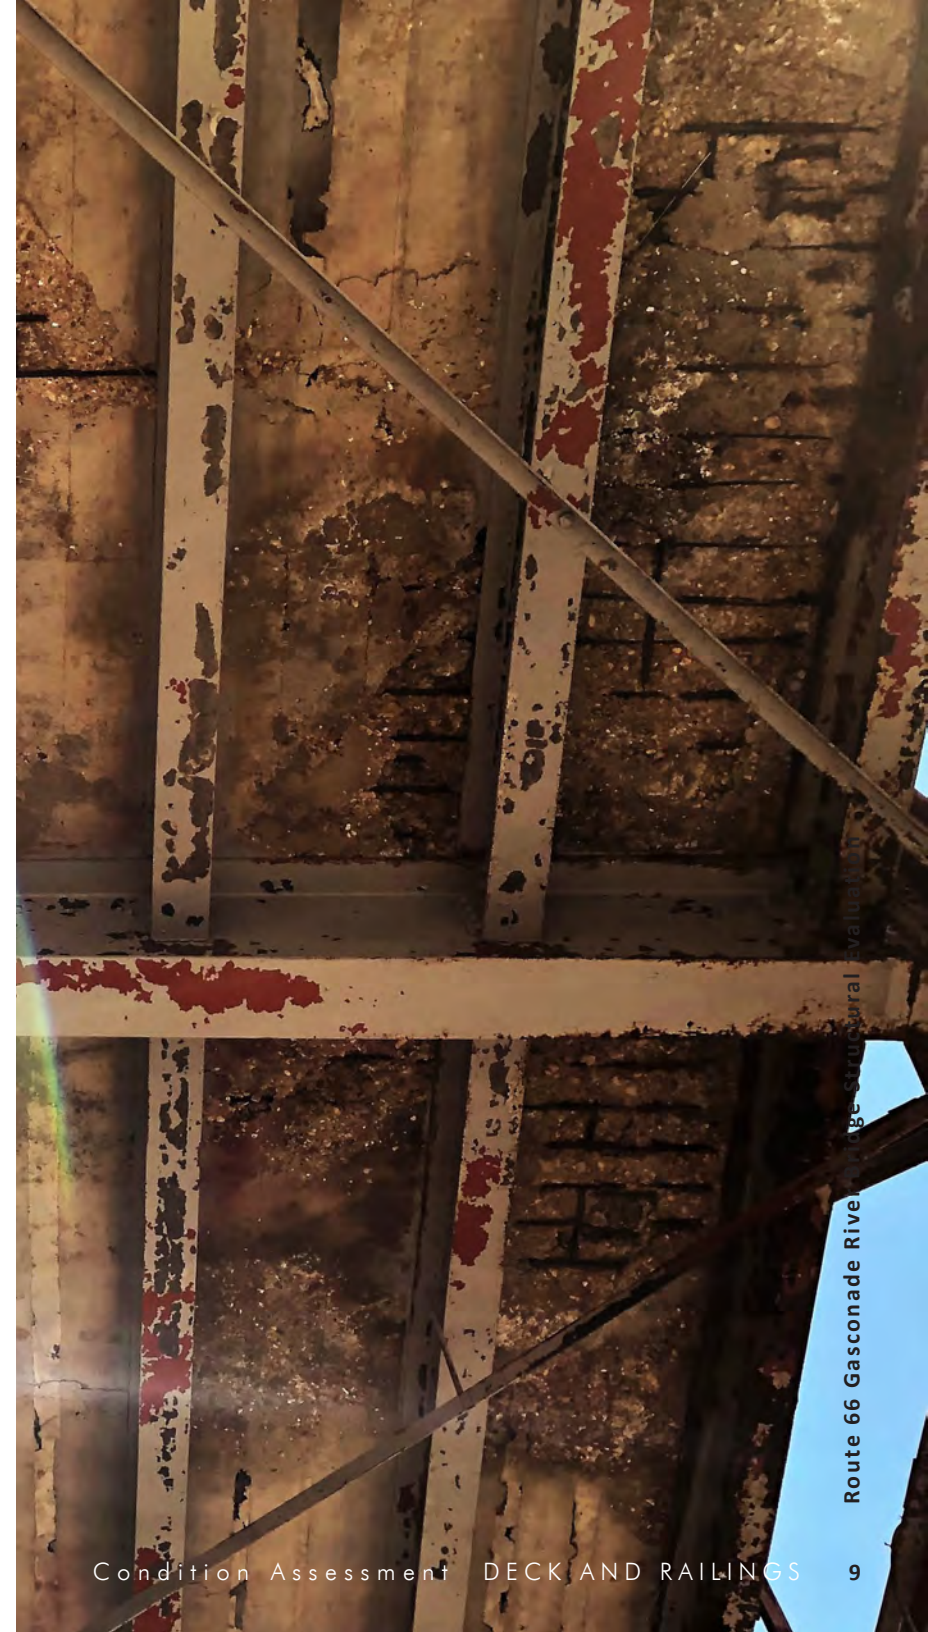
*A view from the underside of the bridge deck exemplifies the poor condition of the deck. Deterioration of the reinforced concrete has progressed to the point where repairs are no longer feasible. Replacement is required.*

- Replace the concrete deck. The actual details of the deck will depend on further design; however, for planning purposes we suggest a cast-in-place, reinforced concrete deck placed over metal form decking (5-inch total deck thickness assumed). We have not included alternatives in our opinion of cost; however, precast concrete deck systems or a fiberglass reinforced polymer (FRP) bridge deck system could also be considered.
- Replace the existing pipe railing with new railing that integrates with the historic nature of the bridge and meets the code requirements.

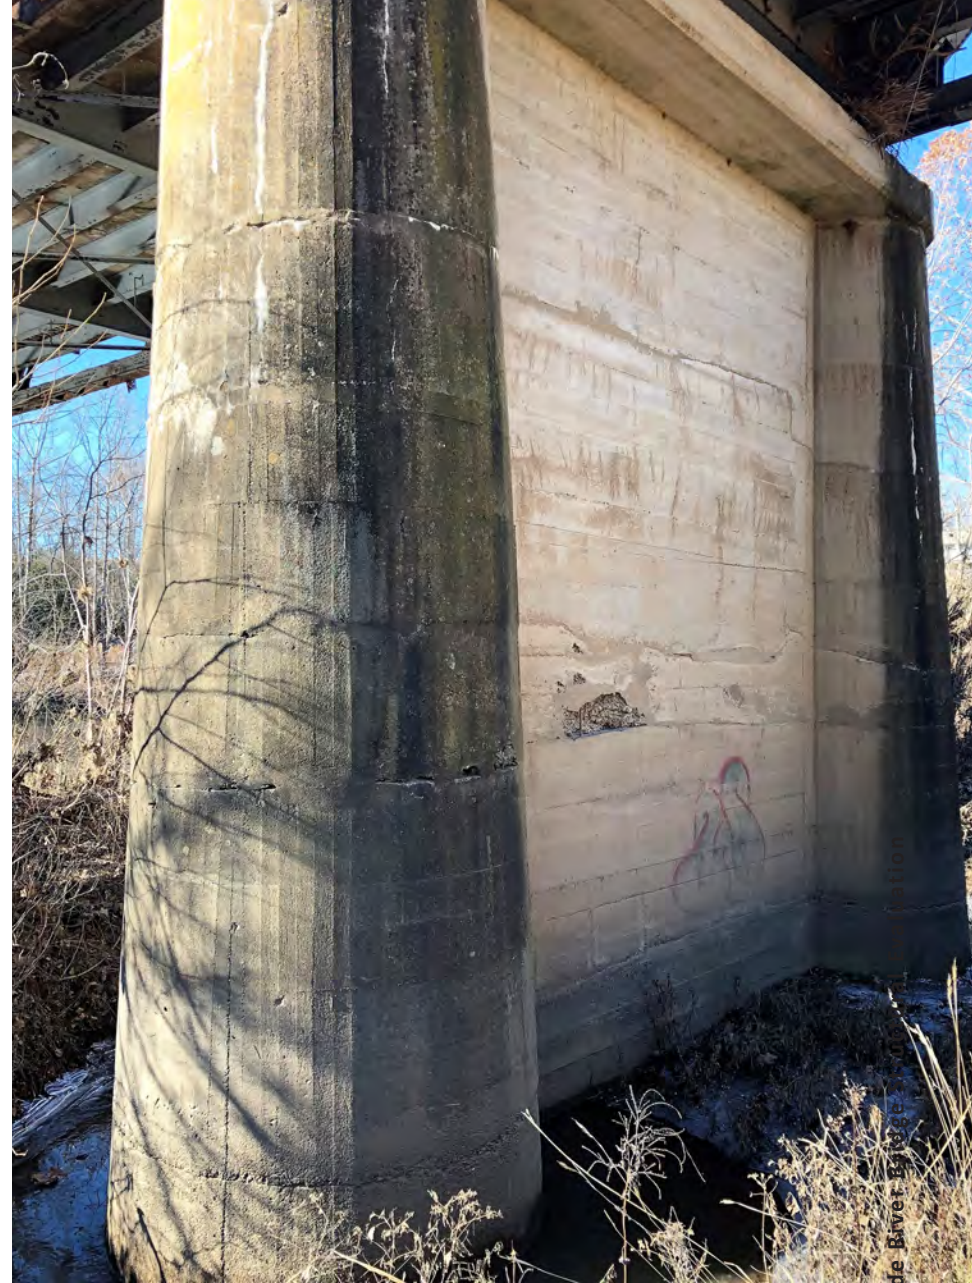
*We found the mass concrete piers are generally in good condition, without structurally significant distress or deterioration.*

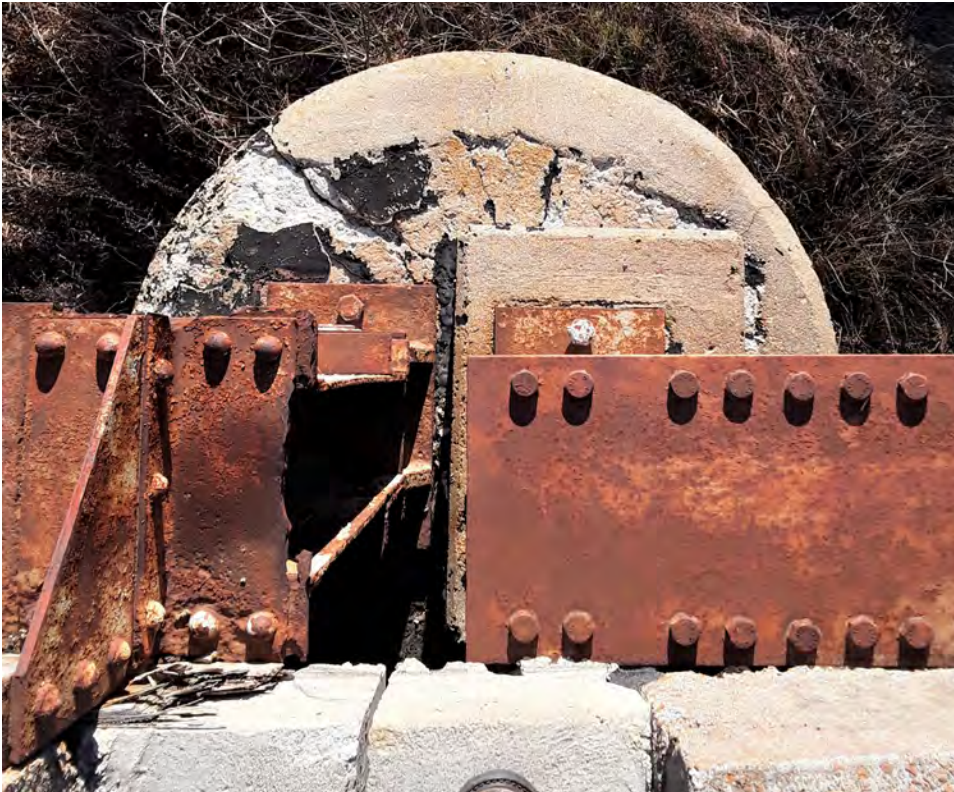
*The exposed concrete at the top of the piers exhibit some cracking and deterioration which require repair.*

- Repair the concrete at the outer edges of the pier top (each) and the abutment wing (one location). Conceptually this will consist of removing deteriorated concrete and recasting with a cementitious concrete repair.

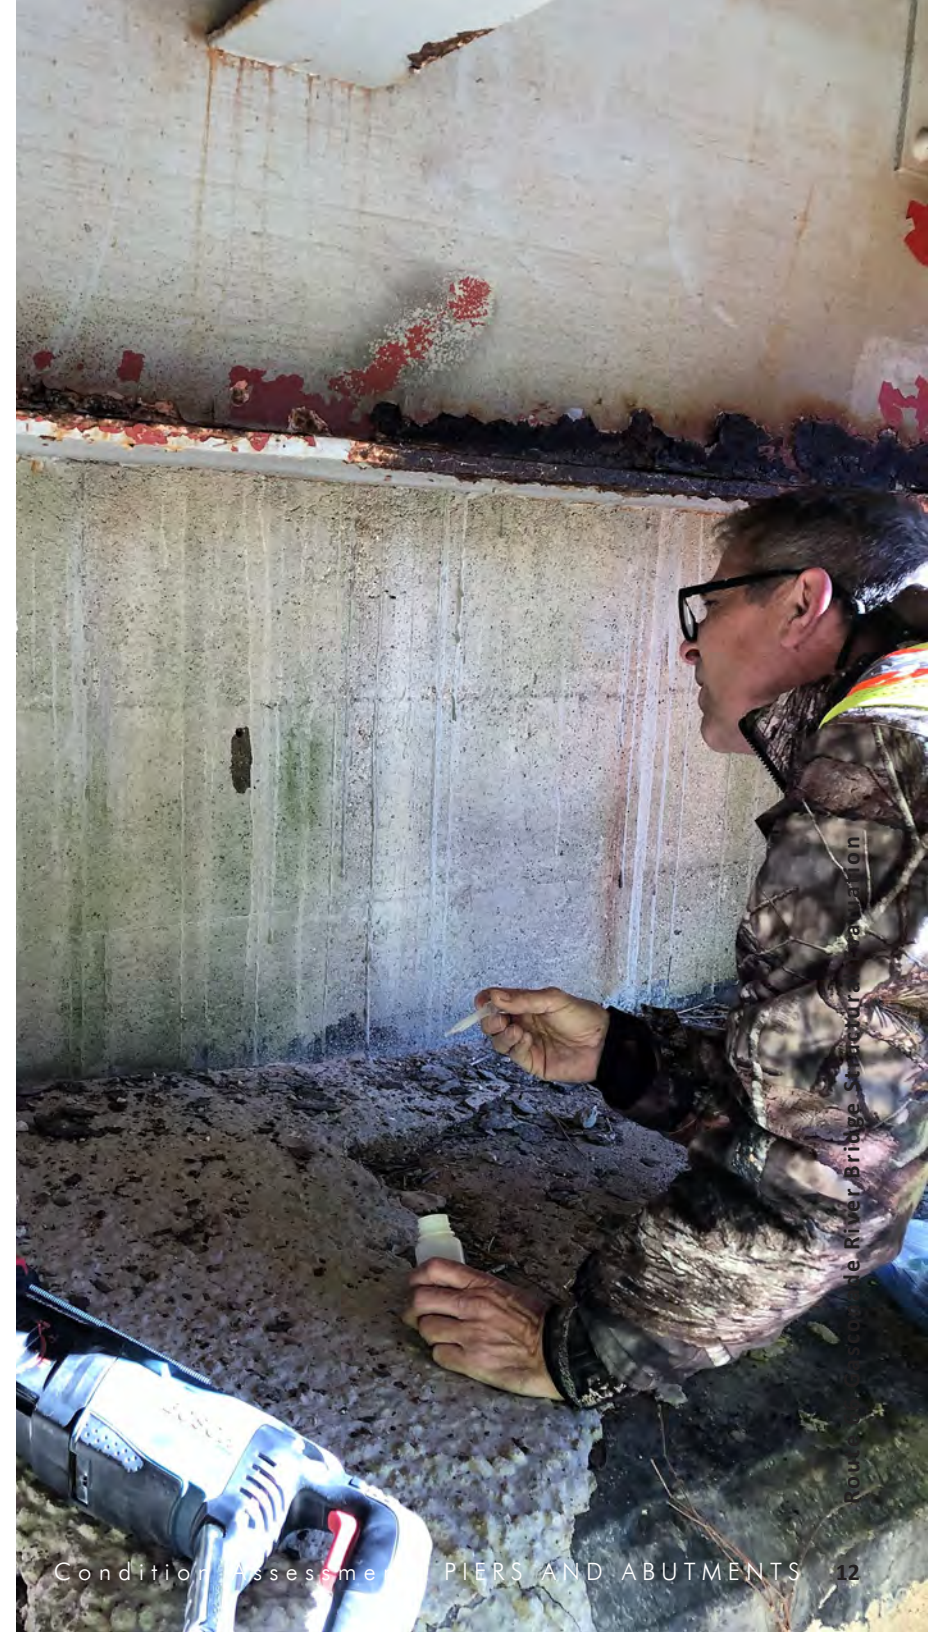
*The concrete abutments are in good condition. Our concrete testing found the abutments are lightly reinforced and the depth of carbonation is ½ to 1-inch.*

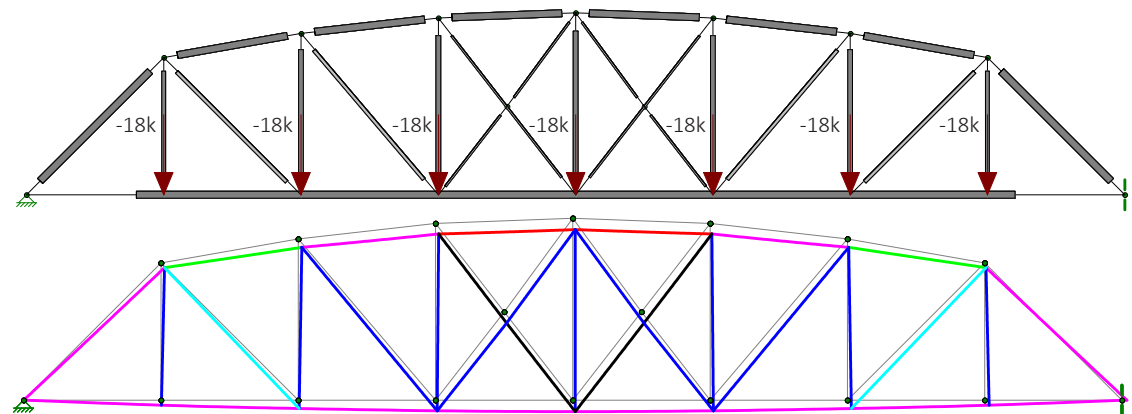
In general, our analysis indicates that the bridge has sufficient capacity for pedestrian/bicycle reuse once the deck is replaced and repairs are made to the steel, without the need for additional strengthening or structural upgrades. Our analysis found that the truss top and bottom chords are at their maximum allowable design capacity with the dead load plus full pedestrian live load cases considered. Therefore, we recommend the rehabilitated bridge include deck replacement using a thinner concrete deck or an FRP deck for pedestrian reuse. We also found that the capacity of the stringers is typically adequate despite corrosion in the top flange and they can generally be reused with limited repairs.

*RISA 3D graphic representation of a Parker truss with pedestrian live load case. The deflection is amplified for clarity.*
