## Central Valley Regional Water Quality Control Board

### ***NOTICE OF VIOLATION FOR SANITARY SEWER OVERFLOWS, CALIFORNIA DEPARTMENT OF CORRECTIONS–MULE CREEK STATE PRISON, AMADOR COUNTY***

**INSPECTION REPORT**

California Department of Corrections, Mule Creek State Prison  
Highway 104, Ione, Amador County  
Inspection Report Photo Log for 11 August 2020

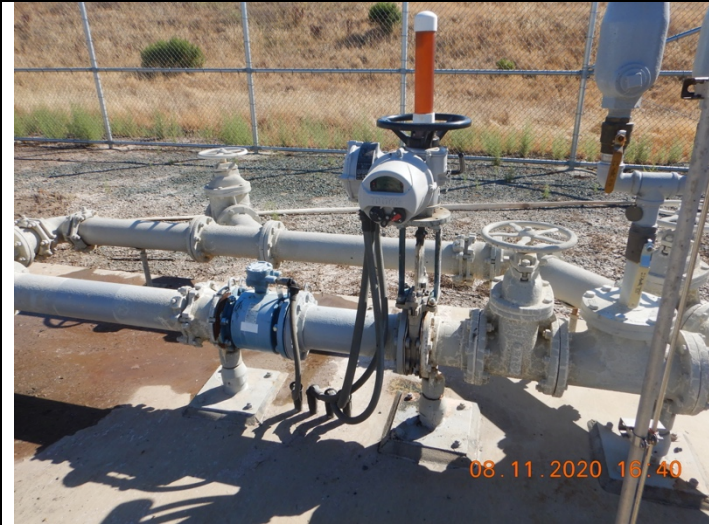
- The spill occurred at the lift station just downhill and southwest of the MCIC. The logic controller for the lift station had faulted, which had automatically closed a knife gate that controls the output flow from the lift station. With the gate closed, sewage slowly backed up in the vault, eventually overflowing and running down the hill towards Mule Creek.

Photo 1. Knife gate that was closed by SCADA system failure, causing the backup in the lift station vault and eventual overflow. Lift station is located just southwest of Mule Creek Infill Complex.

1. No later than **15 October 2020**, submit a statement, certified by the Chief Plant Operator, that the SCADA system and MCIC lift station has been inspected and repairs/corrections have been made to ensure an issue similar to what caused the spill on 10 August 2020 will not occur in the future.
2. No later than **15 October 2020**, submit the current Sanitary Sewer Maintenance Plan for the facility.

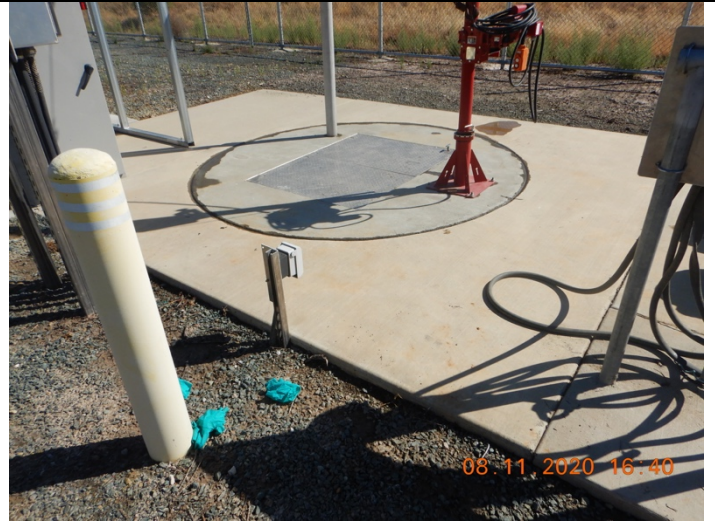
Lift Station: Lift station computer showed an error at the time of the inspection. CDCR staff's efforts to reboot were unsuccessful. The area around the lift station was wet from washdown as part of the cleanup effort. The knife gate was open (Photo 1) and the vault was pumped down (Photo 2). The hose running from the bermed area to the vault was still in place (Photos 3, 4). No solids were observed, and the only odors were directly above the vault opening when the lid was open.

Photo 2. Vault of lift station where overflow occurred. Knife gate in photo 1 is approximately 20 feet to the right. Vault is approximately 500 feet from the creek bed of Mule Creek.

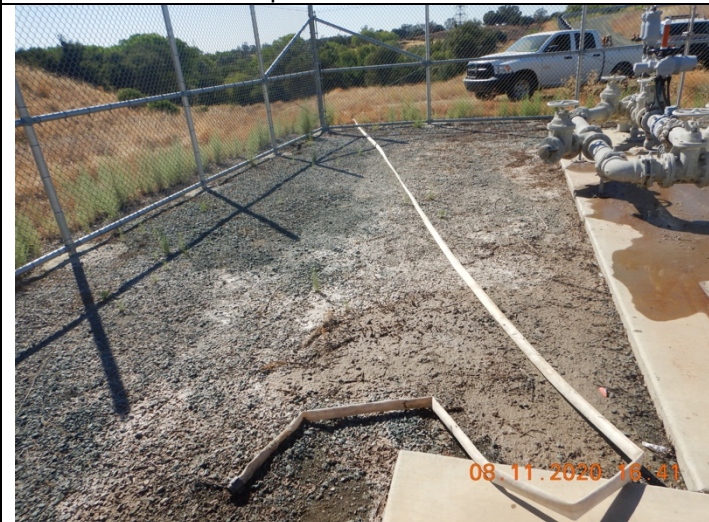
Photo 3. Hose running from small diversion downhill from the lift station back to the lift station vault. Hose was used to pump back collected sewage in bermed area (see photo 4).

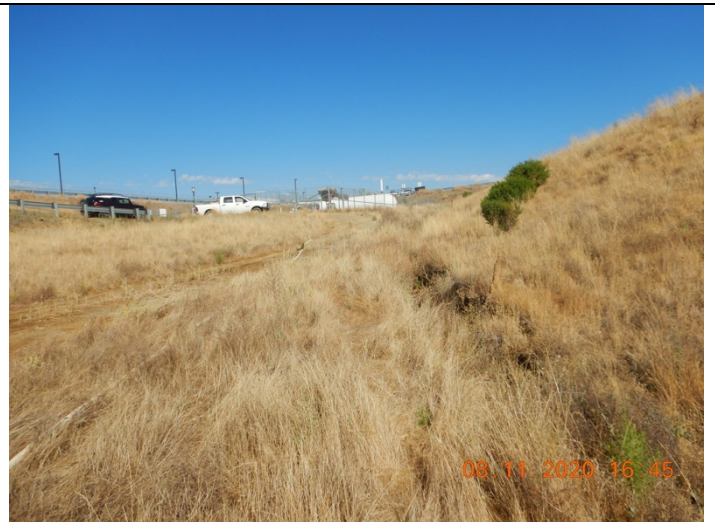
- When the vault overflowed, sewage flowed downhill overland to the west towards the creek. It first encountered a bermed area built to catch potential overflows, approximately 300 feet from the lift station. Unfortunately, the slide gate in the berm was open at the time and so only a small amount of the total capacity of the berm area was utilized to contain the spill. CDCR staff utilized a trash pump and hose to pump the contained sewage back into the vault at the lift station. CDCR staff estimate that 11,100 gallons was contained here and pumped back to the vault.

Photo 4. View from bermed area looking east towards lift station approximately 300 feet away. Hose on left leading from trash pump to vault.

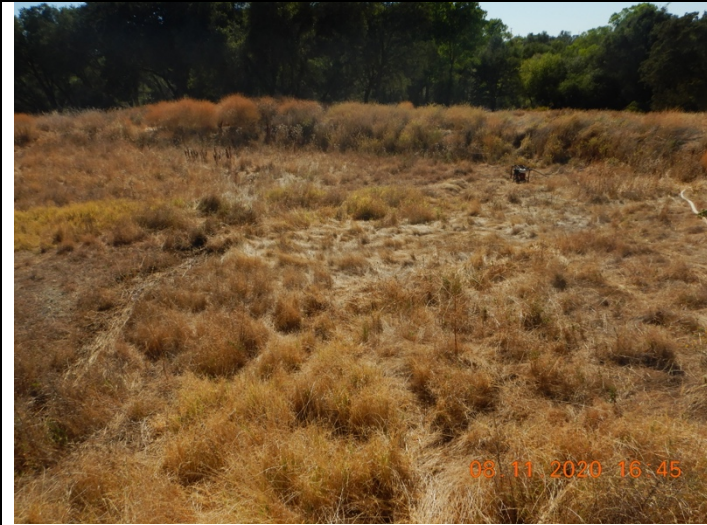
Photo 5. View of bermed area and trash. Bermed area was constructed in case of overflow from lift station. CDCR staff stated that there is a slide gate installed in the berm, but the slide gate was open during the discharge so only a small portion of the total volume of the bermed area was able to hold back sewage.

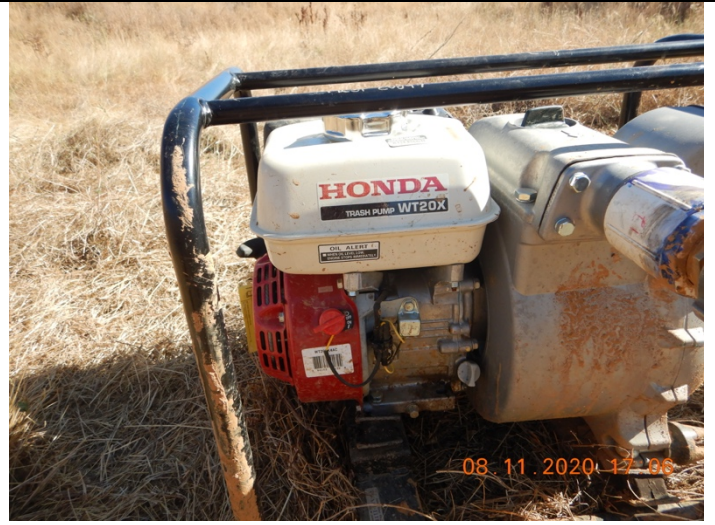
Photo 6. Honda WT20X trash pump which was used to pump sewage contained by bermed area back to lift station vault.

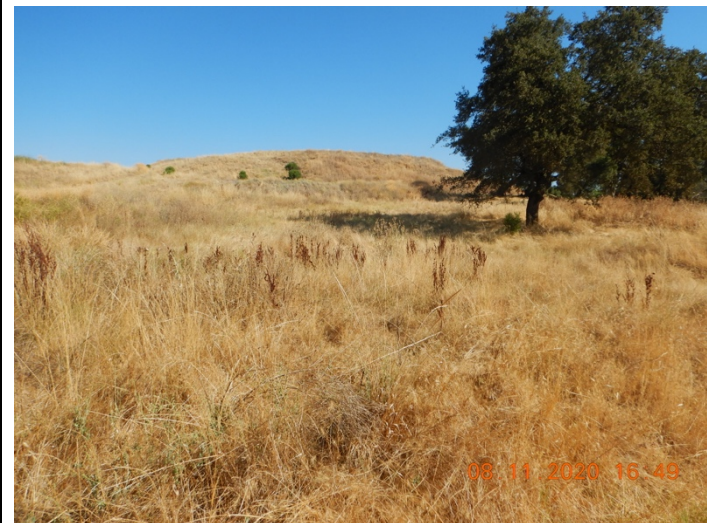
Photo 7. Picture taken from the access road, approximately 400 feet west of lift station. Mule Creek creek bed is approximately 100 feet further west.

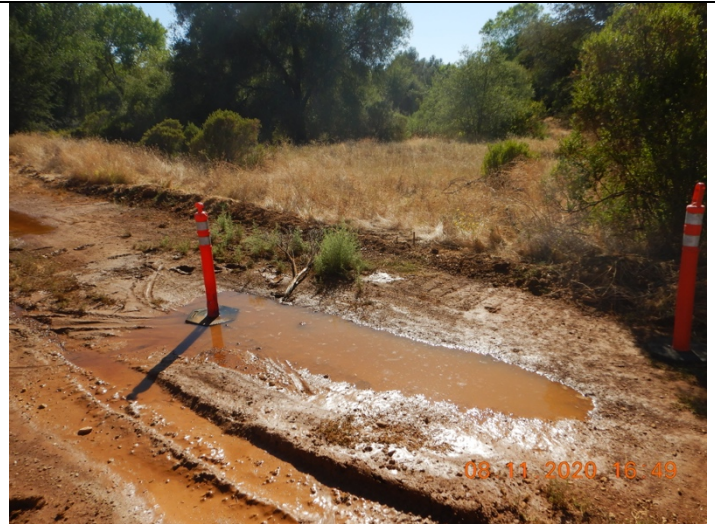
Photo 8. Pooled water on access road from spill, approximately 100 feet from creek.

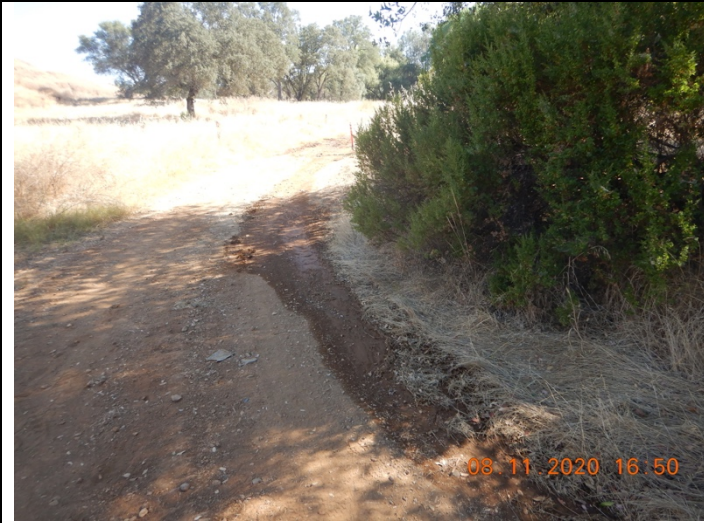
Photo 9. Damp soil going down the road towards creek, facing approximately east.

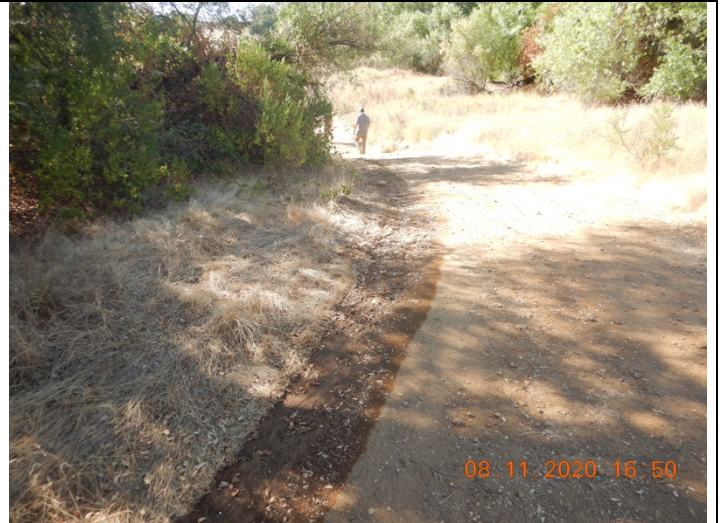
Photo 10. Damp soil going down the road towards creek, facing approximately west.

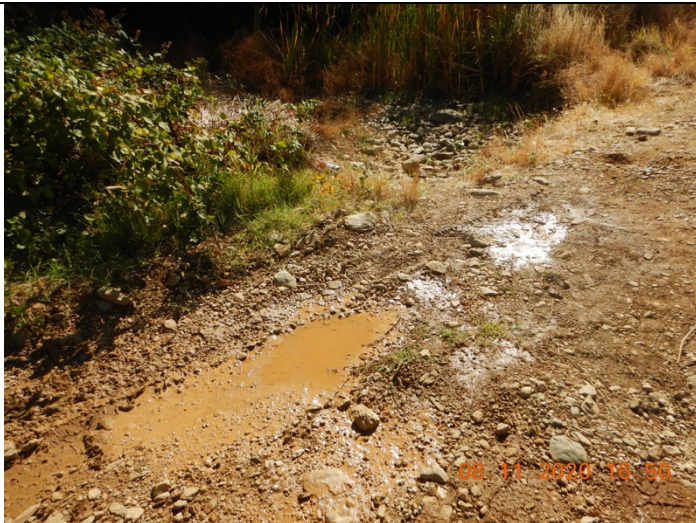
100 feet of that location. Board staff also noted that the creek bed was dry upstream of the stream crossing, and both upstream and downstream of the MCIC access bridge, which is further upstream of the stream crossing in Photo 11. Based on the dead and dry vegetation, it did not appear any water had flowed in the creek from above the stream crossing location in some time.

Photo 11. Small puddle of water on road of creek crossing. Creek bed in background. This is the location where the overland flow of sewage entered the creek bed.

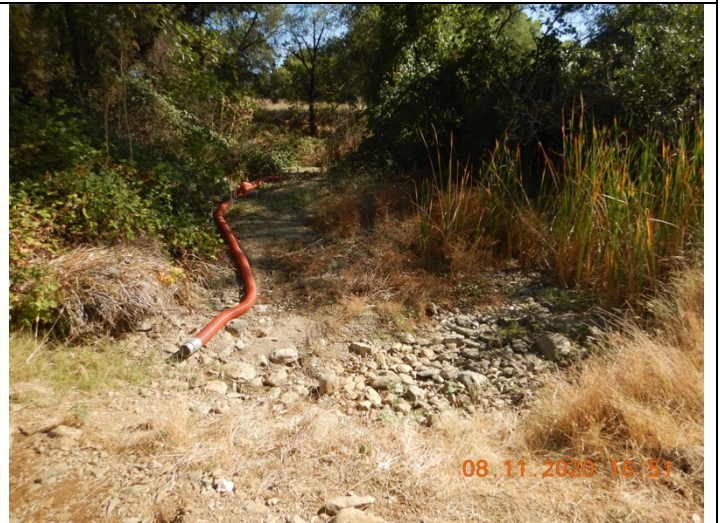
Photo 12. Creek bed of Mule Creek from the stream crossing nearest to the lift station. Lift station is approximately 500 feet to the left of this picture, east of the creek. Hoses were left from vacuum truck after recovery effort.

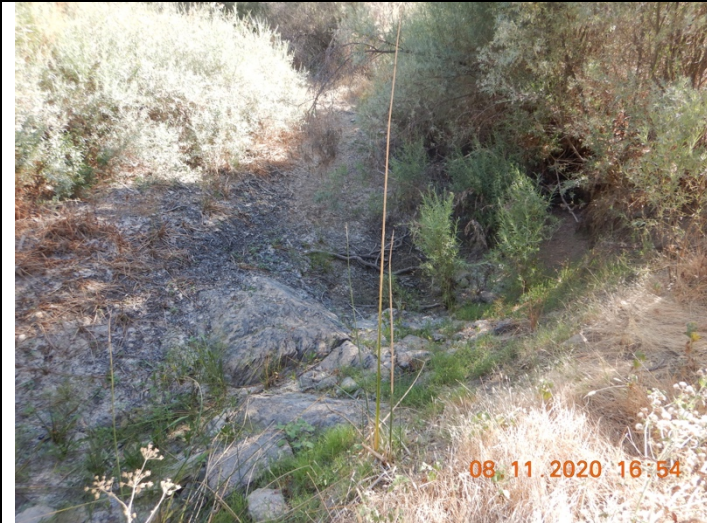
Photo 13. Creek bed of Mule Creek approximately 200 feet downstream from crossing in Photo 11. Damp soil observed.

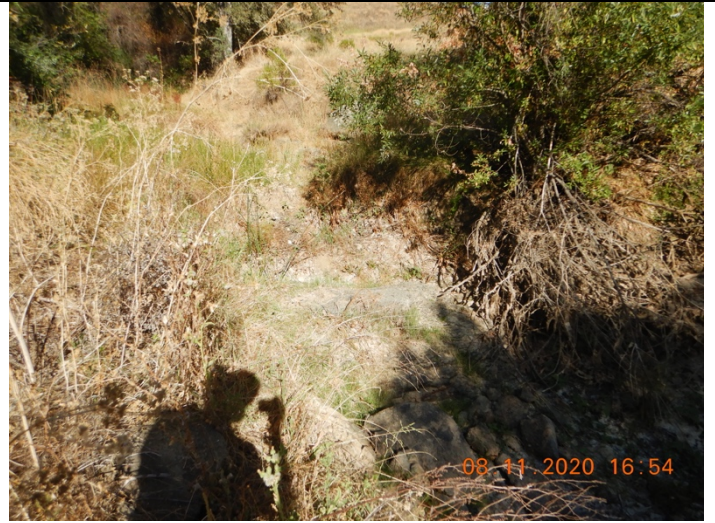
Photo 14. Creek bed of Mule Creek approximately 150 feet downstream from crossing in Photo 11. Damp soil observed.

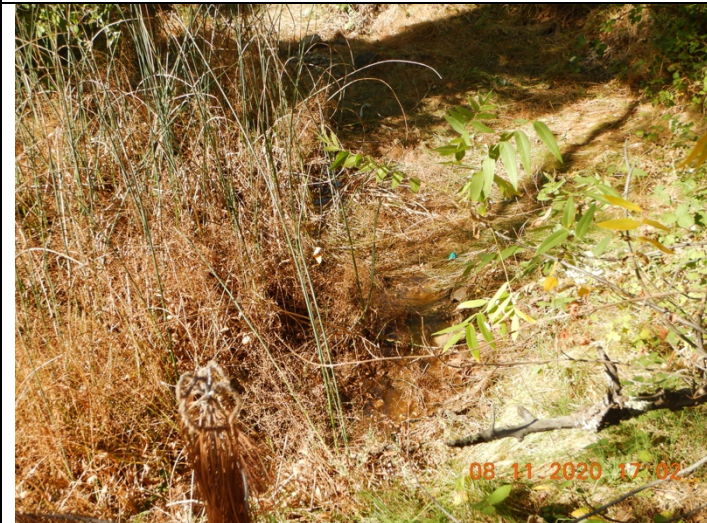
Photo 15. Creek bed of Mule Creek approximately 250 feet downstream from crossing in Photo 11. Small amount of ponded water in depressions.

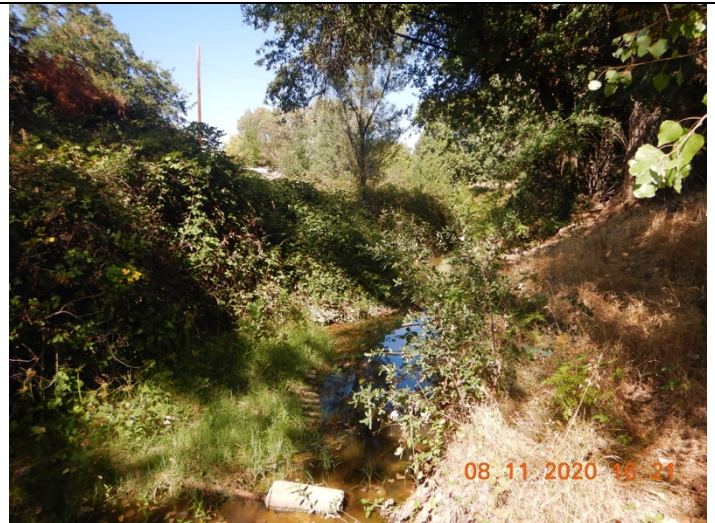
Bridge at Highway 104: Board staff observed a significant amount of water just upstream of (on CDCR property) and under the bridge where Mule Creek passes under Highway 104 (Photos 16, 17, 18, and 19). A small amount of flow was observed in the creek at this location, less than 5 gallons per minute. Water appeared slightly opaque and had a mild stagnant odor (Photo 19). Algae clumps were also observed in the water. Thick green vegetation in the area suggests that the area is wet frequently even through the dry season. The stormwater outfall is located just upstream of the bridge, but was obstructed by thick vegetation. It was unclear if there was a discharge from the stormwater system at the time of the inspection. Just downstream of the bridge was a deeper ponded area of water of a similar quality (Photo 20). Rags including what appeared to be partially broken down toilet paper and sanitary wipes were observed in the brush along the creek just downstream of the bridge (Photo 22). CDCR staff stated they thought it was more likely irrigation runoff from the land application areas than sewage from the spill.

Photo 16. Looking up Mule Creek from the Highway 104 bridge. Location is approximately 4000 feet downstream from the crossing shown in Photo 11. Significant water was present in creek. Very small amount of flow was observed.

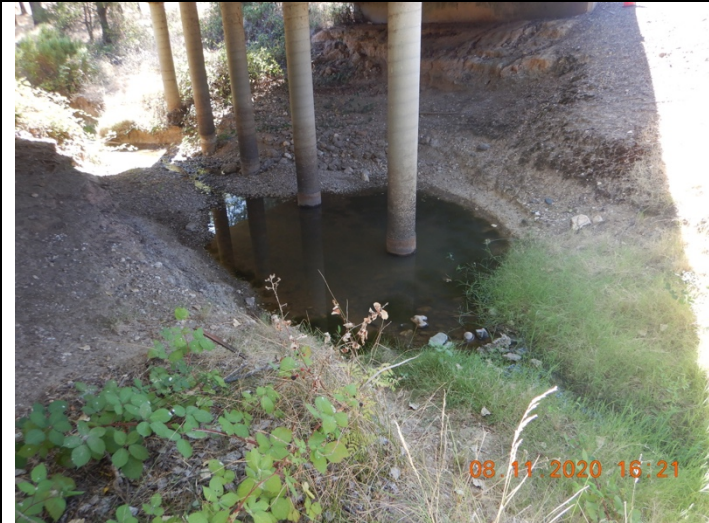
Photo 17. Ponded water under bridge where Mule Creek passes under Highway 104.

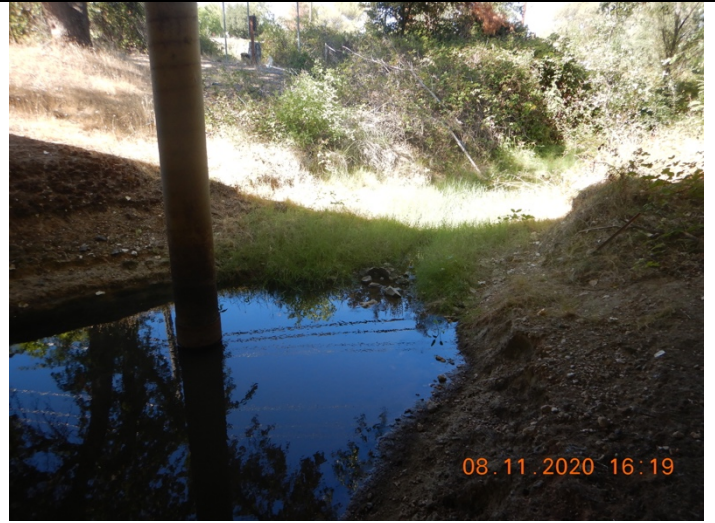
Photo 18. Ponded water under bridge where Mule Creek passes under Highway 104. Mild stagnant water odor observed.

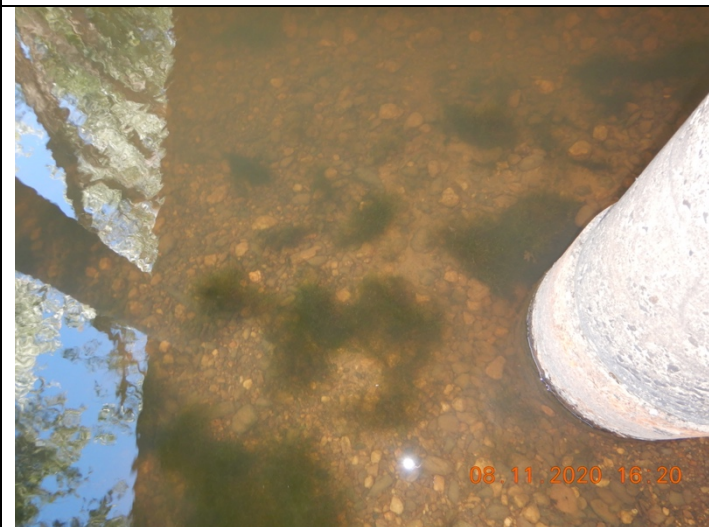
Photo 19. Close up of ponded water under bridge where Mule Creek passes under Highway 104. Water appeared slightly opaque and had large clumps of green algae looking material.

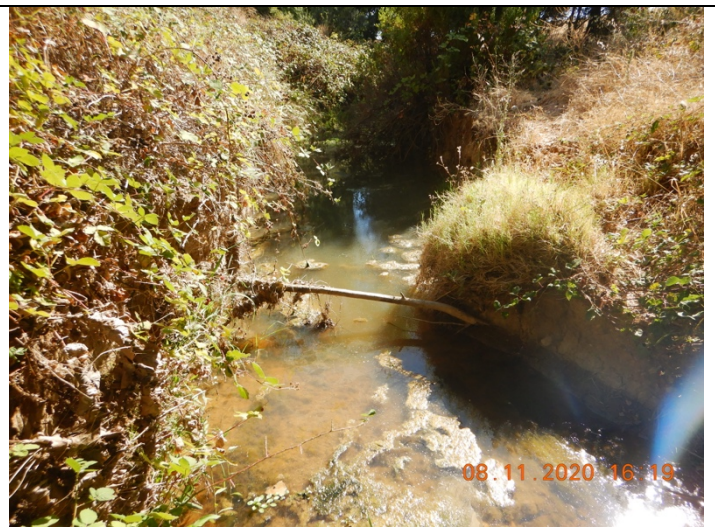
Photo 20. Looking downstream from under the bridge. Small amount of flow moving downstream. Water appeared slightly opaque and had large clumps of algae. Some rags observed (see Photo 22).

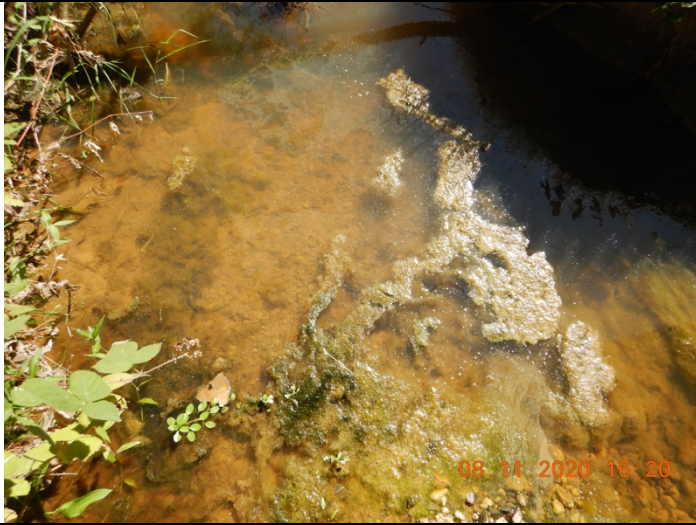
Photo 21. Close up of ponded just downstream of bridge where Mule Creek passes under Highway 104.

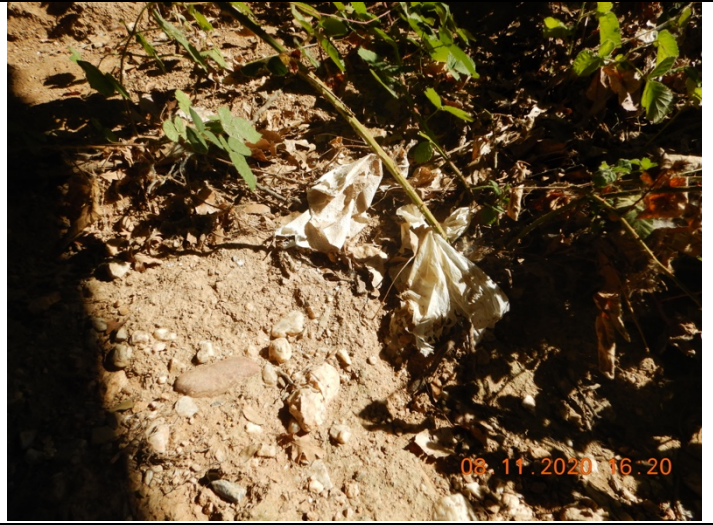
Photo 22. Rags observed in brush next to creek. Appears to be toilet paper and a sanitary wipe.
