Aviation Investigation Preliminary Report

Location:	Dunlap, TN	Accident Number:	ERA25FA239
Date & Time:	June 24, 2025, 18:23 Local	Registration:	N28DR
Aircraft:	Piper J3C-65	Injuries:	1 Fatal, 1 Serious
Flight Conducted Under:	Part 91: General aviation - Instructional

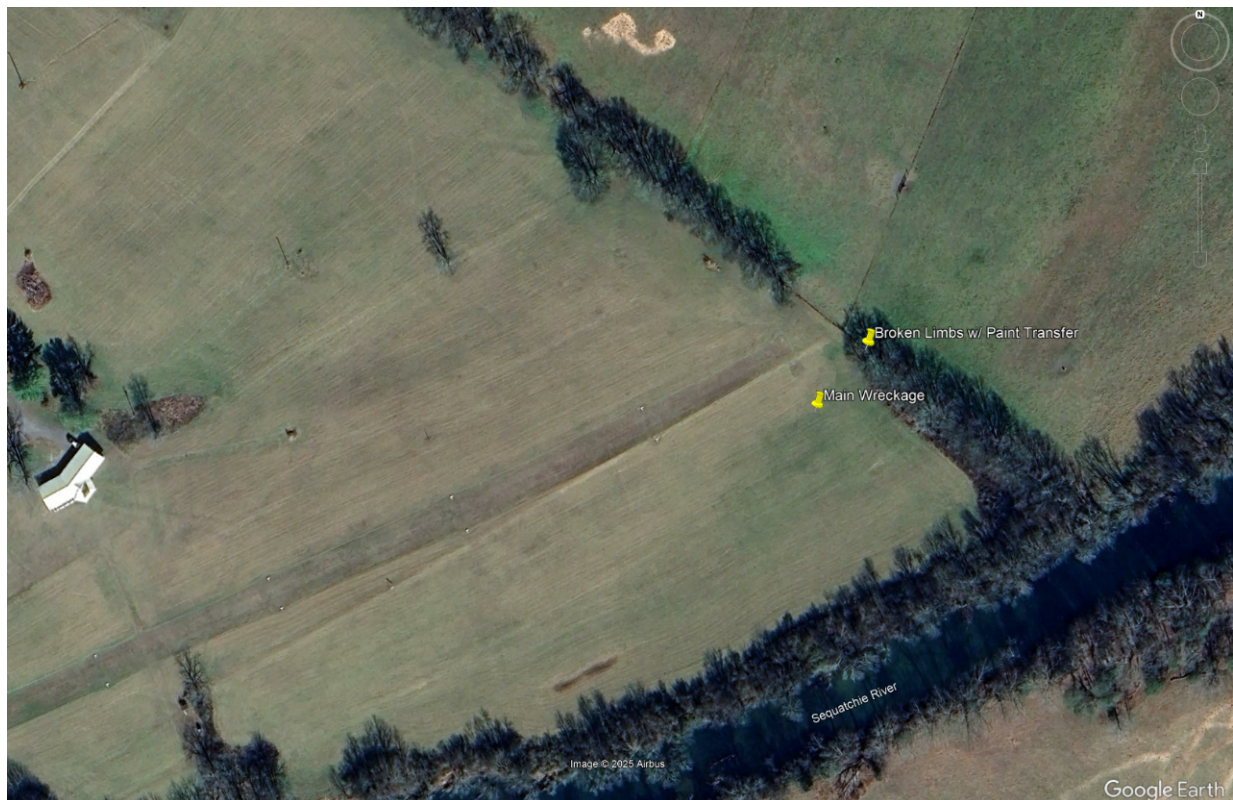
The accident site was located at the airplane owner's private airstrip, about 40 feet to the left side of the runway. The runway heading was 240° and the airplane came to rest on a 335° heading. The airplane came to rest mostly upright in a hay field. A ground scar was observed directly in front of the airplane's engine and was 8 inches deep. The scar was centered with the airplane and protruded to the airplane's right by 2 feet. The right main landing gear collapsed, and the airplane was partially resting on the right wing. The cockpit instrumentation, firewall, and engine were displaced upwards from the fuselage.

Witnesses that responded to the accident site confirmed that the fuel selector was in the "both" position. One witness reported that the forward occupant was wearing the installed four-point harness, and the aft seat occupant was not wearing a harness or lap belt, but that the lap belt was in close proximity to the occupant. A second witness recalled that the aft seat occupant had the lap belt secured, but the shoulder harnesses were not utilized. First responders that documented the scene noted several broken tree limbs with yellow paint transfer about 113ft from the main wreckage.

The grass runway measured 40ft in width. A clearing at the beginning of the runway measured about 100ft wide and was about 50ft from the cut grass on the runway. According to the Federal Aviation Administration, the airstrip was about 2,100ft in length.

Figure 1: Main Wreckage Location in Proximity to the Private Airstrip and Broken Tree Limbs
