IAQTN
ENVIRONMENTAL TESTING AGENCY

Mold Inspection & Testing

Coffee County Manchester Public Library

1005 Hillsboro Blvd

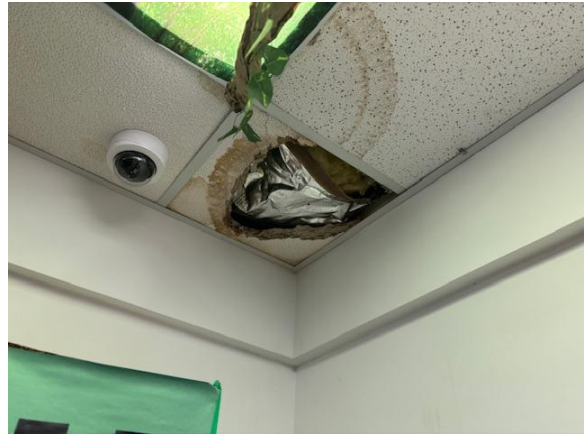
moisture were identified in a few areas, primarily the back right corner of the building where there was evidence of water intrusion in the drop ceiling tiles. The drywall beneath measured wet at the time of inspection. The source of moisture was identified to be from a leaking gutter and poor flashing at this corner transition of the building. Another area of water damage was in the back left corner of the Large Print section of the library. This area presented a significant amount of water damage as the drywall was soft, delaminating and crumbling. No elevated moisture was identified at this location during the inspection, which may be due to the deteriorating nature of the finished materials, lack of full access due to the bookshelves or lack of rainfall in recent days. The source of this moisture damage was noted at this location due to the poorly maintained transition between the exterior walls just outside this area. The backer rod and sealant were completely deteriorated or missing at this location leaving a large gap in the exterior wall allowing wind driven rain to enter the structure. Also, at this location the gutter was showing signs of issue, leaking seams, poor flashing transitions between the wood siding and the block exterior wall. There were many inefficiencies in the exterior envelope of the structure. Another area of obvious moisture issue was in the ceiling of the main lobby where the roof had leaked significantly to cause deterioration and mold growth in the ceiling materials. Due to the height of the ceiling moisture readings were unable to be collected but thermal imaging showed that the issue was not active at the time of inspection.

Figure 2 – Water intrusion area – back corner of juvenile area

4. Any deteriorated materials should be removed and properly disposed of. All affected drywall should be cut out and removed a minimum of 2' surrounding the last visible trace of mold or moisture. Removal of materials should continue until moisture or mold affected areas are not detected. This should be done in the ceiling of the main lobby, the back corner of the "large print" section and the back corner of the Juvenile section as well.

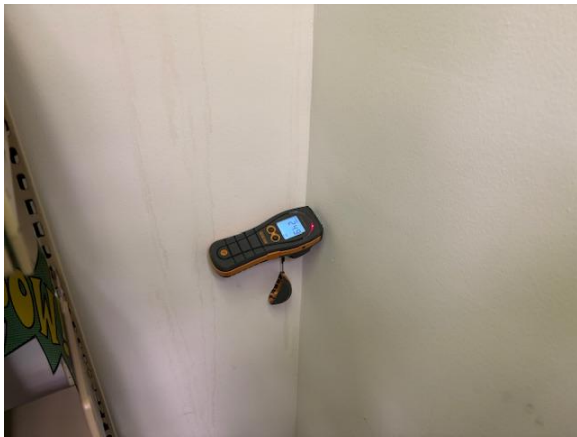
Figure 3 - Elevated moisture in drywall below

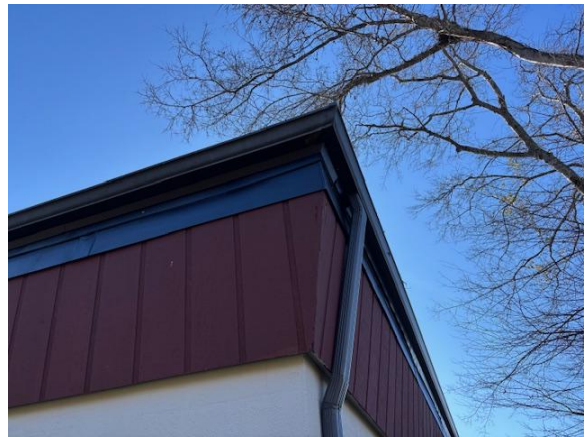
Figure 4 – Leaking gutter

- Remediation was needed throughout the building. This should be done following the IICRC S520 Best Practices which include:
 1. Identifying and correcting the moisture source and drying the wet materials. A proper evaluation and repair by a roofing and siding professional is needed to prevent further moisture intrusion into the structure. This should be focused on the water management systems such as the gutters and flashing, along with the exterior siding and transitions.
 2. Removal of some of the bookshelves and interior finishing is needed along with covering to prevent further contamination from the remediation process.

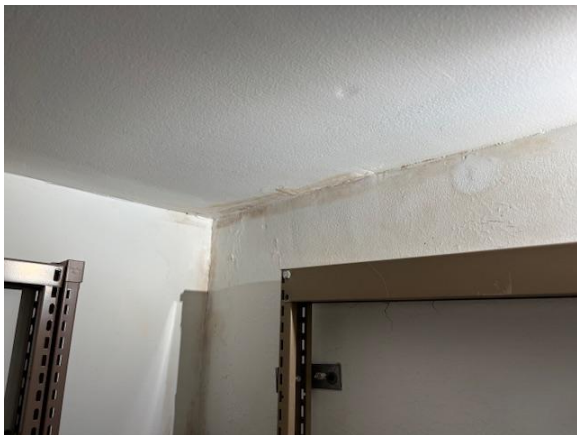
Figure 5 - Water damage in "large print" Section

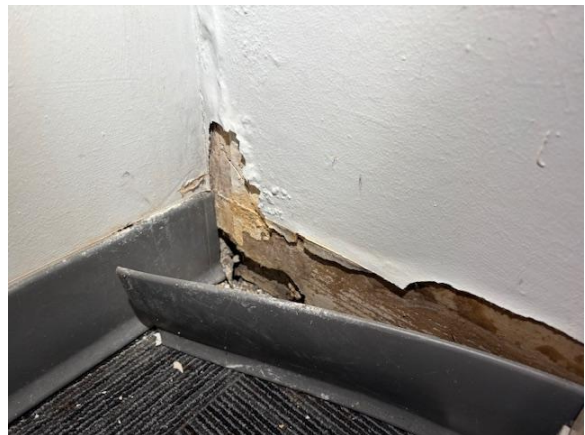
Figure 6 – Water damage in "large print" Section

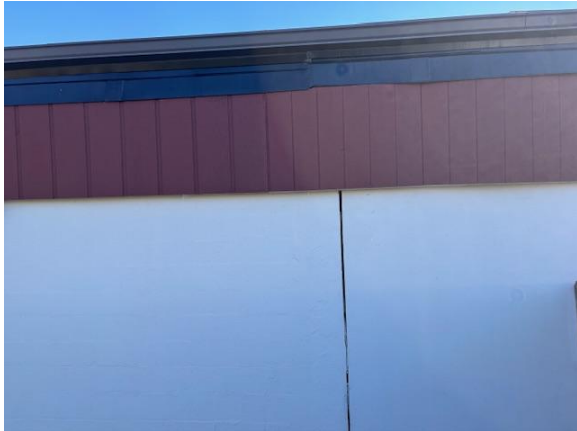
Figure 7 - Poor flashing and sealing

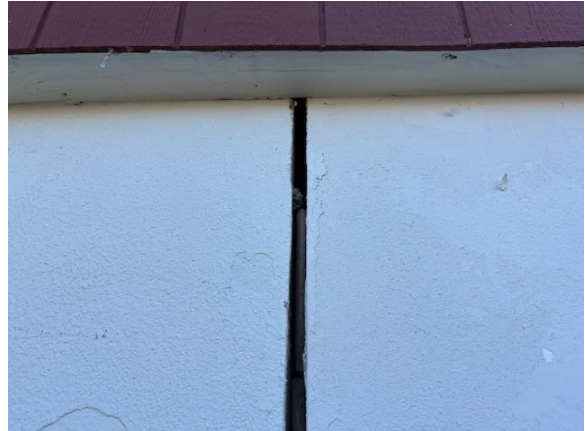
Figure 8 – Deteriorated sealant

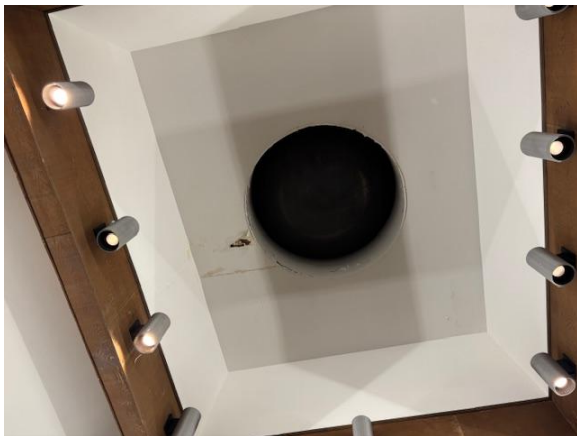
Figure 9 - water damage in ceiling of main lobbyt

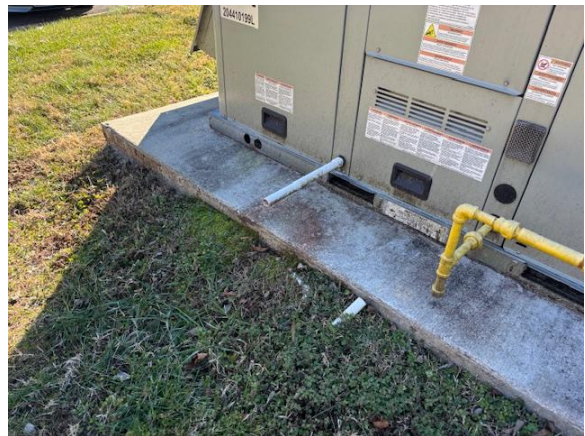
There was visible mold growth on the ceiling registers in the main lobby area, and a significant amount of dust and debris collected on the returns as well. This could restrict the system and create condensation within the HVAC. Mold growth on supply registers is an indication of poorly functioning systems, as it would cause elevated humidity, and allow the surfaces of the registers to meet the dew point and condense. This would cause for dust collection, providing a food source for mold to grow off of in addition to the moisture needed for growth. Further with the Package units on the exterior of the building, the condensate drain lines did not have traps, which could cause exterior air to be brought into the system, preventing the system from draining condensation properly, which would result in elevated humidity levels within the interior of the structure. It was also evident that the shrouds were in need of repair as water was pooling on top of the systems outside.

Figure 10 – No condensate trap on HVAC systems

- During this process, a qualified HVAC contractor in conjunction with a mold remediator should be hired to properly repair and clean the system. It is also recommended for the supply ducts be evaluated to determine if they could be properly cleaned or if replacement of the ducts is necessary. Due to the type of mold detected within the HVAC system, replacement is recommended.
