April 3, 2017

# Facility Condition Assessment

Nissan Stadium

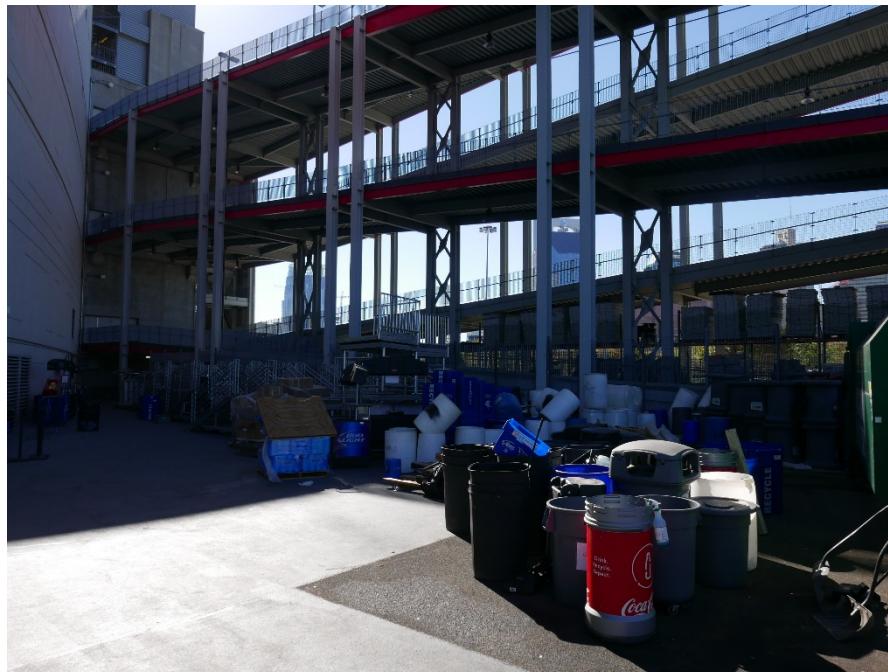
One way the lack of building storage at the field level manifests itself is with the existence of a “boneyard” in the shadow of the northwest pedestrian exit ramp. This is general building storage that would better be placed out of sight of guests. While screened at eye level, the boneyard is fully visible to guests using the ramp.

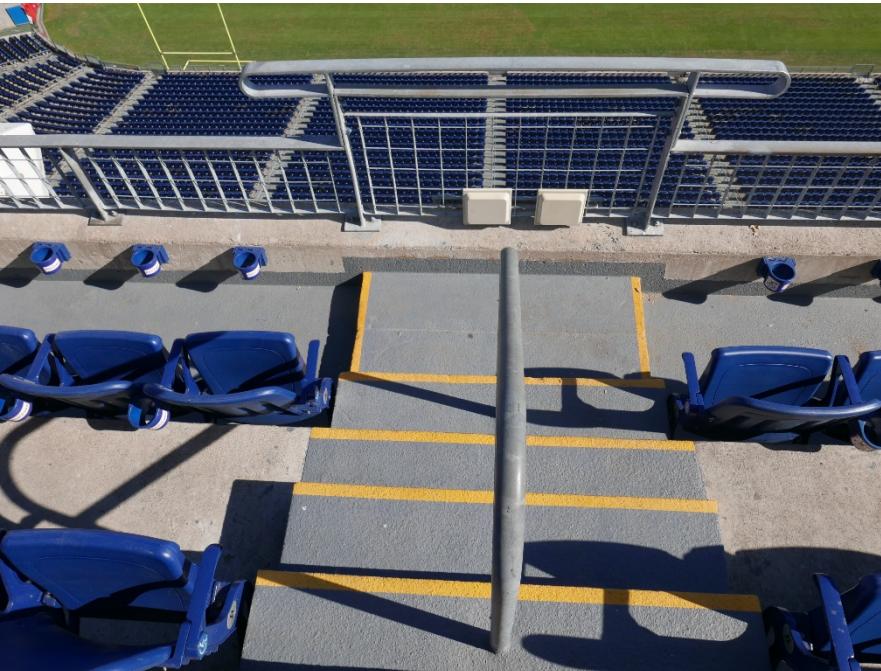
Some corrosion is evident at galvanized guardrails and handrails. Galvanized rail should not corrode (in theory). One solution to this is painting the rails, but painting galvanized metal is very difficult and should only be undertaken with very strict specifications regarding products used, surface preparation, and application methods.

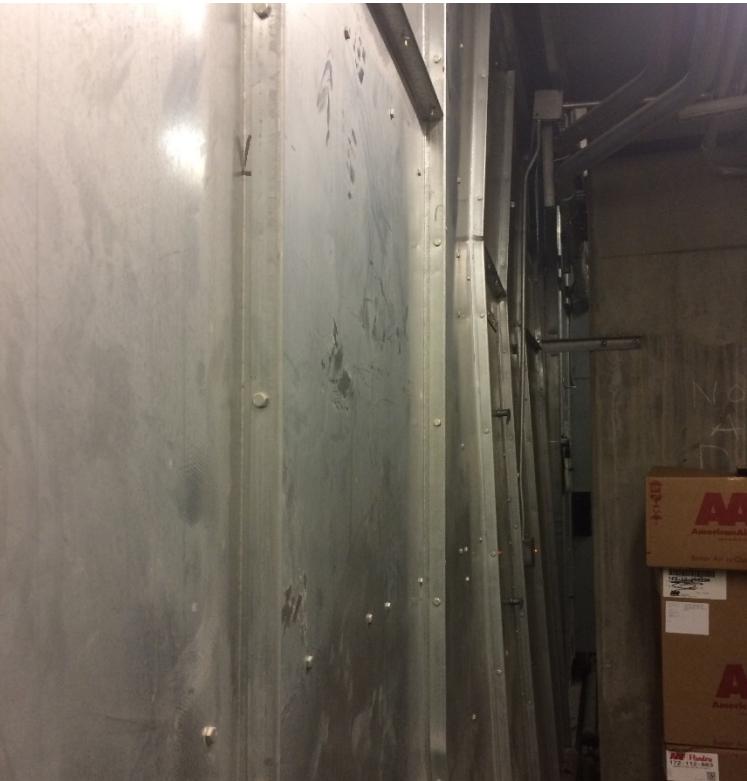
The club level air handlers and their associated components appear to be in generally good condition considering their age and runtime. However, one of the air handlers apparently has a leak in the condensate drain pan that is getting onto the floor. The air handler on Level 3 Sector B has a buckled, return air mixing box plenum due to a restriction within the ductwork at one point in time. While this is not a replacement issue, it should be reviewed and confirmed there is no leakage of airflow through the buckled seam. The coils are original to the unit and need to be cleaned. The unit with the leak may require replacement of the coil in the immediate future due to rust spreading up the coil.

Club AHU Buckled Return Plenum

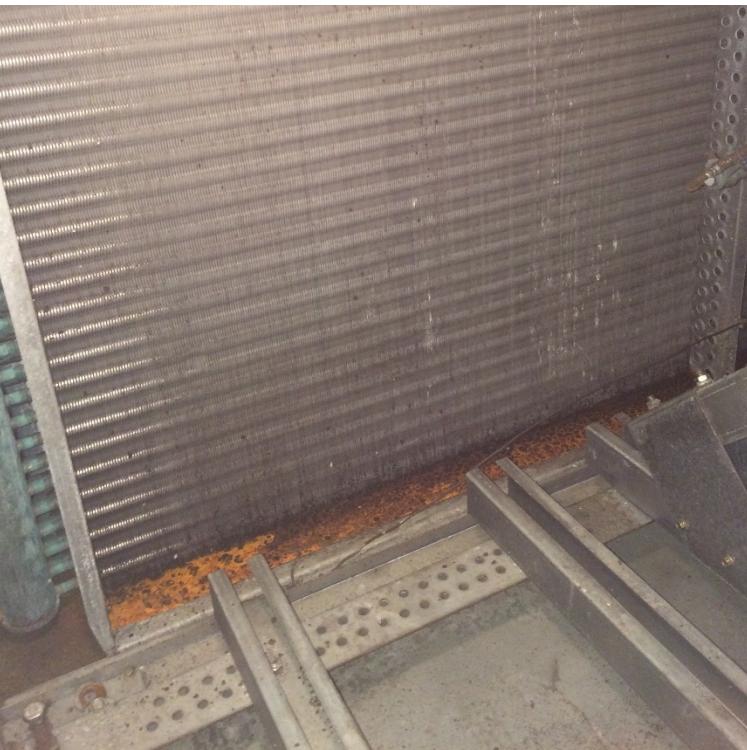
The air handlers serving the locker rooms are units that have a high percentage of outside air, ranging from 50-70% outside air. These units do not appear to have a UV antimicrobial coil protection or an energy recovery device. A large percentage of utility costs are associated with conditioning outside air. Because the facility utilizes electric resistance reheat, this energy consumption is only exacerbated.

*Air Handling Cooling Coil with Biological Growth*

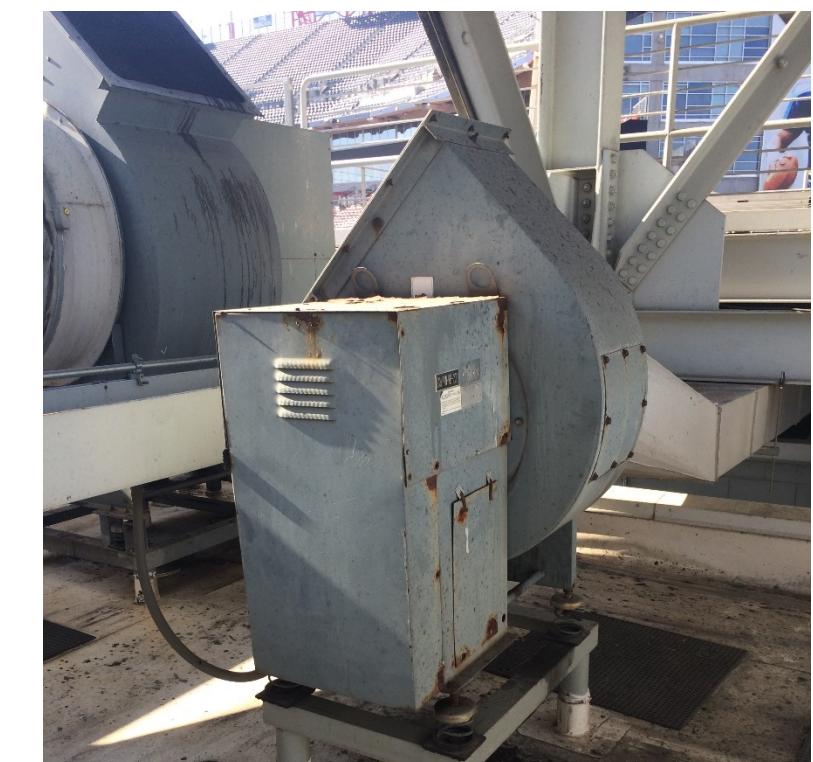
The grease fans during a full cooking mode are not able to eliminate all the smoke produced under the kitchen hood; this can be caused by the kitchen hood not being properly cleaned or a grease build up the ductwork which creates a low flow situation.

*Grease Fan on Low Roof*

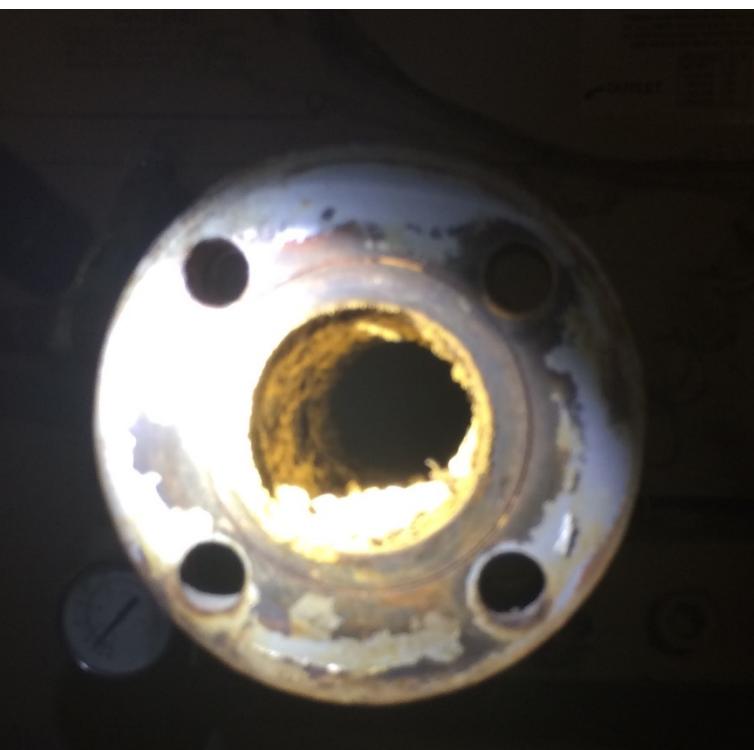
*Inside Chilled Water Pipe with Corrosion*

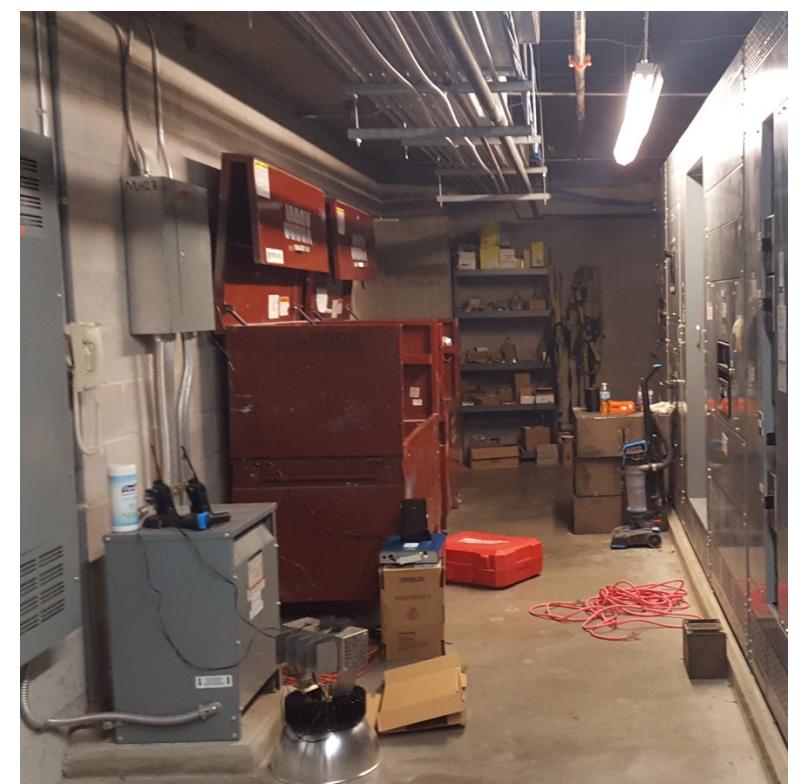
*Concession Transformer with Improper Clearance*

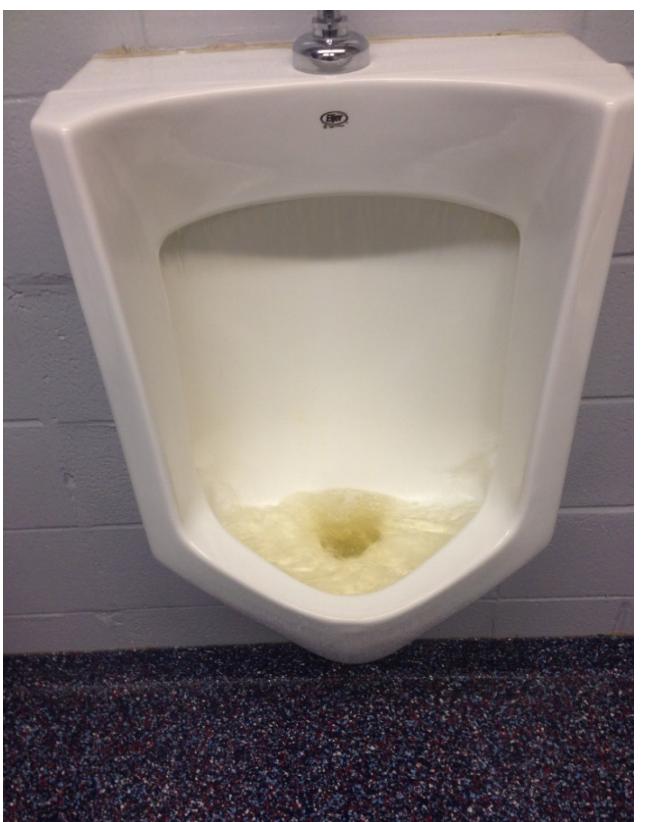
The galvanized coating inside all of the cold water piping has deteriorated over the years, and now the piping is oxidizing at an accelerated rate. Currently the maintenance staff is flushing the entire cold water piping system four (4) days before an event. (Example: Flush Thursday before a Sunday Titans game.) The staff has installed flushing ports at the event level and upper concourse level. These flushing ports consist of a 2 ½-inch valved hose connection. There are four (4) on the low-pressure zone system at the event level and six (6) on the high-pressure zone system at the upper concourse level.

Urinal Upper Concourse – Discolored Water from Corrosion

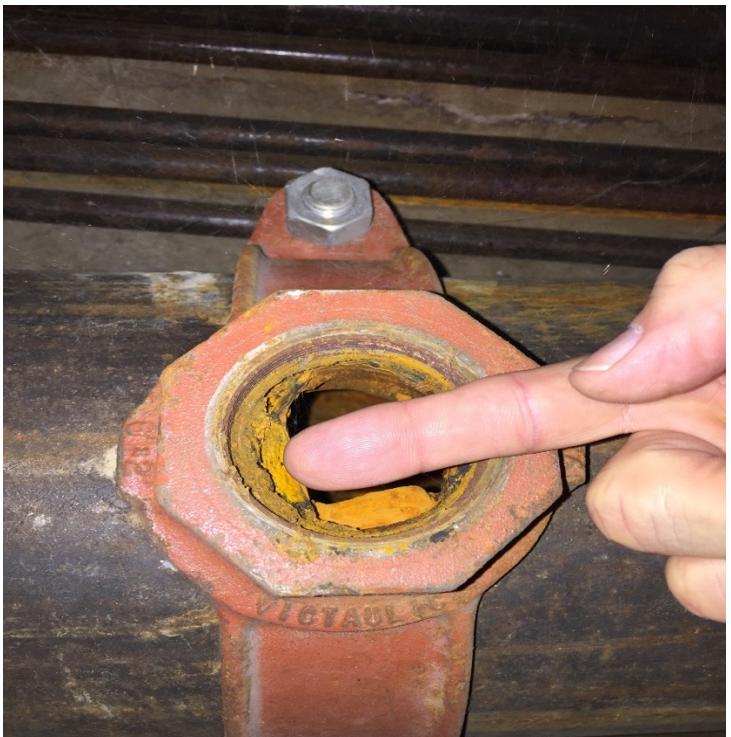
*Interior Pipe Corrosion*

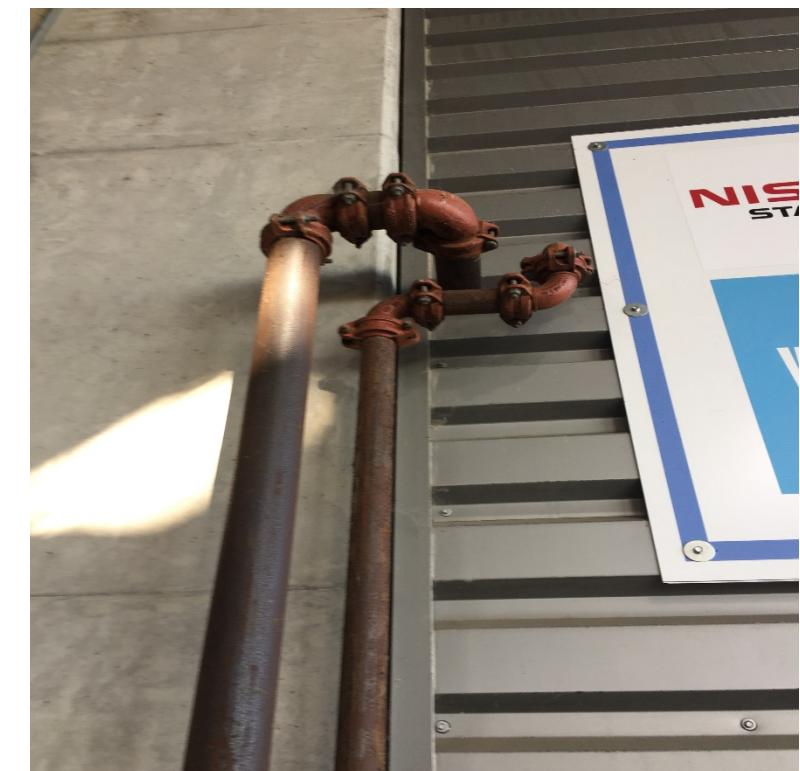
*Rust on Exterior Dry Pipe System Piping*

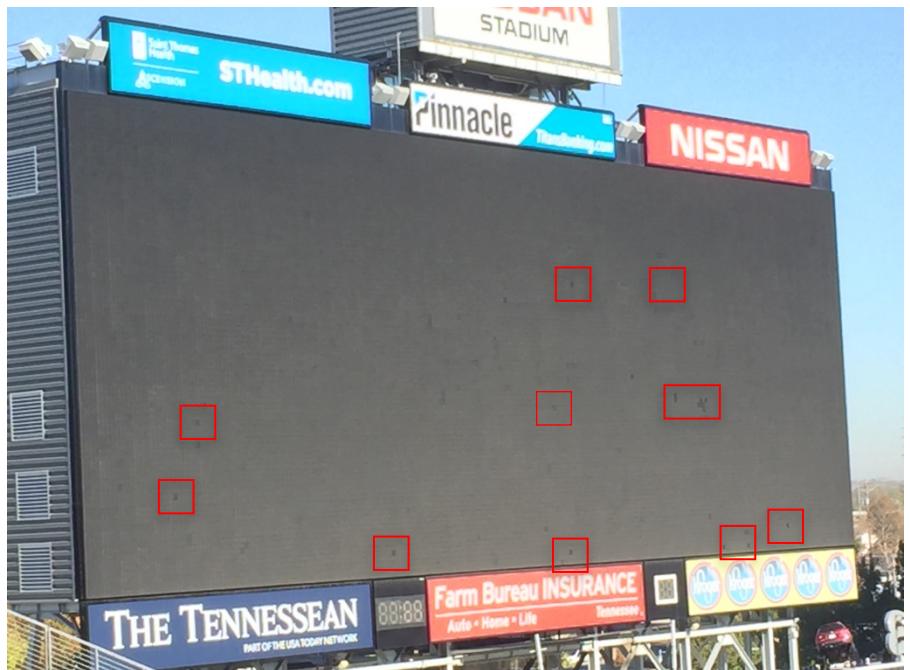
North Display

- There are issues with the uniformity between modules as highlighted below on the North display.

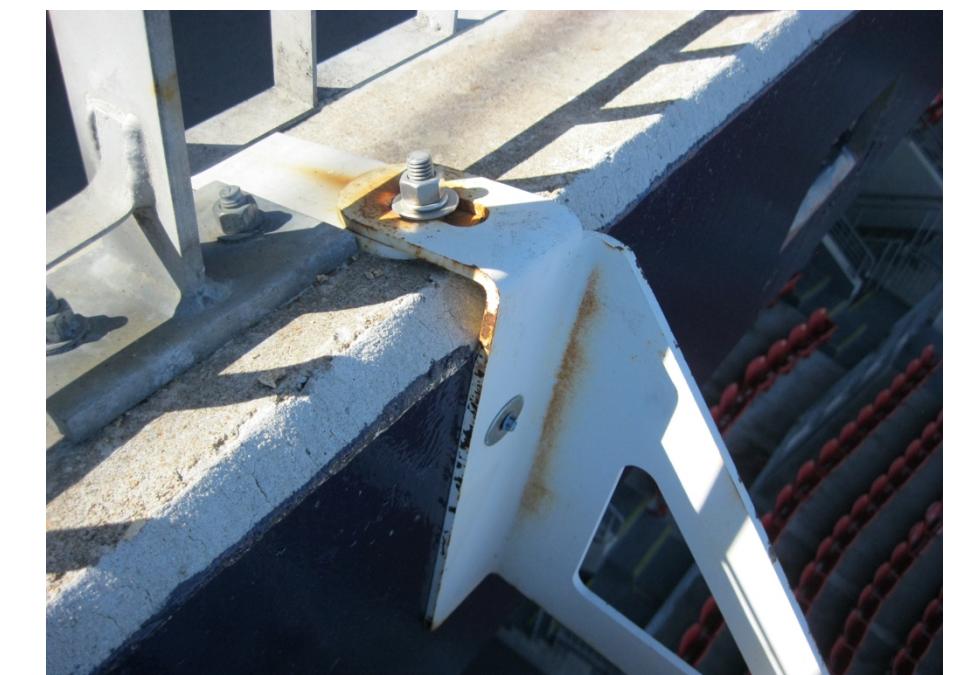
Minor surface rust was noted on some of the speaker brackets throughout the facility. During the bidding process, there was a VE option selected to change the brackets from aluminum to steel in order to bring the project within budget. At bid time, the additional finish maintenance of the steel bracketing was discussed and the option accepted. Repainting of the bracketing with the appropriate coating should be considered within the next few years.

*Existing speaker bracket showing rust*

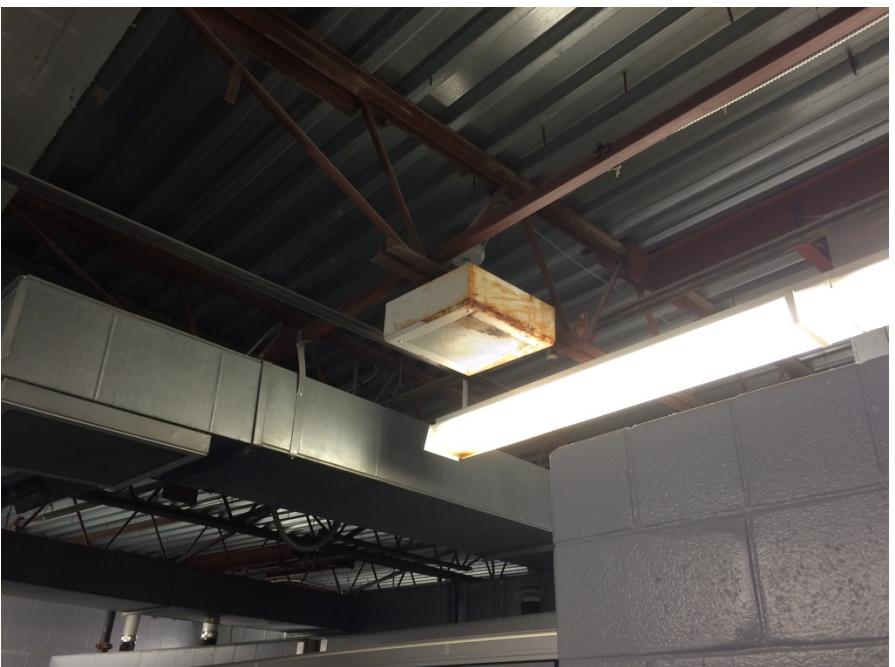
Existing restroom rusted speaker

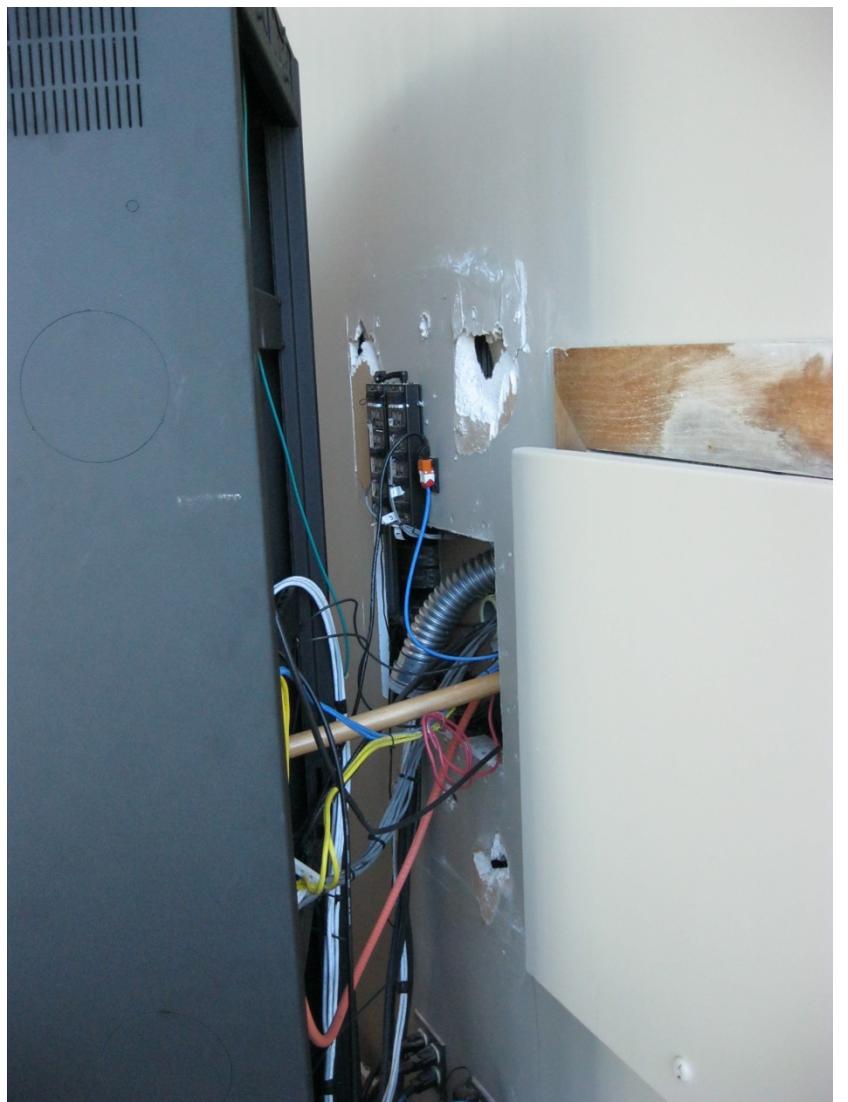
Poor installation workmanship at club AV rack

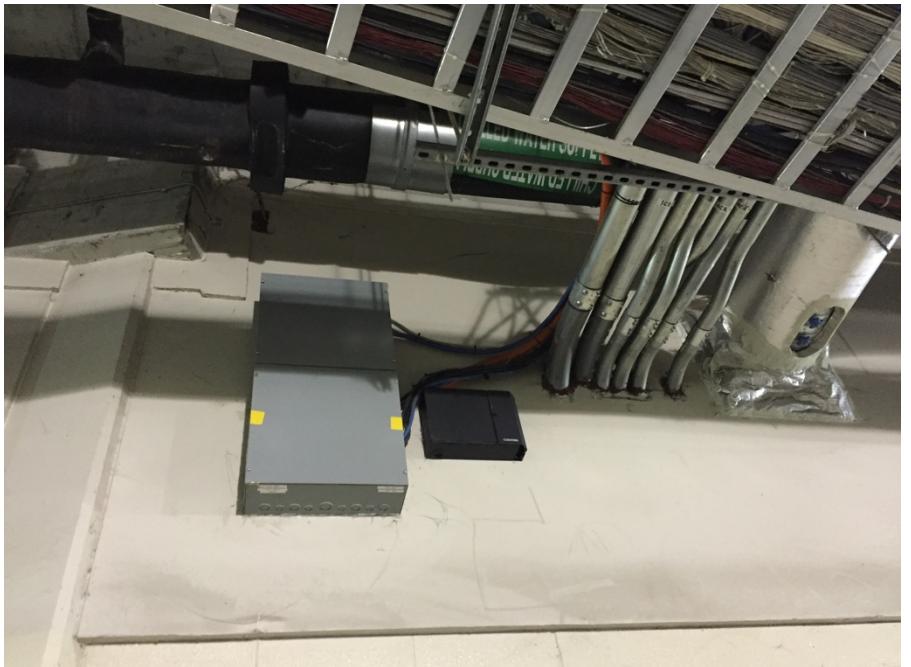
Splice point for damaged cable

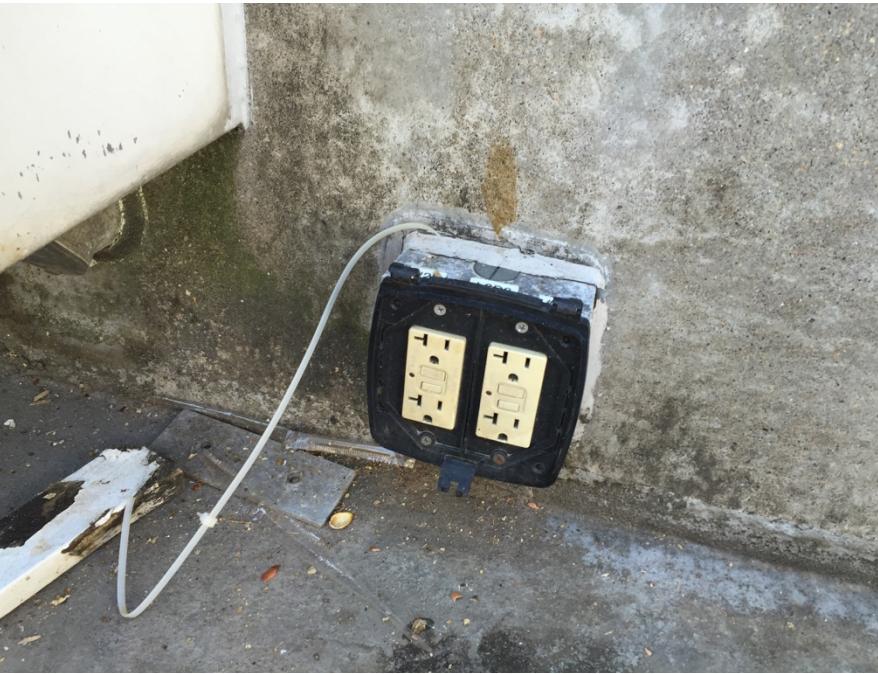
*Non-weatherized outlet subject to standing water*

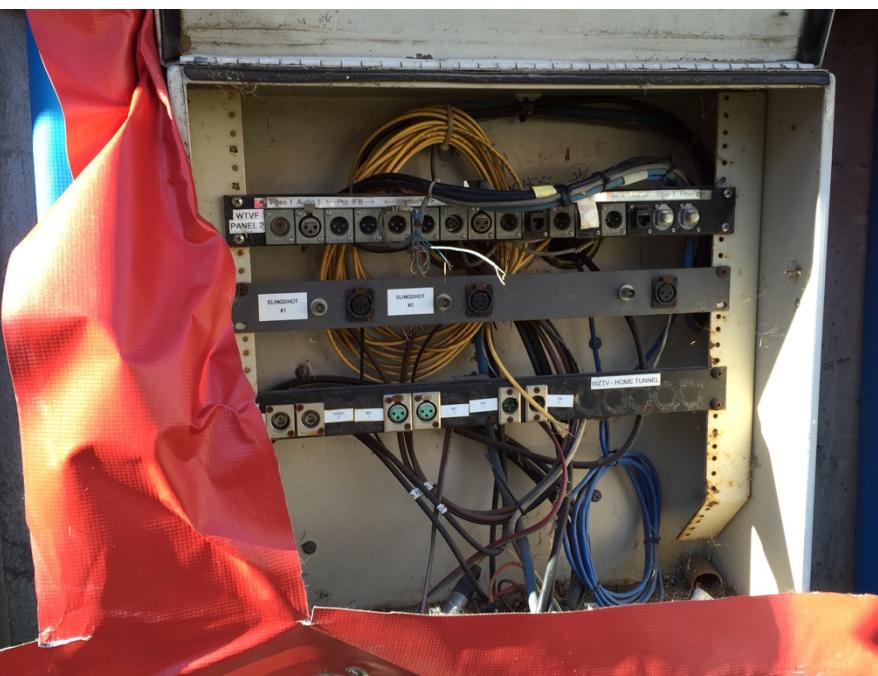
*Rusted and corroded coax and audio connections in corroded connection box*

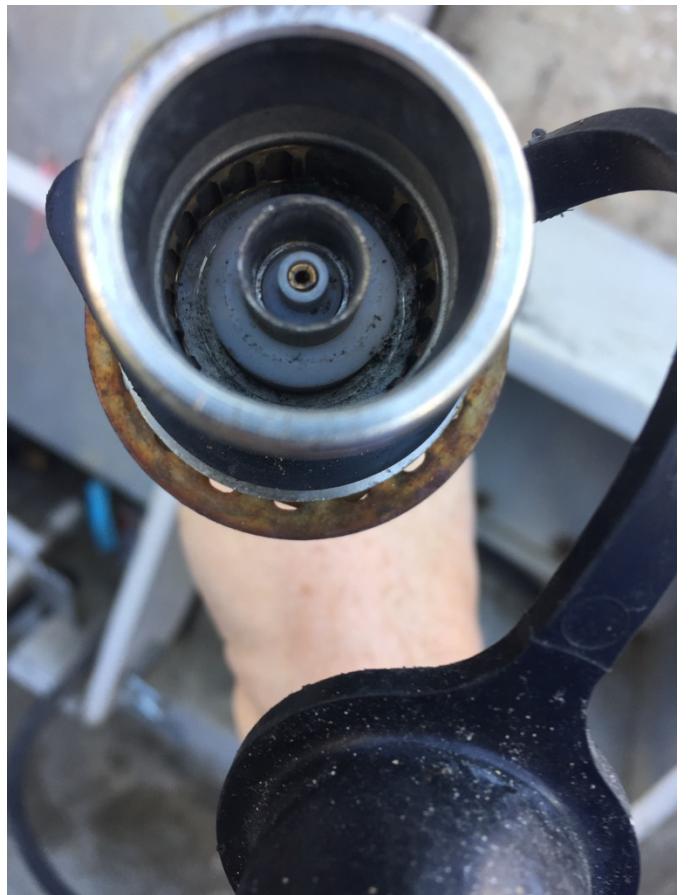
Same connector with corrosion in interior

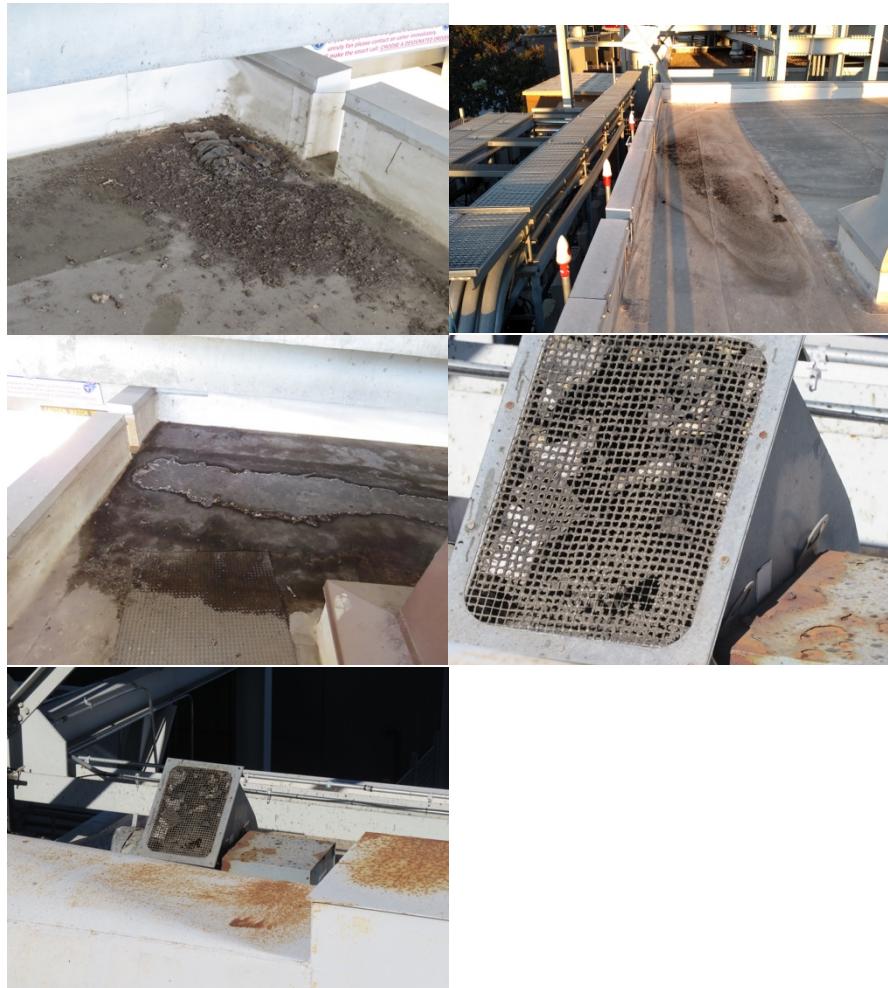
*Debris and grease/oil deposited from rooftop exhaust fans/vents onto the roof surface can cause hazardous conditions to persons walking/working on the roof, and may potentially cause damage to the single-ply roof membrane (four photos, above). Some small areas of roof appear to retain ("pond") water on the roof surface (photos below left and far below left). Although the roofs were dry at the time of our inspection, water stains/silt deposits on roof surfaces are an indication of areas that retain water. At least one open/non-watertight lap seam was noted on the PVC/TPO-covered roof areas (below right). This was the only such condition noted during our inspection of the roofs.*

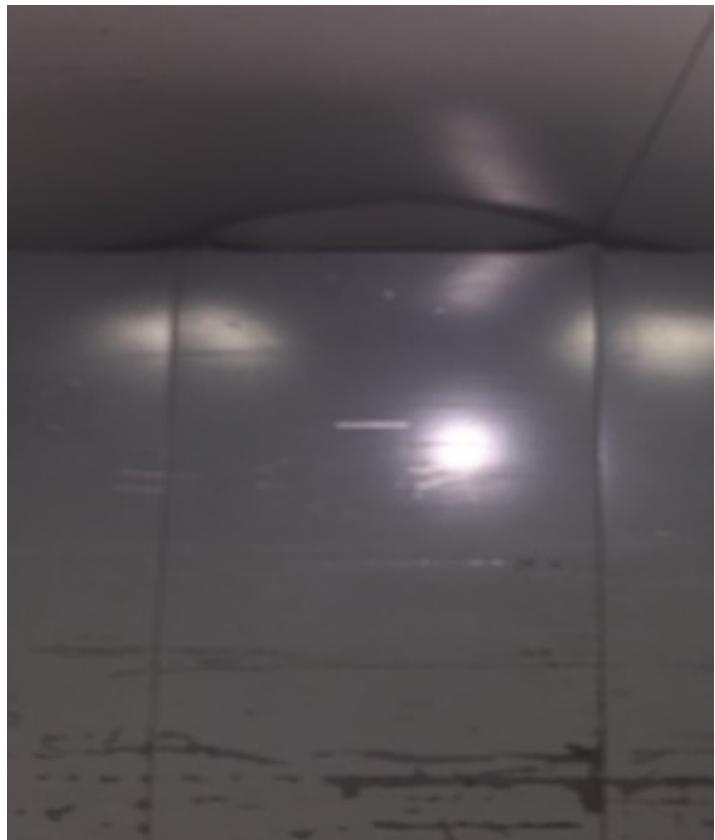
*Damaged Interior Ceiling on Freight #4*

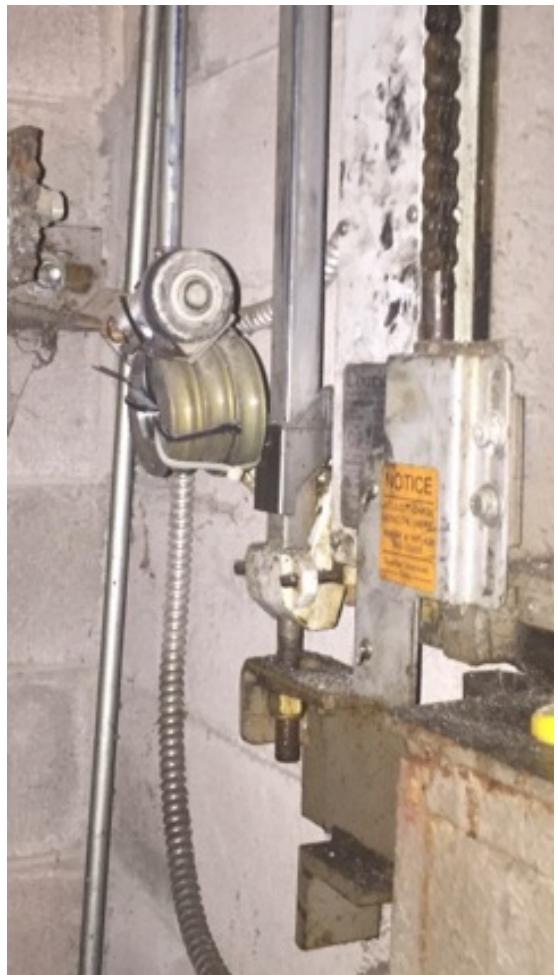
*Field Engineered Gate Switch in need of Repair*

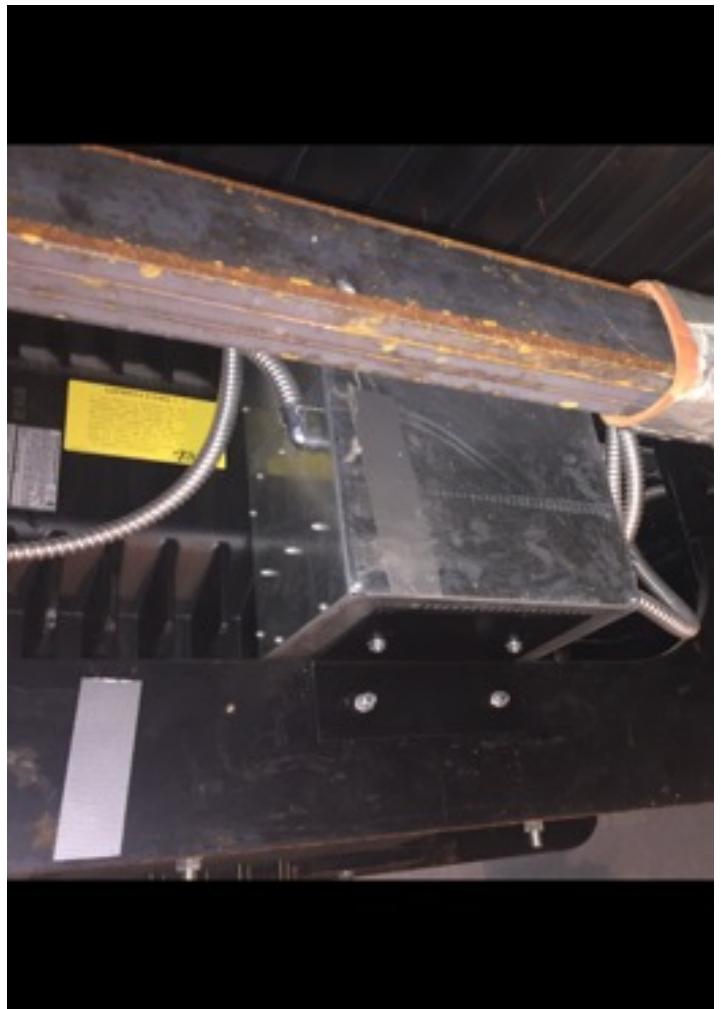
*Typical Rust on Equipment in Overhead on Express Cars*

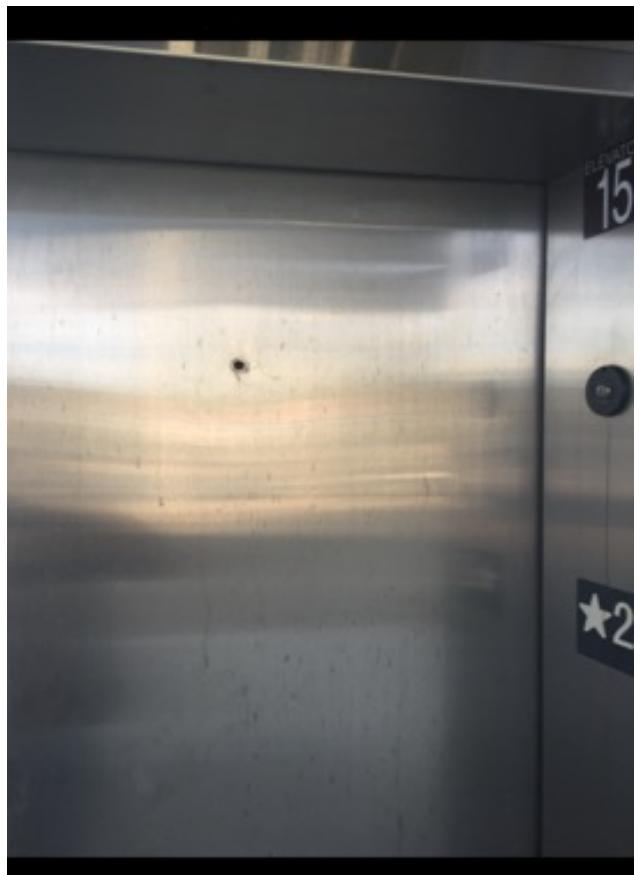
*Weather Damaged Hall Door Entrances on Express Units*

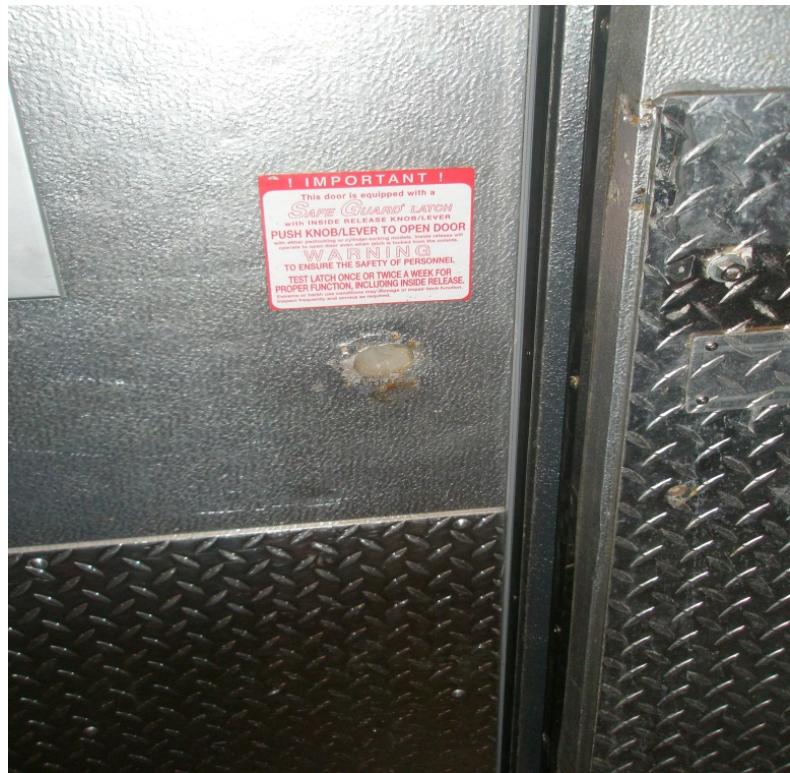
*Missing Door hardware on Cooler*

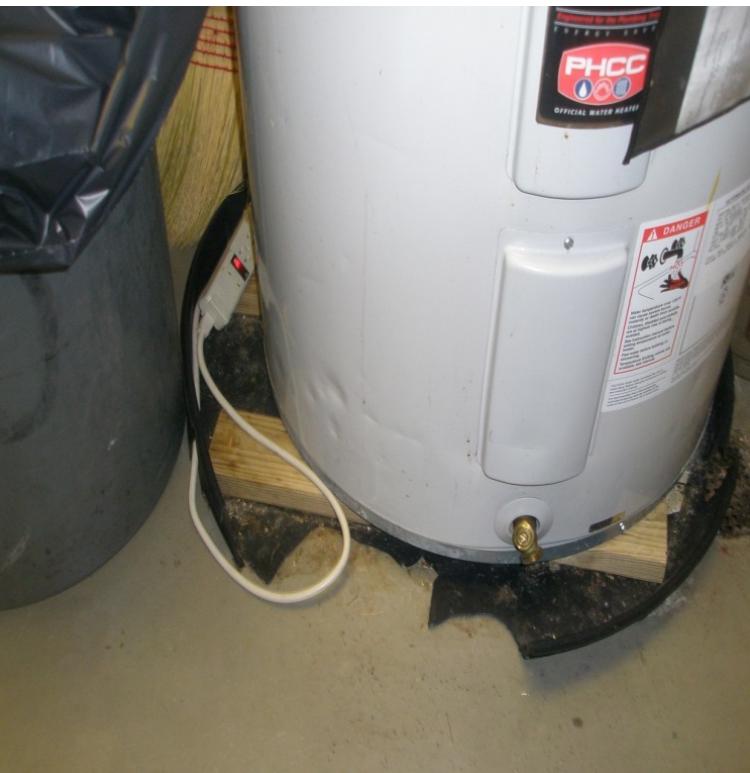
*Non-code compliant stand for hot water heater*
