## MEMORANDUM

DATE: June 21, 2024

RE: 509 North High Street Site Observations  
SEH No. PDRES P-179539 14.00

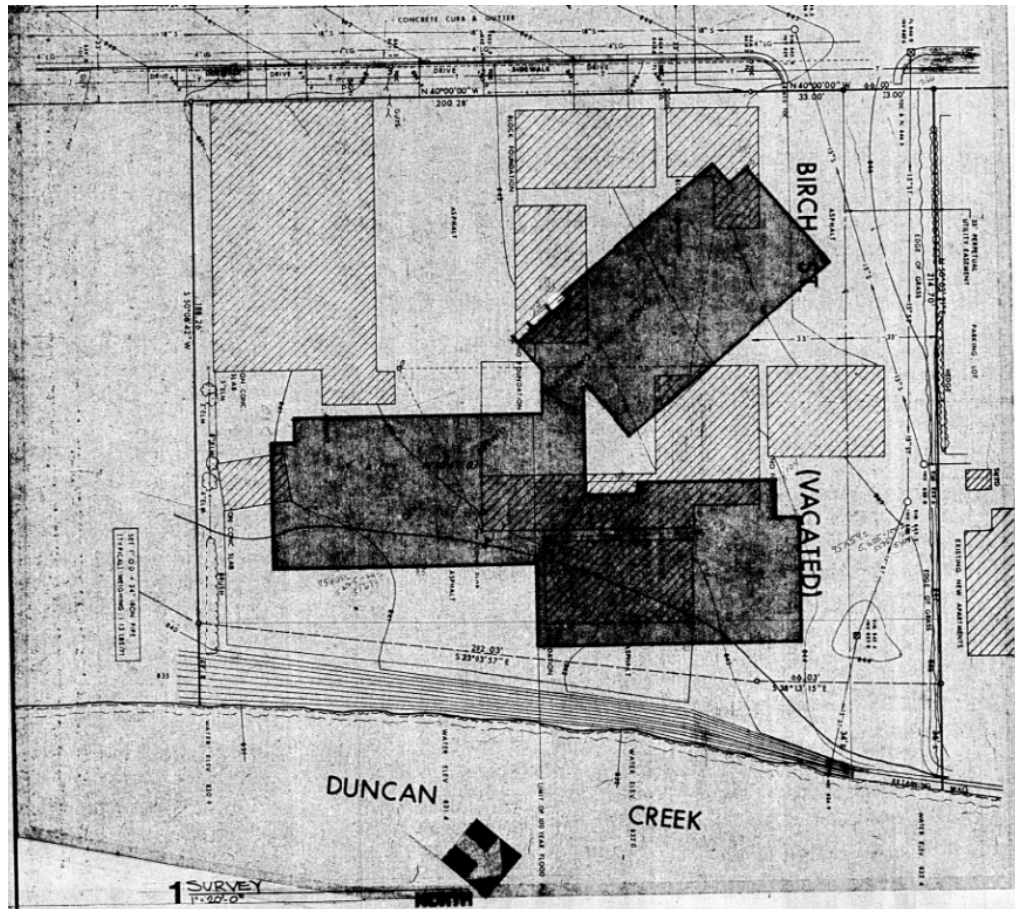
Figure 8 – Existing Building Drawings Site Plan

The structure at 509 North High Street sits on a site with historic use in the wood products manufacturing industry dating back to the late 19 century. A site grading plan dating to the structure's construction (see Figure 8) appears to indicate that portions of the footprint of 509 North High Street sit over the footprint of previous structures at the site. It is unclear what foundations existed on the site from the previous structures, and how or if those were fully removed during construction. It is also unclear if any portion of the site was previously filled (reclaimed land), or if debris was buried on the site while it was being used for industrial purposes. If debris did exist on the site at the time of construction, it is unclear if it was removed, and if it was removed, how those excavations were backfilled.

A site grading plan from the time of construction that was provided to SEH indicates some filling of the site was required to establish the current grade of the site during construction. The maximum fill thickness was placed under the southern portion of the structure. A maximum fill thickness of between 5 and 6 feet was required to reach the interior slab elevation of 846 feet. The required fill thickness appears to have tapered off to roughly 2 feet under the northern portion of the structure.

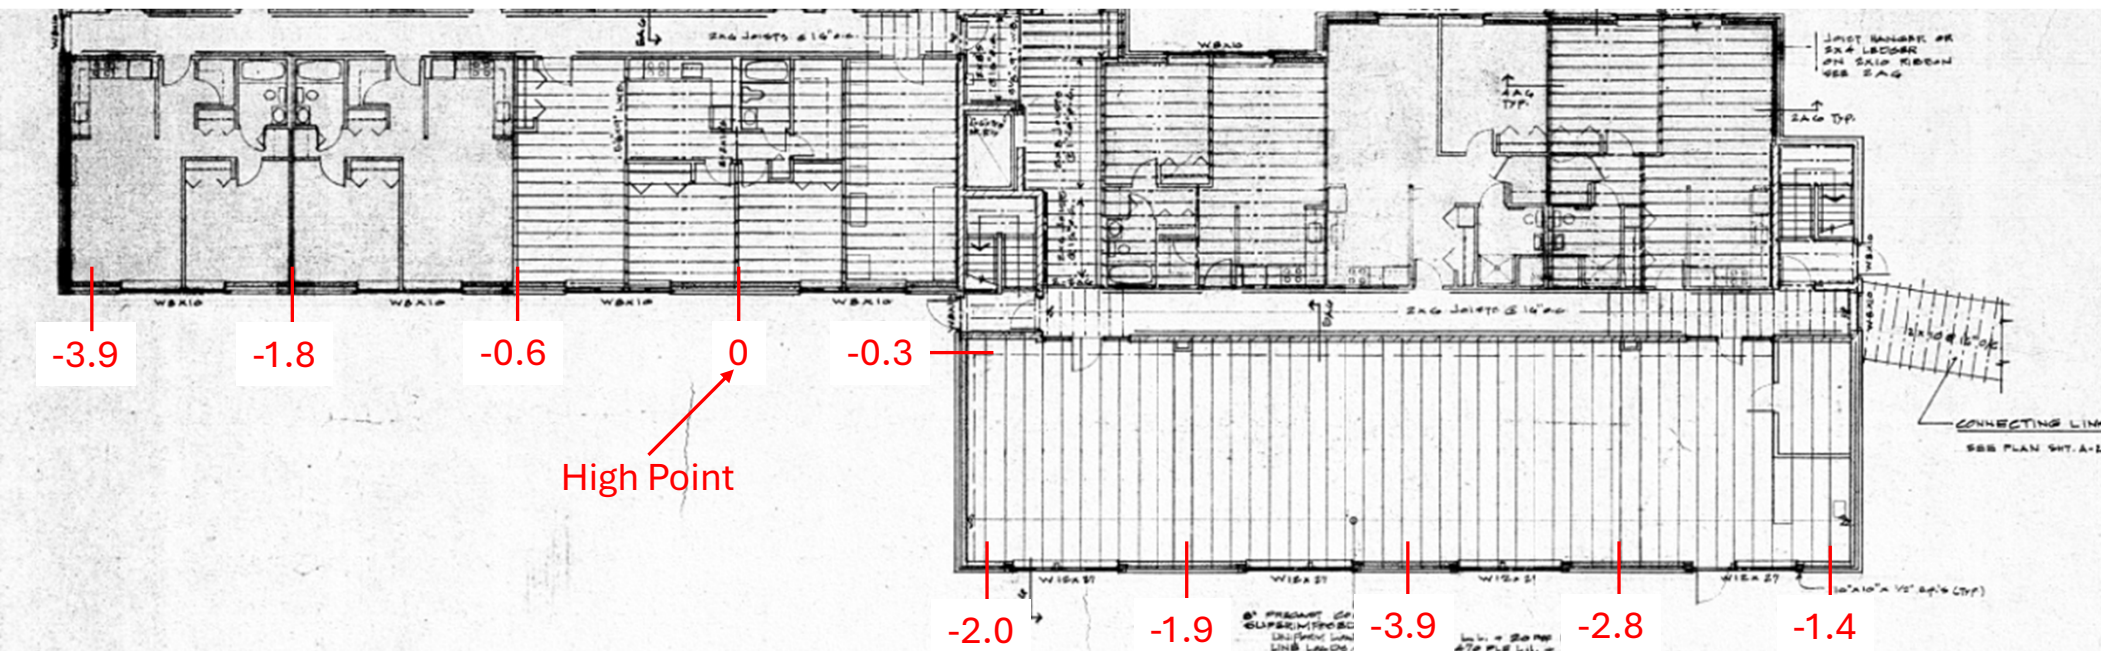
## Deviation From High Point of Measurement, June 11, 2024

The highest point along the wall line is just south the entry door that sits on the east-west wall. From there, the mortar line dips a maximum distance of 3.9 inches at the southeast corner of the structure. There is visible cracking on the brick facing at that corner of the structure. An offset from level of 3.9 inches was also measured near the midpoint of the north-south wall line on the northern half of the structure. The brick facing at this location is visibly lower than adjacent brick facing, but no visible cracking is readily apparent on the exterior of that portion of the building.

In the community room, the highest portion of the floor slab is in the northwest corner. The floor slab slopes to the southeast, reaching a maximum deviation of approximately 5.6 inches, referenced to the highest portion of the floor slab. At the location of the maximum deviation, it is apparent the interior wall has previously cracked and been repaired, and there is a significant difference in the width of the trim strip above the adjacent window.

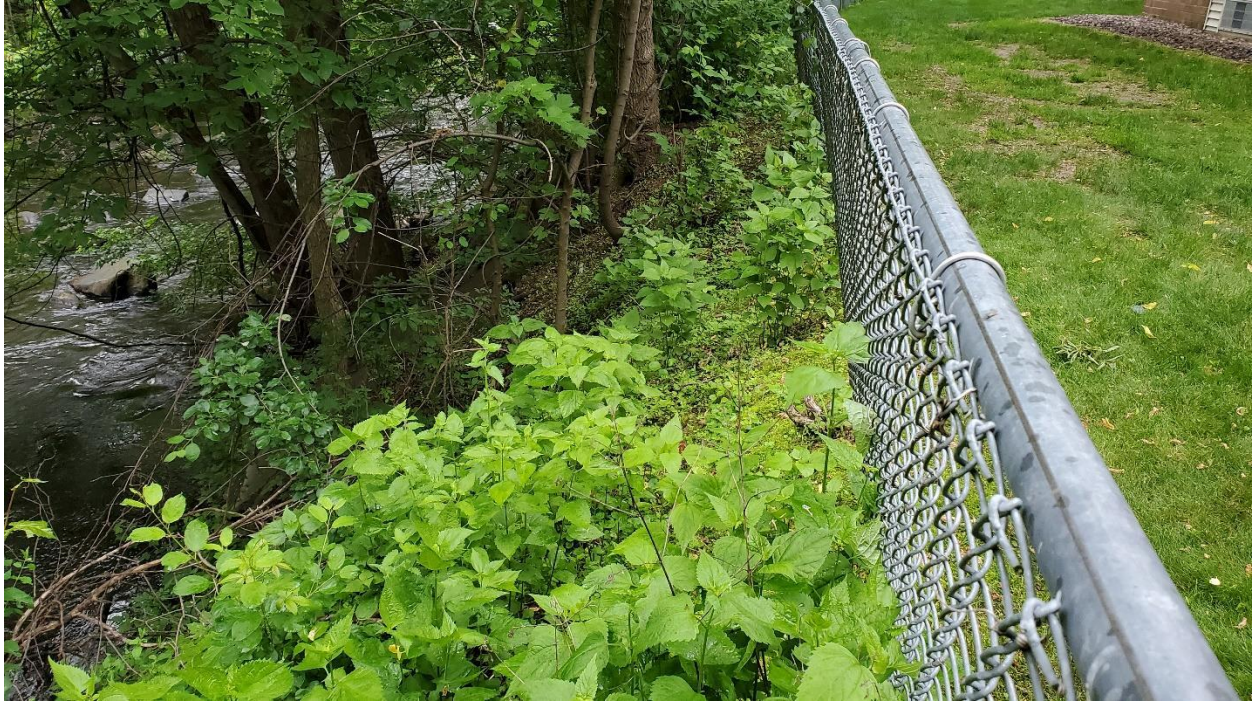
The grade from the crest of the bank of Duncan Creek to the creek appears to drop at a slope between 1H:1V and 1.5H:1V. The top of the creek bank appears to be between 10 and 15 feet above the water line. The surface of the slope is vegetated with a mix of large and small trees and some ground surface vegetation. Trees located on the slope were generally vertical and did not show signs of recent movement along the face of the slope. No toe cutting from erosion was observed along the toe of the slope. Vegetation made it difficult to fully observe the toe of the slope. However, debris consisting of concrete slabs and concrete rubble was observed on the slope face and along the toe of the slope. We also observed a chain link fence located at the crest of the creek bank which leans towards the creek. There was no visual evidence that recent movement of the slope face was causing the fence to lean. No visual signs of ground settlement could be seen along the edge of the building foundation and there appeared to be flat to positive grade away from the structure. A row of pavers separating the turf from landscaping gravel, which runs parallel to the structure, was generally straight and did not show signs of lateral ground movement towards the creek.

Existing Slope of Duncan Creek – Facing South

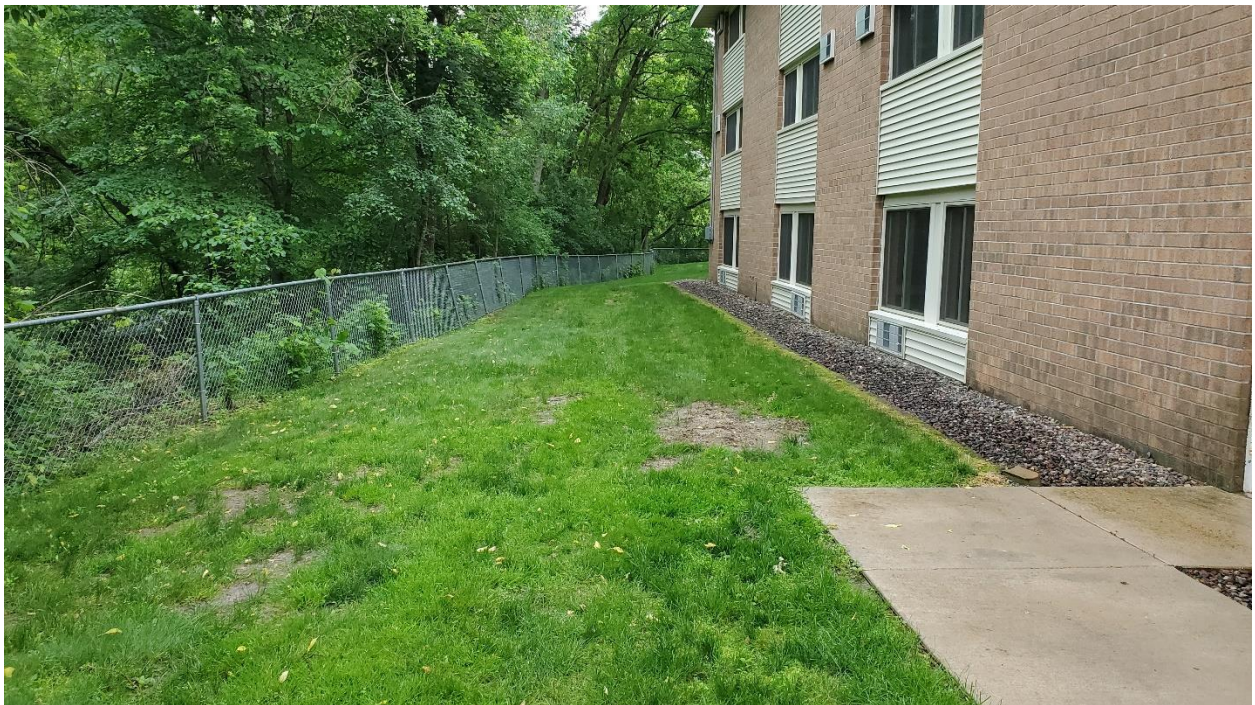
No visible evidence of lateral movement was observed on the ground surface between the structure and the creek. Visible evidence of movement can include cracking on the ground surface, or signs of a depression or drop in the ground surface running parallel to the creek, which would be the expected direction of movement if lateral ground displacement were to occur.

Area Adjacent to the Northern Portion of the East Wal Line – Facing South

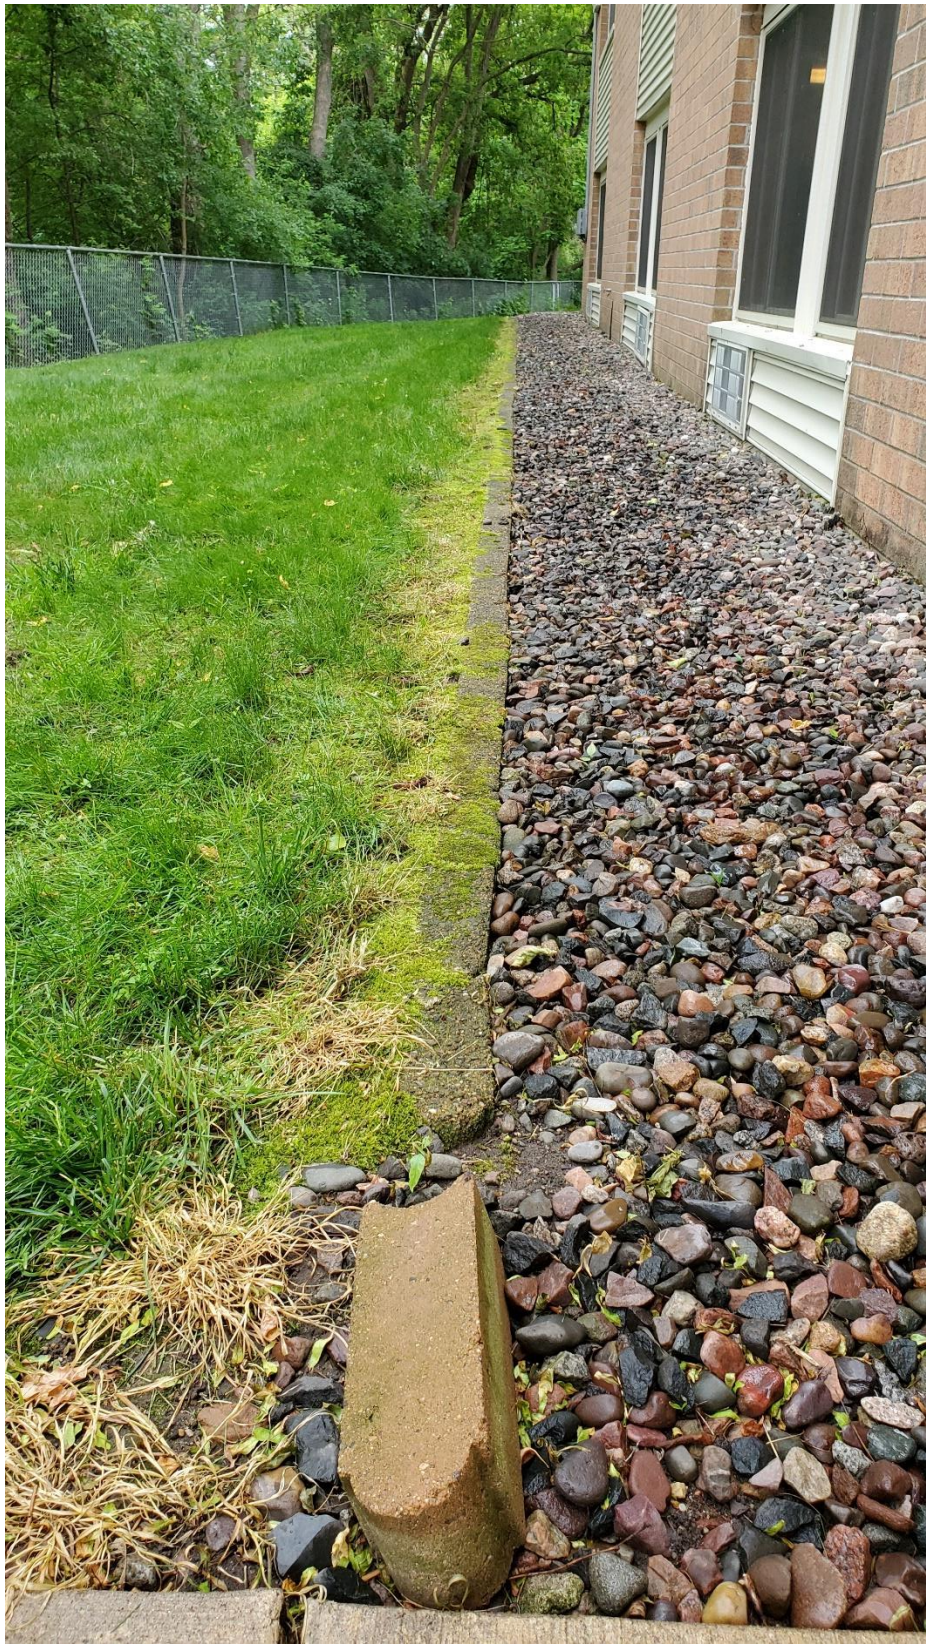
Paver Line Along Northern Portion of East Wall Line - Facing South

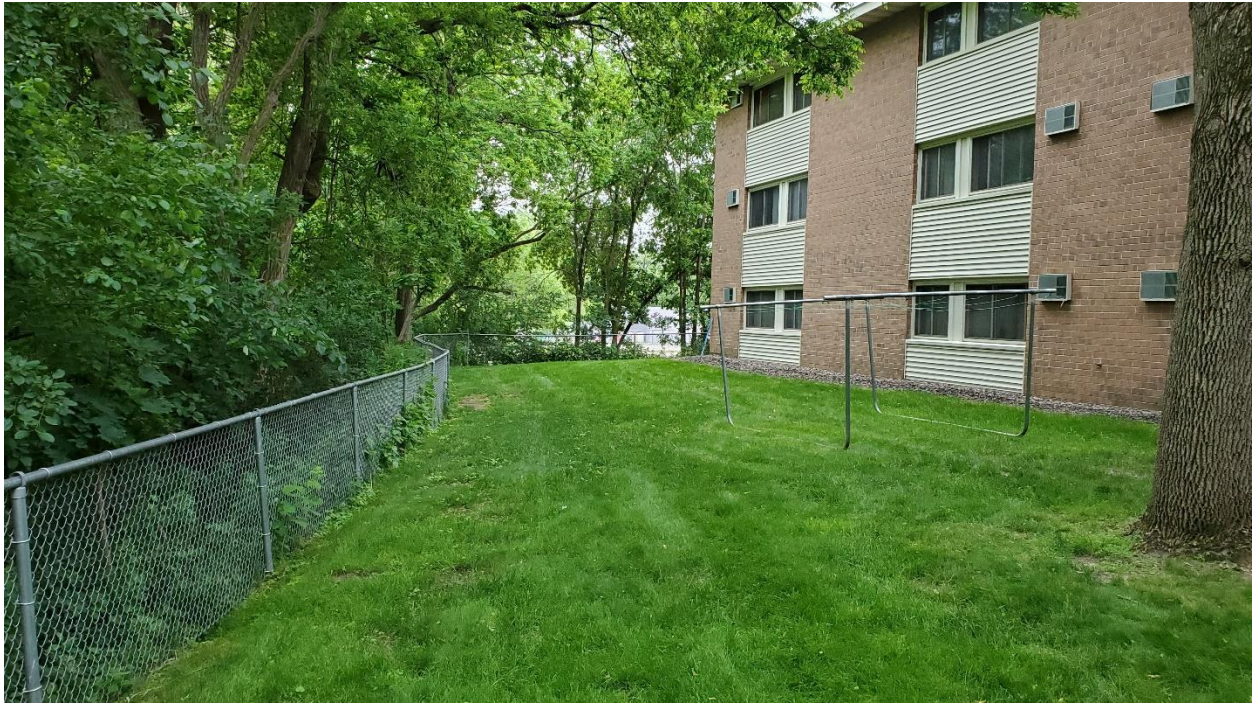
Area Adjacent to the Southern Portion of the East Wal Line – Facing South

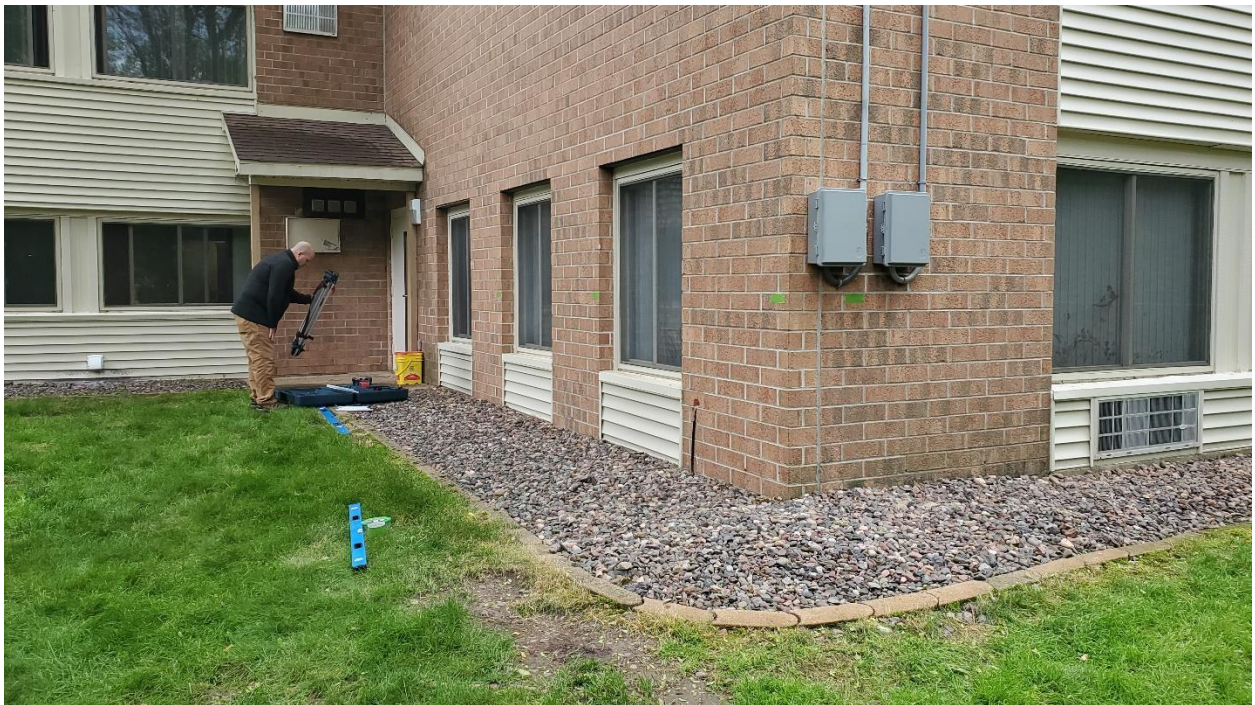
East-West Wall Line Near Midpoint of Structure – Facing West

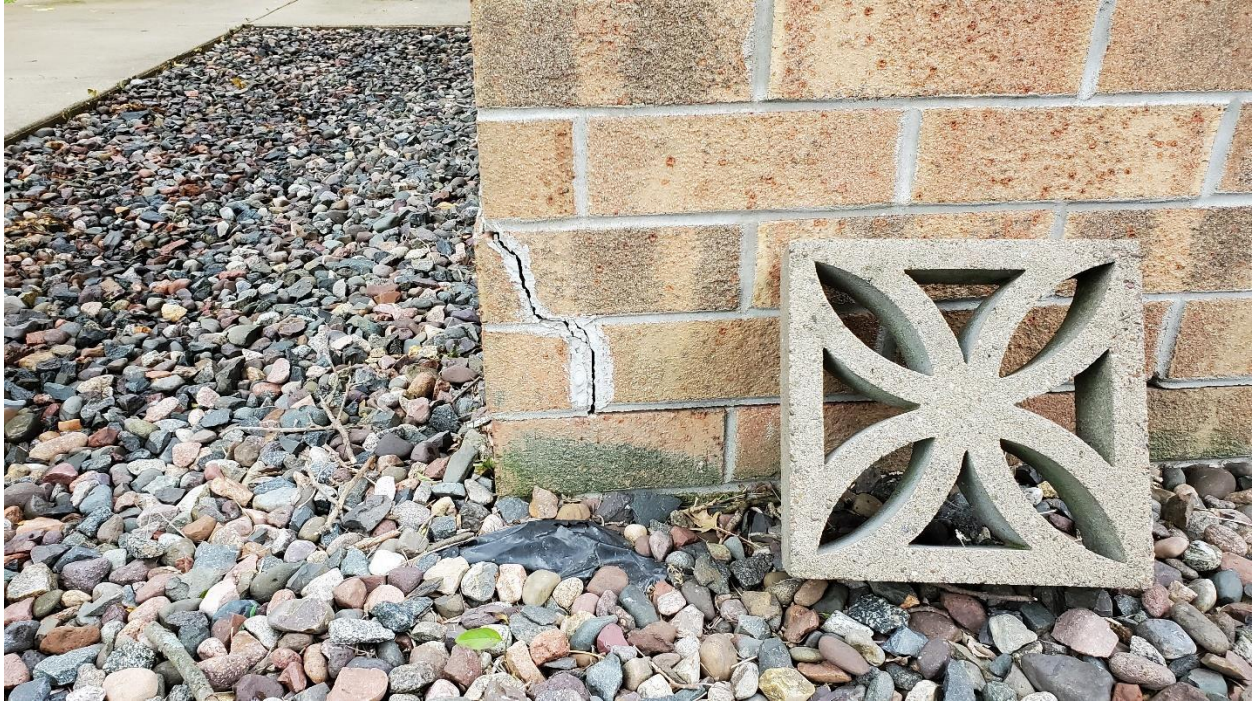
Exterior Cracking at the Northeast Corner of the Structure – Facing South

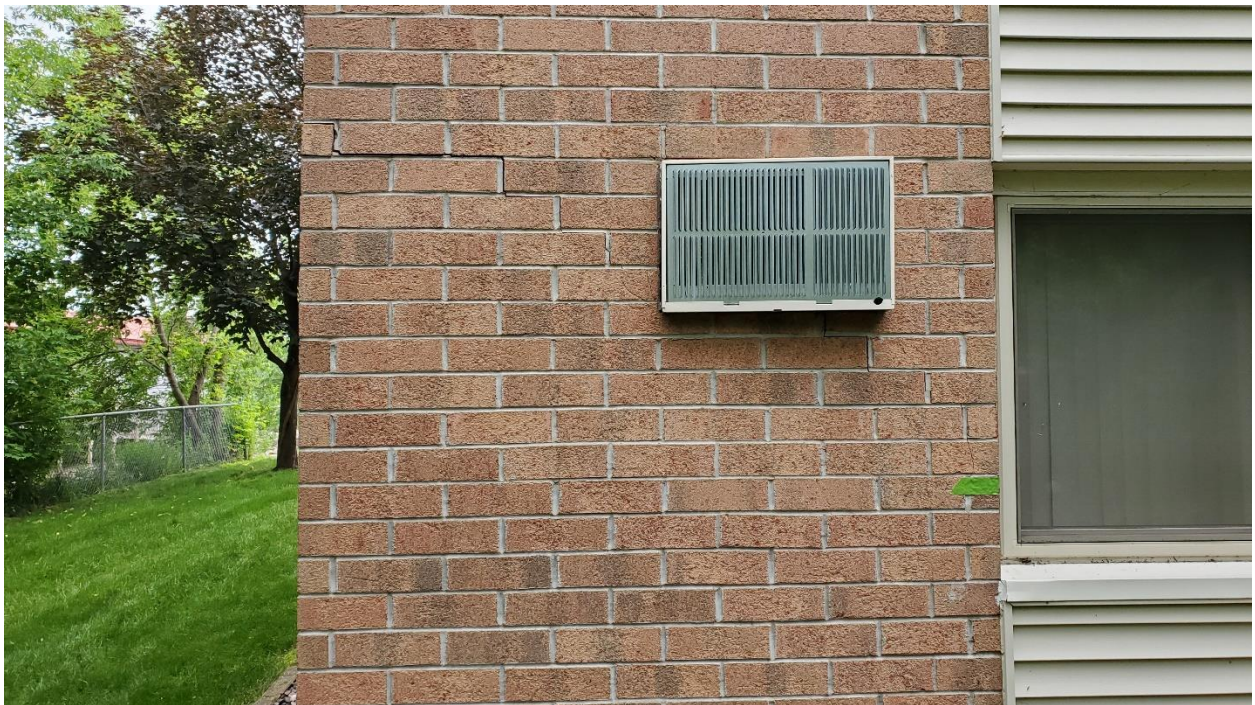
Exterior Cracking at the Southeast Corner of the Structure – Facing South

- Perform four geotechnical borings along the east side of the structure to check for the presence of possible debris, fill materials or poor soil conditions that could be contributing to the observed movements. One boring should be performed near the southeast corner of the structure, and one boring should be performed near the middle of the wall like on the northern half of the structure where there is obvious visual evidence the structure has moved. One boring should be performed near the high point on the east wall line and the fourth boring should be performed at the northeast corner of the structure.

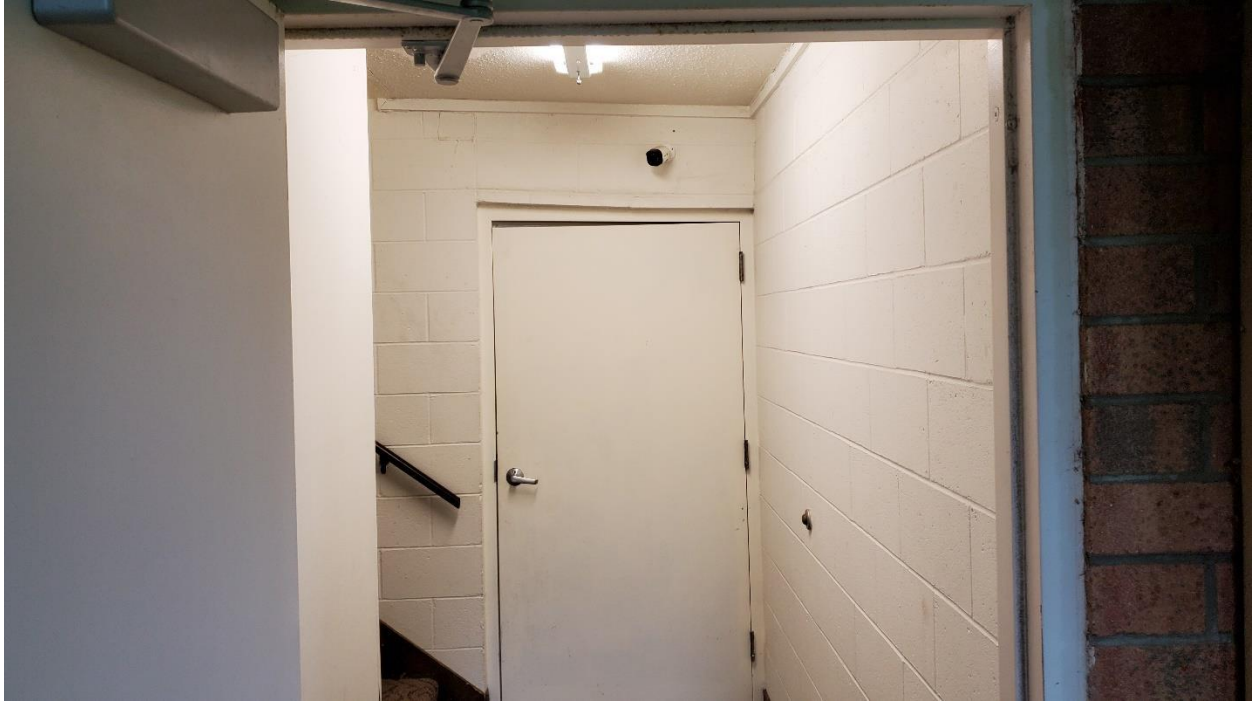
Out of Plumb Door Jamb, Entry Door Along East-West Wall Line – Facing North

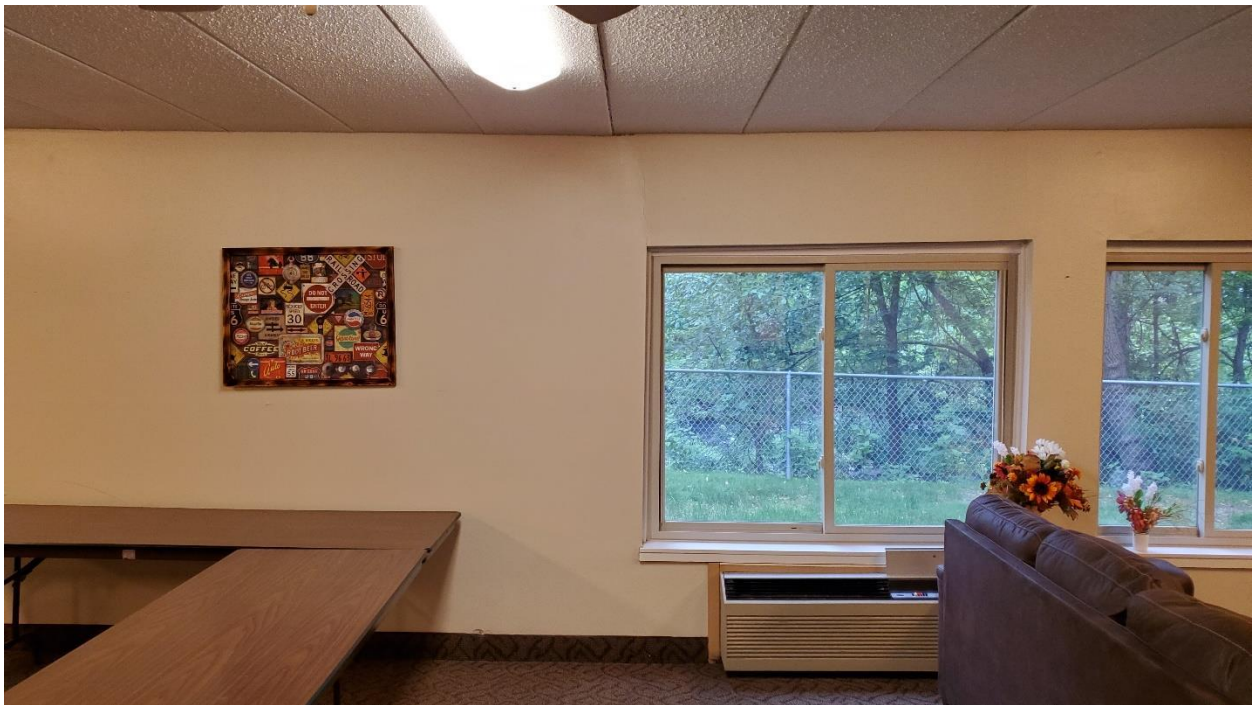
Community Room East Wall – Facing East

- Remove a portion of the interior sheet rock in the community room and at roof truss bearing in the area of the most observed movement so the condition and configuration of the interior masonry units can be observed.
